STATEMENT OF PASSING OVER INFORMATION

Reference
Repairs to deck as per
building inspection dated
may 2025

The purpose of the inspection is to identify major current deficiencies that are visually identifiable at the time of the inspection. The report shall include: grounds, structure, exterior, roofs, plumbing, electrical, interior, and insulation/ventilation. The property report does not include in depth testing of services such as, underfloor heating, specific and specialized heating systems, heat pumps, water pumps, functionality of any solar power source, swimming pool heating or alike.

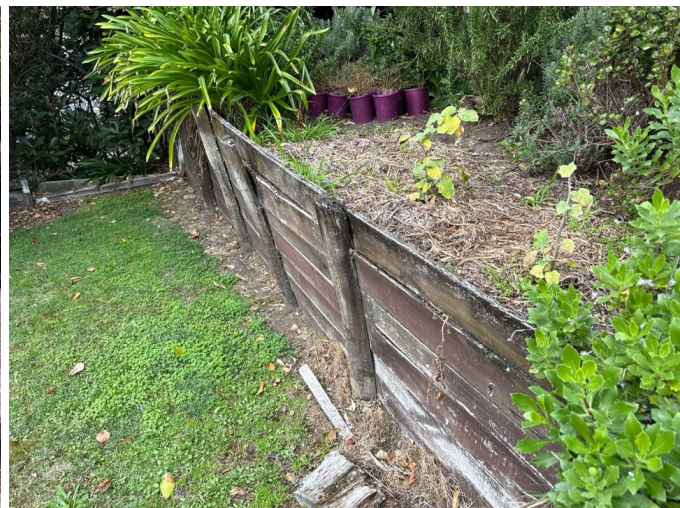
Retaining walls that are leaning significantly at the front should be replaced to prevent the risk of eventual failure.

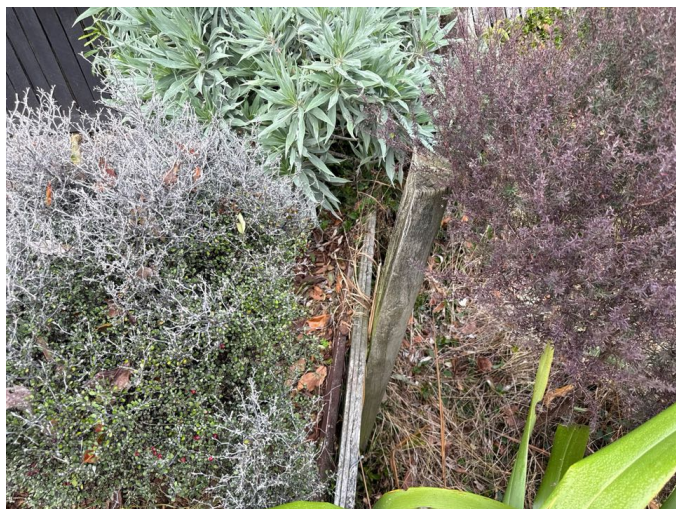
The retaining to the west side is leaning significantly and should be replaced

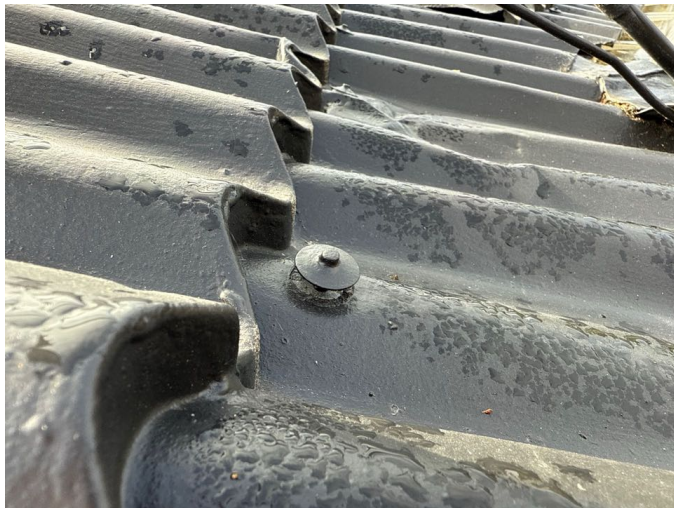
Any nails that are lifting should be replaced with self sealing screws. Risk of water ingress where the nails are loose.

Seal 6x cracks & holes in corrugated iron roof & touch up paint. Replace a number of roofing nails with self sealing screws, colour matched to roof. Scrape, seal and apply two top coats of Dulux Weathershield on north fascia.

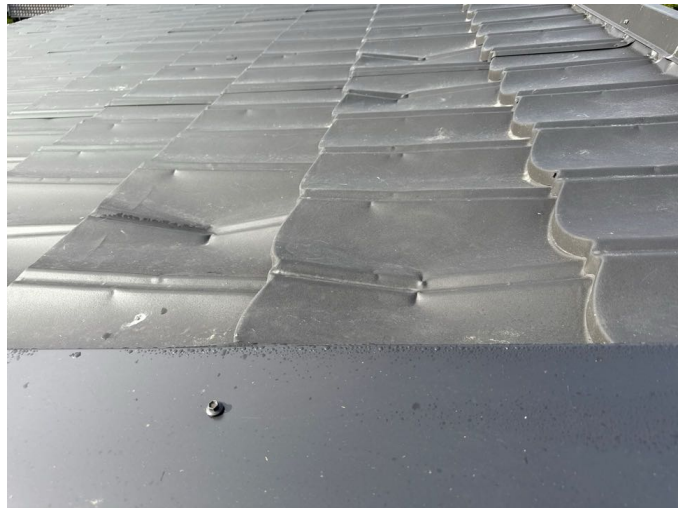
Dented tiles to various locations. The dents are not currently affecting the performance of the roof however they are prone to splitting and should not be walked on.

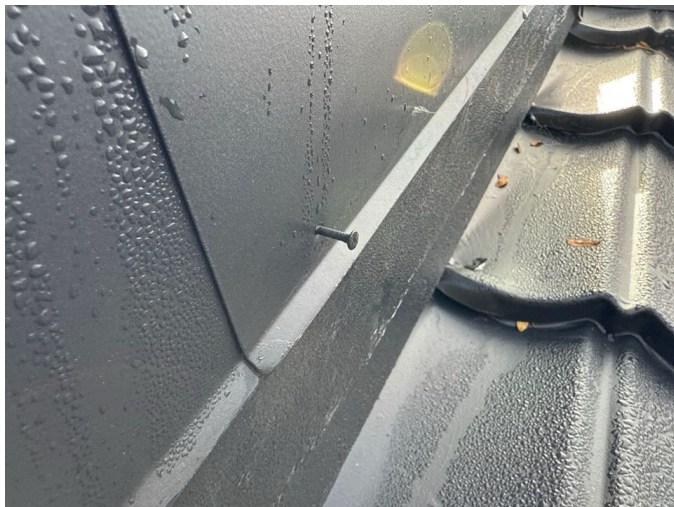
The nails have come loose at the barge flashings in the middle. Better fixings are required here.

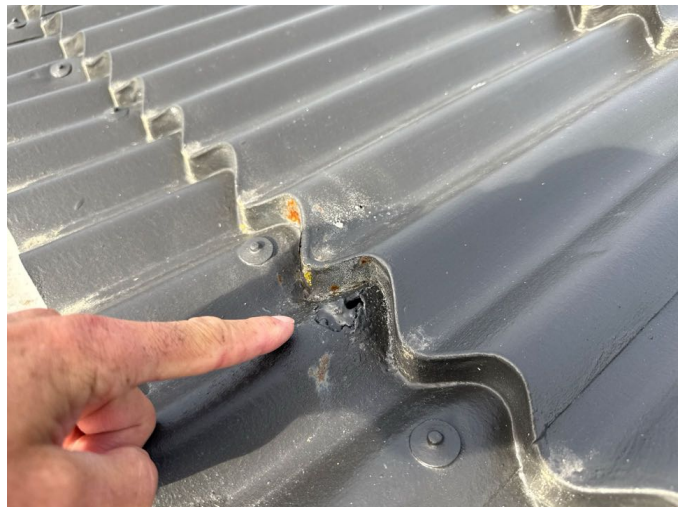
The steel tile roof appears to have been recently painted and is in an average overall condition. The rust and holes to the northeast side above the deck require professional repair asap. Any loose nail fixings should be replaced with a more effective fixing method. No evidence of failure could be found at the time of the inspection. A roofer should be engaged for maintenance.

Rust and holes to the tiles above the deck on the northeast side. Patch repairs or replacement of the tiles recommended asap.

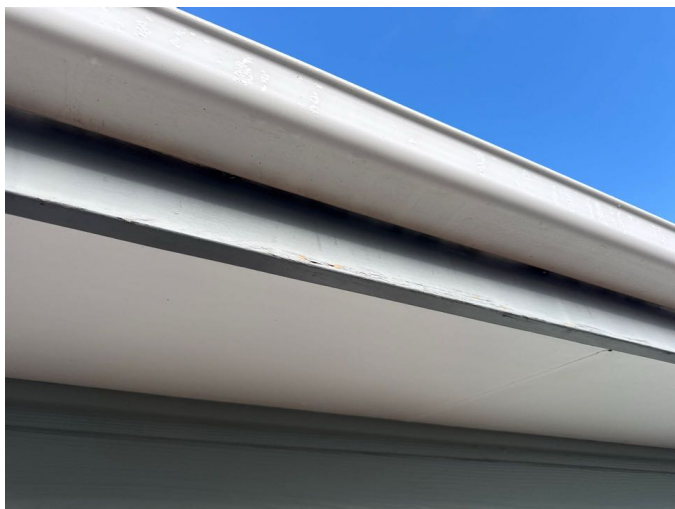
Paint deterioration to the timber fascia.

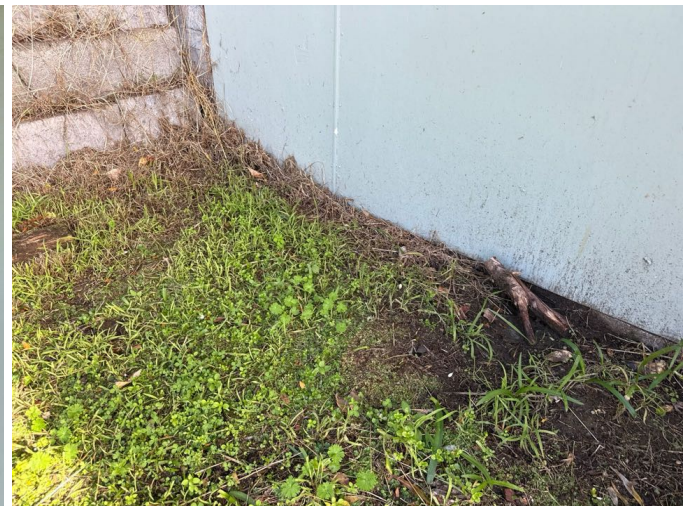
Poor ground clearance can result in moisture ingress via capillary action, a particularly high risk due to the bottom plate being at risk of decay. The current building code requires a 150mm clearance between the internal floor height and the sealed ground and 225mm to unsealed ground. The ground level should be lowered on this side. There is moisture staining and slight damage to the internal lining opposite.

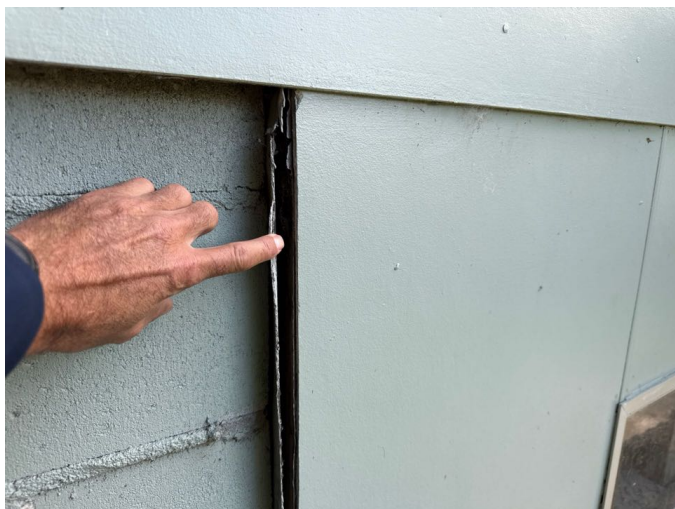
A licensed builder should be engaged to install a corner flashing at the foundation/cladding junction where the framing is exposed.

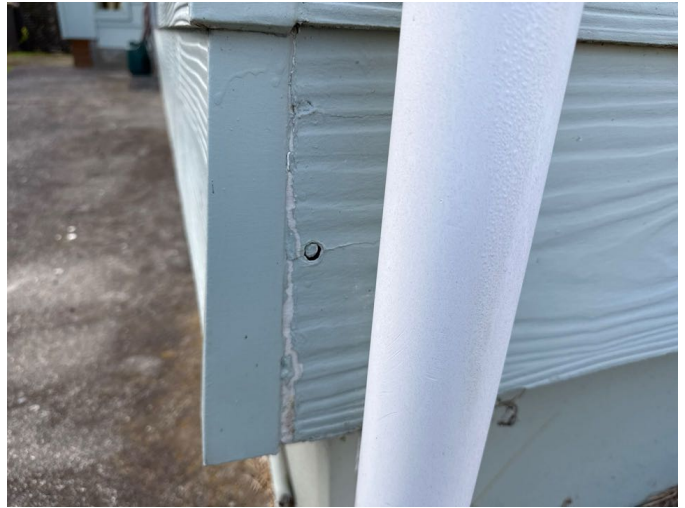
Northwest corner.

Additional fixings recommended where the nails have popped through the cladding. Nails that have failed need to be sealed to prevent moisture ingress.

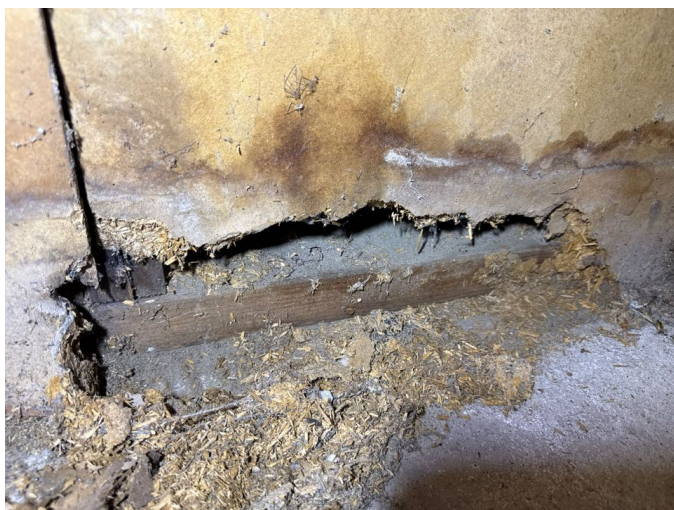
Moisture damage to the garage linings at the southeast side but no visible damage to the framing behind.

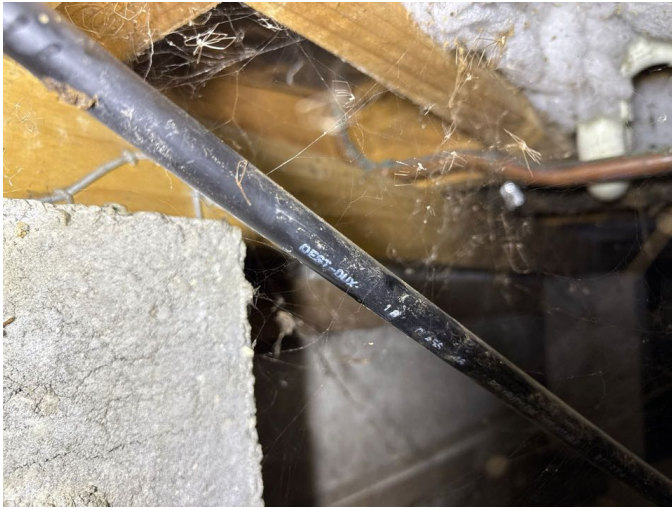
Polybutylene, Copper and Dux Qest. A plumber should be engaged to replace ALL active Dux Qest from the home.

Dux Qest pipe in service under the bathroom. T.H.I.S recommends full replacement of this plumbing type. Dux Qest was commonly used in the 70's and 80's and is a failed building product which has the potential to cause damage if left in place.

Building inspector report found Dux Quest water pipes under house, which need to be removed/replaced for selling house.
Remove all Dux Quest pipe and fittings under house, servicing ensuite bathroom and exterior hose tap on right side of garage.
Replace with Secura Gold pipe and fittings.

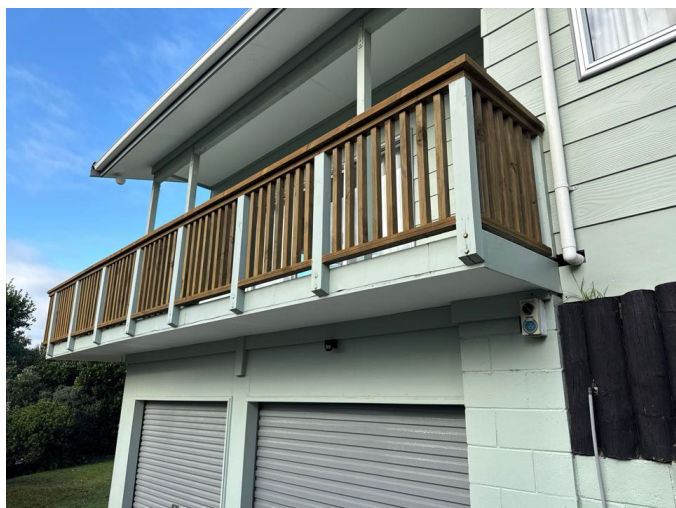
The rusting balustrade connections have caused the timber to split at the west end. Treating the rust may help slow the deterioration however the connections bolts will need to be eventually replaced with stainless steel.

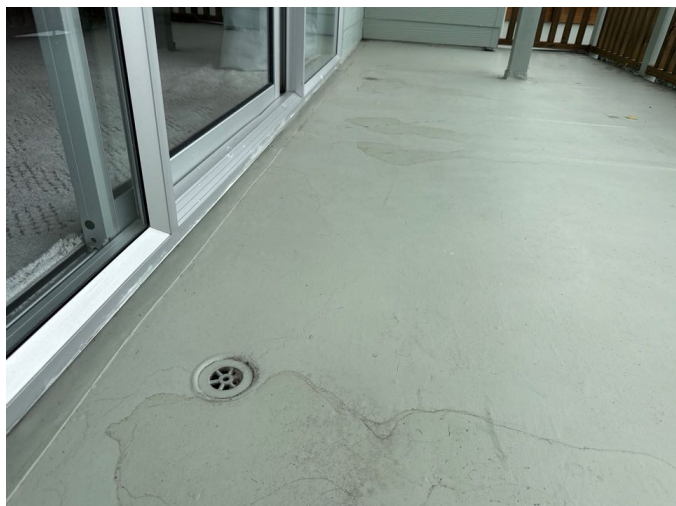
The membrane has failed at the base of the posts and rot damage is present beneath. Further investigation is recommended by a licensed builder initially.

The base of the timber roof supports has been poorly detailed and have failed. The timber is soft at the base of the deck. Further investigation is required.

Item	Description	Quantity	Unit Price	GST	Amount NZD
	Repairs to leaking and damaged butyl deck and Silcoat overlay	1.00	4,720.00	15%	4,720.00
Subtotal					4,720.00
TOTAL GST 15%					708.00
TOTAL NZD					5,428.00

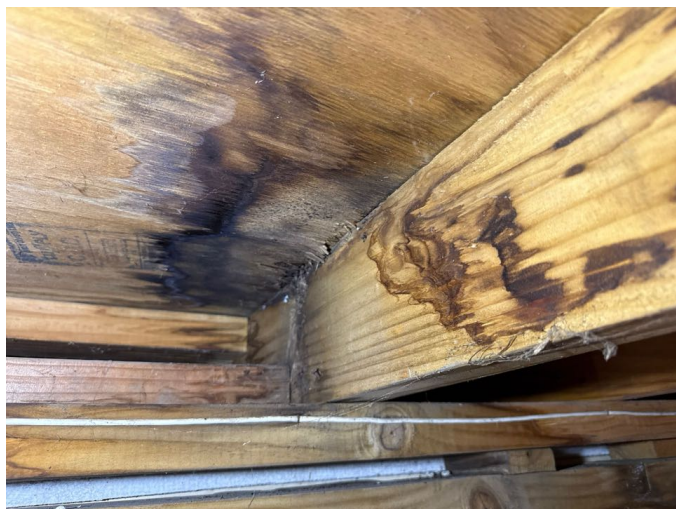
Failure beneath the deck confined. Rot damage to the plywood.

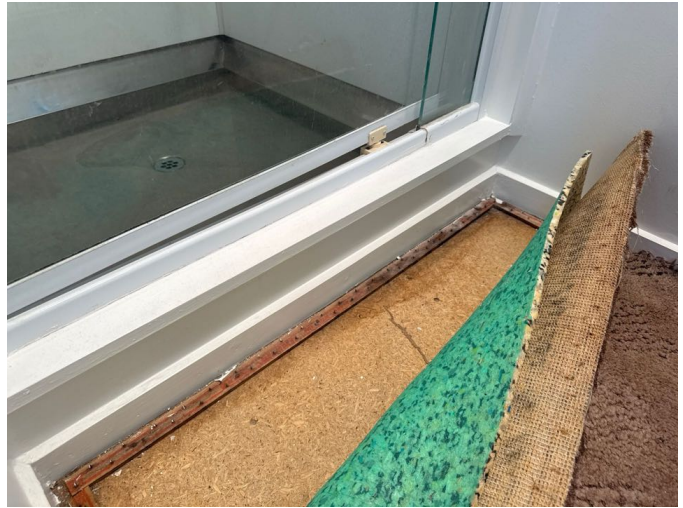
Minor moisture staining at the shower base. The carpet should be replaced with a more durable floor covering.

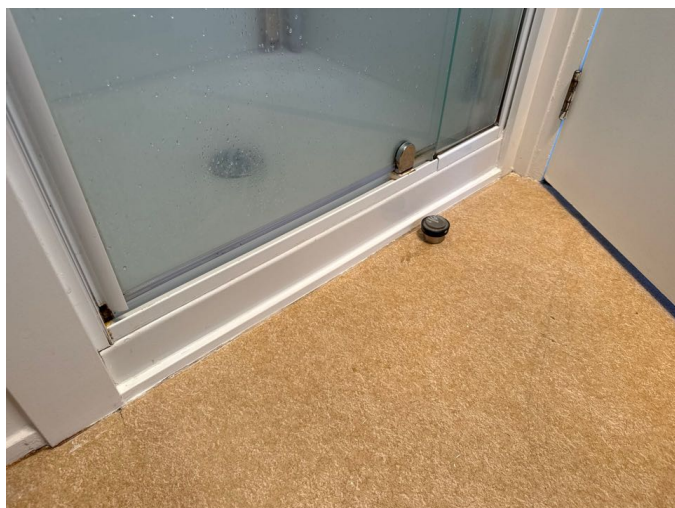
The base of the shower/floor junction appears to be effectively sealed. There is evidence of slight moisture damage beneath. The area must be kept well sealed and moisture managed well to prevent further deterioration.

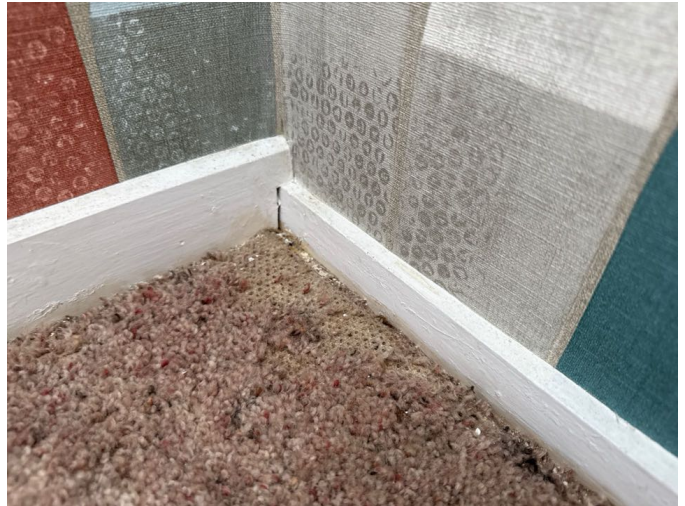
Deterioration to the carpet

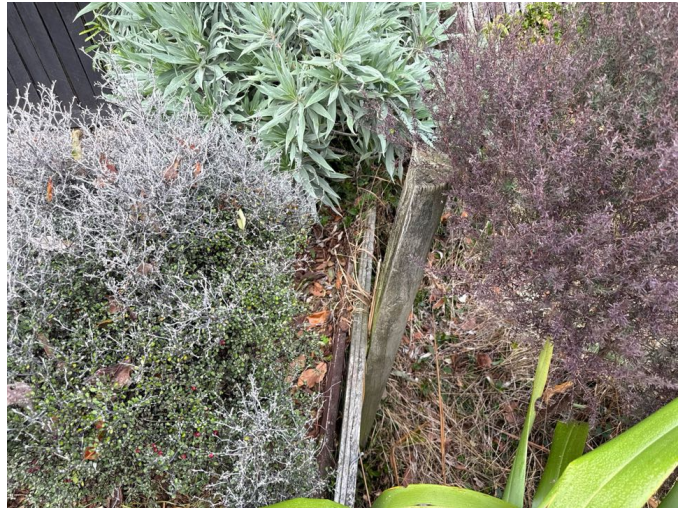
The retaining to the west side is leaning significantly and should be replaced

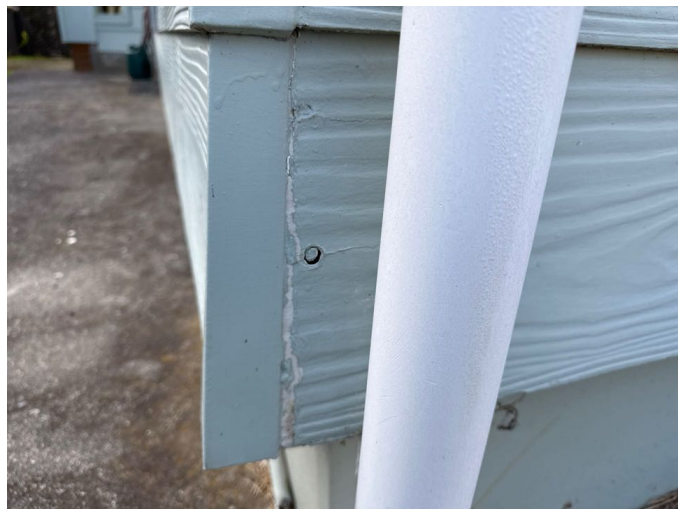
Northwest corner. Additional fixings recommended where the nails have popped through the cladding. Nails that have failed need to be sealed to prevent moisture ingress.

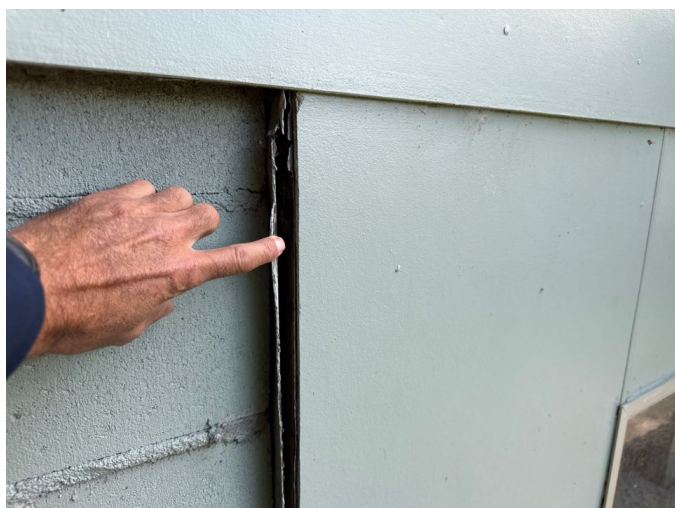
A licensed builder should be engaged to install a corner flashing at the foundation/cladding junction where the framing is exposed.
