EQC CLAIM DOCUMENTATION

EQR Property Overview Report

70 Landsdowne Terrace, Cashmere Structural Report

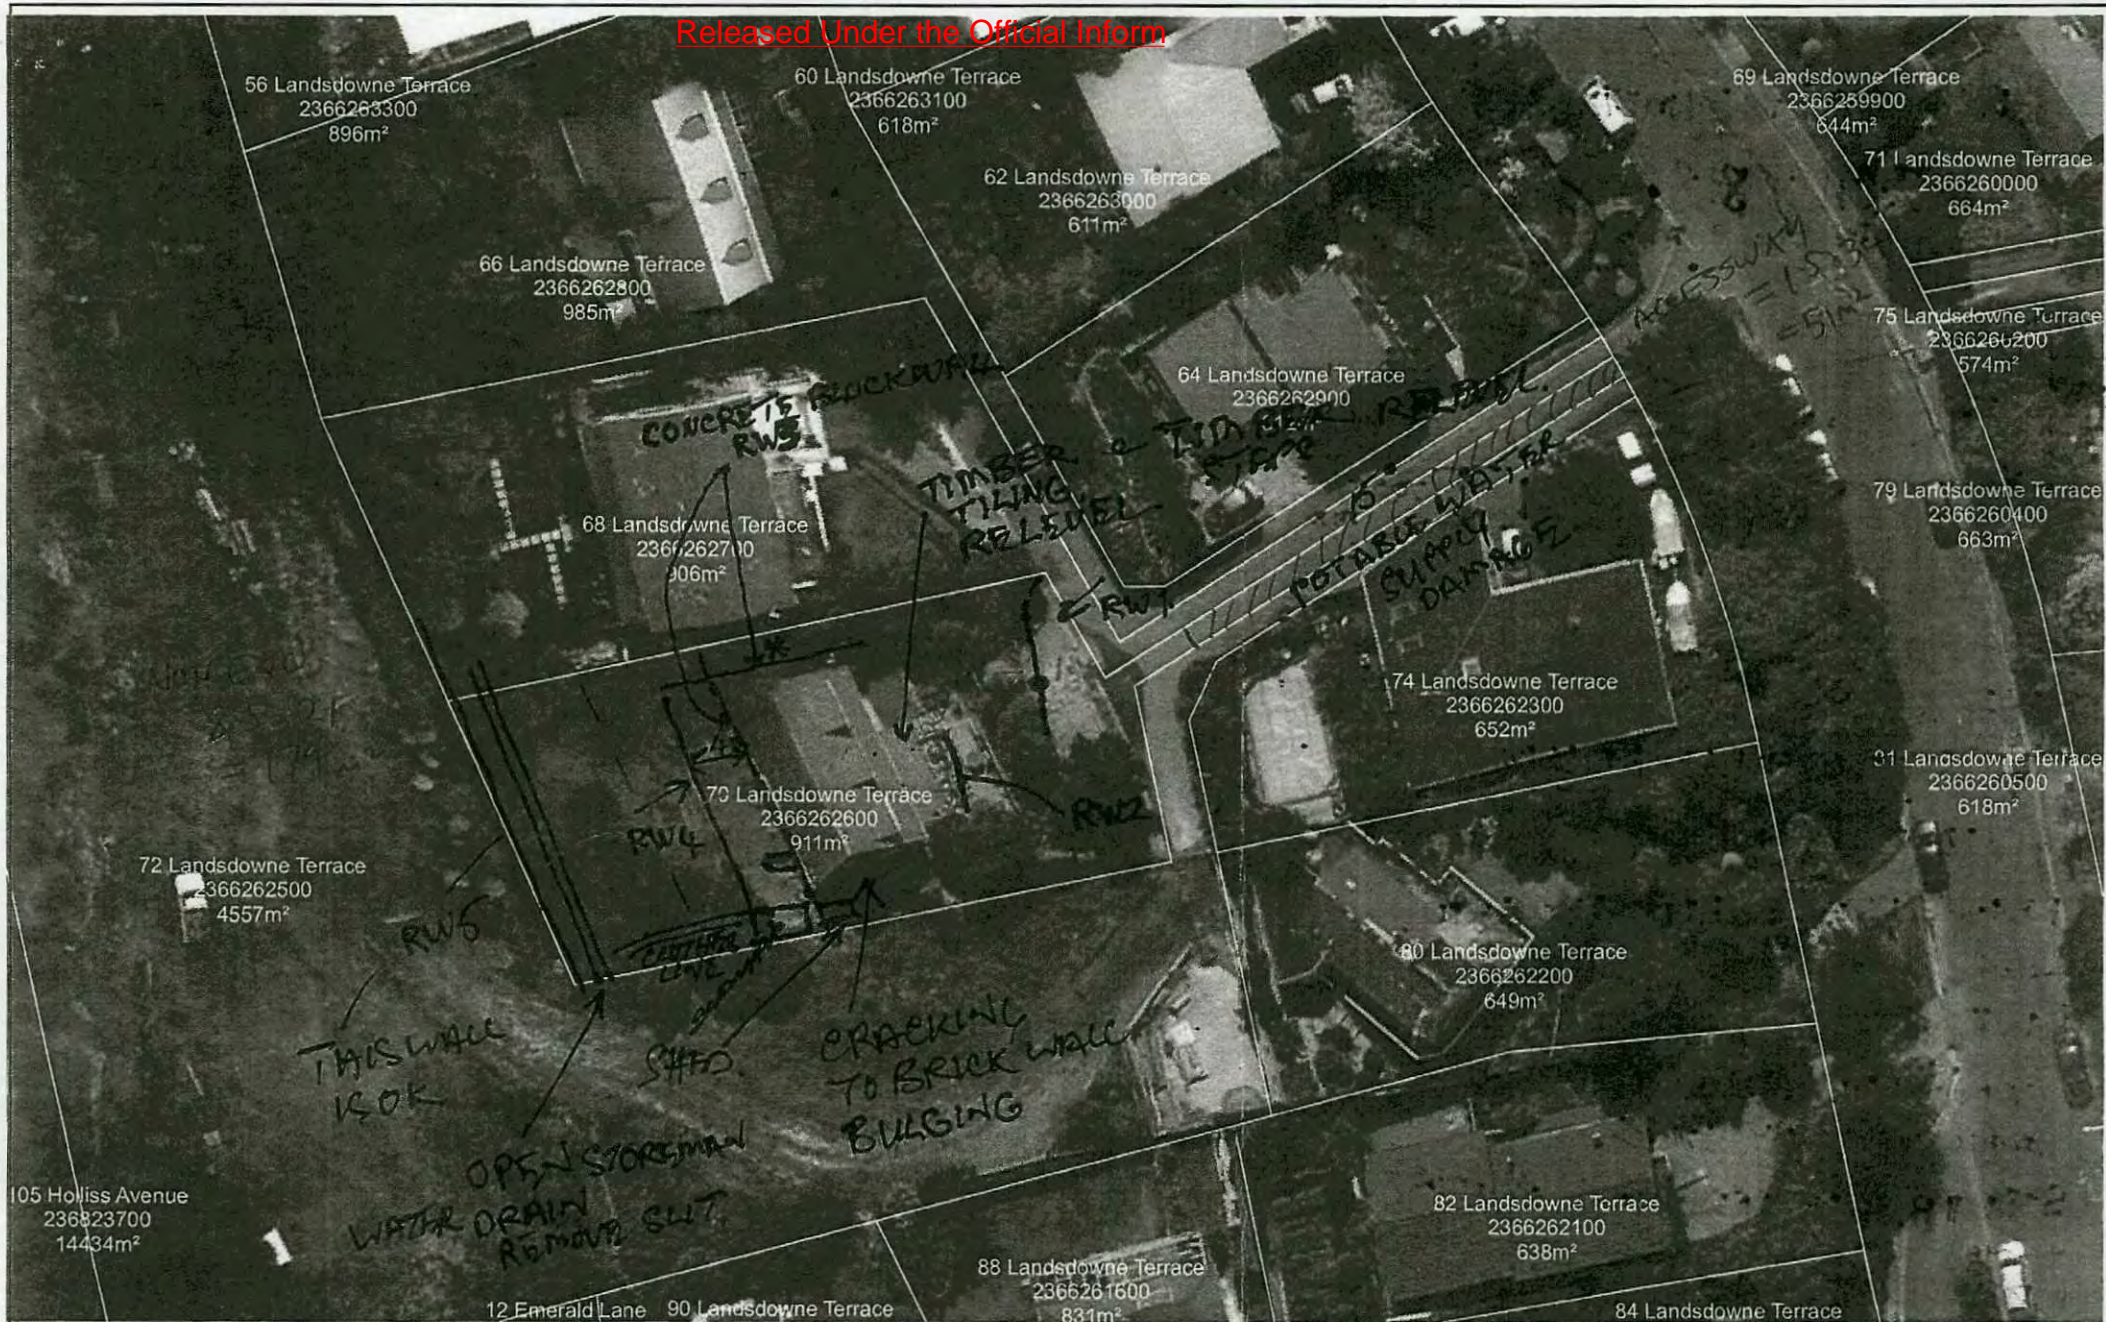
PATIO ALSO SLUMPING BEHIND RW1

NO OBSERVED CRACKS IN SLAB BUT I SUSPECT
THE FRONT OF HOUSE IS TILTING FORWARD SLIGHTLY.

Notes: RETAINING WALL DAMAGE P.T.O LEAF
 5 RETAINING WALLS ON THIS SITE
