RED LBP PRE-PURCHASE REPORT

CERTIFICATE OF INSPECTION IN ACCORDANCE WITH NZS 4306:2005

Company: ProInspect HB Ltd trading as RedLBP Hawke's Bay.
Client: Whistle Trustees Limited
Date of Inspection: 28th July 2025
Site Address: 151 Durham Drive, Havelock North, 4130
Inspector: Henare Waapu
Qualifications: National Certificate in Carpentry

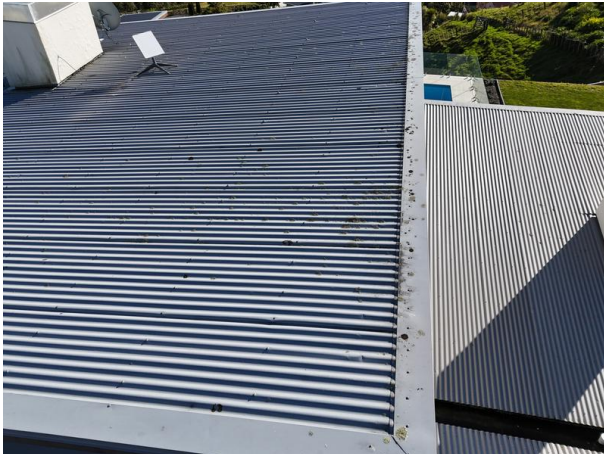
Photo 3
Profile metal roof. Visible moss and lichen.

The roof displayed visible signs of moss, mould, or lichen growth in certain areas, and it is advised to address this issue as part of regular maintenance. Failure to do so could cause deterioration of the coating.

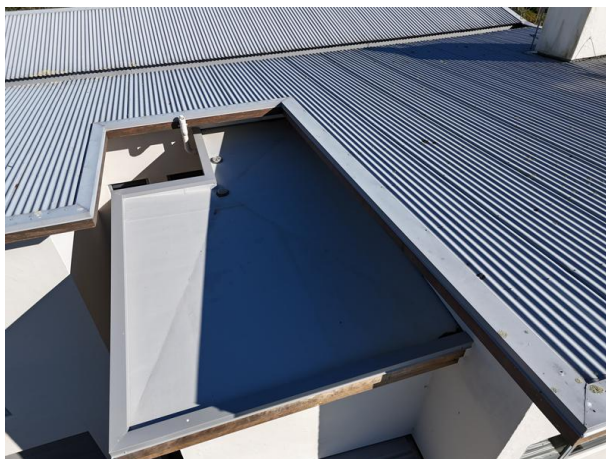
Photo 8

Barge flashings installed. Visible moss and lichen.

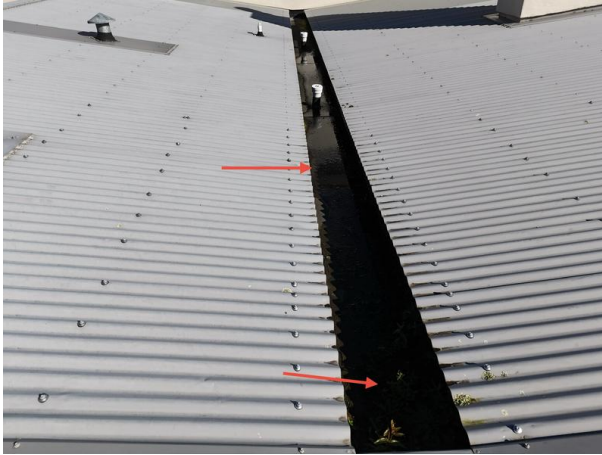
Photo 13
Internal guttering with visible water ponding and vegetation.

The guttering system has areas where water is ponding. Ponding water can lead to premature wear, corrosion, and potential overflow during heavy rainfall, increasing the risk of water damage to the property.

It is recommended to clear the gutters regularly to ensure proper drainage and prevent potential issues. When gutters become clogged with debris such as leaves and twigs, water can overflow and accumulate on the roof or other parts of the building. This can lead to water damage and leaks. Keeping the gutters clean ensures efficient water flow away from the roof, protecting the property from moisture-related damage.

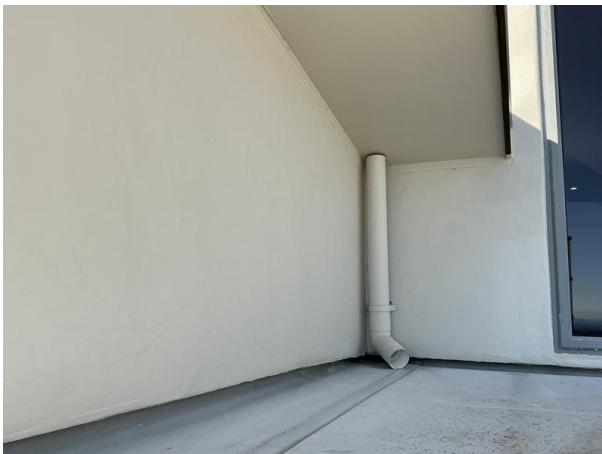
Photo 15
Downpipe on northern side of the roof, recommend installing spreader.

It is recommended to install spreaders to downpipes that discharge onto lower roofs. This installation helps to distribute the flow of water evenly, preventing excessive water concentration in specific areas and reducing the risk of damage to the lower roofs.

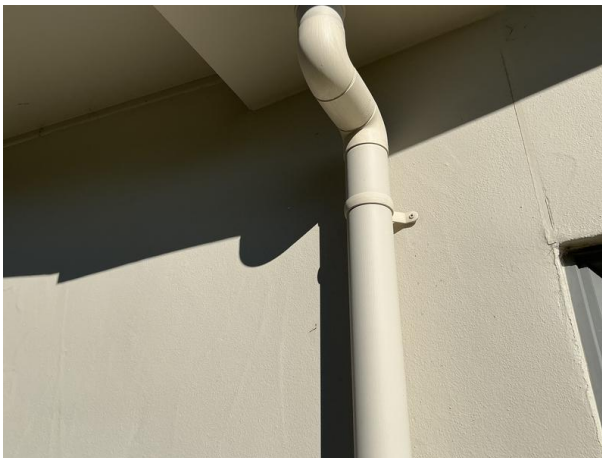
Photo 17
The screw to the down pipe on the eastern side of the house is loosely fitted.

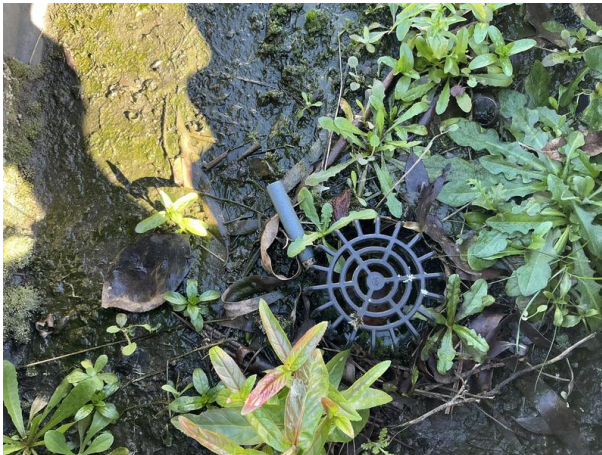
Photo 18
Vegetation in the internal guttering, recommend cleaning.

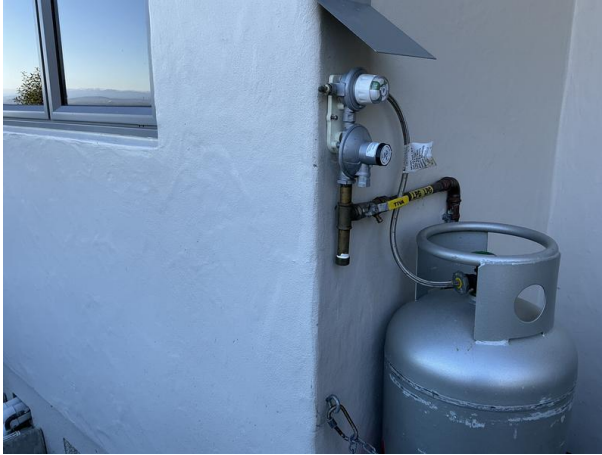
Photo 22

Penetrations to cladding for gas line on western side of the house are not completely sealed.

It is recommended to seal the gas line and power cable cover on the western side of the house to reduce risk of moisture ingress.

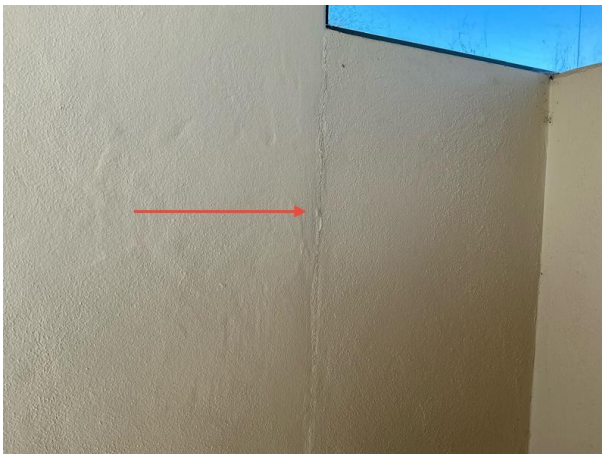
Photo 24

Uneven joint finishing at the wall junction in the north-western corner of the house. No active cracking was observed at the time of inspection. Refer to supplementary thermal image (Photo 81).

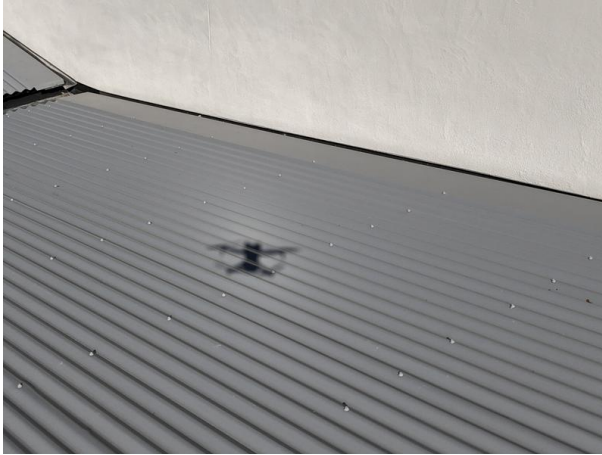
Photo 25

Cladding to apron flashing is within 30mm.

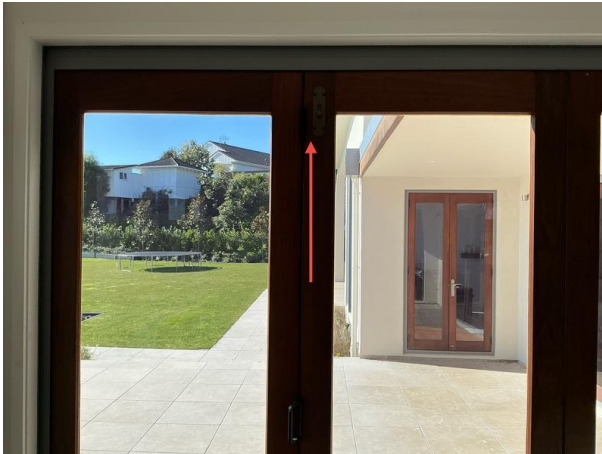
Photo 32
Maintenance recommended to lock on door in living room.

Some window latches were loose and/or require minimal repairs, it is recommended these are remedied as part of general maintenance to the property to assist with draughts.

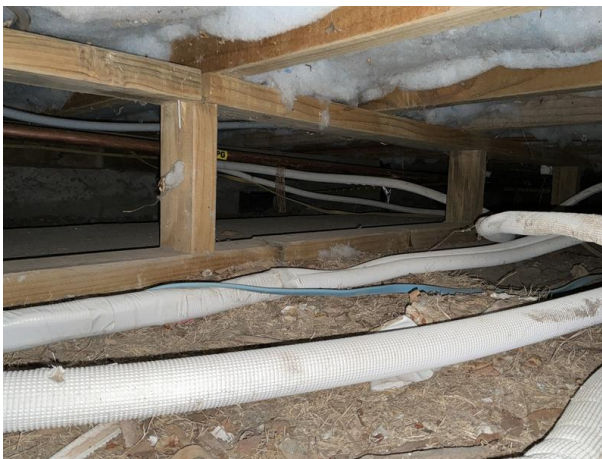
Photo 35

There is timber framing sitting directly on the ground, propping the joists. The timber on the ground may be prone to moisture related deterioration over time.

- It is recommended to engage a Licensed Building Practitioner in Carpentry to assess and report on the timber framing resting on the ground in the subfloor to ensure structural integrity and durability. Refer to Foundation section.

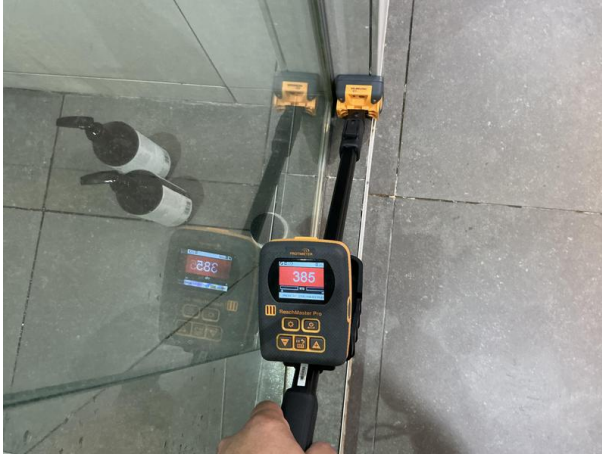
Photo 49

Moisture reading of 385 to the exterior of the shower ensuite in bedroom 1. Indications of elevated moisture levels were detected.

Have a suitably qualified building surveyor further investigate the indications of elevated moisture levels and weathertightness of the property.

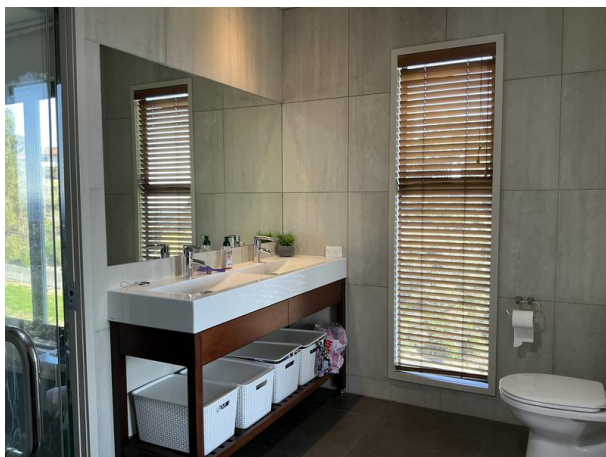
Water leakage is visible at the corner of the shower enclosure, particularly where water flow is directed toward these areas. It is recommended to engage a qualified professional to assess the issue and properly remove, reseal, and reinstall the affected components of the enclosure to prevent further leakage and potential water damage.

Photo 62
Ensuite.

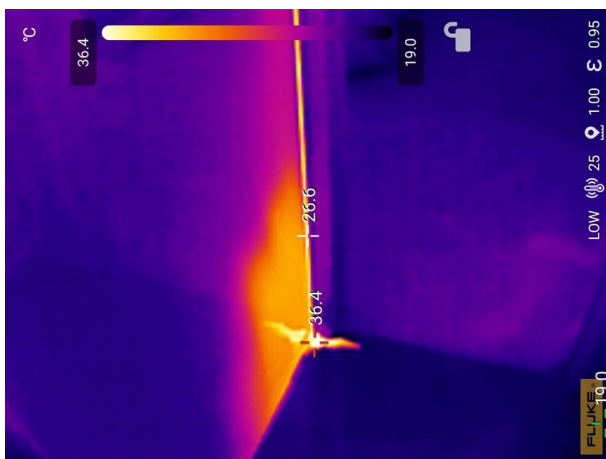
Photo 80

Visible temperature variation at exterior corner of upper-level ensuite shower. Refer also to Photo 62.

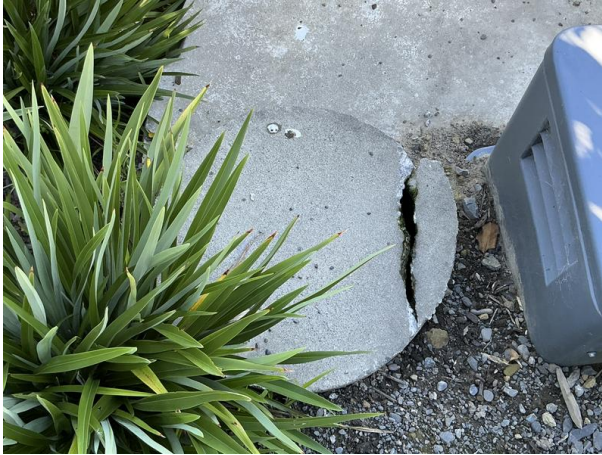
Photo 101

The cover to the septic tank is cracked recommend repair.

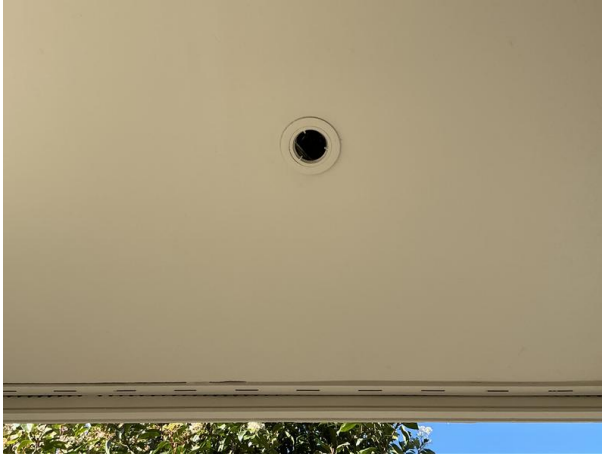
Photo 113

There is a missing lightbulb in the soffit on the southern side of the house.
