Presale Building Report.

15 Pitoitoi Street, Otaihanga, Paraparaumu 5036

Date: 16/08/25

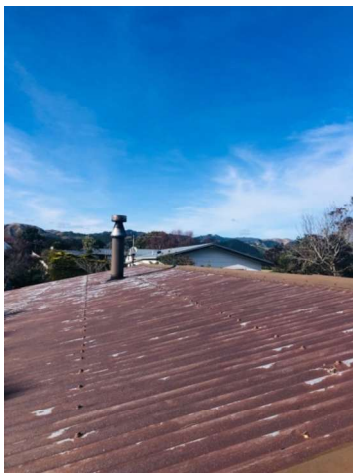
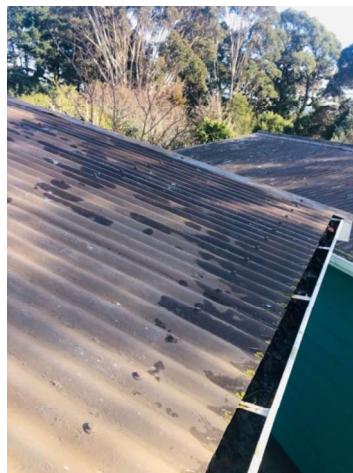
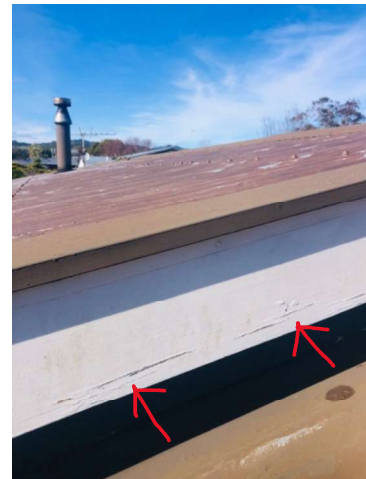
The roof is corrugated profile iron, nail fixed, all iron, flashings and fixings are in place and average condition for its age, the paint coating has worn and flaked in many areas, the roof is functioning without any issues sighted. The PVC spouting and downpipes are all in place, just the front run needs adjustment and new jointers, all needs cleaning out to ensure it can drain properly. The timber facias are in need of paint maintenance in some areas where paint is starting to flake.

Paint coating flaking.

The roof whilst old and paint surface flaking is functioning without issue, just the spouting needs cleaning and the front run adjusted with new jointers.

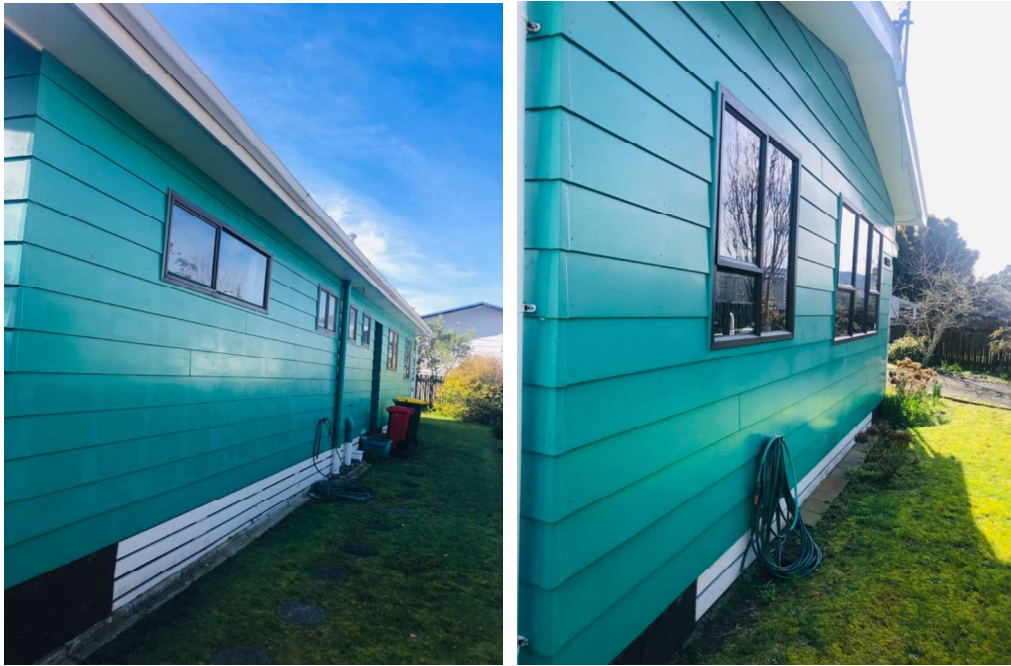
The cladding is direct fixed Weatherside weatherboard. Weatherside was a cladding product used in the 1980's and removed from the market due to its durability issues, as a pulp based timber product and not resilient to moisture if the painting surface is not maintained. We found all the cladding to be in a good well maintained condition with no issue sighted.

The Weatherside weatherboards are still in good condition and providing they are painted regularly should remain functional.

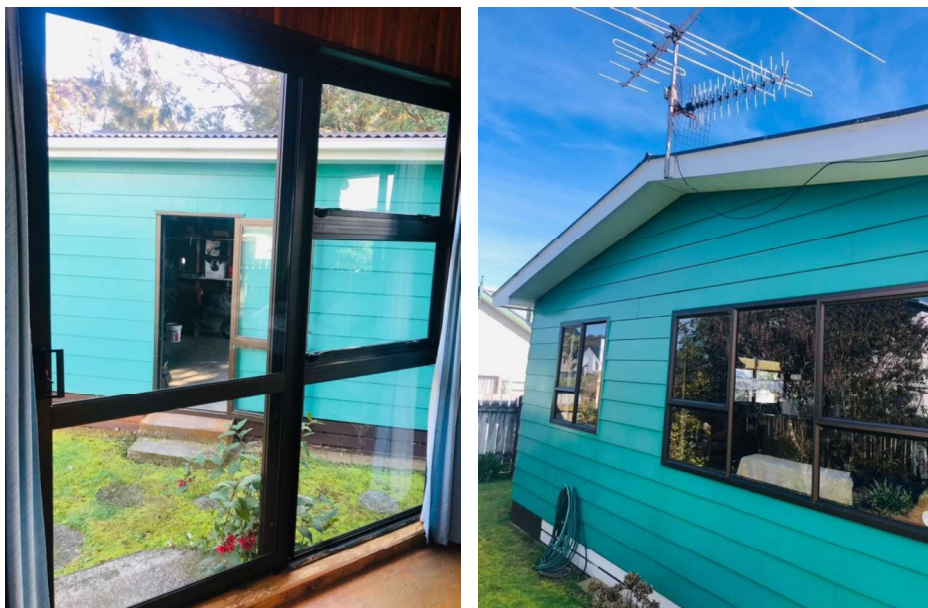
The joinery is aluminium single glazed units, all in working order, just maintenance to seals, hinges and latches is due to ensure they continue to function without issue. They have also been installed without head flashings, although all are well sealed and weathertight.

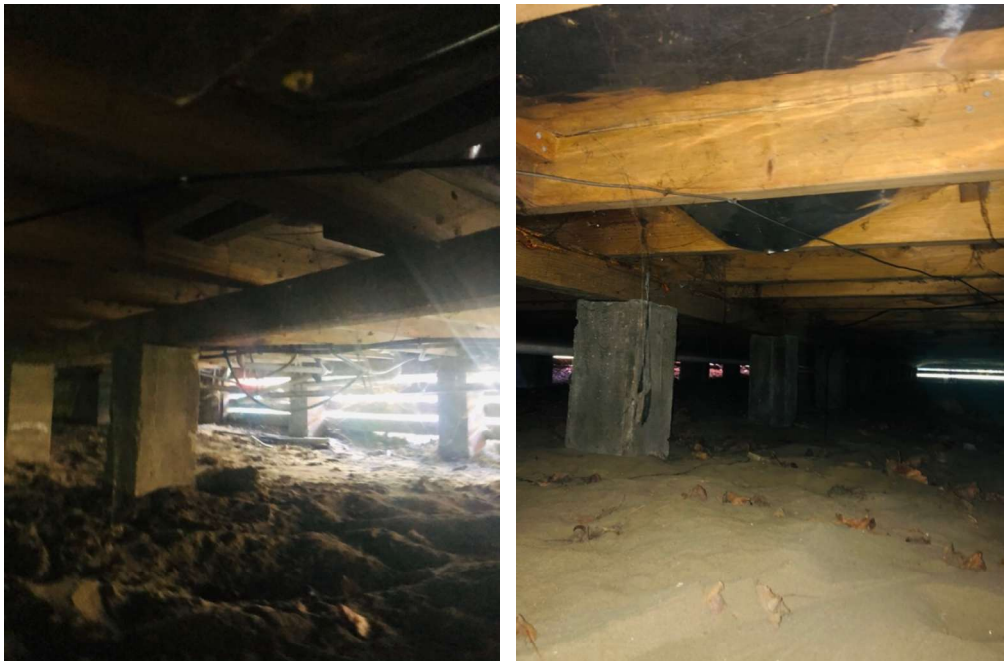
The concrete spread foundations and concrete piles are all in good condition with no visual sign of any structural issues sighted. All subfloor timber framing and connection are in place and good order, the underfloor foil insulation was banned in 2016 due to its ability to conduct electricity and a fatal accident, as it was installed prior to the ban it can remain, although not repaired if required, instead replaced with an alternative. If Healthy Homes compliance is needed a polythene vapour barrier is required over bare ground.

The ceiling insulation is flat and best upgraded with a new layer over the top, the underfloor foil insulation can remain, although easily cut out and replaced with more efficient batts. Should Healthy Homes compliance be needed and polythene vapour barrier will be required over the bare ground of the subfloor.

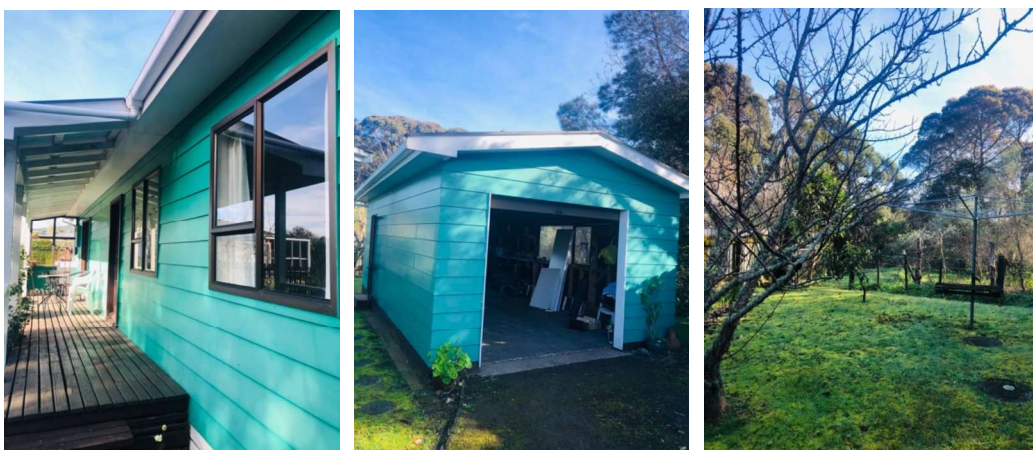
The property is fully fenced and gated, with a stand-alone garage in good condition. The front deck is well constructed and maintained, no issues sighted.

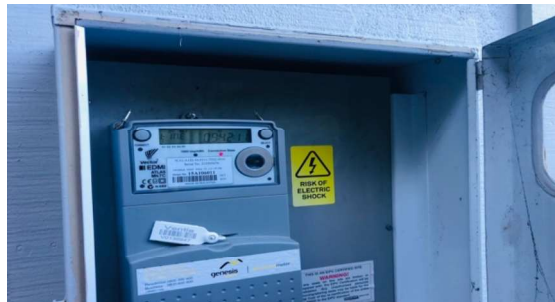
Electrical systems have been inspected however this is not a detailed assessment with testing carried out, but rather a visual inspection switching on fittings, the fuse box and visible wiring is in an acceptable age and state.

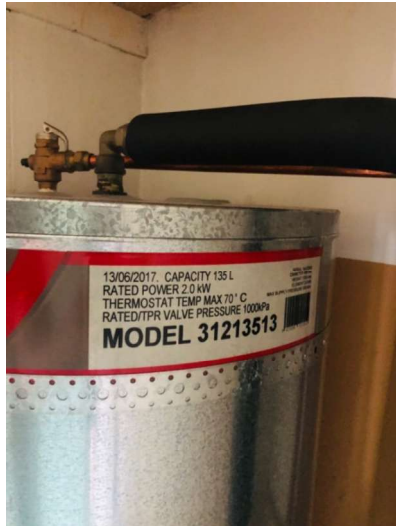
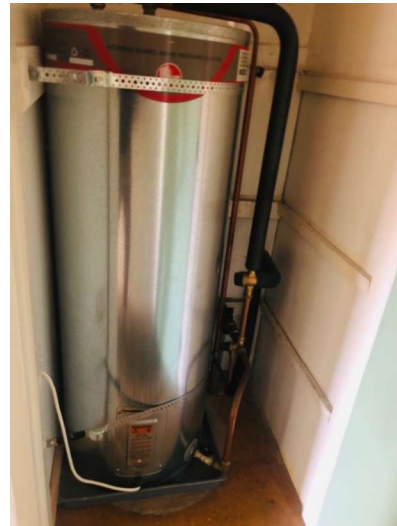
Plumbing systems have been inspected however this is not a detailed assessment with pressure testing carried out, but rather a visual inspection only running fittings, all was in good working order at the time of inspection.

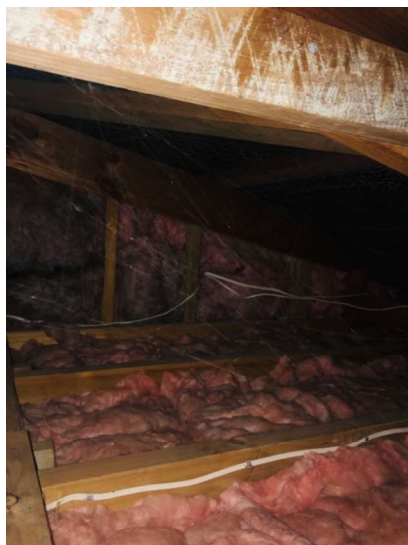
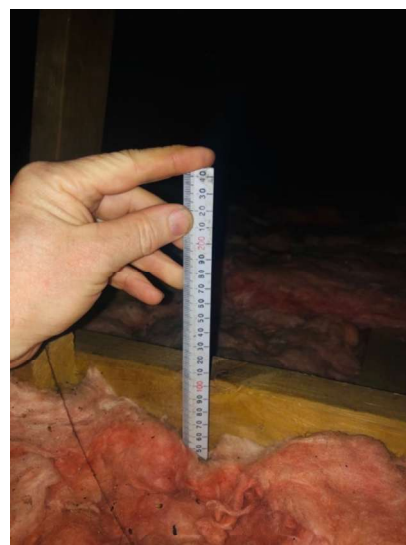
The roof space is dry and shows no visual sign of any weathertightness or structural issues. The pink batts is old and has flatten to 50mm and a secondary insulation should be installed over the top.

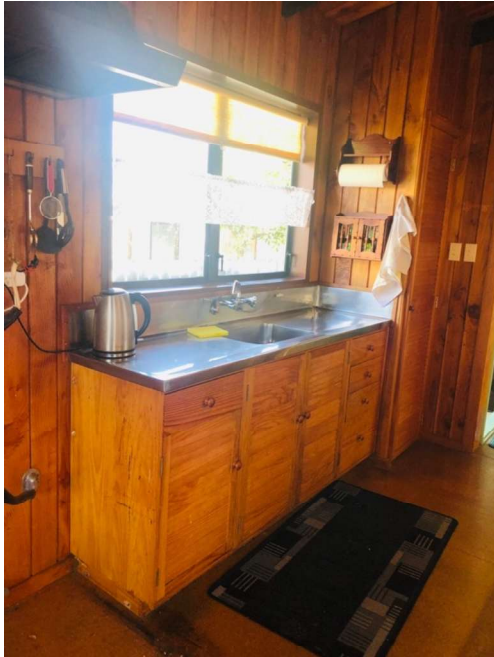
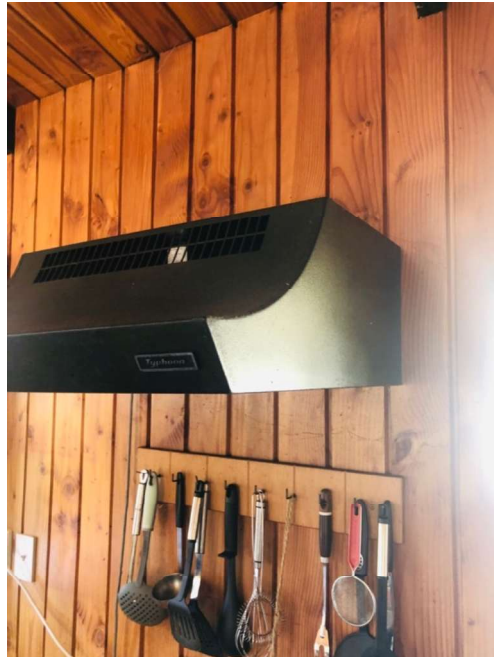
The kitchen is tidy and well presented, the cook top range hood is not ducted, filter only.

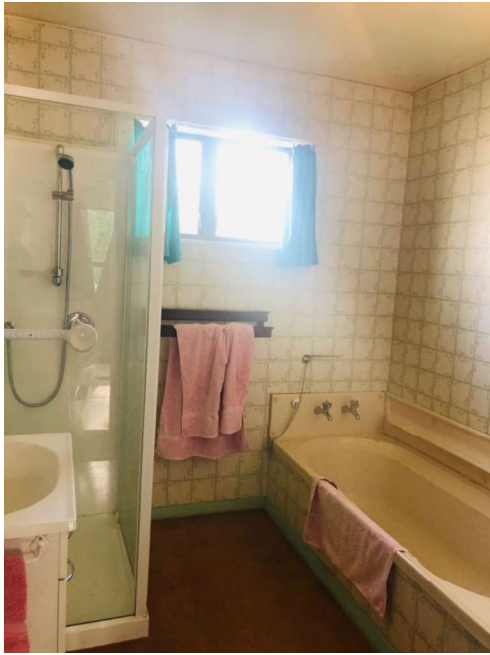
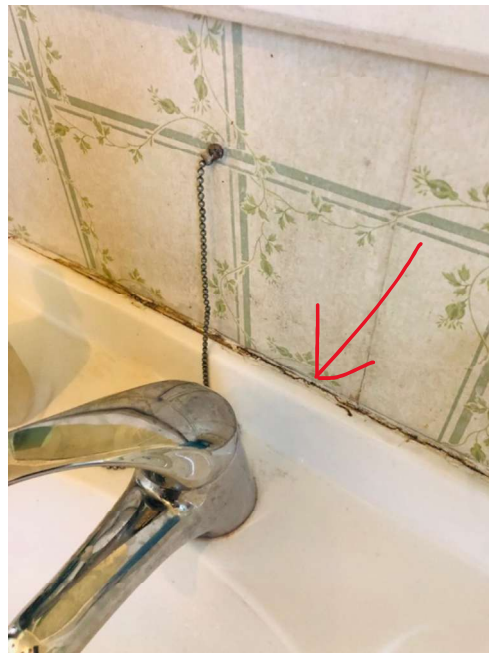
We have tested the bath, basin and shower for leaks, none found. The basin needs sealing to the wall, all is in good working order.

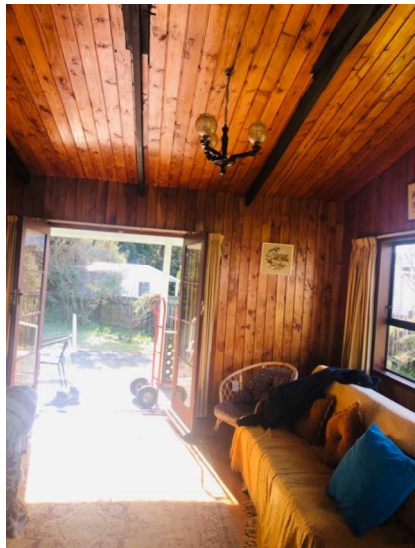
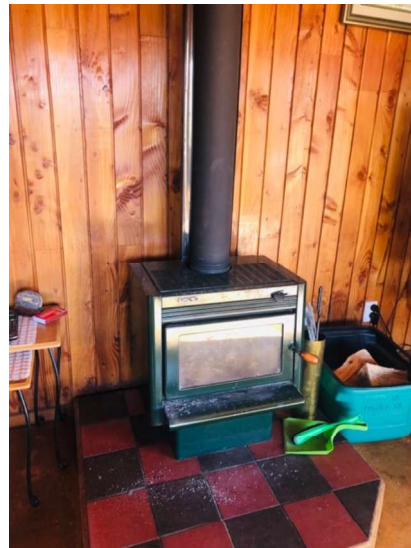
The living area is tidy and well presented, heated by a log burner, this will require servicing and certification prior to use by new owners for their new insurance policy.

The log burner will require servicing and certification prior to use by new owners for their new insurance policy.

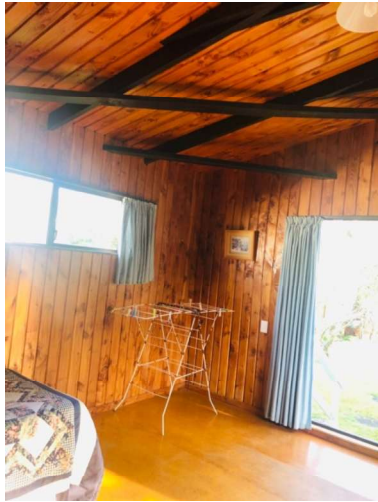
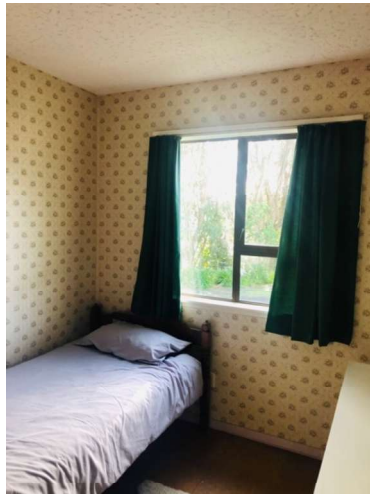
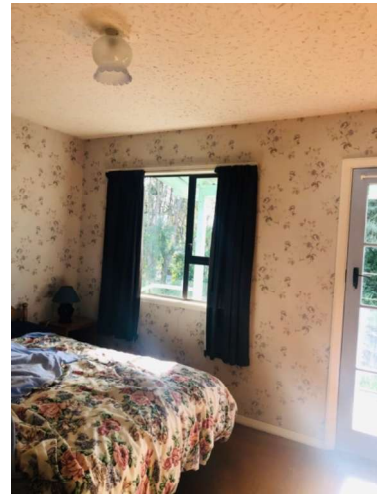
The bedrooms are tidy and well-presented, hallway smoke alarms are required, the rule is no more than three meters from any bedroom door.

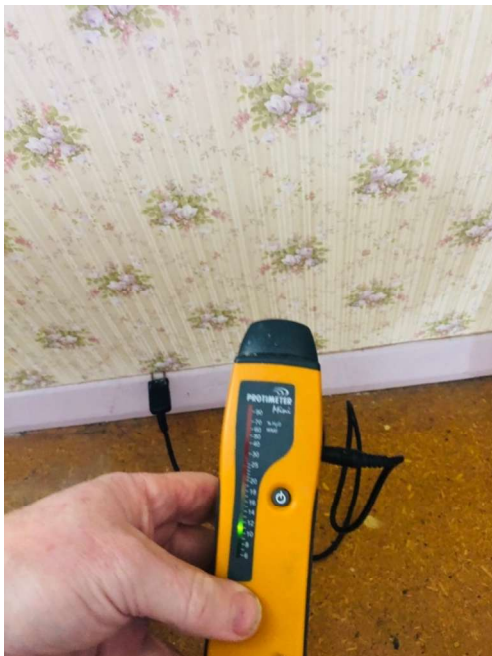
Dry 11%

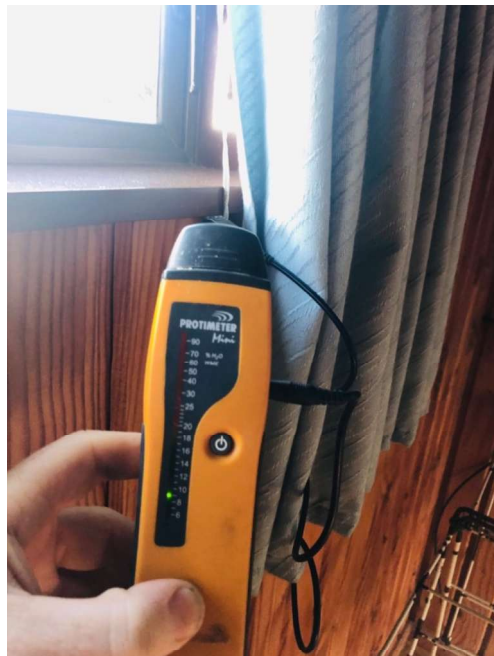
Dry 9%
