RELEVELING REPAIR PLAN: 25 FLEMINGTON AVENUE, NORTH NEW BRIGHTON, CHRISTCHURCH.  
CLIENT: HELIO JACUNDINO C/- VIKING BUILDERS

**IN RESPECT OF:** Foundation Re-leveling and Structural Repair and Renovation designs to Residential Building  
(Description of Building Work)

**RE: STRUCTURAL REPAIR AND ALTERATION ASSESSMENT – 25  
FLEMINGTON AVENUE, NORTH NEW BRIGHTON, CHRISTCHURCH.**

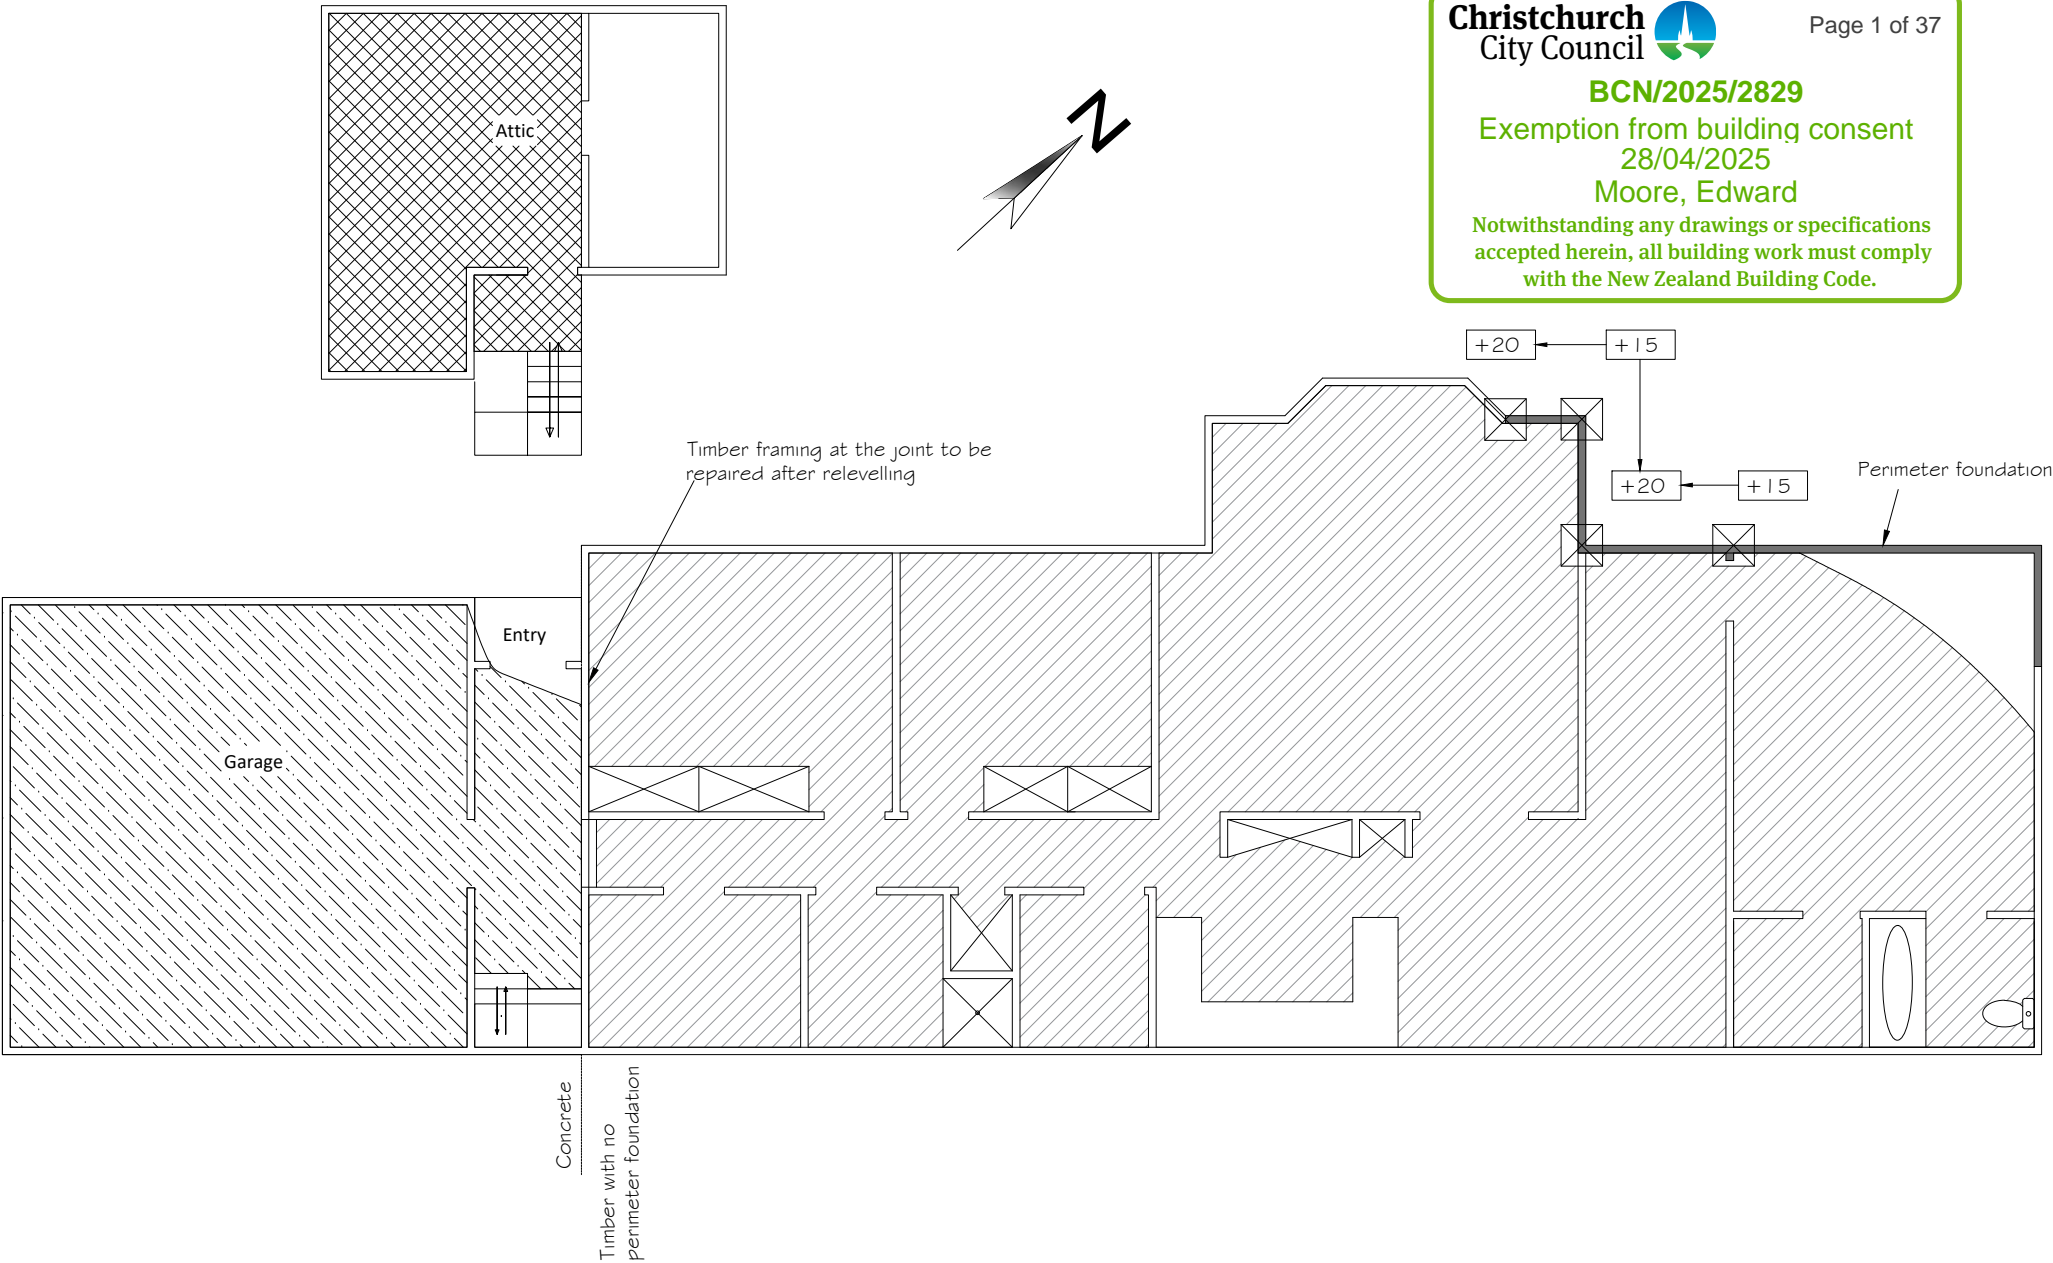
Current overall difference: 120mm for the main dwelling  
40mm for the garage and entry area  
42mm for the attic area

Target tolerance: re-level to within 25mm overall, and remediate all local slopes exceeding 1:200

1. Locate and ensure services can accommodate lift heights, or detach these before the lift begins.
2. Excavate jacking pads at locations shown. Excavate and expose the top of the footing ribs/outstands along entire perimeter (refer to section).

3. Install portable jacks into position.
4. Concurrently lift perimeter foundation wall in maximum 3mm increments. First, create a uniform sloping planar floor plate. Ensure planar floor plate is maintained during lift to final horizontal level.

5. Place 90x90 H5 timber struts between jacking pads and foundation wall and remove jacks (jacks may be kept and cast in instead of timber struts if preferred).

6. Fill between jacking pads and foundation wall with concrete. Fill under all other areas of the foundation wall with flowable grout to restore bearing between foundation wall and the ground.

7. Concurrently jack and pack internal piles as per MBIE guidelines.
8. Place 90x90 H5 timber struts between jacking pads and foundation wall and remove jacks (jacks may be kept and cast in instead of timber struts if preferred).

9. Repair perimeter foundation cracks using approved epoxy injection following re-leveling.
10. Repair remaining items as per original engineering report.

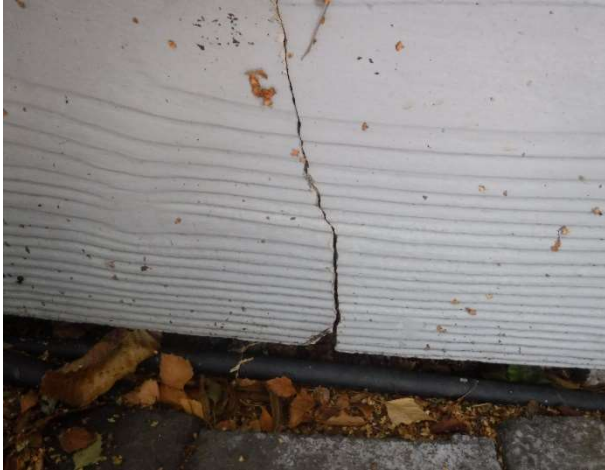
There are some minor cracks and deterioration have been observed to the external cladding and the external door framing. However, we note that due to limited ground clearance between the bottom of the external cladding and natural ground, and presence of external amenities and vegetation, parts of the foundation of the dwelling could not be investigated during our site inspection.

Photo 4. Minor crack observed to the external cladding.

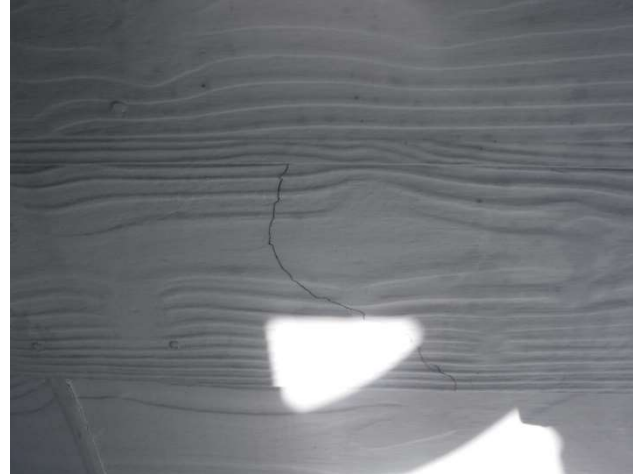
Photo 5. Minor crack observed to the external cladding.

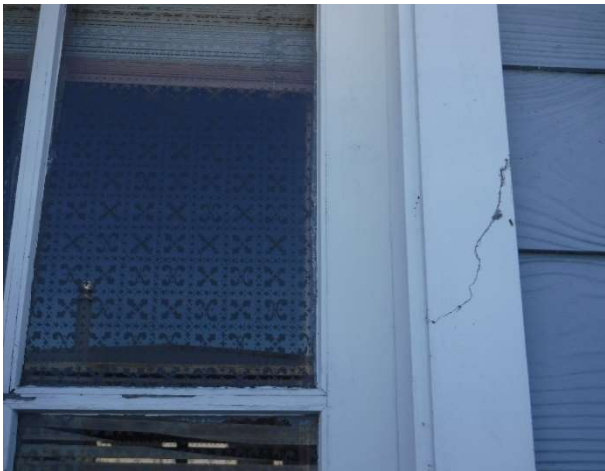
Photo 6. Minor deterioration observed to the external door framing.

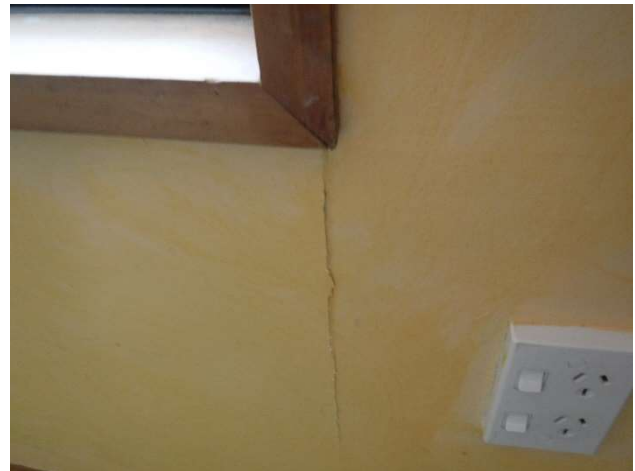
Photo 7. Minor crack observed to the wall lining under the window.

- Where diagonal cracks from corners of openings are less than 50mm long and cracks or separations are typically along sheet joints, re-stop to the wall (Fibafuse) and ceiling plasterboard. Installation of new fasteners required around the plasterboard sheet perimeter where fasteners have pulled through or plaster bulges around fastener heads.

- Where diagonal cracks from corners of openings are exceeding 50mm length or panel fractured, replacement of wall and ceiling plasterboard with equivalent bracing elements (GIB Braceline) is recommended. Installation new fasteners to be in a bracing pattern around the plasterboard sheet perimeter in accordance with manufacturer's guidelines.

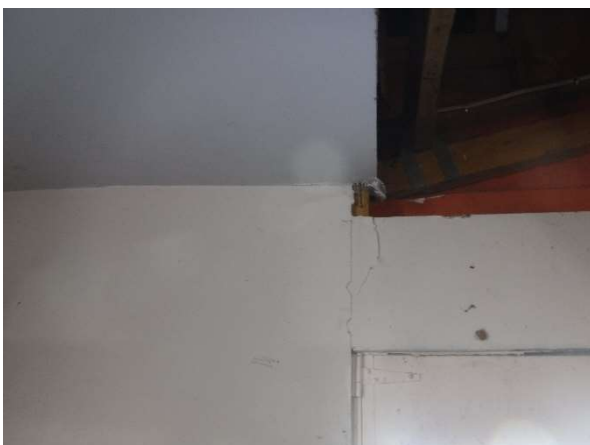
Photo 8. Minor crack observed to the wall lining.

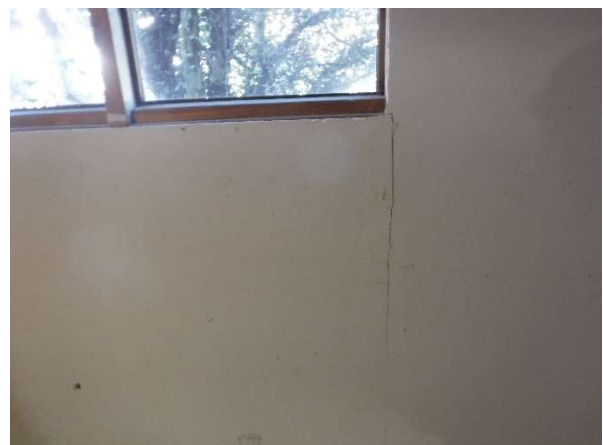
Photo 9. Minor crack observed to the wall lining under the window.

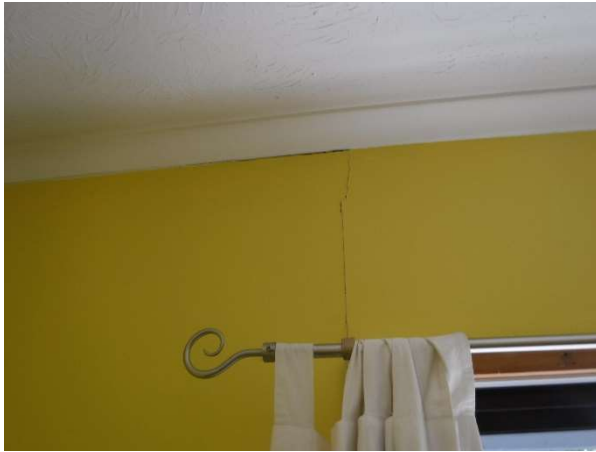
Photo 10. Minor vertical crack observed to the wall lining above the window.

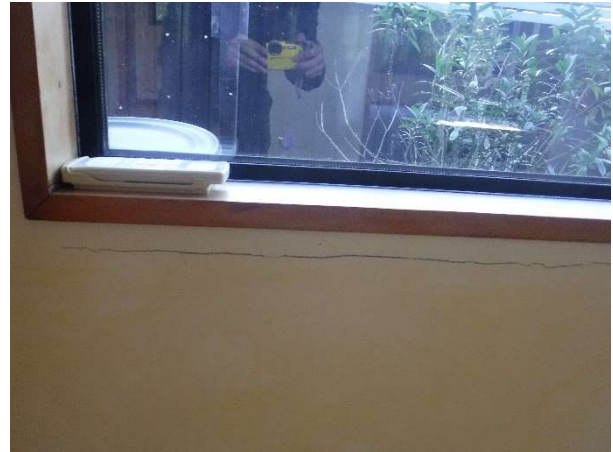
Photo 11. Minor horizontal crack observed to the wall lining under the window.

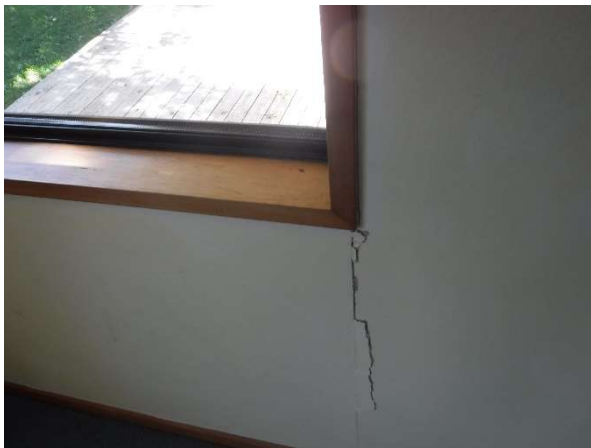
Photo 12. Minor vertical crack observed to the wall lining under the window.

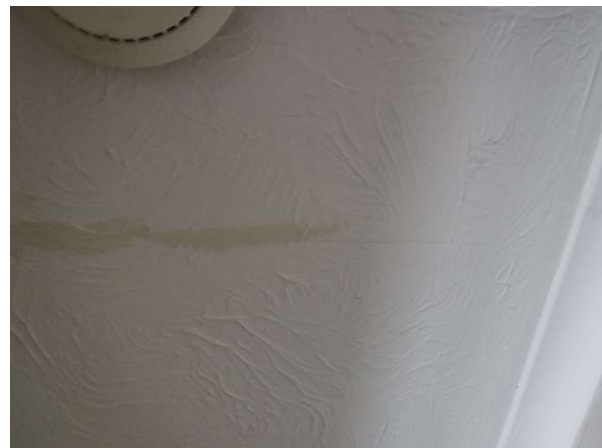
Photo 13. Minor crack and previous repair have been observed to the ceiling.

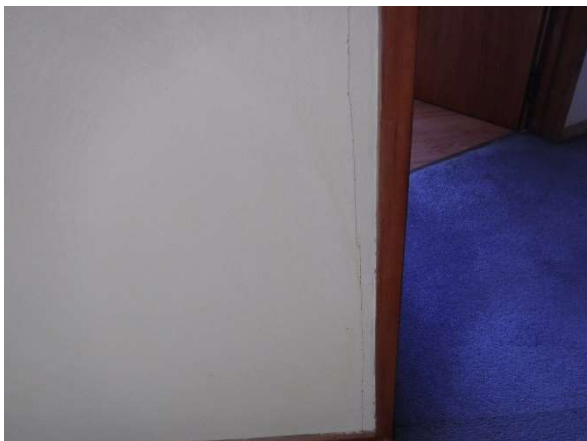
Photo 14. Minor crack observed to the wall lining near the door.

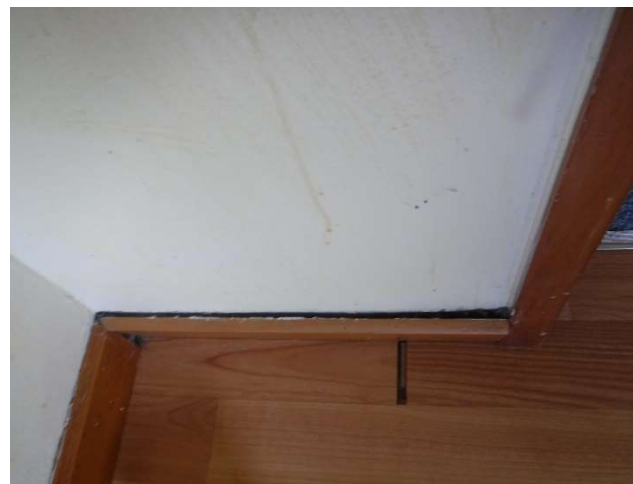
Photo 15. Minor separation observed to the timber skirting.

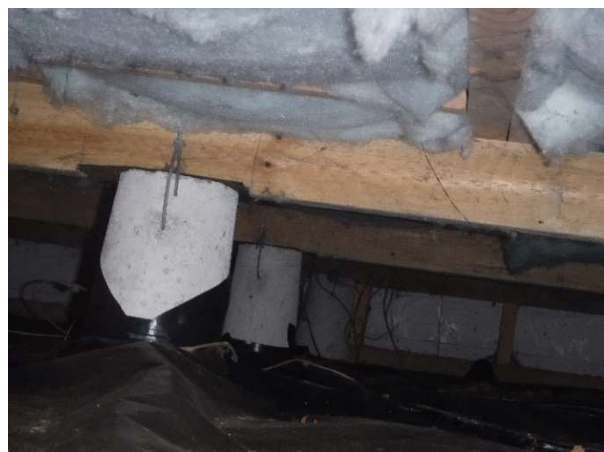
The subfloor was accessed through a manhole in the floor. Due to the subfloor clearance, only limited access was possible. The subfloor showing a timber floor founded upon concrete piles and one minor portion of the foundation has concrete perimeter foundation. The condition of the subfloor piles appeared to be consistent with the age of the building. It has been observed that steel wire connection and no DPC are present at the pile to bearer interface. Non-compliant bearer notching observed, there was no splice plates.

Photo 19. Non-compliant bearer notching observed, there was no splice plates.

- Minor notching to subfloor bearers may be carried out, and flitch plates should be installed as per MBIE guidelines.
  - Our recommended target tolerances are within 25mm overall floor level variation with local floor slopes not exceeding 1:200.

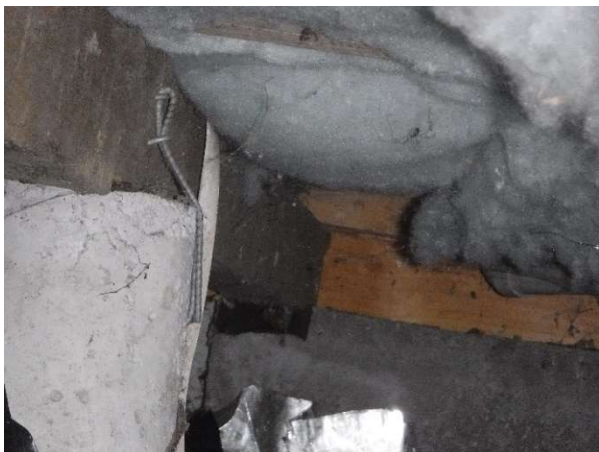
Photo 20. Steel wire connections and no DPC were observed at the pile to bearer interface.

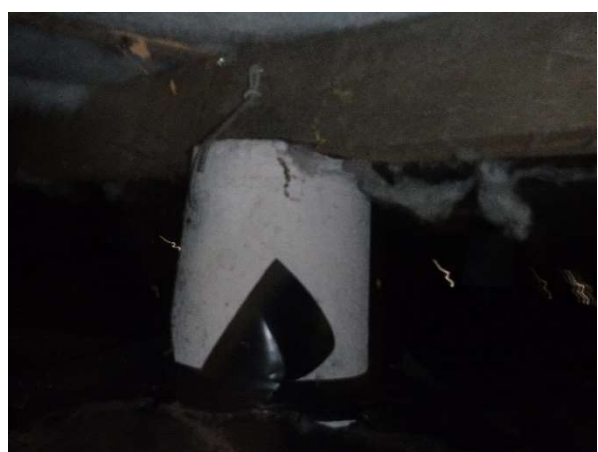
Photo 21. Steel wire connections and no DPC were observed at the pile to bearer interface.

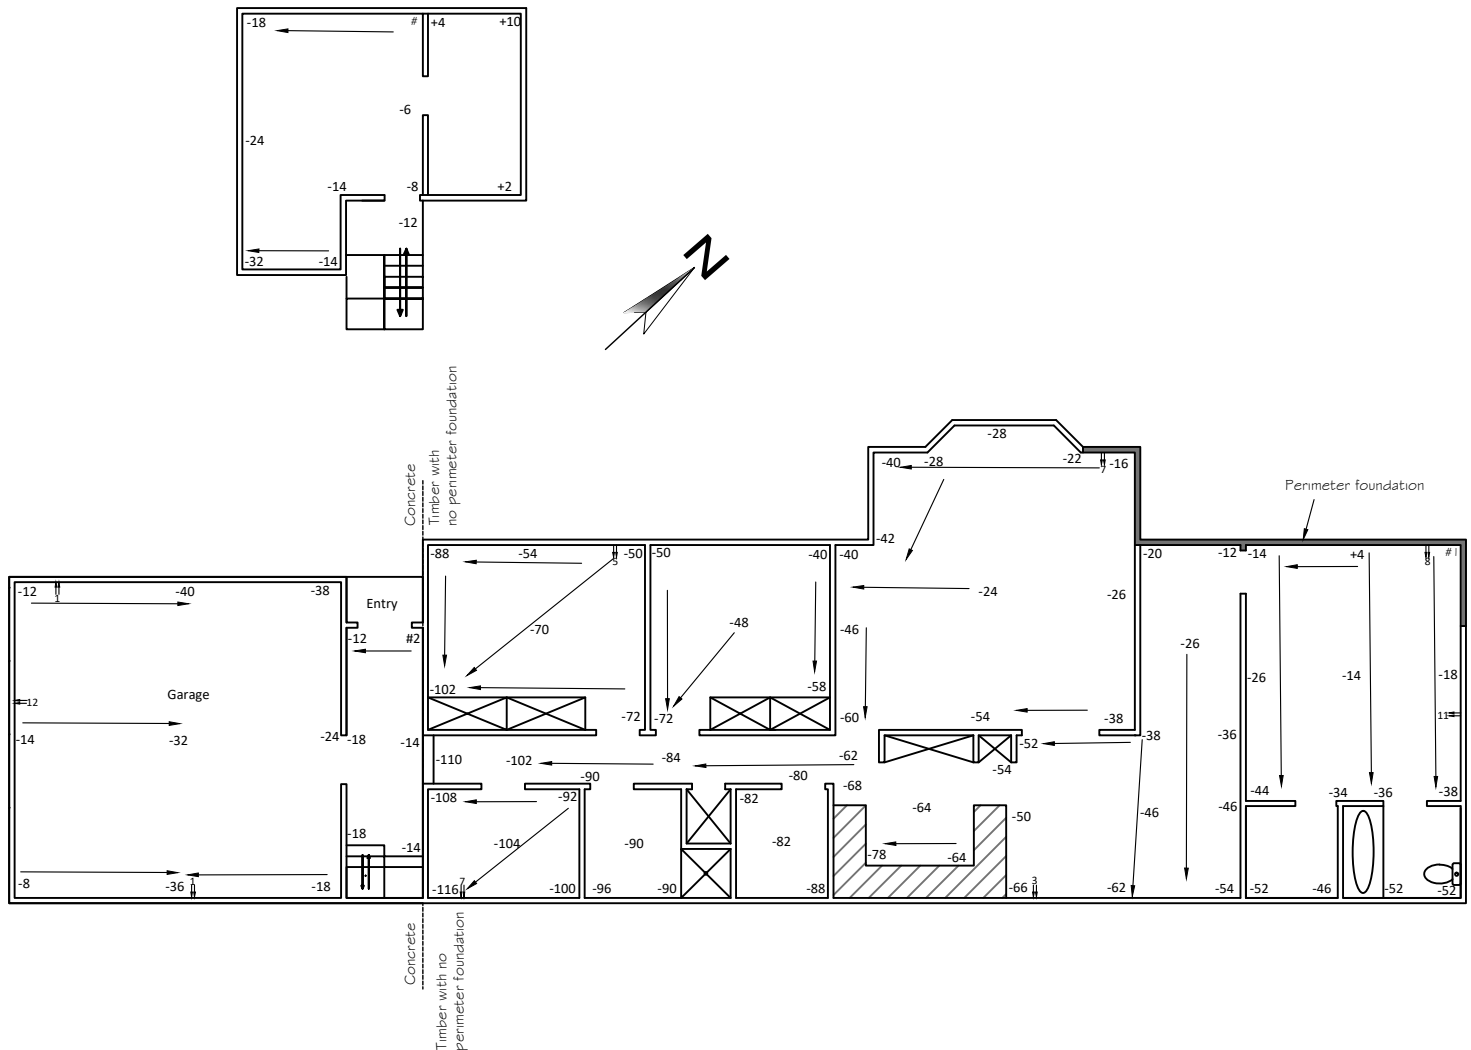
## FLOOR LEVEL SURVEY PLAN (NTS)

The floor levels measured across the attic floor of the building footprint showed a maximum floor level variation of 42mm (-32, +10). The overall floor level variation does not exceed the 50mm tolerance for floor variation recommended in Table 2.3 of the MBIE Guidance. However, some locations were observed to exceed the 1:200 (0.5%) MBIE tolerance for local floor slopes. The floor slopes are generally sloping down from northeast towards southwest.

The floor levels measured across the garage and entry (concrete area) of the building footprint showed a maximum floor level variation of 42mm (-32, +10). The overall floor level variation does not exceed the 50mm tolerance for floor variation recommended in Table 2.3 of the MBIE Guidance. However, some locations were observed to exceed the 1:200 (0.5%) MBIE tolerance for local floor slopes.

The ground floor (timber area) levels measured across the dwelling footprint showed a maximum floor level variation of 120mm (-116, +4). The floor level variation of the dwelling exceeds the 50mm tolerance for floor variation recommended in Table 2.3 of the MBIE Guidance. At the same time, multiple localised floor slopes exceeding 1:200 (0.5%) were identified within the building. The floor slopes are generally sloping down from northeast towards southwest.

Based on above measurements, the dwelling falls into the "foundation rebuild indicated" category based on MBIE.

- As stated above and based on MBIE Guidance, the floor falls into the "rebuild" category. However, since most undulations did not occur near the perimeter foundation walls, we consider it acceptable to re-level the perimeter foundation walls in accordance with Option 1 of the MBIE Guidance (Part A, Appendix A1.1.2).

- The timber floor may be re-levelled to meet target tolerances by performing local jacking and packing repairs to internal dwelling piles. Any pile requiring more than 100mm of packing should be replaced with a new pile.
