## EQC CLAIM DOCUMENTATION

# CASH SETTLED CLAIM(S)

Claim No: 2010 / 030128

22 FEB 2011 - EARTHQUAKE  
BURWOOD, CHRISTCHURCH  
(C109-110005) - 41 Parnwell Street

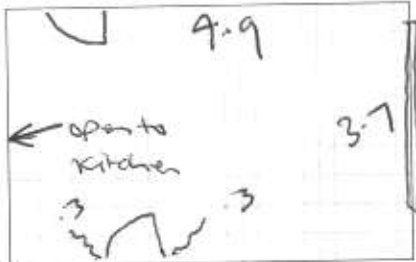
Lounge

| Room | Earthquake Damage<br>Y/N | Walls<br>✓ | Ceiling<br>✓ | Floor<br>✓ | Repair Strategy |
|---|---|---|---|---|---|
| Lounge<br>5.2x3.7 | Y | / | ✓ | / | CEILING CRACKS 2.0m<br>- STRIP LINING PAPER, RAKE OUT, STOP, SKIM<br>PLASTER, NEW PAPER, PAINT CEILING |

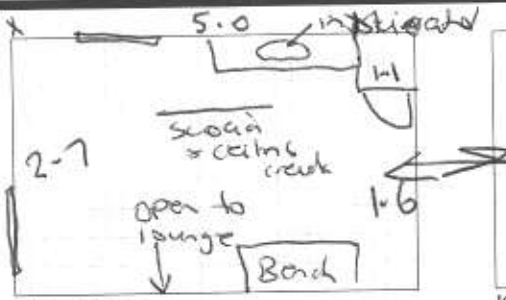
| Room | Earthquake Damage<br>Y/N | Walls<br>✓ | Ceiling<br>✓ | Floor<br>✓ | Repair Strategy |
|---|---|---|---|---|---|
| Dining Room | Y | ✓ | / | / | CRACKS TO WALLS WHERE HARDBOARD JOINS.<br>(1.5)<br>FIT 'D' MOULD TO CRACKS, PAINT WALLS |

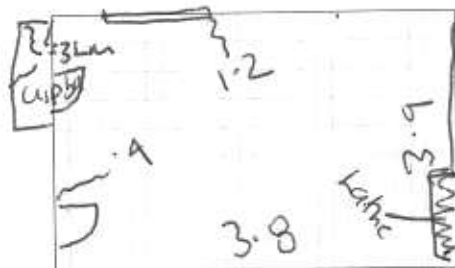
Bed 1

| Room | Earthquake Damage<br>Y/N | Walls<br>✓ | Ceiling<br>✓ | Floor<br>✓ | Repair Strategy |
|---|---|---|---|---|---|
| Bedroom<br>1<br>3.8x3.9 | Y | / | ✓ | / | CEILING CRACKS 6.0m<br>- STRIP LINING PAPER, RAKE OUT, STOP, SKIM<br>PLASTER, NEW PAPER, PAINT CEILING<br>AND 1/4 ROUND SCOTIA. |

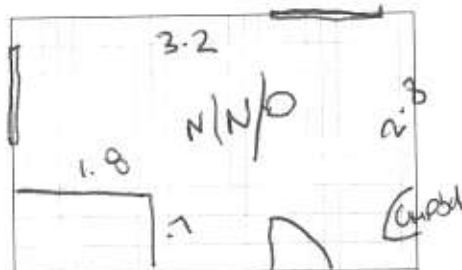
Bed 3

| Room | Earthquake Damage<br>Y/N | Walls<br>✓ | Ceiling<br>✓ | Floor<br>✓ | Repair Strategy |
|---|---|---|---|---|---|
| Bedroom<br>3<br>2.8x3.2 | Y | ✓ | ✓ | / | WALL & CEILING CRACKS 6.0m<br>- STRIP LINING PAPER TO WALLS & CEILING, RAKE<br>OUT, STOP, SKIM PLASTER CEILING, NEW<br>PAPER, PAINT WALLS & CEILING |

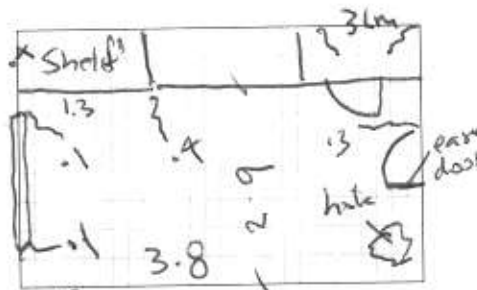
Bed 2

| Room | Earthquake Damage<br>Y/N | Walls<br>✓ | Ceiling<br>✓ | Floor<br>✓ | Repair Strategy |
|---|---|---|---|---|---|
| Bedroom<br>2<br>2.9x3.8 | Y | ✓ | / | / | WALL CRACKS - 8<br>- STRIP LINING PAPER, RAKE OUT, STOP, NEW<br>PAPER, PAINT WALLS |

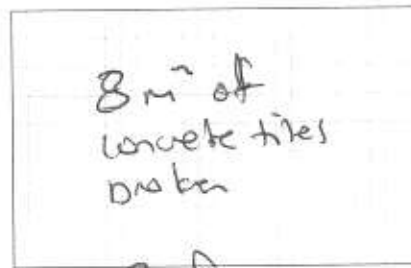
| Item | | Event<br>Damage<br>Y / N | Repair Strategy |
|---|---|---|---|
| Roof | | Y | REFLITCH CEILING RAFTERS x 2 #2 x ROOF BRACES.<br>LARGE SECTION OF ROOF TO BE RETIRED. TEMPORARY<br>TILES IN PLACE @ PRESENT.<br>REPLACE 7m <sup>2</sup> OF CONCRETE TILES. QUOTER<br>HAS ALREADY SOURCED. |

| Roof | Reflash two ceiling rafters and two roof braces<br>Remove and replace 7 sq mtrs of temporary tiles with correct tiles, replace battens<br>100 tiles @ \$5.00 each<br>Scaffolding \$250.00 | | 500.00<br>1500.00<br>500.00<br>250.00 |
