## BUILDING INSPECTION REPORT

## RED LBP CONDITION REPORT

# CONDITION REPORT

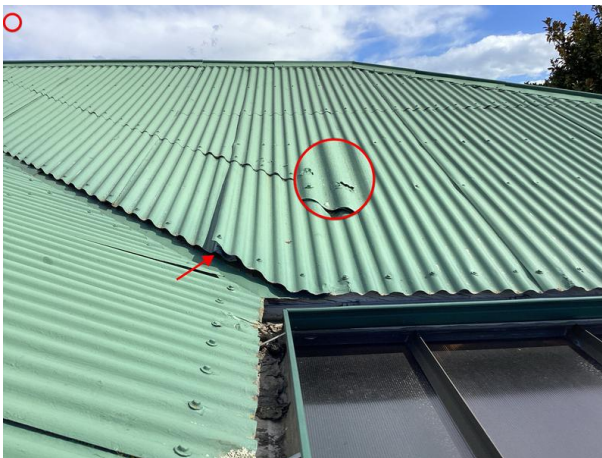
**Photo 5**

Example of a lifting lap joint and likely corrosion holes visible near the conservatory.

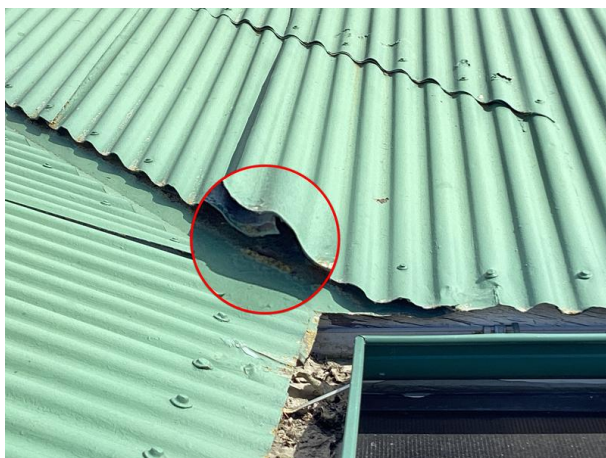
**Photo 6**

Corrosion was visible under the lifting sheet join on the metal valley.

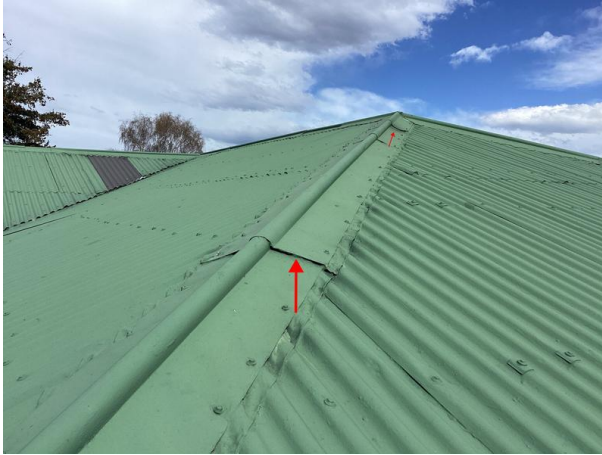
**Photo 7**

Gaps were visible between some metal hip flashings. This was common around the dwelling.

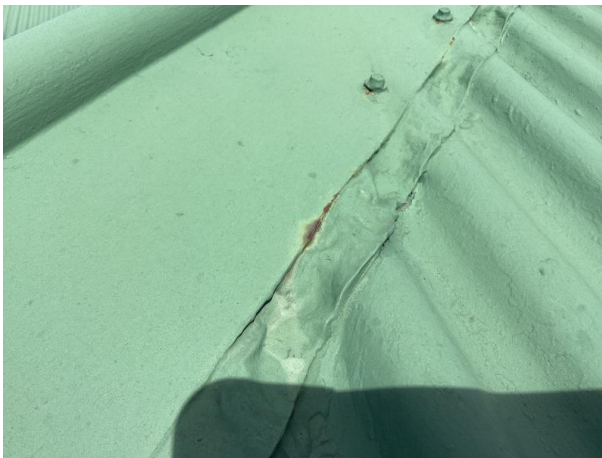
**Photo 8**

A couple areas of corrosion were also noticed on the metal hip flashings.

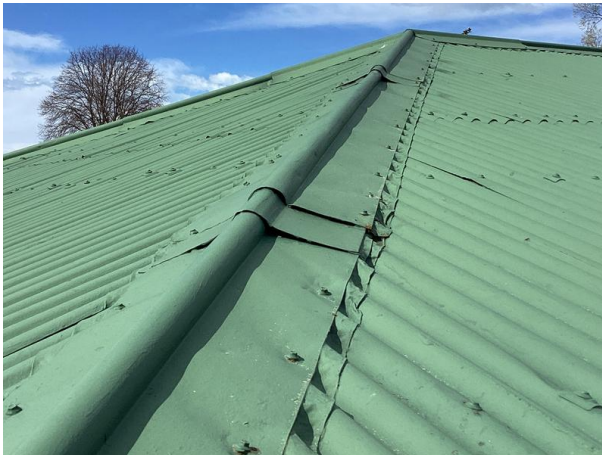
**Photo 9**

Example of the gaps visible on the metal hip flashing joints.

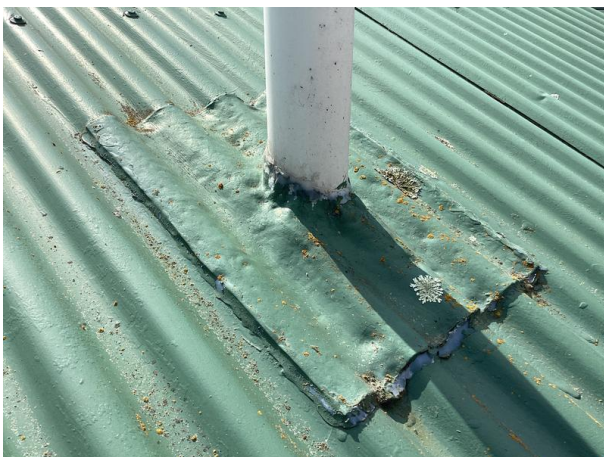
**Photo 10**

Silicone repairs and ageing were noticed around the southside vent penetration with lead flashing. Have a licensed roofer to advise further on this flashing.

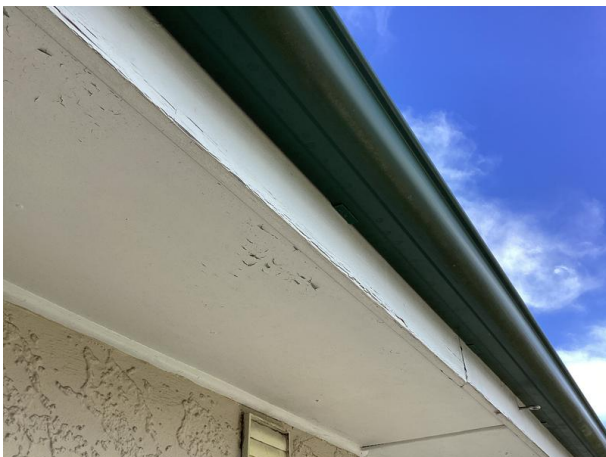
**Photo 11**

Paint flaking on the fibre cement soffits and timber fascia boards were noticed around parts of the dwelling.

There are areas of the timber fascia and fibre cement soffits that require sanding back any loose flakey paint, apply a sealer coat then redecoration to prevent further deterioration.

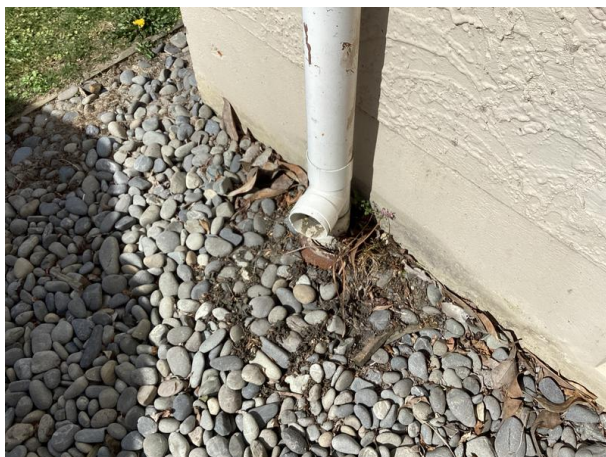
**Photo 14**

A T join has been installed on the east side PVC downpipe. Blocking this off is recommended so the stormwater goes directly into the stormwater riser.

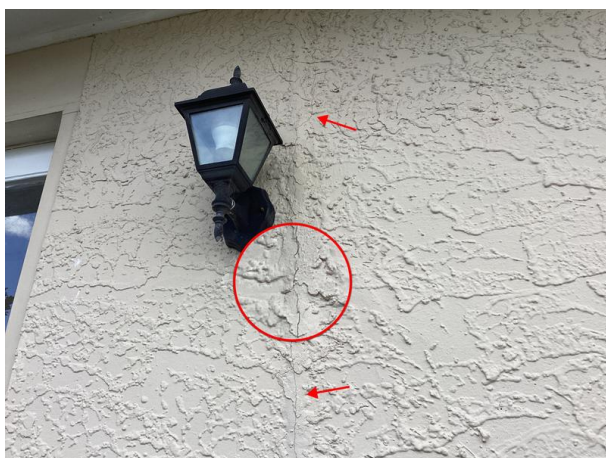
**Photo 16**

Vertical cracking was noticed on the west side of the dwelling.

There are cracks to the exterior cladding, in our view these need to be professionally repaired, as any cracks can allow moisture in behind the cladding and into the timber framing. Some of the cracking may relate to the lack of control joints and this can be determined by a exterior cladding specialist before carrying out the repairs.

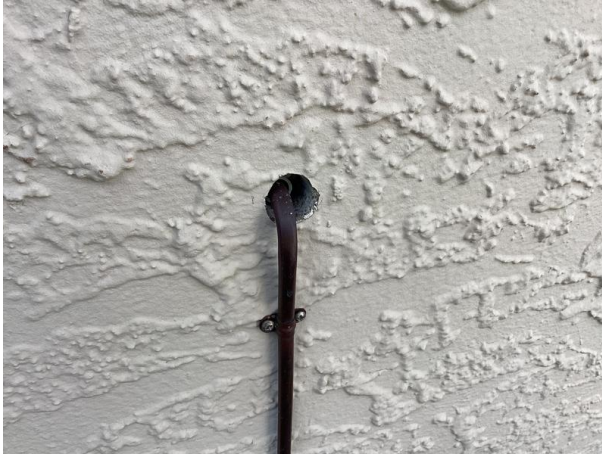
**Photo 17**

It is recommended to appropriately seal around this west side cladding penetration.

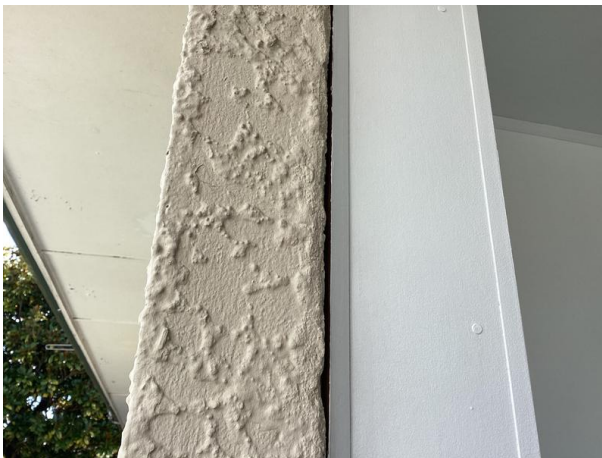
**Photo 18**

It is recommended to seal along this plaster to fibre cement sheeting junction located near the laundry.

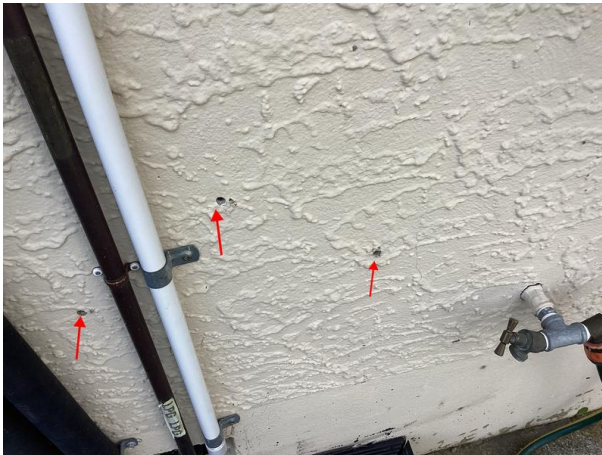
**Photo 19**

Unsealed penetration holes were visible on the South/West corner of the dwelling.

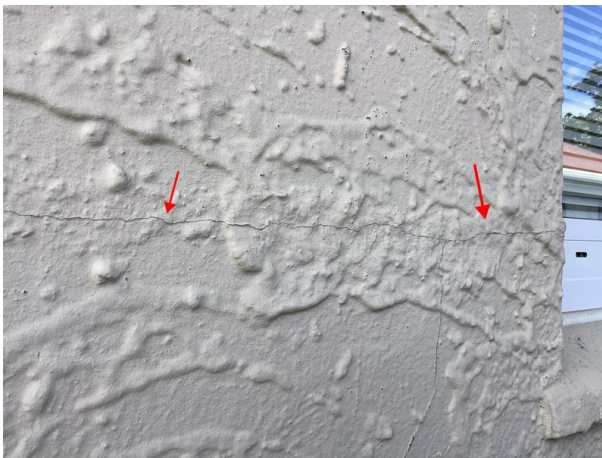
**Photo 21**

A horizontal crack was noticed on the south side of the dwelling.

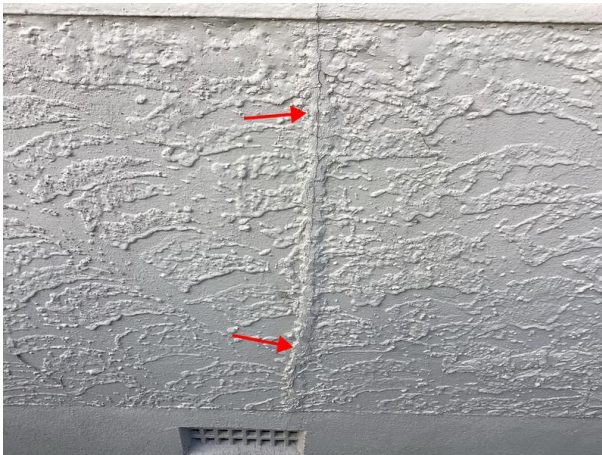
**Photo 22**

Recracking was noticed on the south side of the dwelling.

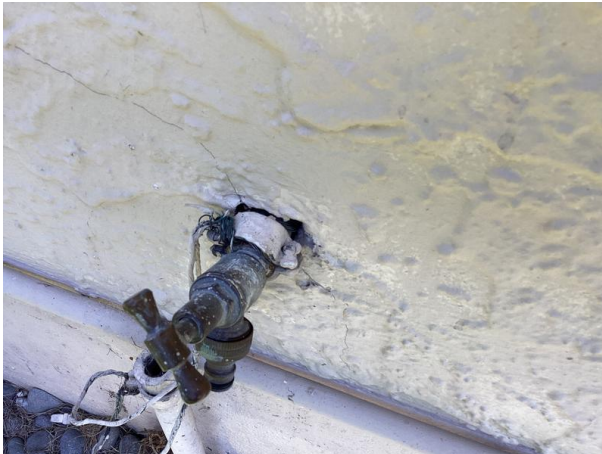
**Photo 23**

It is recommended to appropriately seal around this tap penetration.

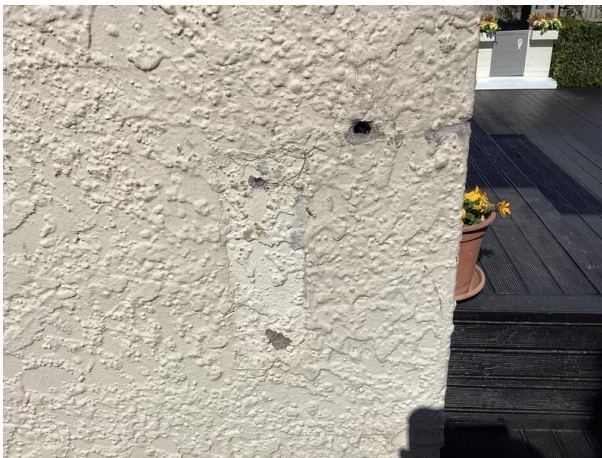
**Photo 24**

Unsealed penetration holes were noticed on the north side of the dwelling.

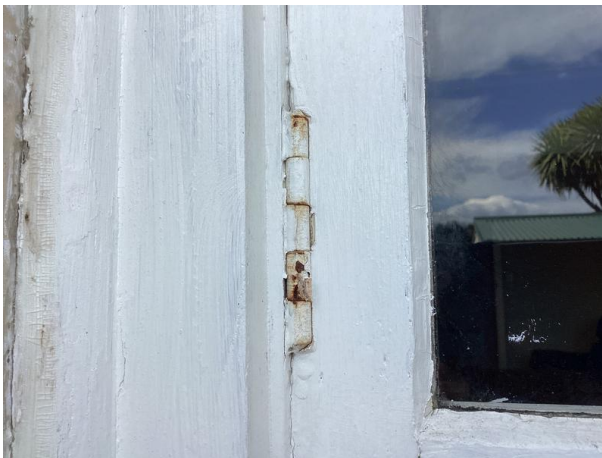
**Photo 28**

A couple window hinges around the dwelling had visible corrosion. Replacing these as part of future maintenance is recommended.

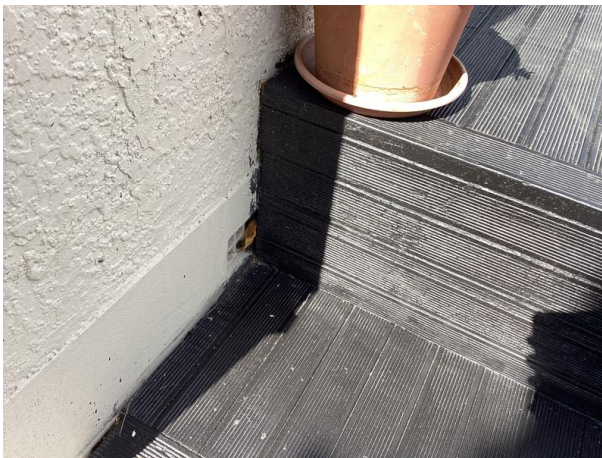
**Photo 35**

A couple vent holes were blocked by the timber deck on the west side of the dwelling.

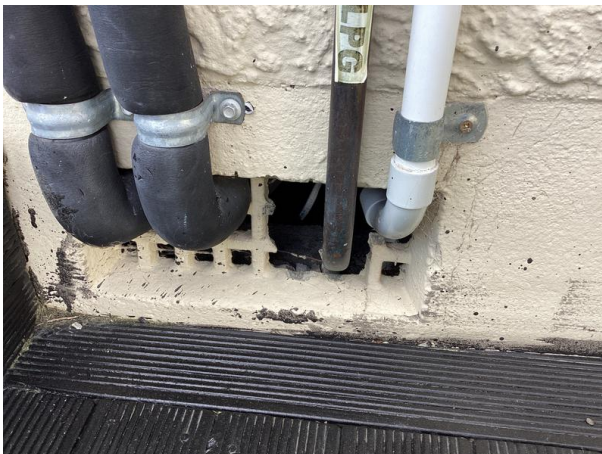
**Photo 36**

It is recommended to seal some vent holes to avoid rodents from entering into the subfloor.

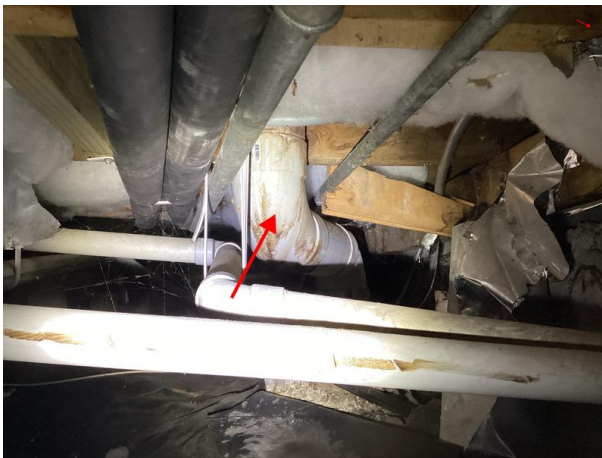
**Photo 41**  
Signs of leaking was coming from the toilet waste pipe in the subfloor. See the next photo.

As viewed in the photos below, signs of leaking were noticed coming from the toilet waste pipe. It is recommended to have a licensed plumber to inspect and advise further.

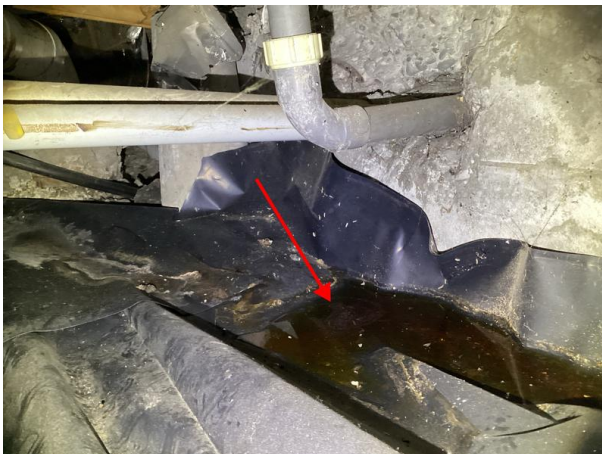
**Photo 42**  
Example of the water ponding visible on top of the ground moisture barrier near the toilet waste pipe in the subfloor.

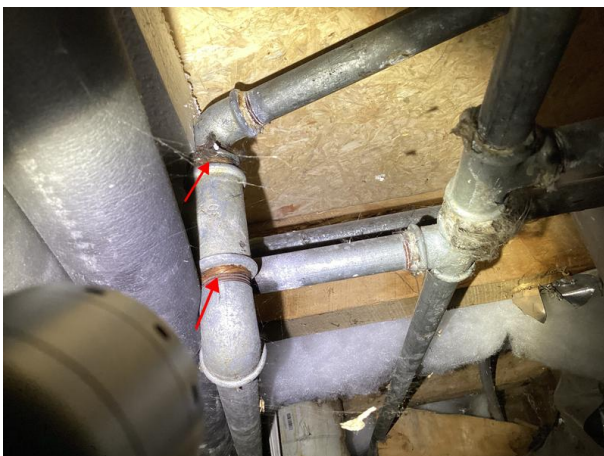
**Photo 45**

Corrosion around some galvanized plumbing joints were visible in the subfloor. It is recommended to have a licensed plumber to advise further.

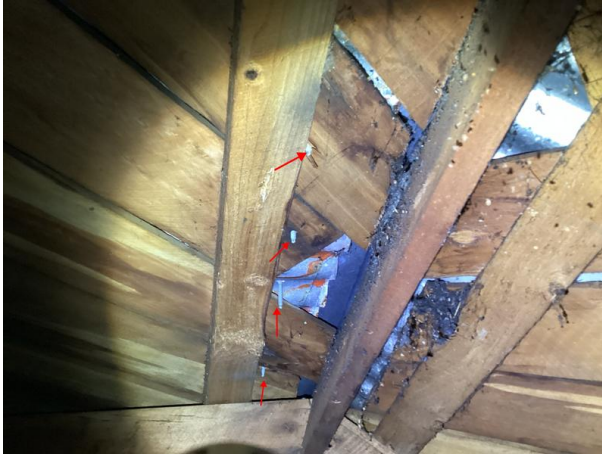
**Photo 47**

Some screw fixings below the ridge capping near the manhole were missing the timber purlin.

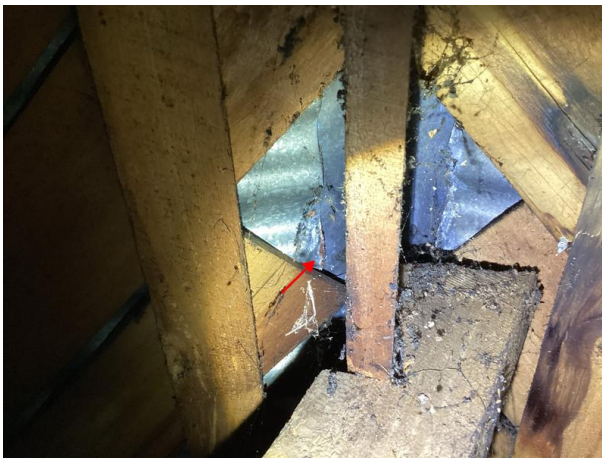
**Photo 48**

A couple areas of corrosion were also identified on the profiled metal roof viewed from inside the roof space.

As viewed in the photos below, and in the roof system section of this report, defects on the roof system and possible moisture staining inside the roof space was noticed. It is recommended to have a licensed roofer to inspect and advise further on this roof system.

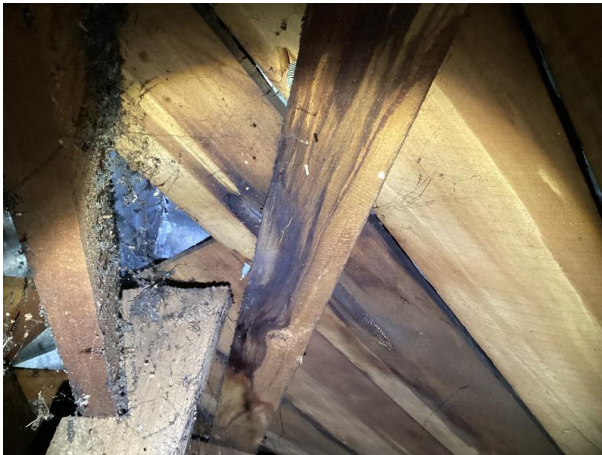
**Photo 49**

Areas of visible timber staining was noticed throughout this roof space on the timber roof framing.

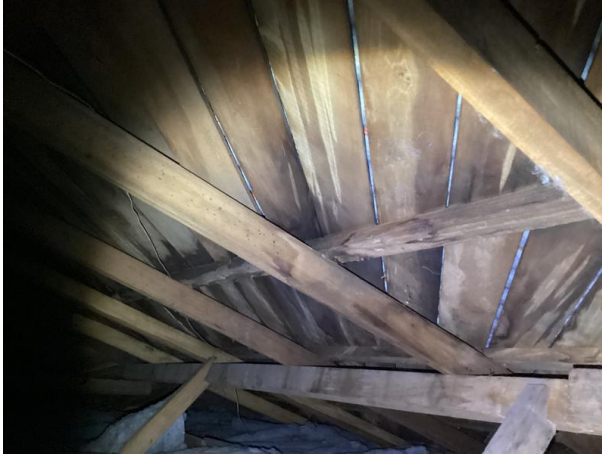
**Photo 50**

Example of the discolouring and staining noticed on the timber sarking boards.

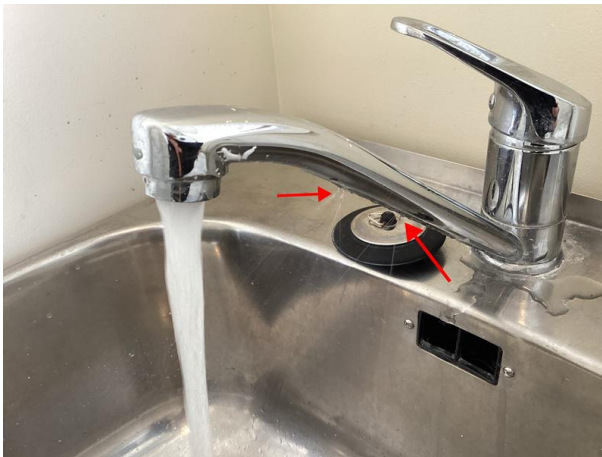
**Photo 69**  
The laundry tap was leaking and requires replacing.

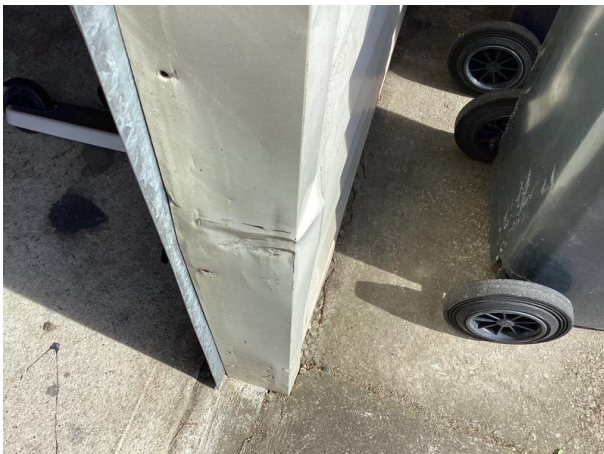
**Photo 71**  
Metal dents and defects were noticed around the garage.

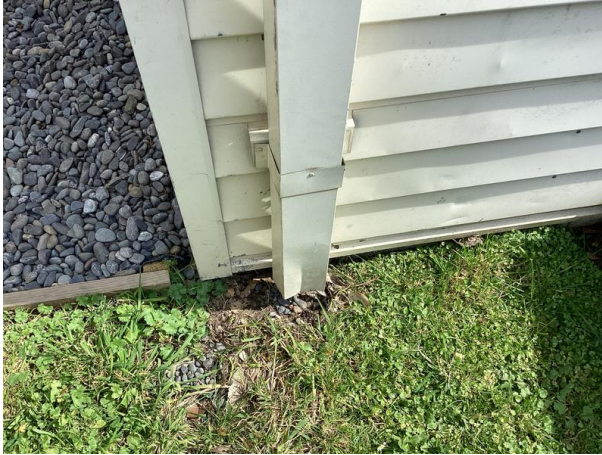
**Photo 72**

It is recommended to connect the garage downpipes to an approved stormwater system.

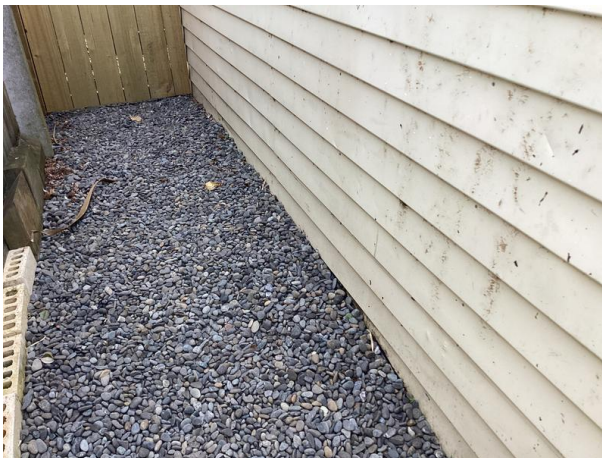
**Photo 73**

Recommend lowering the stones on the south side of the garage so it is below the garage cladding.

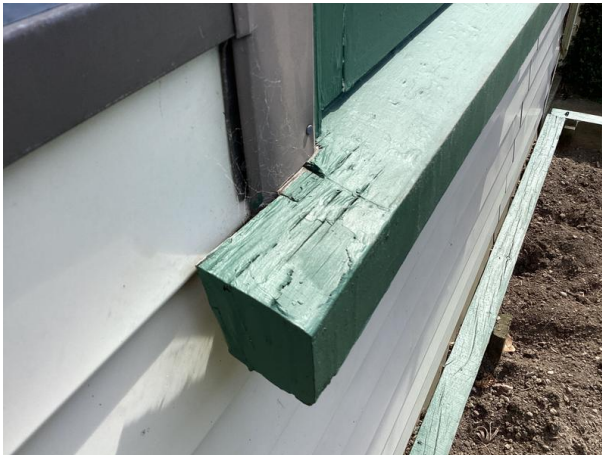
**Photo 74**

General ageing was noticed on the timber windowsills.

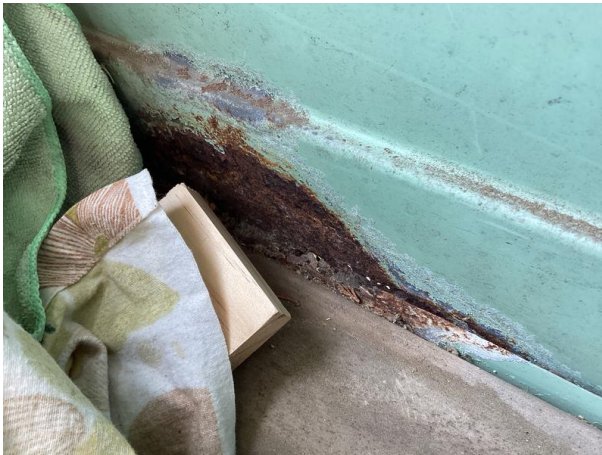
**Photo 77**

Corrosion was visible on the metal cladding weatherboards viewed from inside the garage.

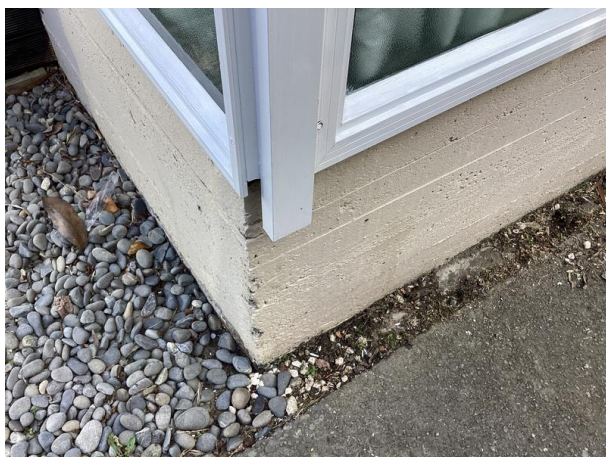
**Photo 79**  
It is recommended to connect the conservatory downpipe to an approved stormwater system.

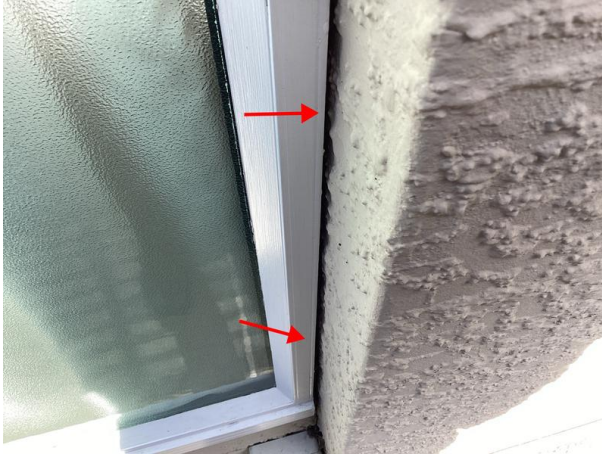
**Photo 80**

There were gaps between the conservatory and the dwelling noticed. It is recommended to seal these junctions.

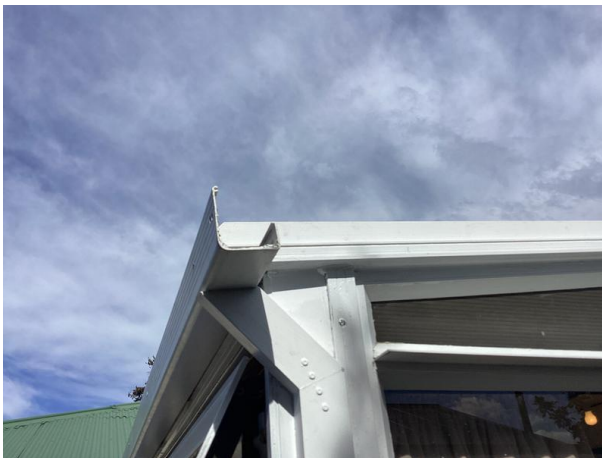
**Photo 81**

It is recommended to reinstall the conservatory gutter end capping.

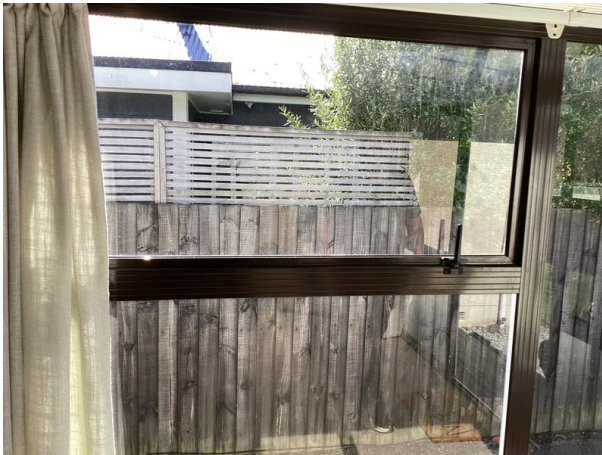
**Photo 85**

The Northside Conservatory window was difficult to open and close. Adjustments are recommended for better functionality.

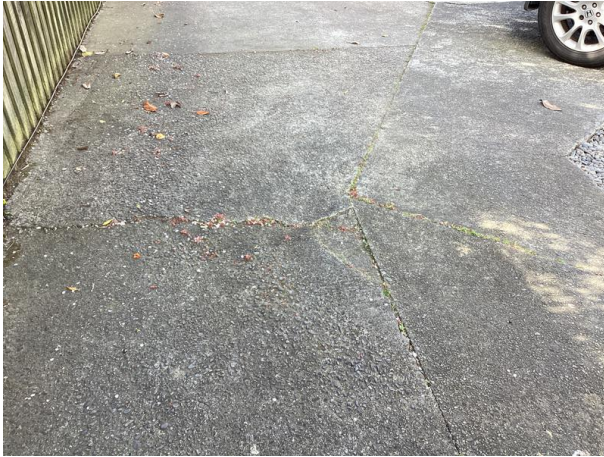
**Photo 86**

Concrete cracking was noticed in the driveway.

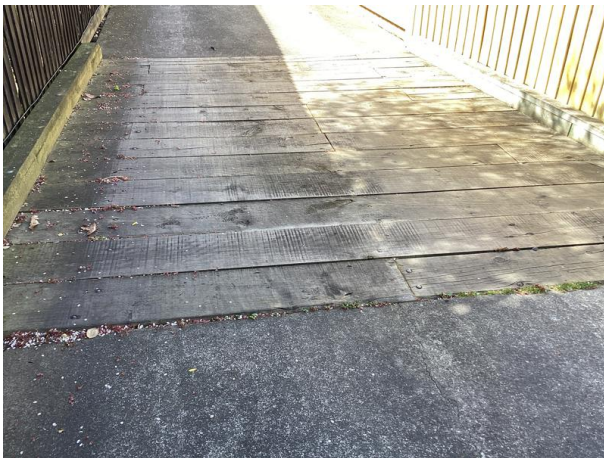
**Photo 87**

A timber bridge is also located on the driveway. Under this was not viewed or inspected. However, general ageing and timber splitting was noticed on top.

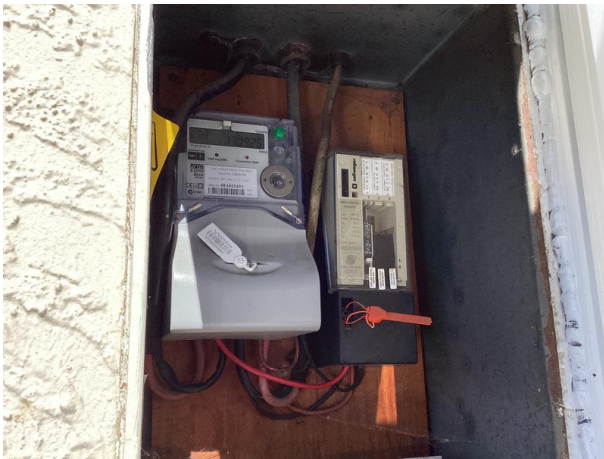
**Photo 105**

Meter box located on the east side of the dwelling. Corrosion was noticed around the meter box.
