## RED LBP PRE-PURCHASE REPORT

# CERTIFICATE OF INSPECTION IN ACCORDANCE WITH NZS 4306:2005

**Company:** Ragnarok Building Inspection Ltd trading as RedLBP Christchurch South  
**Client:** Rachel Bartlett  
**Date of Inspection:** 22nd August 2025  
**Site Address:** 29 Neville Street, Spreydon, Christchurch 8024  
**Inspector:** Shannon Faulkner  
**Qualifications:** National Certificate in Carpentry. Licensed Building Practitioner

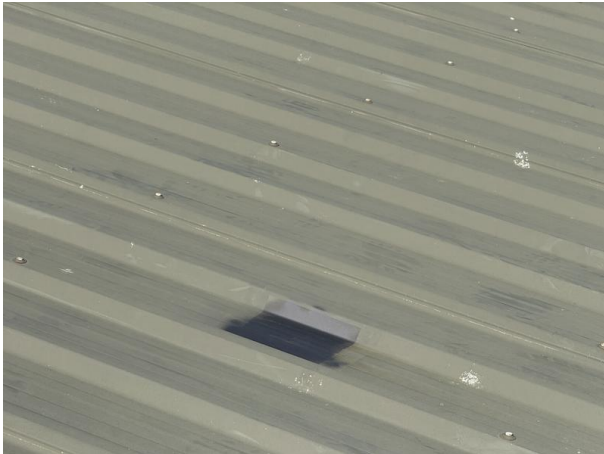
**Photo 4**

Painted patch observed to the roof, further investigation recommended.

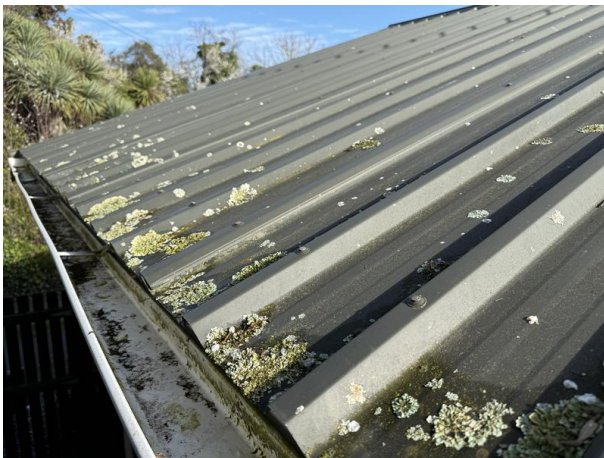
**Photo 5**

Lichen visible to the southern elevation.

The roof displayed visible signs of lichen growth in certain areas, and it is advised to address this issue as part of regular maintenance. Failure to do so could cause deterioration of the coating.

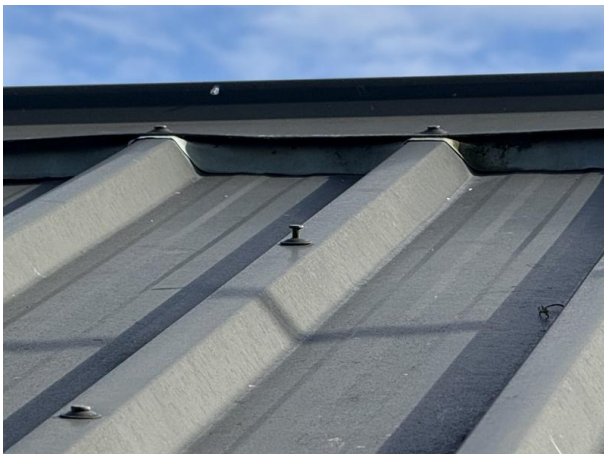
**Photo 6**

An example of a popped nail. Multiple popped nails were observed on the roof.

Considering the age of the roof, it appears to be in a maintainable condition. To preserve its condition and extend its lifespan, it is recommended to prioritise the maintenance of the paint coating and replacement of some fixings. This should be undertaken in the near future.

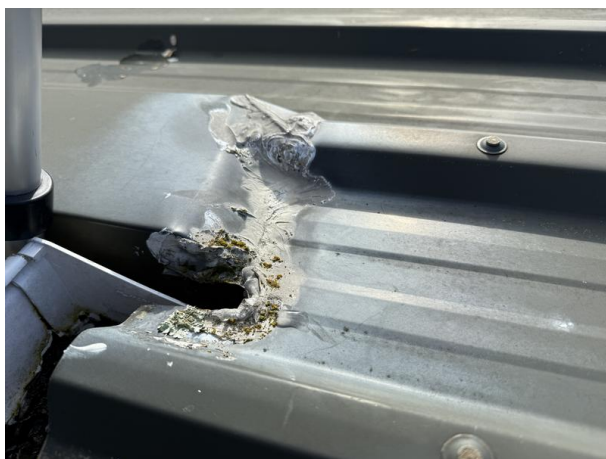
**Photo 7**

Barge flashing is reliant on sealant to maintain weathertightness.

Laps in flashings should comply with the following criteria:

- Water must flow over a lap, not into it,
- a lap must not rely solely on sealant, sealed laps must be mechanically fixed at 50 mm centres, and
- end laps must be a minimum of 150 mm for unsealed laps and 100 mm for sealed laps.

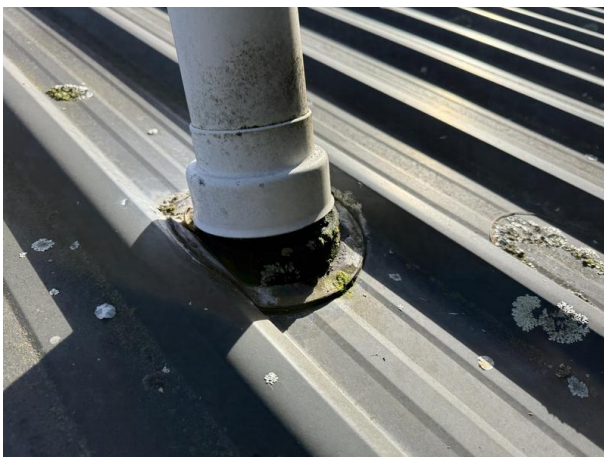
**Photo 8**  
Roof penetration is showing signs of ageing.

It is recommended that future maintenance includes the installation of a watershed back flashing beneath any EPDM boot flashing where the pipe diameter exceeds 85 mm or covers one or more trough's. In accordance with E2/AS1.

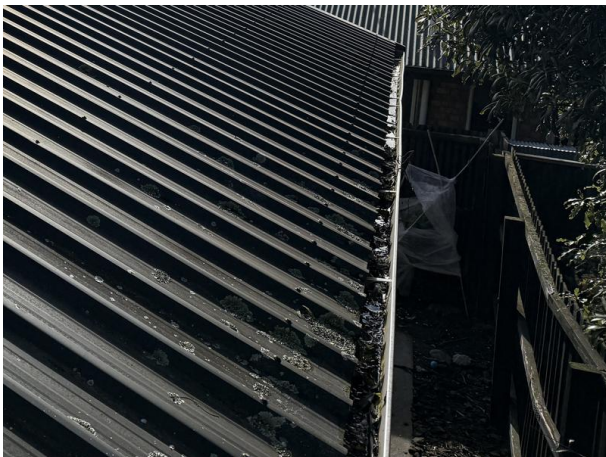
**Photo 9**

Guttering on the southern elevation has areas of ponding and debris.

The uPVC guttering system displays areas of water ponding, which suggests inadequate fall and/or sagging between support points. Ponding in uPVC profiles can accelerate UV degradation, promote microbial growth, and increase the risk of overflow during heavy rainfall, potentially leading to water ingress and damage to adjacent building elements. To resolve this, the guttering should be realigned to maintain a consistent fall toward the droppers, ensuring efficient drainage. Additionally, supplementary uPVC-compatible brackets should be installed at reduced intervals—typically no more than 600–750 mm apart—to reinforce the profile

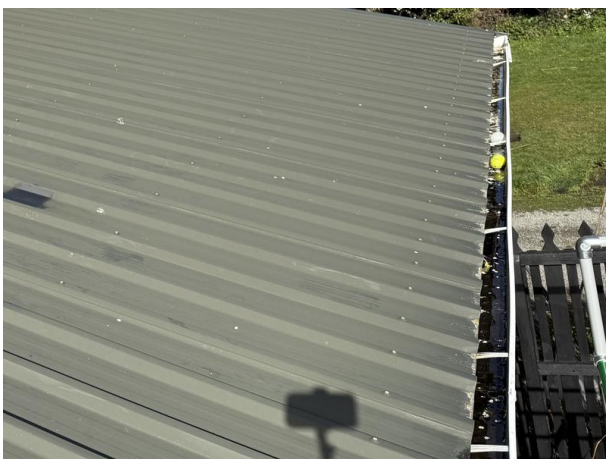
**Photo 10**

Guttering to the north elevation has areas of ponding and other obstructions.

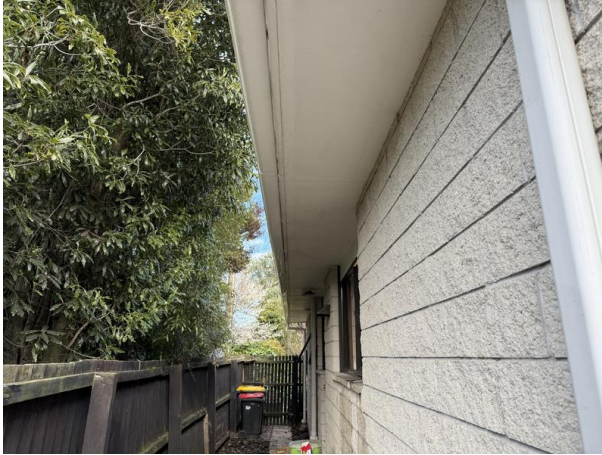
**Photo 11**

Discolouration and grime observed to the soffits, general maintenance recommended.

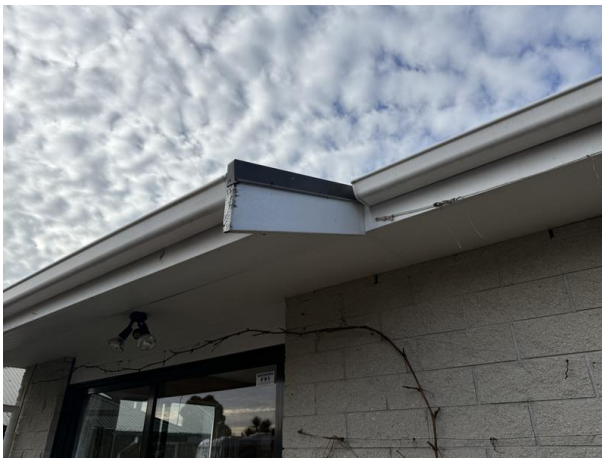
**Photo 12**

The ends of the barge boards are showing signs of deterioration.

Sections of the timber fascia are starting to exhibit areas of decay requiring repair. Any areas of rotten timbers should be removed and replaced by a suitably qualified professional. Remaining sound timbers should be prepared by sanding back any loose or flaking paint, followed by the application of a suitable sealer coat and redecoration. These works are recommended to prevent further deterioration.

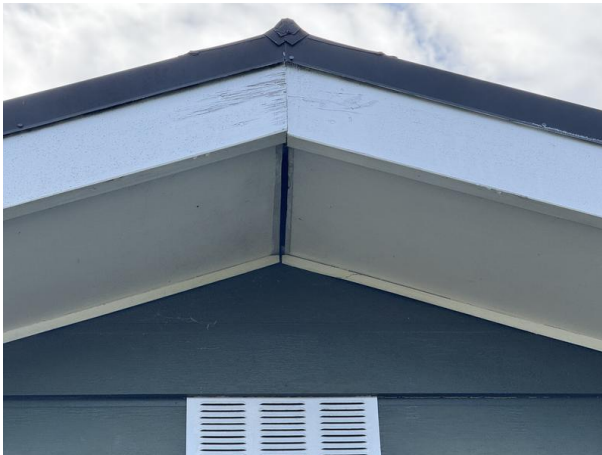
**Photo 13**

An example of deterioration to the fascia. The apex of the soffit is missing the jointer capping.

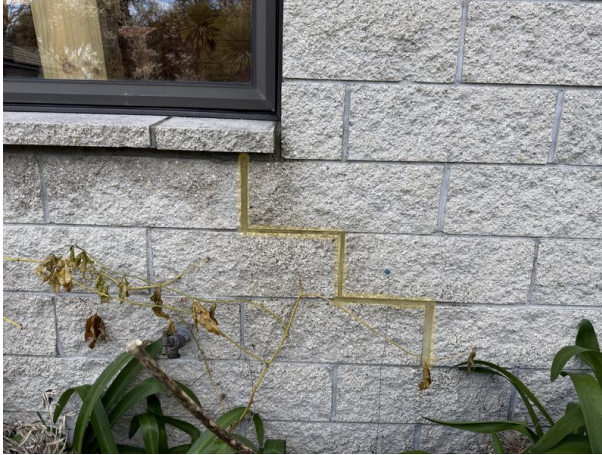
**Photo 15**

An example of step cracking was observed, with multiple areas displaying this pattern across most elevations of the property.

The exterior cladding has visible cracks that require professional repair. Cracks in the cladding can serve as entry points for moisture, potentially allowing water to penetrate behind the cladding and reach the timber framing. If left unaddressed, this can lead to issues such as rot, structural damage, or compromised insulation. Prompt and professional repairs are essential to maintain the integrity of the cladding system and prevent further deterioration.

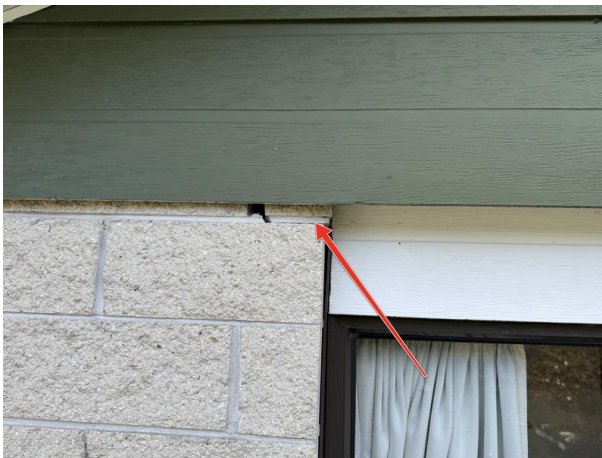
**Photo 16**

The top brick next to the window on the west elevation is loose.

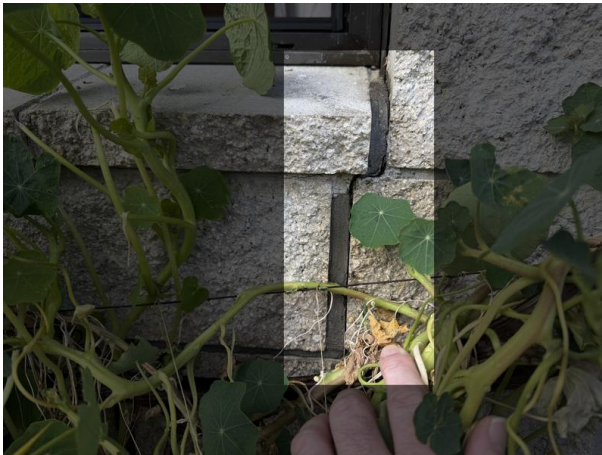
**Photo 17**

Cracking observed to the mortar under the window of bedroom 1.

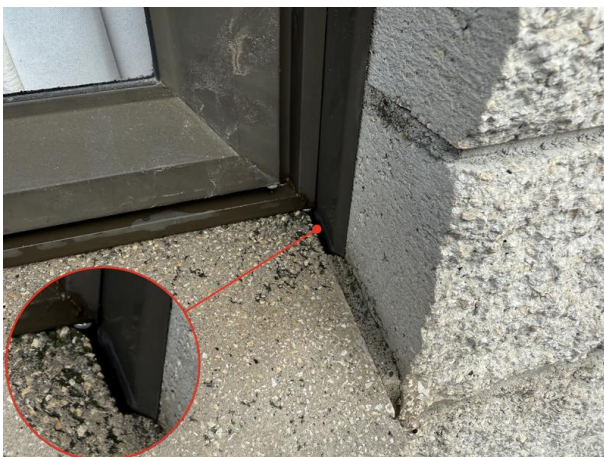
**Photo 18**

Window flashing-to-sill junctions require maintenance to ensure weathertightness.

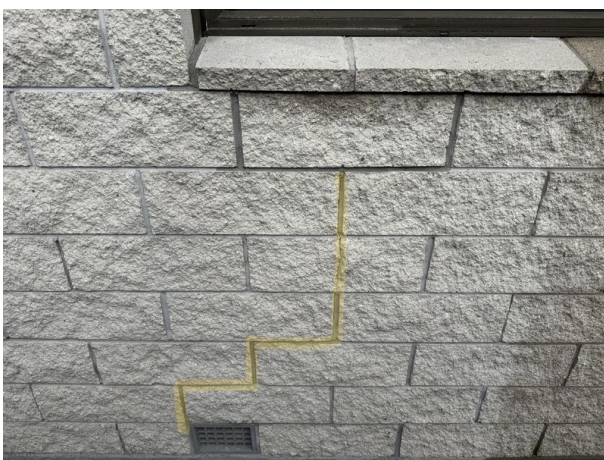
**Photo 19**

Step cracking and cracking through the veneer observed on the east elevation under the dining room window.

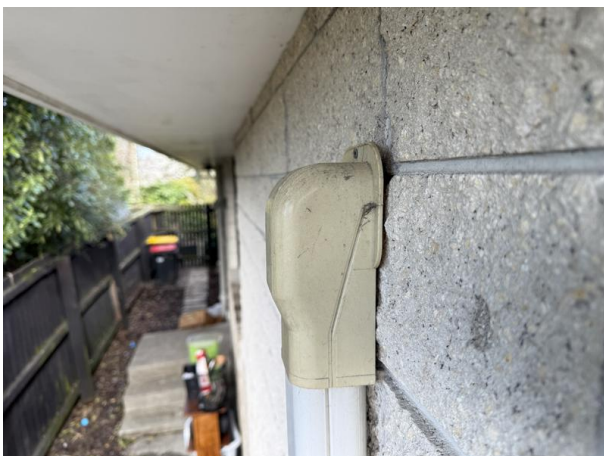
**Photo 20**

Heap pump penetration cap appears inadequately sealed to the cladding.

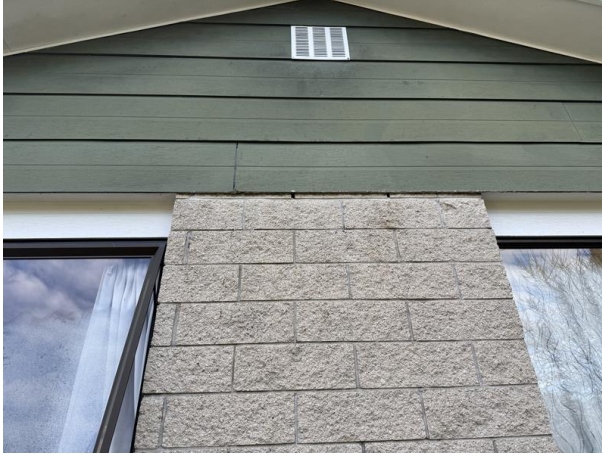
**Photo 21**

Chalking and deterioration to fibrous cement weatherboard at gable ends.

The exterior paint system of the home is showing signs of deterioration. This degradation compromises the protective barrier provided by the paint, leaving the underlying materials vulnerable to environmental elements such as moisture and temperature fluctuations. Over time, this can lead to more severe issues, including water ingress, rot, or corrosion.

To restore the integrity of the exterior, we recommend repainting of the home.

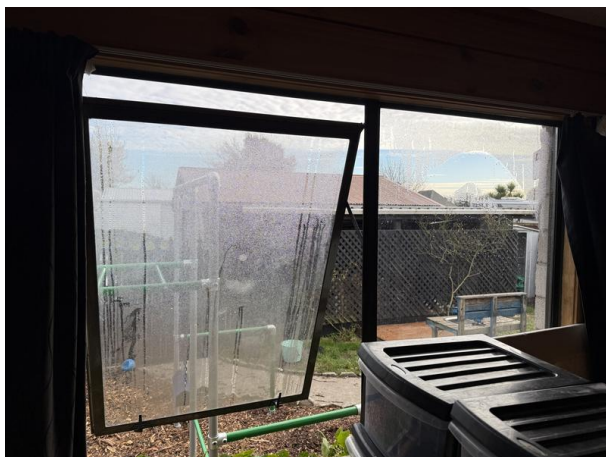
**Photo 22**

Condensation noted to multiple windows throughout the dwelling..

To prevent the condensation from forming, upgrading or a new ventilation system such as an HRV, DVS, I-Vent or similar should be considered. These greatly reduce any moisture in the home.

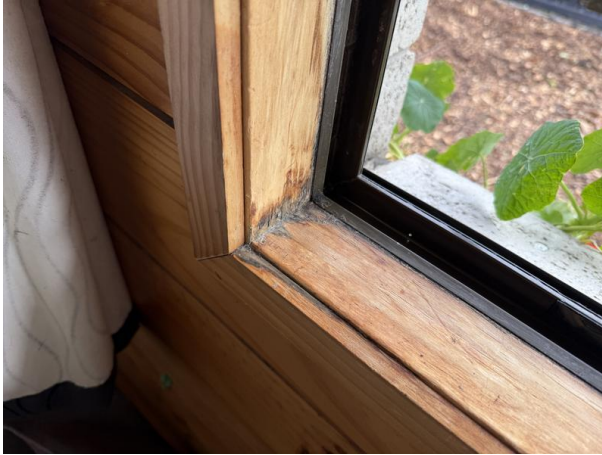
**Photo 23**

There is moisture staining to the timber reveals. Indications of elevated moisture readings were detected, this may be due to condensation, or the joinery leaking. This should be monitored for signs of moisture. This may be due to wind-driven rain or condensation.

The bottom corners of multiple windows throughout the dwelling show signs of moisture damage.

Make sure polyurethane is maintained and moisture is kept at a minimum.

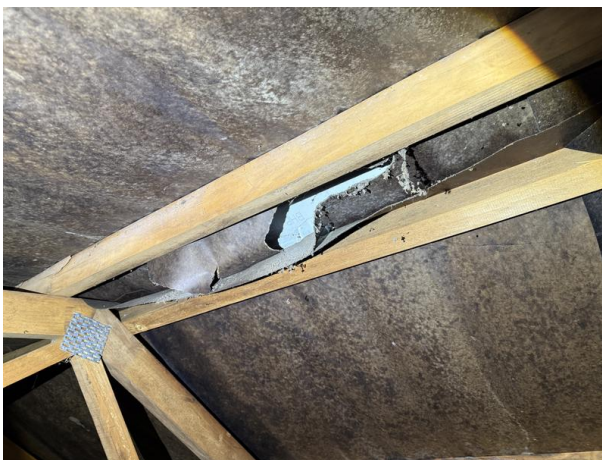
**Photo 29**

Areas of the roofing underlay have torn.

Damaged or torn roofing underlay should be repaired in accordance with the manufacturer's specifications to ensure it performs as intended and meets the requirements outlined under Clause B2 Durability of the New Zealand Building Code. Proper repairs are essential to maintain the underlay's role in providing secondary protection against moisture ingress, enhancing the roof system's overall weathertightness.

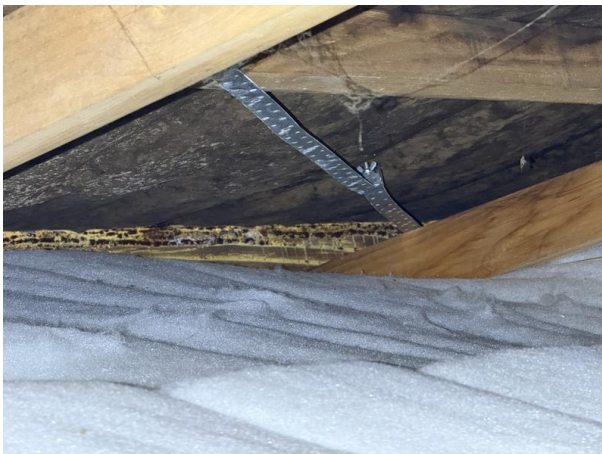
**Photo 30**

Further investigation is recommended into the discolouration of the purlins to the southwestern end of the dwelling.

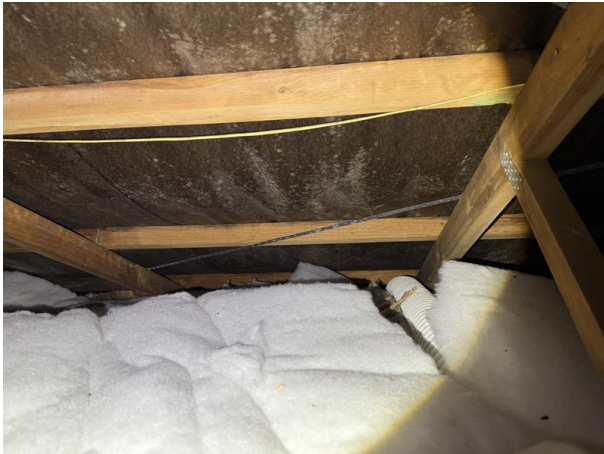
**Photo 31**

Mould visible to the underside of the roofing underlay. Further investigation required.

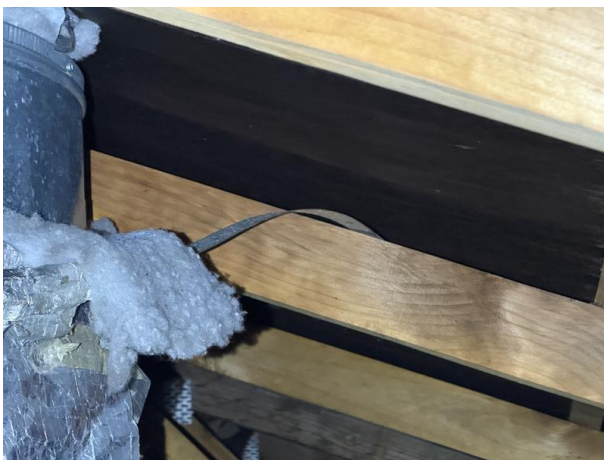
**Photo 32**

Roof strap bracing has been cut where the hot water cylinder has been installed. Further investigation recommended.

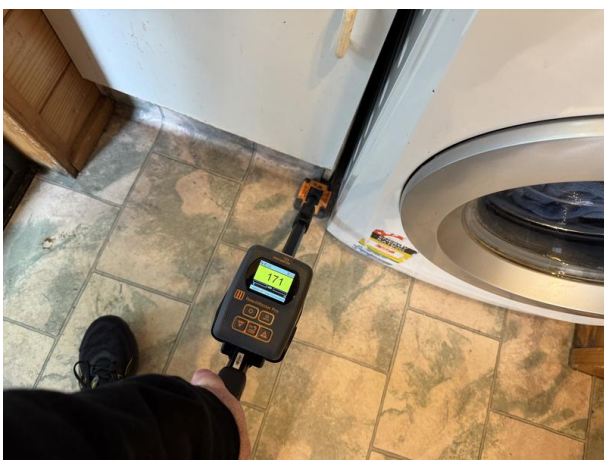
**Photo 34**

Indications of elevated moisture readings noted to the floor at the corner of the laundry tip. Further testing and investigation recommended.

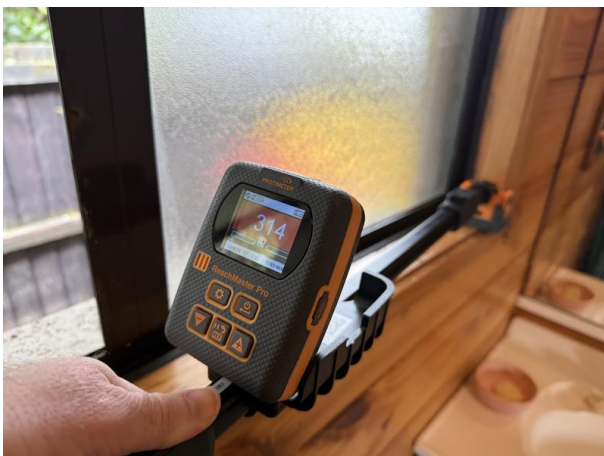
**Photo 35**

Indications of elevated moisture readings were detected to the corners of most windows. Windows were in the process of being cleaned at the time of inspection.

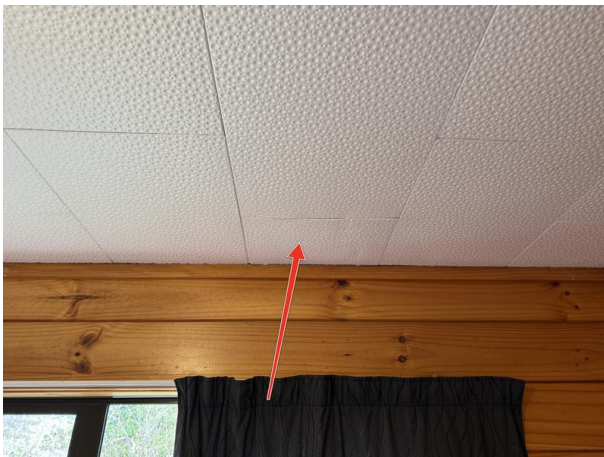
**Photo 50**  
Moisture damage to ceiling tiles—tested dry at time of inspection.

Monitor the ceiling tiles for signs of moisture ingress and remediate as required.

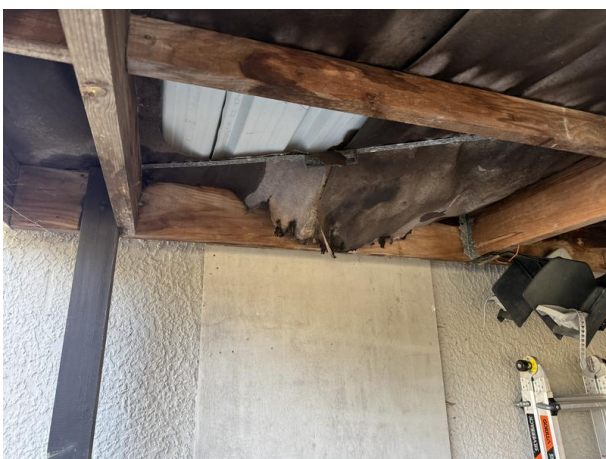
**Photo 52**  
Torn roofing paper and water damages observed to the roof framing.

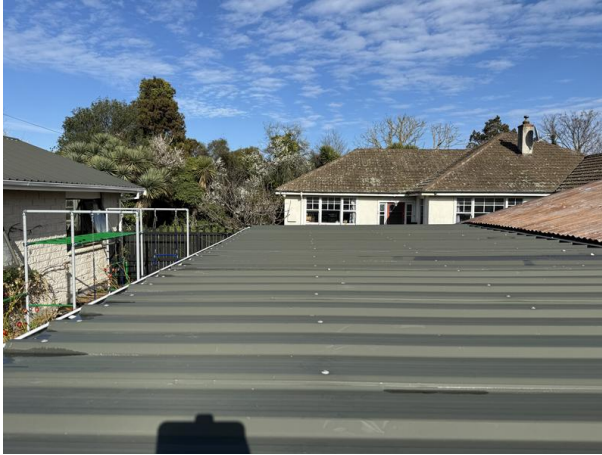
**Photo 53**

The pitch of the carport roof does not meet the minimum 3° required for this profiled metal roofing, increasing the likelihood of water ponding and wind-driven ingress beneath flashings.

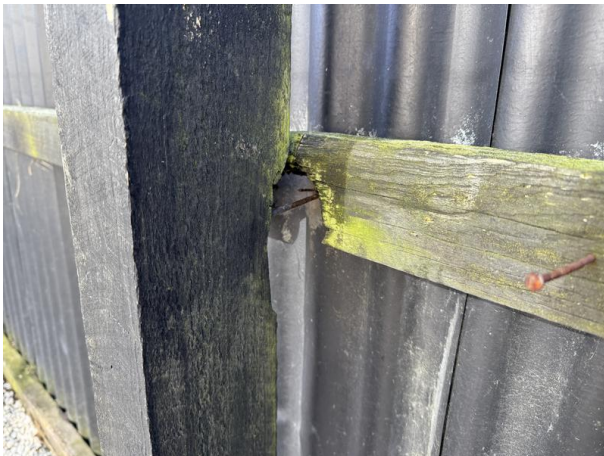
**Photo 55**

Deterioration observed to the fence post and rail by the clothesline.

Ensure regular upkeep and maintenance by keeping vegetation and soil away from exterior timbers. These timbers are treated for external exposure but are not designed for prolonged contact with vegetation or soil, which can trap moisture and accelerate rot. Periodically inspect the area and clear any overgrowth or soil buildup.

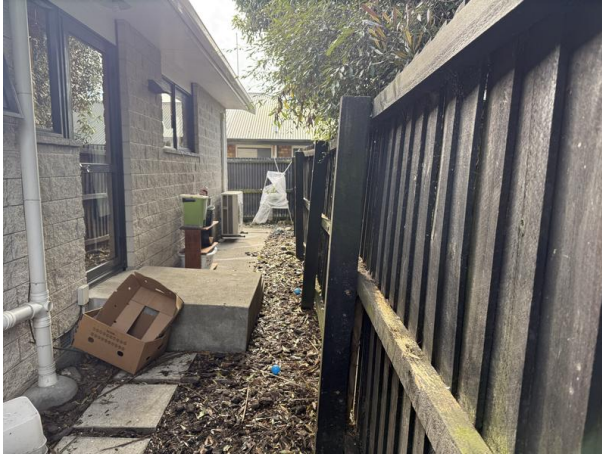
**Photo 56**

Rotation observed to the southern boundary fence.

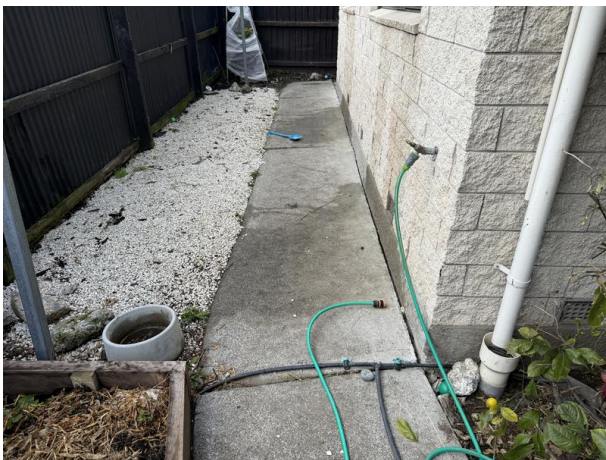
**Photo 57**

The concrete paths and back steps are exhibiting localised subsidence, as indicated by differential settlement up to 25 mm and cracks wider than 3 mm. This movement may create a trip hazard, impede surface drainage, and accelerate further deterioration. If further settlement or new cracking occurs, seek advise from a suitably qualified professional.

Concrete path - Functional. Cracking and subsidence observed.

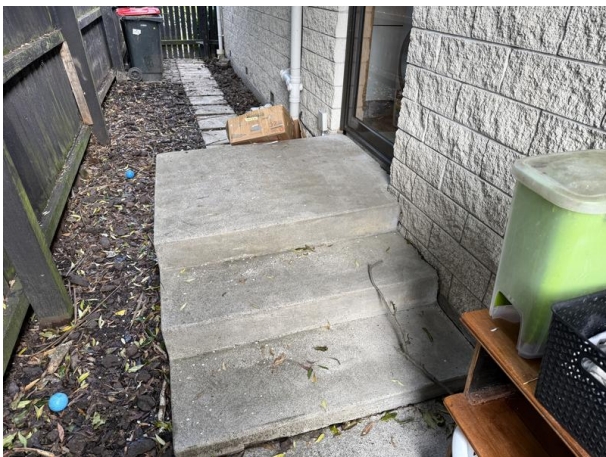
**Photo 58**

Concrete back steps have slumped away from the dwelling.
