RESIDENTIAL PROPERTY INSPECTION

Inspection Address: 125 Harris Crescent. Christchurch

Inspection Date: Tuesday, 2 September 2025

Version Control Version 2 – More photos added

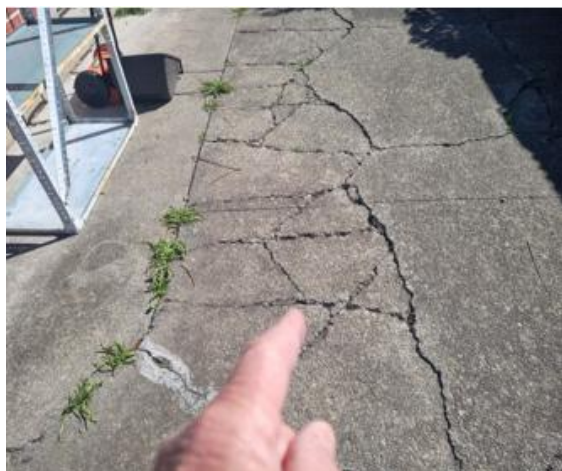
- Driveway has cracking, patches, and undulations
- The steel gate to the right of the garage does not work

Drive – cracked and unlevel

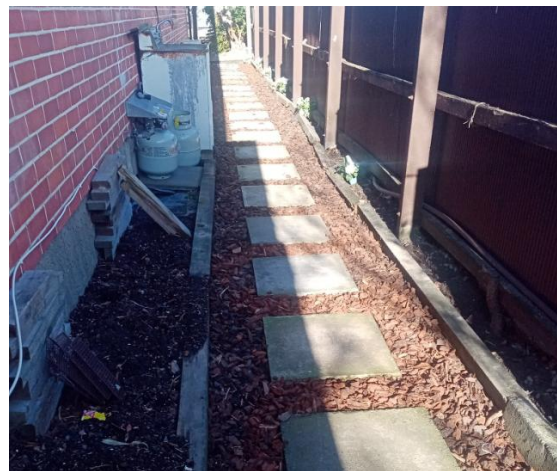
Path reinstated

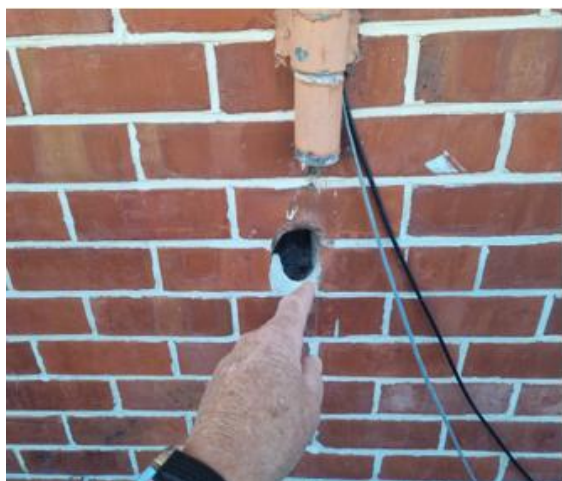
- Surface wear to the tiles in front of conservatory
- Holes in brickwork on the fence side of the house, and a broken drainage vent pipe

Several holes in brick work

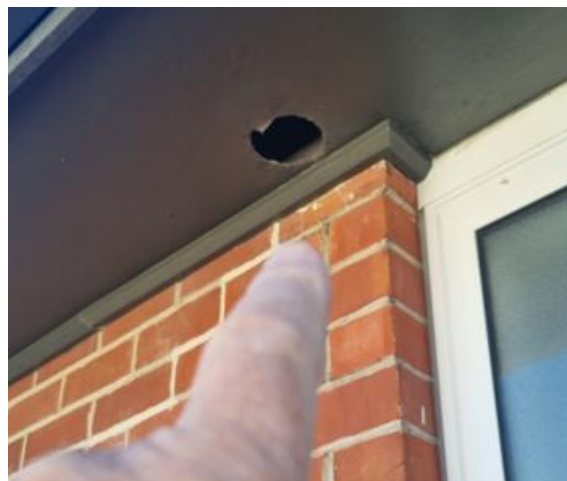
- Soffit has damage and a hole in where overflow pipe comes through. May allow vermin access to the roof space

ITEM ASSESSED	DEFECT	COMMENTS/NOTES
Roof System - material	-	Concrete tile
Roof condition	None	No defects noted
Gutters/Spouting/downpipes	None	No defects noted
Eaves/Fascia/Soffits	Minor	Soffit has damage and a hole in where overflow pipe comes through. May allow vermin access to the roof space.

Holes in soffit

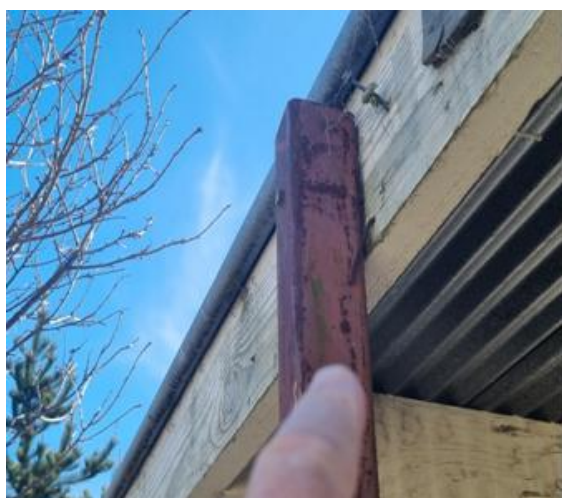
- The garage spouting has corrosion. The garage cladding is coming away from frame – right-hand side and has surface corrosion
- Carport structure is in poor condition with sagging timbers, a lack of support post and the spouting on the right-hand side has no stormwater outlet. The conservatory has a jerry-rigged downpipe system

Carport in poor condition

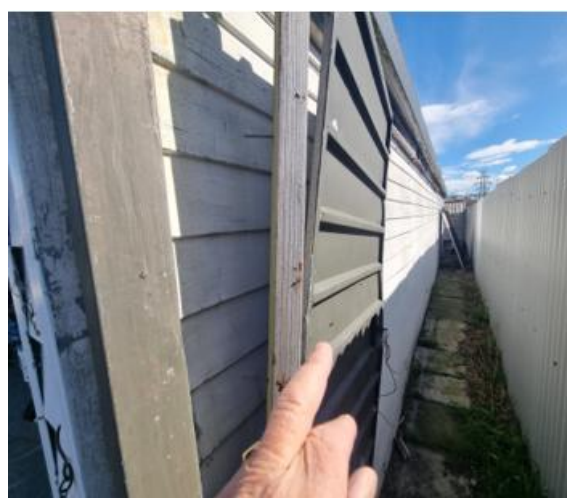
Gate RHS garage nonfunctional

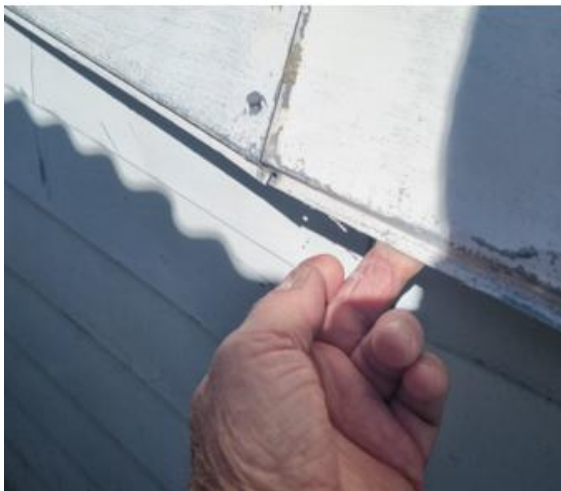
Garage wall cladding coming away from frame

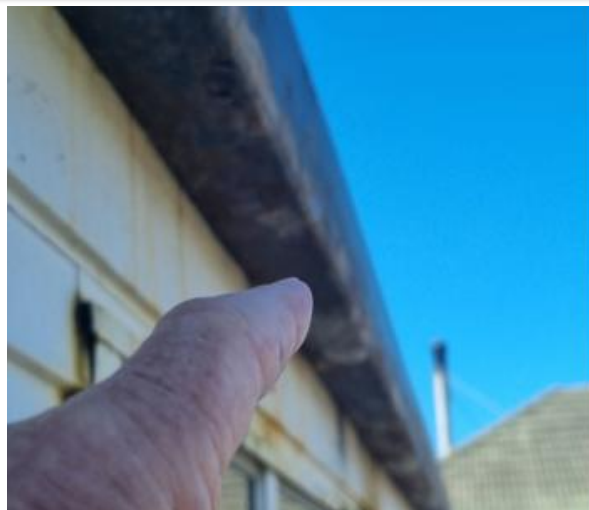
Rust to garage spouting

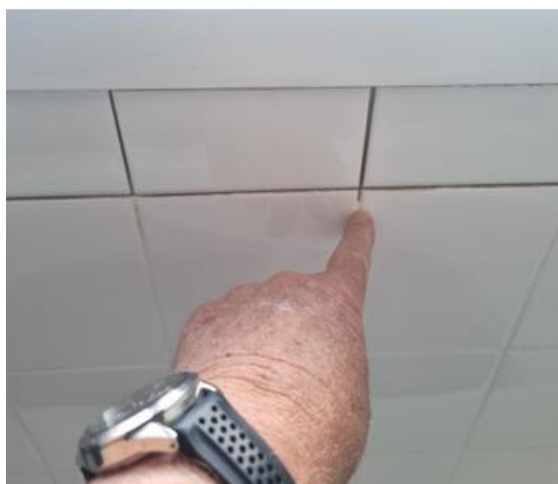
Grout missing above bath

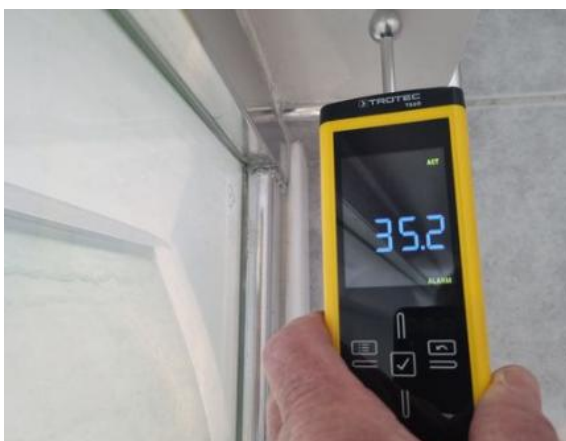
The moisture readings were between 15.8 and 45.3 – these are in the dry range.

Moisture testing – dry range

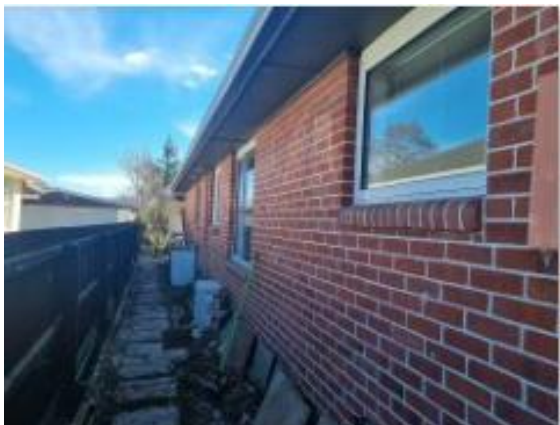
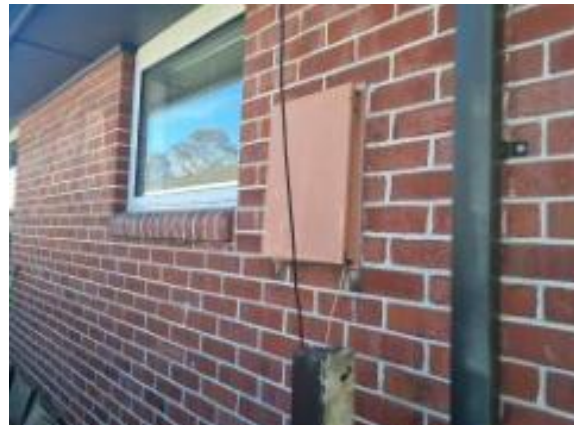
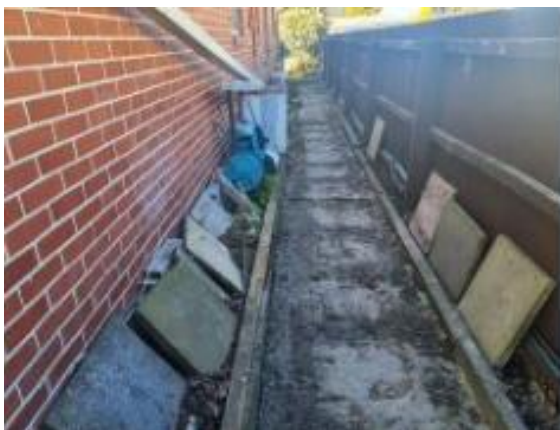
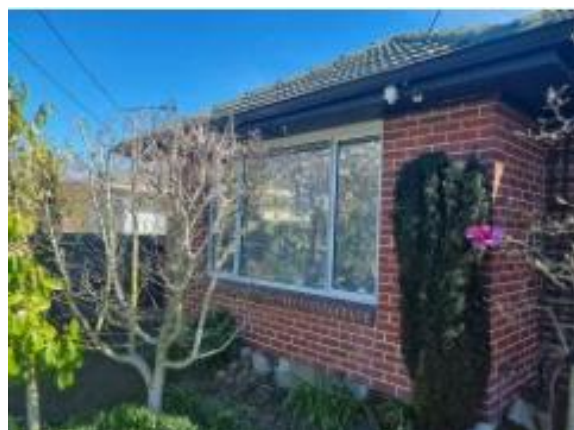
No EQ Mortar cracking noted

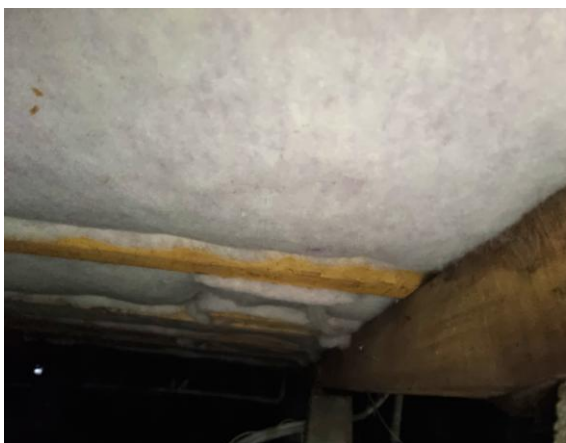
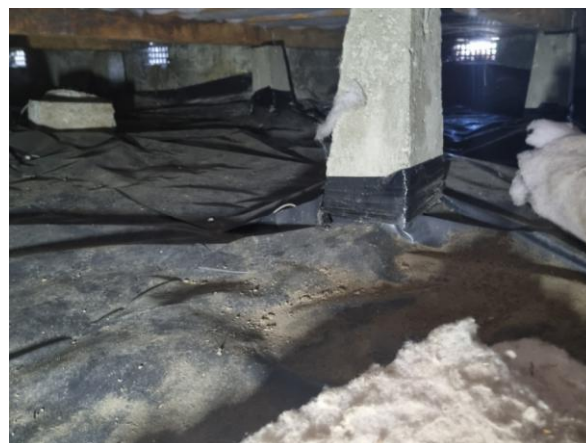
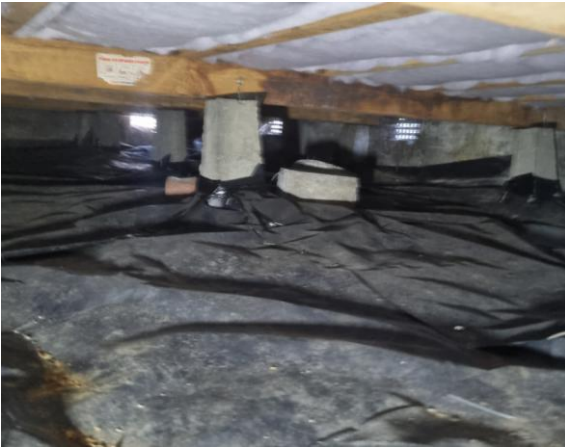
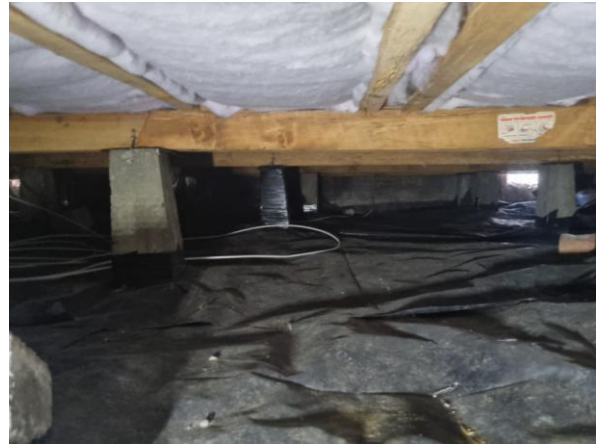
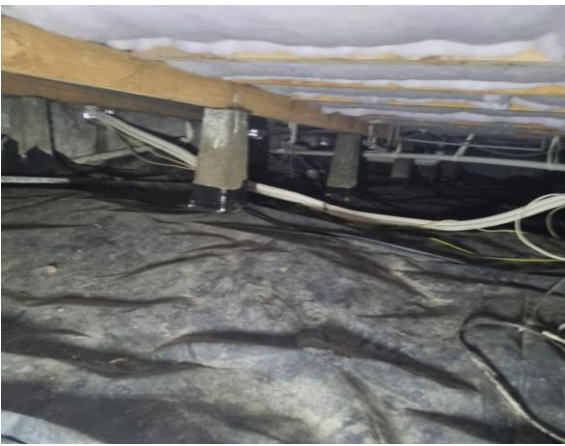
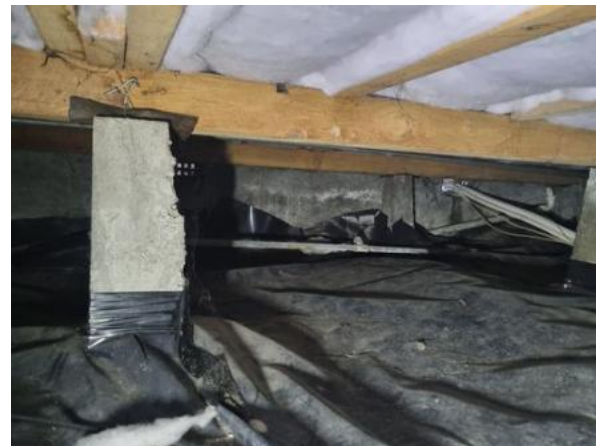
Subfloor - adjustment
