## Building Report

57 Matai Road

Paraparaumu

| <b>Type of inspection:</b> | Building Inspection |

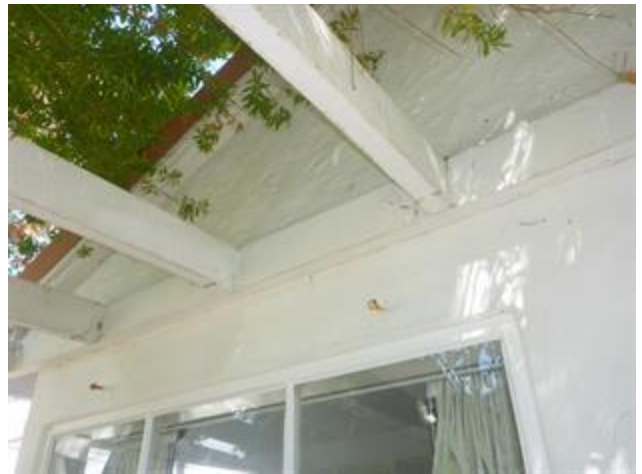
The pergola to the side of the lounge is direct fixed through the cladding, which can allow moisture retention that can contribute to progressive damage. A gap between the cladding and the pergola is recommended. The top of the pergola would also benefit from a new paint seal

Direct fixed

The pergola to the side of the lounge is direct fixed through the cladding, which can allow moisture retention that can contribute to progressive damage. A gap between the cladding and the pergola is recommended. The top of the pergola would benefit from a new paint seal.

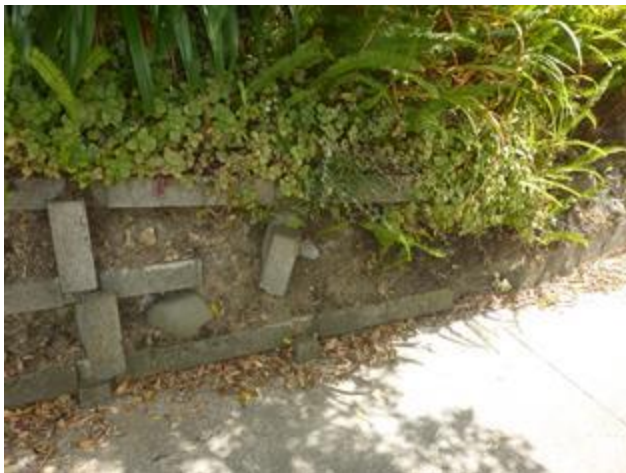
The property has numerous retaining walls in place, the majority appeared in good condition with no evidence of movement or subsidence except the wall to the front of the dwelling that has a small area that would benefit from repair to ensure stability.

Small repair recommended

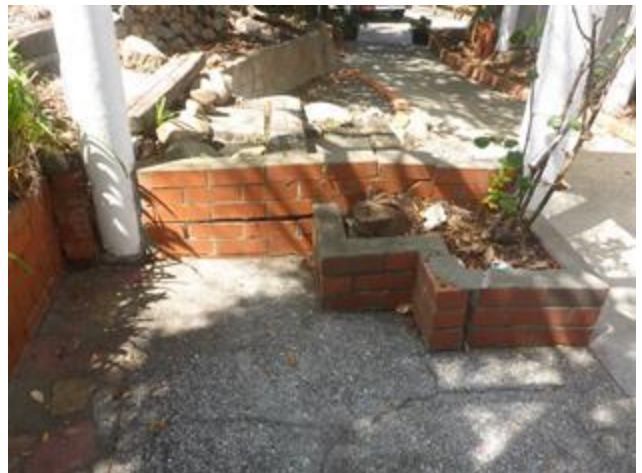
Some tree root penetration was also noted to the small brick wall to the side of the lounge.

Tree root penetration

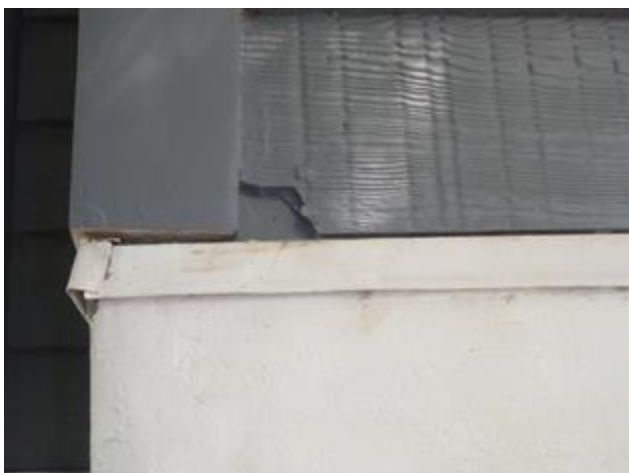
The cladding appeared to be generally in good condition. Some impact damage was sighted to a small area to the northern side of the dwelling with a crack to the cladding sighted to the southern side.

Small area off impact damage

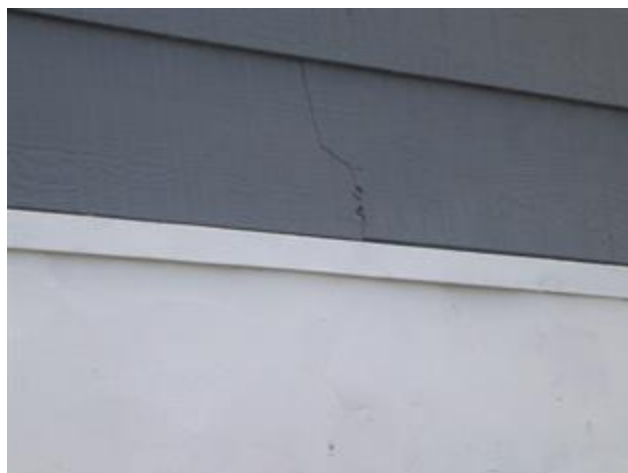
Crack

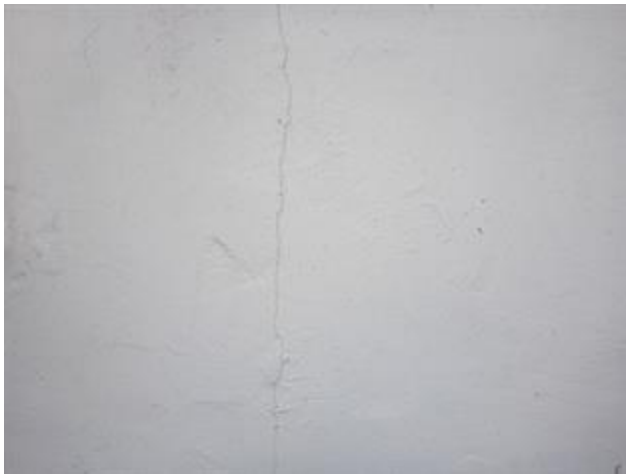
The cement board cladding was in good condition except for a small crack in the cladding to the side of the garage that would benefit from further appraisal and repair.

Garage cladding crack

The cement board cladding was in good condition except for a small crack in the cladding to the side of the garage that would benefit from further appraisal and repair.

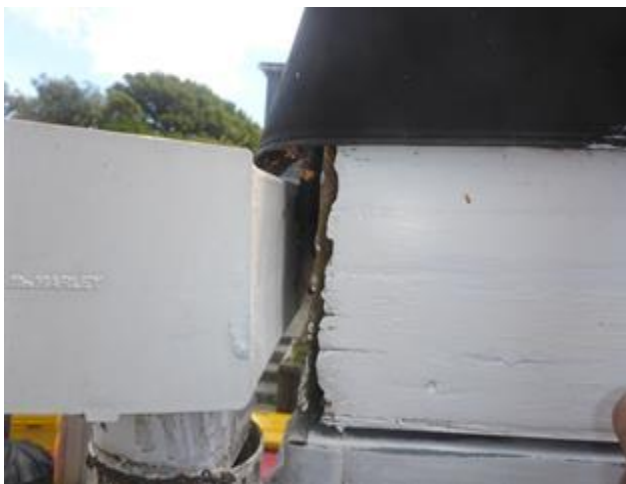
The corner junction of the fascia to the southeastern side had a small area of deterioration and would benefit from repair and a flashing to seal the corner.

Repair recommended

The corner junction of the fascia to the southeastern side had a small area of deterioration and would benefit from repair and a flashing to seal the corner.

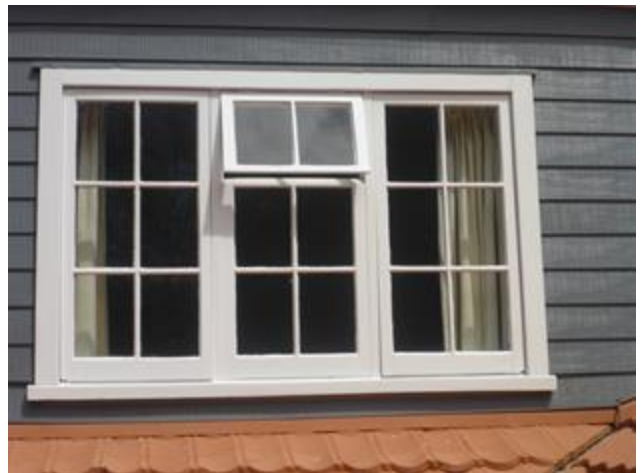
The paint finish to the window joinery was of a good standard. The side garage door however would benefit from a touch up.

Touch up

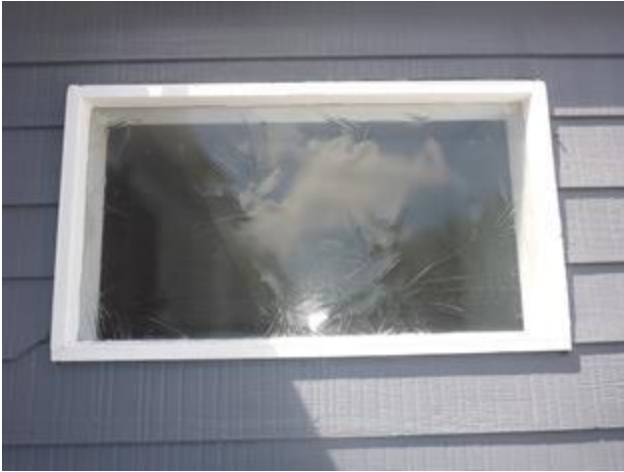
One window flashing to the southern side has aged with a new seal recommended.

Flashing deterioration, new flashing could be retro fitted

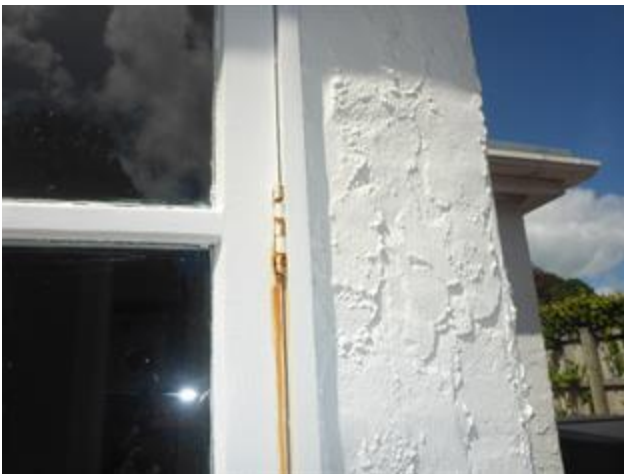
Some window hinges were showing signs of corrosion. I recommend removing the corroded hinges from the windows to be cleaned and oiled or replaced with brass or stainless-steel hinges if existing hinges cannot be cleaned and re-installed.

Hinge corrosion

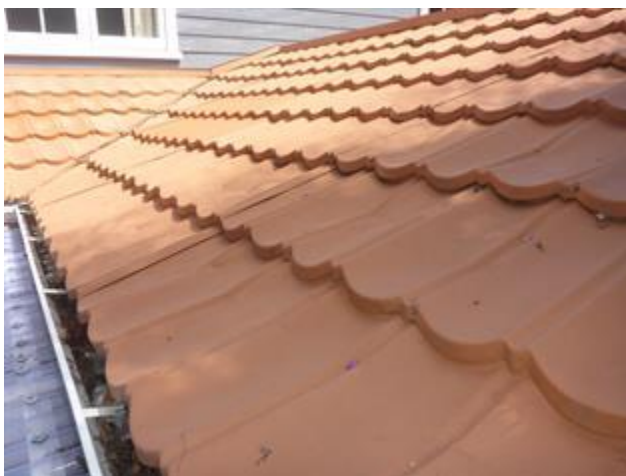
The majority of the colour tile roof cladding was in good condition however foot traffic over the roof has led to noticeable dents across small areas of its surface. These dents can compromise the integrity and performance of the roofing system. Not only can these dents reduce the roof's lifespan, but they can also be the direct cause of leaks and accelerated deterioration. The dented tiles could be replaced as part of the dwelling's maintenance planning.

Dented tiles

I recommend that the roofing material have further appraisal by a licensed roofer to give you advice on the degree of tile repair and potential costs.

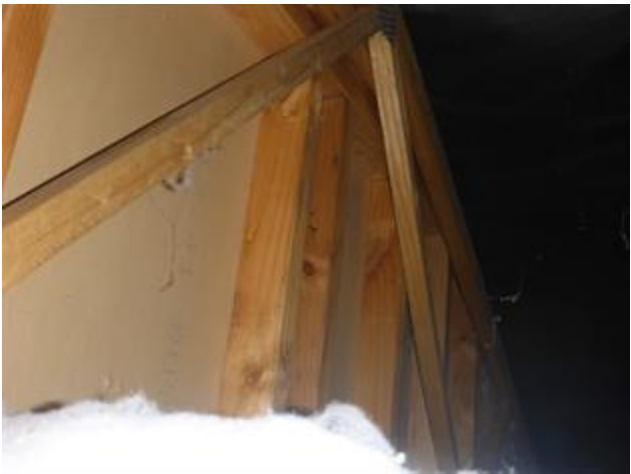
Dropped insulation

It is also recommended that insulation is fitted snugly between framing without gaps, tucks or folds but not compressed or packed tightly around electrical wiring.

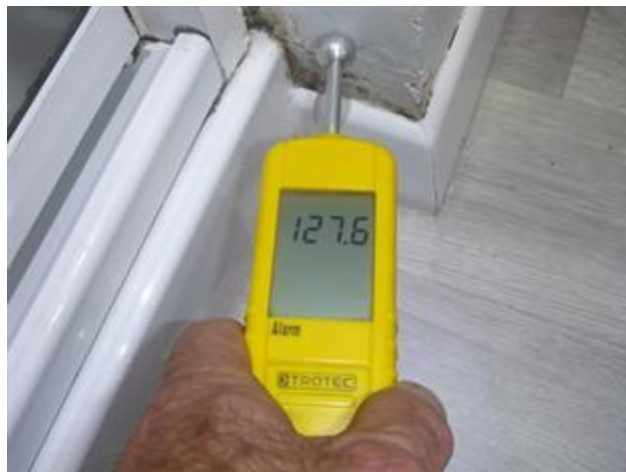
All moisture readings were within acceptable parameters except to the right side of the end bathroom shower enclosure.

High moisture levels

I suggest first removing the skirting to assess the wall lining to ensure there are no further indications of moisture issues. If further indications are present a small piece of wall lining could then be removed to determine the extent of the moisture damage.

I recommend that the area identified with high moisture levels now have further invasive appraisal to ensure repairs can be fully carried out and any compromised material can be removed and replaced.
