Inspection Report

Ausispec

20 Harward Street, The Gap, Queensland, 4061

Report/Agreement # 240725054013322
Inspection Date: 24 July 2025
Inspection Time: 03:00 pm

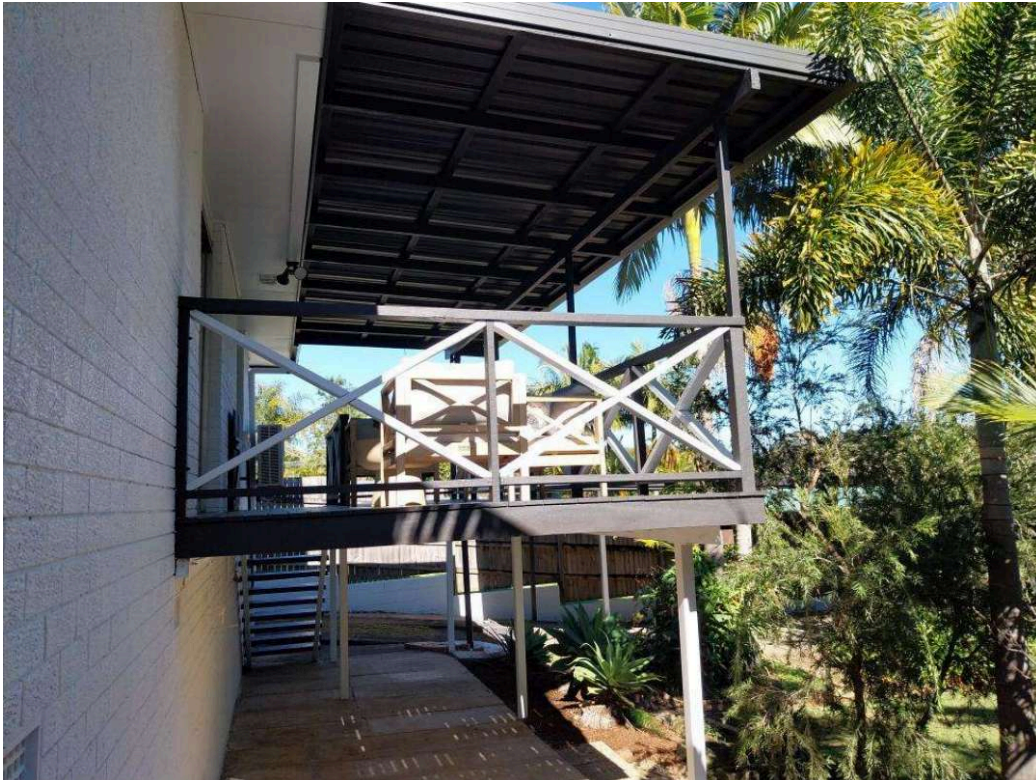
(Recommendation): Existing handrails/balustrades are non-compliant with current regulations. Whilst these may not require upgrading due to the age of construction/installation, this report strongly recommends that all noncompliant items in regards to the stairs and handrails be independently assessed and upgraded to the latest building regulation requirements.

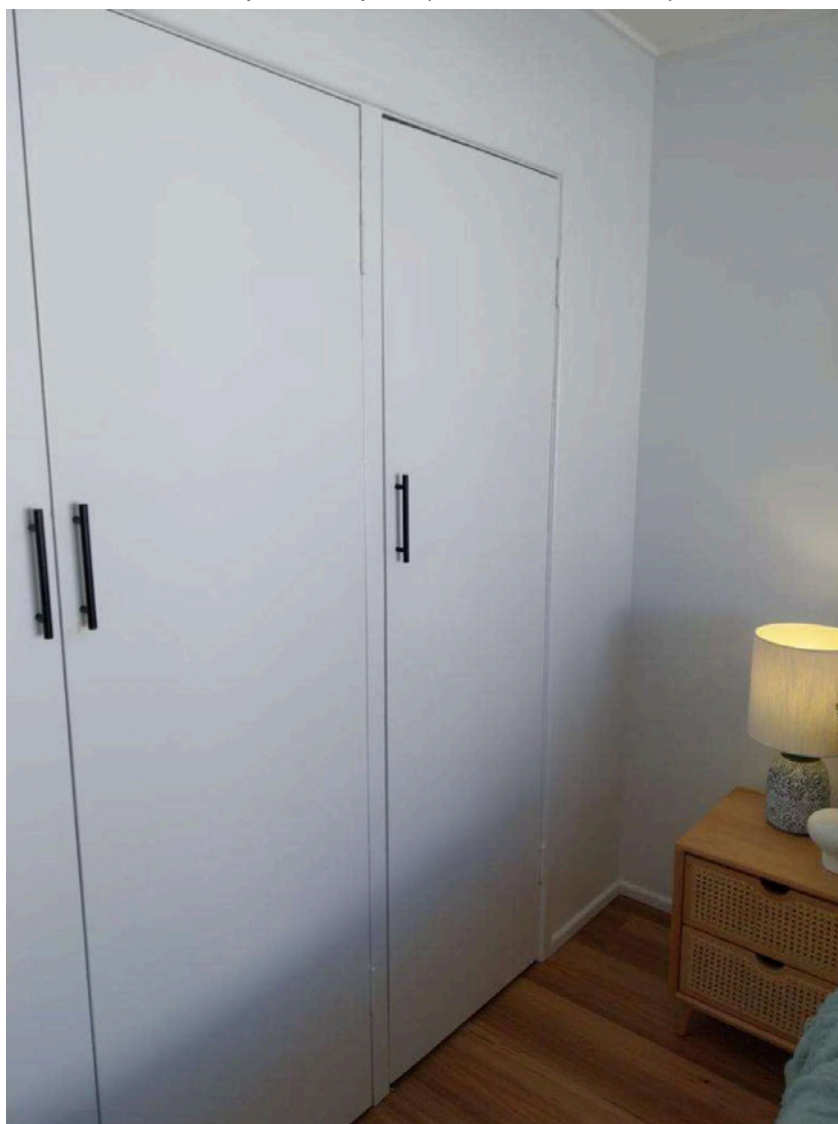
The sliding windows/doors would require replacement of the roller mechanisms to improve function.

Wardrobe door in 2nd bedroom requires repair (has delaminated).

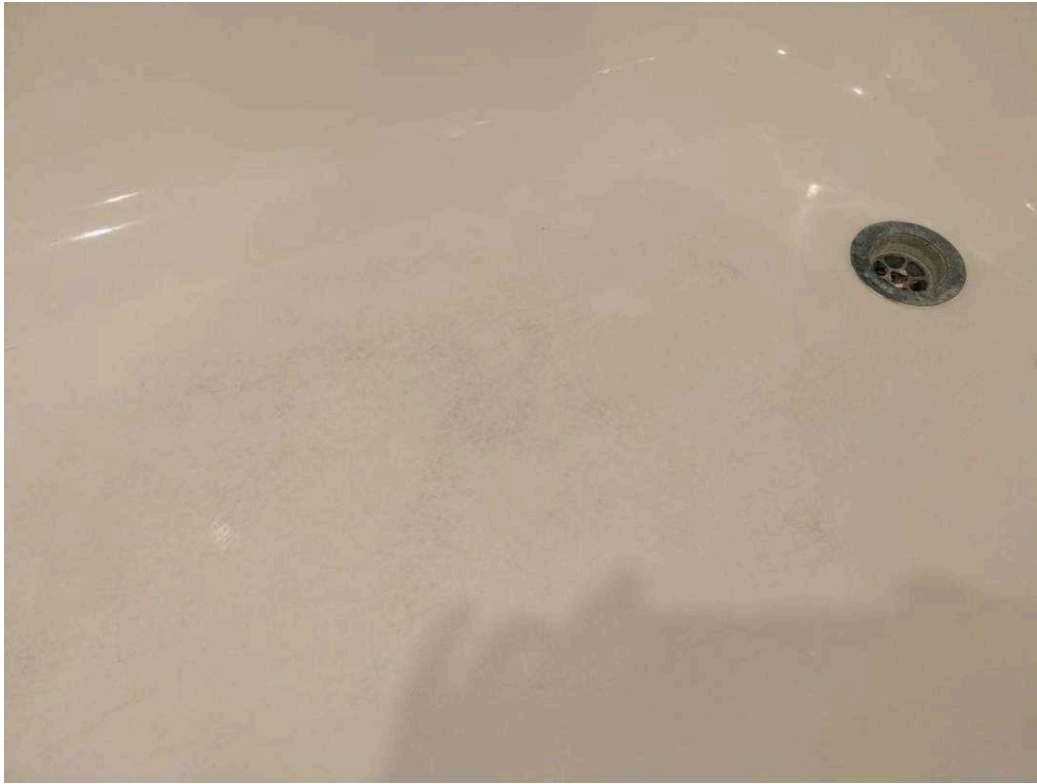
Bath tub surface finish is noticeably deteriorated.

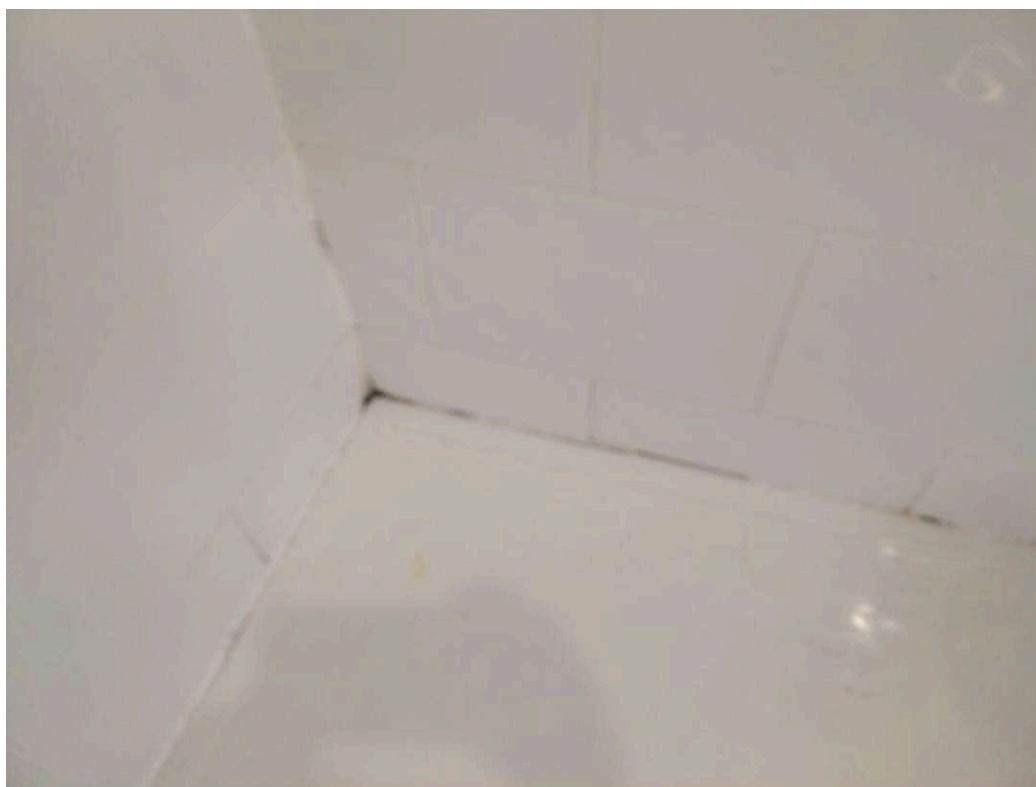
Mould spores exist in the main bathroom shower recess

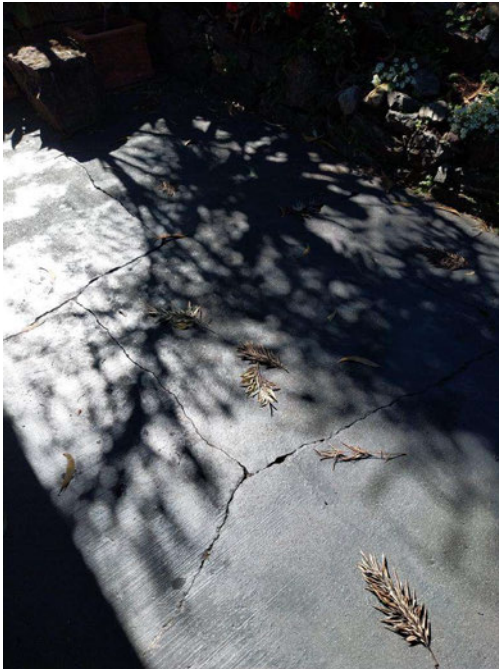
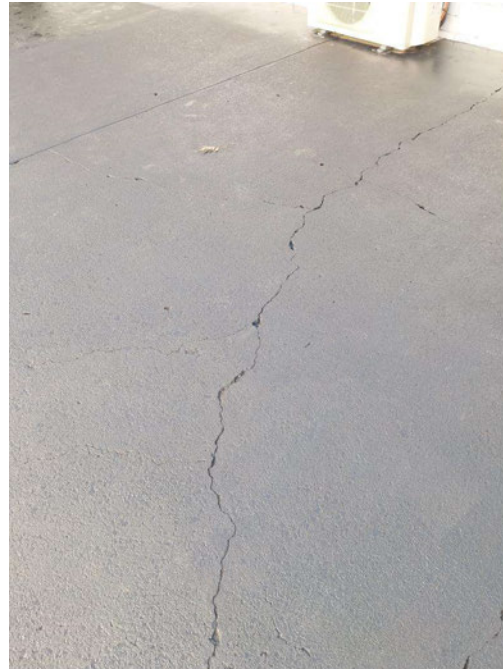
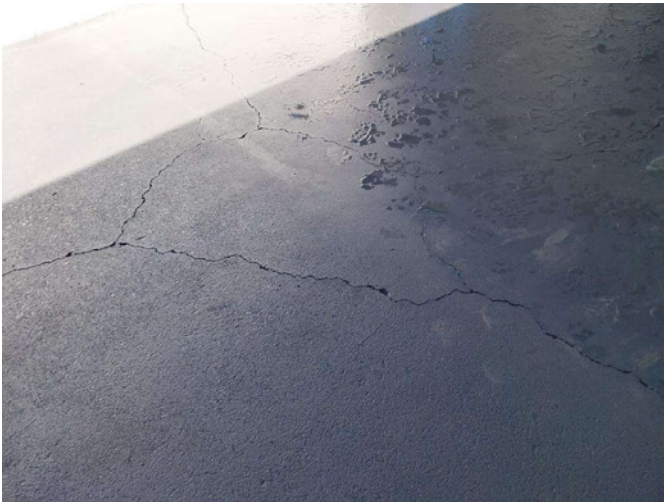
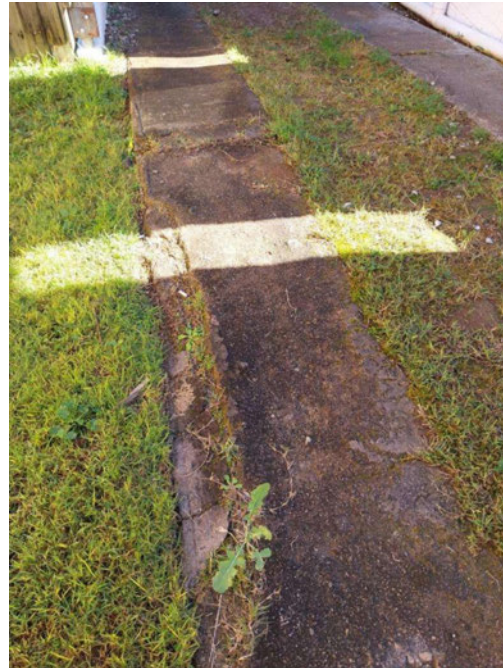
Notable cracking has occurred in the cement paving along the front patios and driveway. Repairs are recommended.

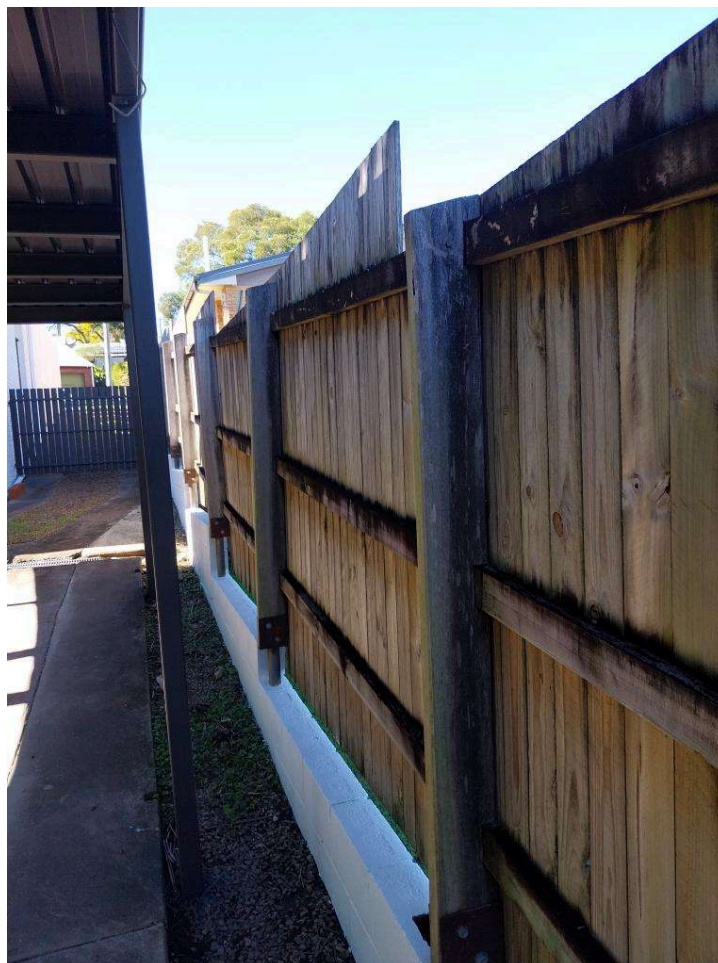
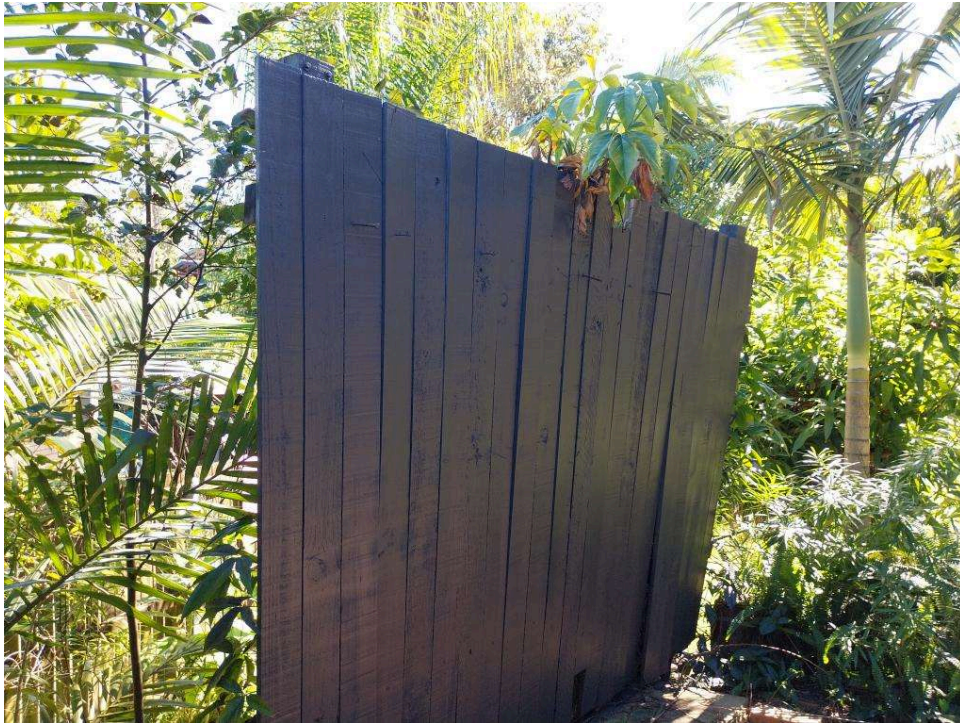
Fencing is leaning noticeably in places.

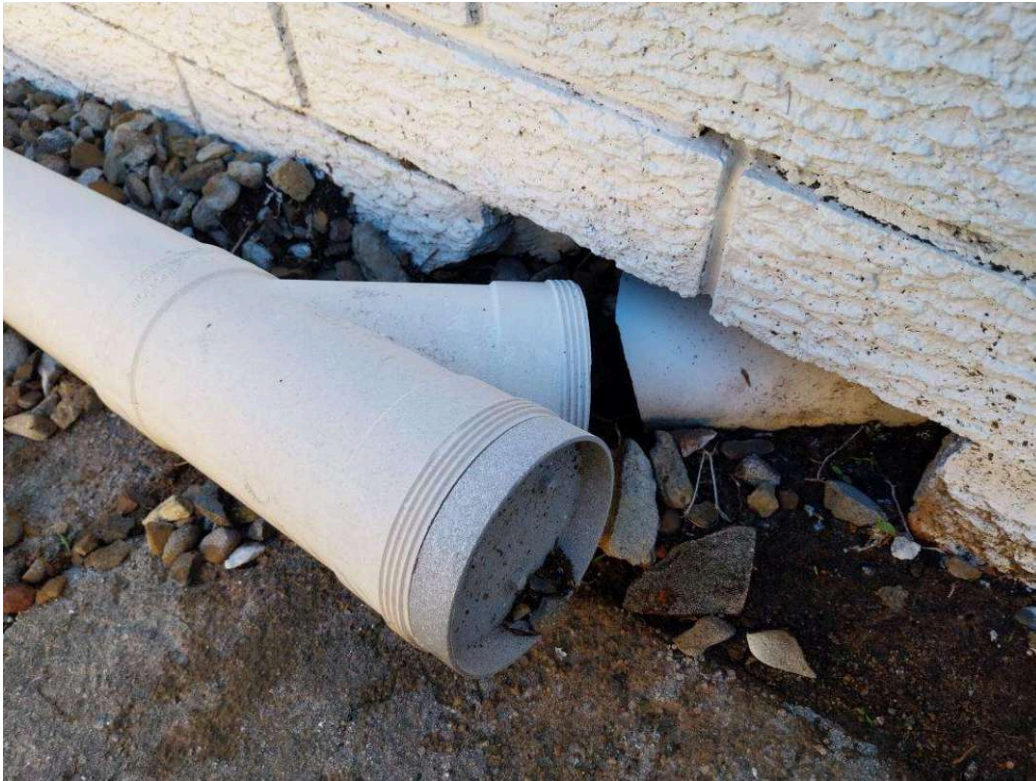
Storm water pipe along side of driveway requires repair.
