Southern Response
C/- Arrow International (NZ) Ltd

26 June 2014

RE: Geotechnical Investigation of 20 Dunarnan Street, Avonside, Christchurch (D3430254)

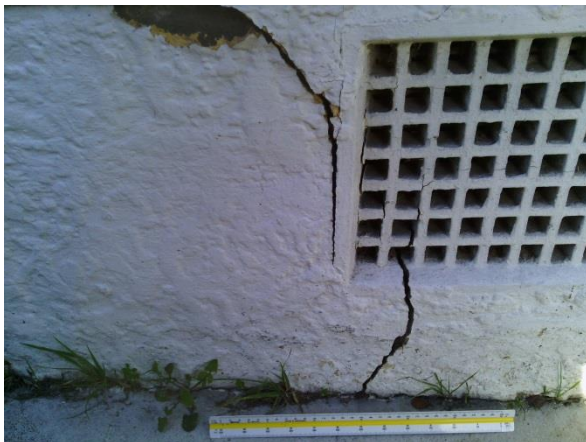
- The perimeter foundation has cracks up to 10 mm wide in the north, east and west sides of the dwelling. One of the perimeter cracks in the north continues up through the cladding to the window. A 10 mm wide crack extends up from the foundation into the cladding leading to the two nearby windows. The entrance way in the west has a 5 mm horizontal crack that runs along the south wall of the entranceway and under the door.

Photo 1: Perimeter crack in the north foundation.

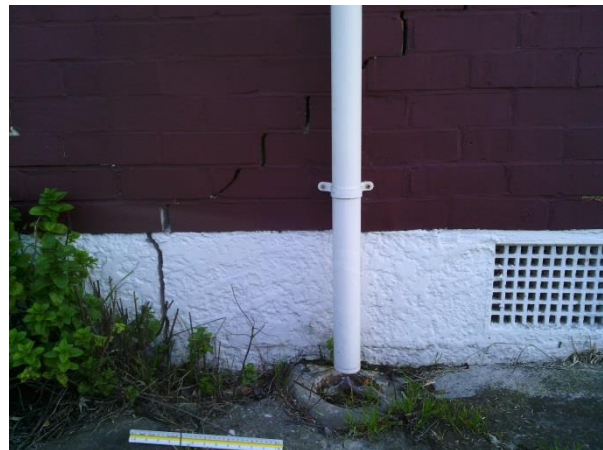
Photo 2: Perimeter and cladding crack in the east side.

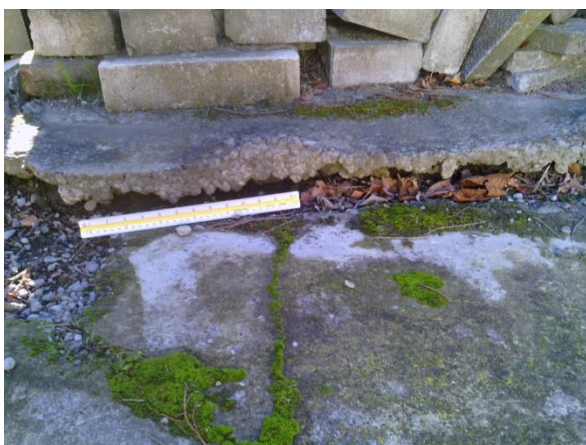
- The site has remnant ejecta behind the single garage and undulations within the southwest patio of up to 50 mm. The patio and concrete in the southwest side of the site has multiple cracks up to 5 mm wide and vertical offsets of 30 mm due to undulations. The tenant states that the concrete slab behind the single garage was level before the earthquakes implying that it has lifted up to 60 mm as a result of the earthquakes. The driveway has cracks up to 10 mm wide and separations of up to 10 mm wide; the driveway also has vertical offsets of 15 mm due to undulations

Photo 3: Damage to slab south of the single garage and remnant ejecta.

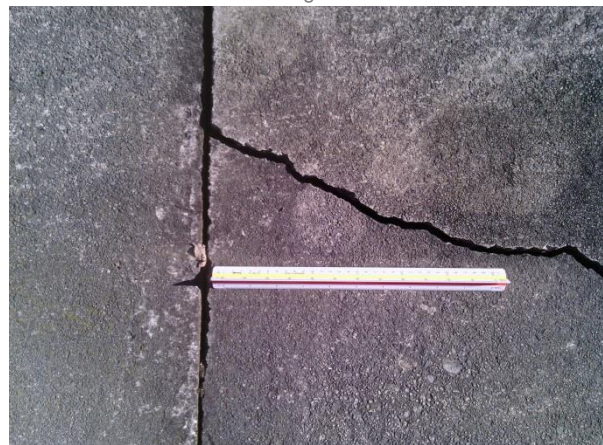
Photo 4: Damage in driveway west of dwelling showing cracks with vertical offset.
