**20 DUNARNAN STREET
AVONSIDE**

E SAWERS & S SAVAGE

INITIAL STRUCTURAL REVIEW REPORT

Job No.1567

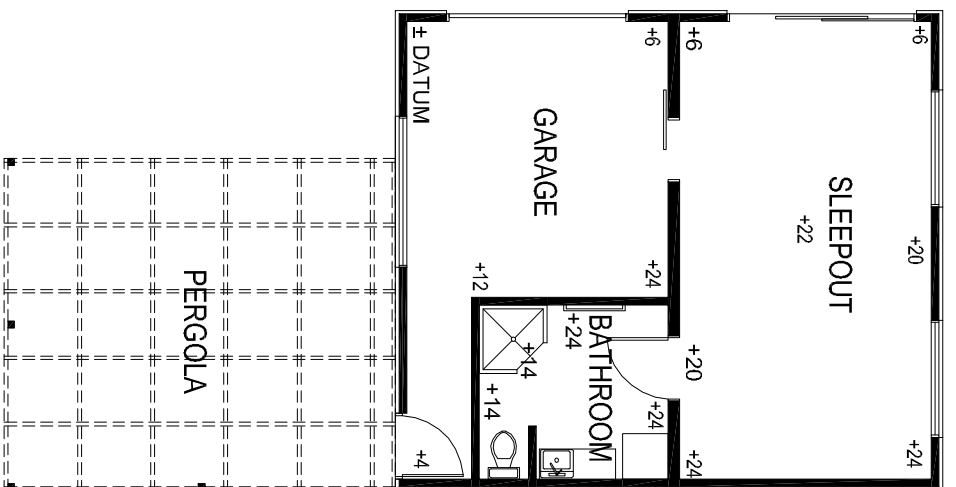
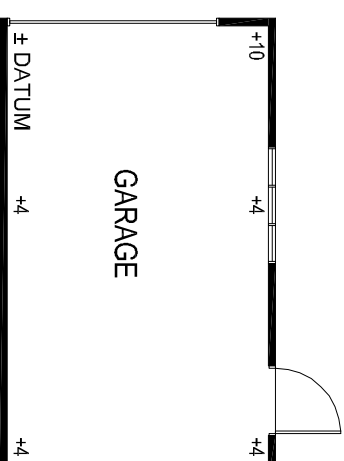
POST EARTHQUAKE FLOOR LEVELS PLAN

The measurements were taken on top of the existing floor coverings which have been adjusted to a common floor level. Post-earthquake floor levels have been recorded for the footprint of the dwelling and have been transposed onto a Floor Level Plan by SPL Consultants Ltd. A copy of the Floor Level Plan is attached in Appendix A.

- Maximum Variation across the ground floor = 95mm (> 50mm MBIE criteria for re-level and very close to > 100mm MBIE criteria for foundation re-build).
- Maximum slope recorded 1.3% approximately (>0.5% MBIE criteria).

- Replace damaged perimeter wall sections with engineered design enhanced perimeter wall foundation where required. Approximately 40 - 50% of perimeter wall to be replaced. (Geotechnical reports specifies 200kPa ultimate bearing capacity can be assumed.)
- Re-level the rest of the house by jacking the perimeter foundation using engineered resin or mechanical jacking/grout filling with jacking and packing / trimming the piles and bearers in accordance with MBIE Appendix A1.1. This will be subject to confirmation by a geotechnical engineer's report that will need to confirm the adequate bearing capacity and the appropriateness of the proposed method.
