BUILDING INSPECTION REPORT

House Inspection at

51 Wayside Avenue Burnside

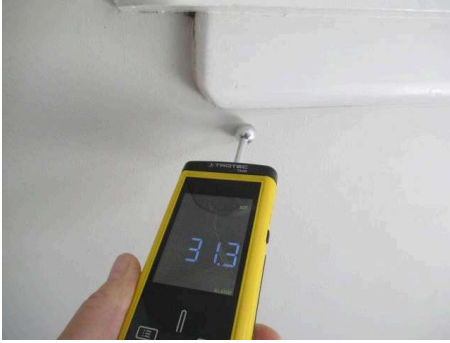
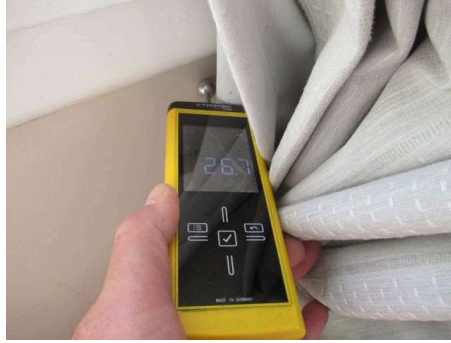
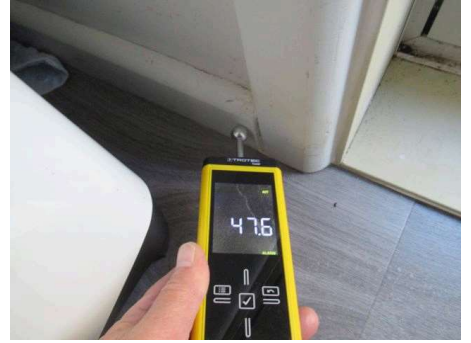
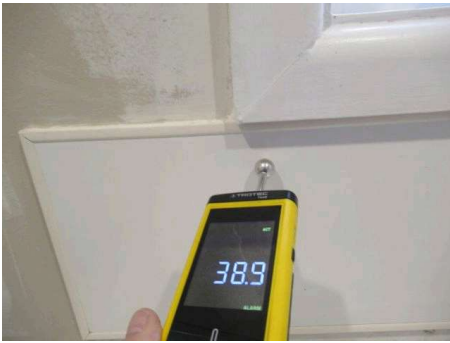
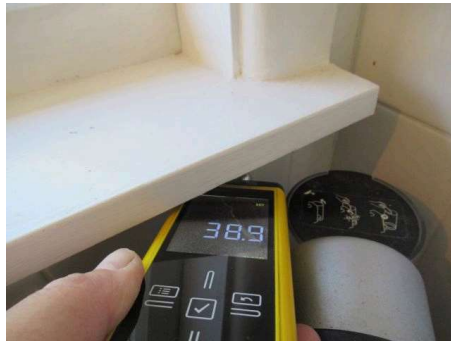
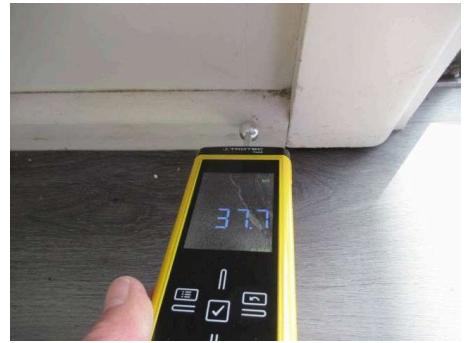
Levels were found to be	acceptable in all areas checked
Possible causes for moisture	
Further investigations recommended ?	No
Type of Meter	Trotec 660 moisture levels 10-50 ok, 50-80 getting higher, 80+ alarm goes needs further investigating. This is not a weather tightness report if that information is needed a specialist company will need to be used.

example of various tests in rooms around windows and doors, approximately 30 taken.

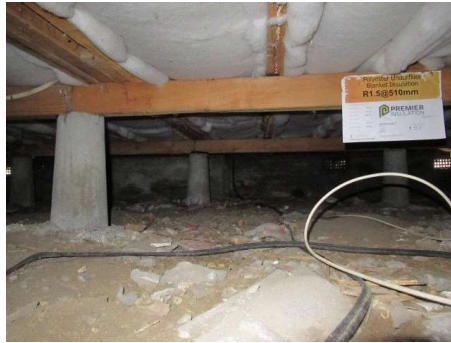
sub floor, and insulation is in generally good condition, unable to sight all

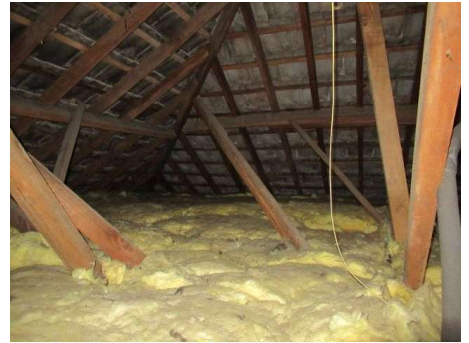
Ceiling insulation in generally good condition, unable to sight all

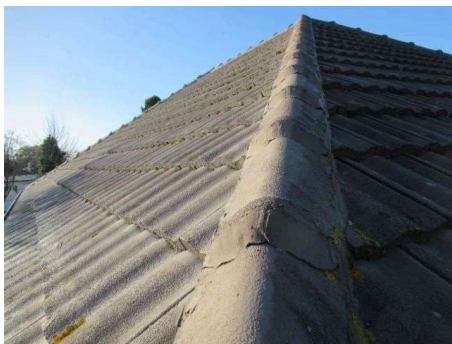
roof is in generally good condition

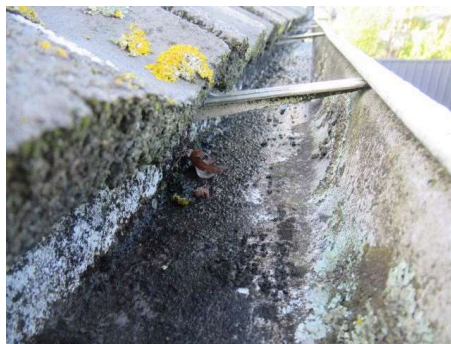
gutters, in generally good condition,

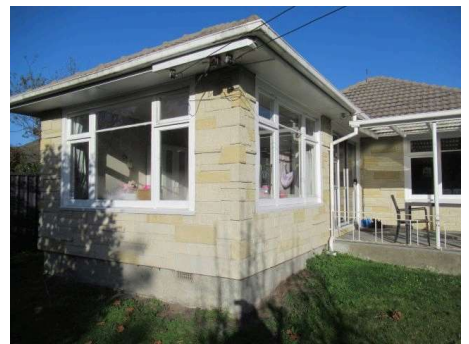
example of windows and cladding, are in generally good condition.

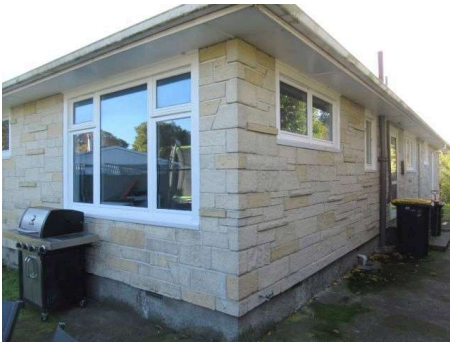
example of windows and cladding, are in generally good condition.

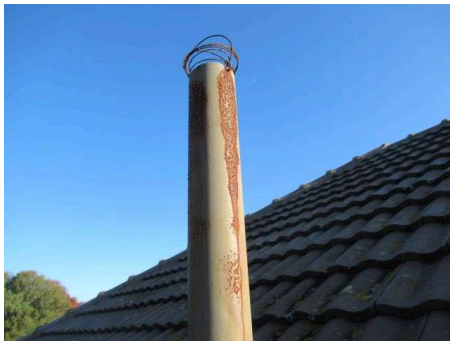
example of surface rust on roof vent pipe, clean/treat and paint to extend life.

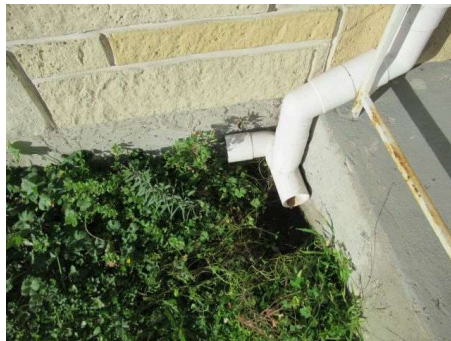
Example of downpipe by deck may need directed to appropriate outlet.

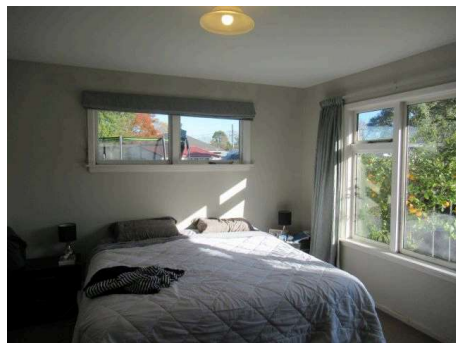
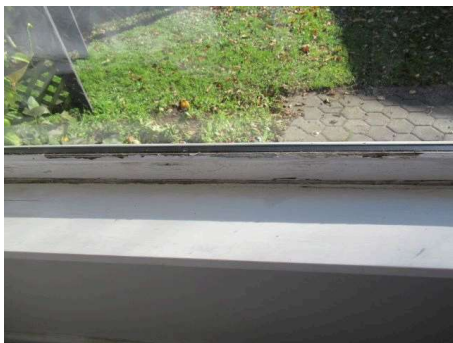
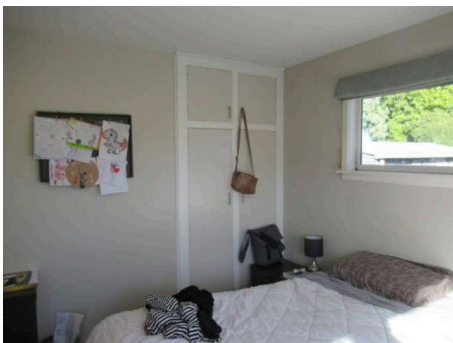
surface wear to window timber paint,
can repaint noted noted,

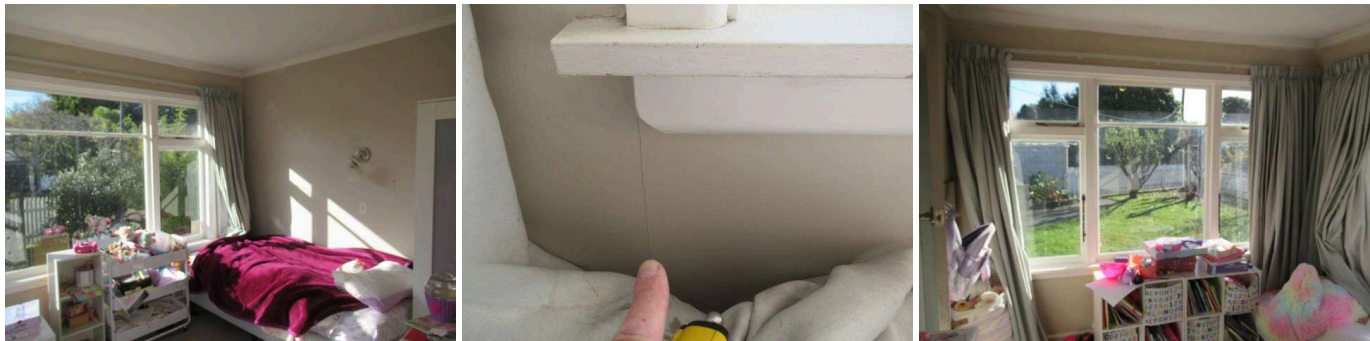
sheet joint movement noted

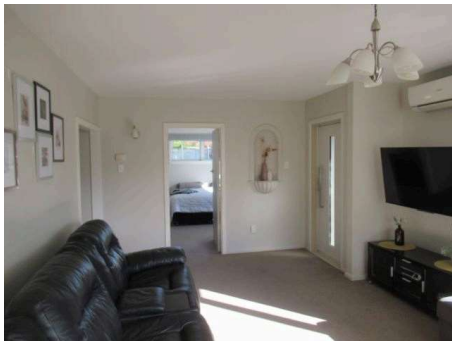
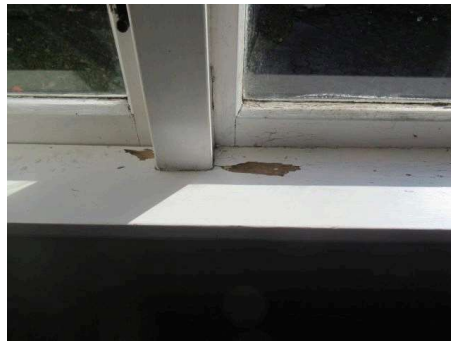
surface wear to window trim noted,
can re paint

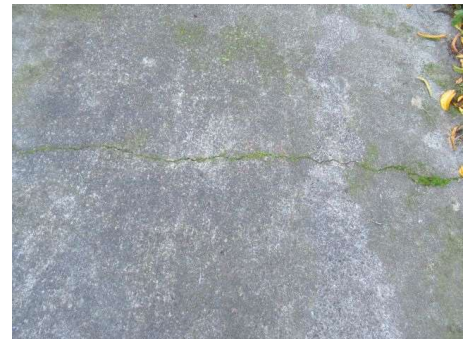
example of cracking in paths, noted,
appears sound

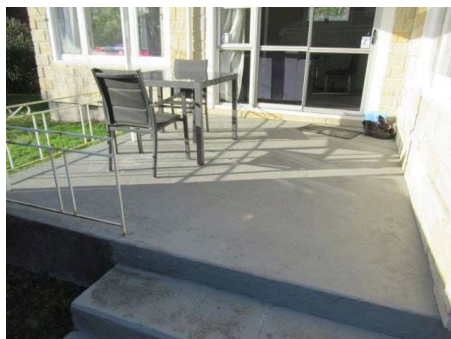
example of cracking to deck steps noted

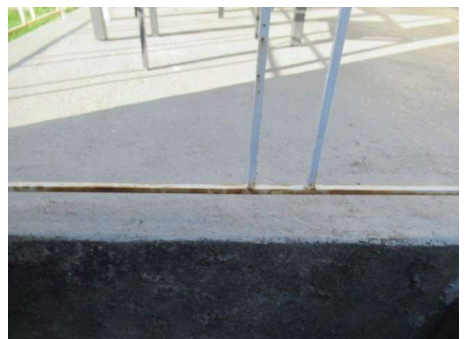
example of surface rust to deck railing,
clean/treat and repaint noted

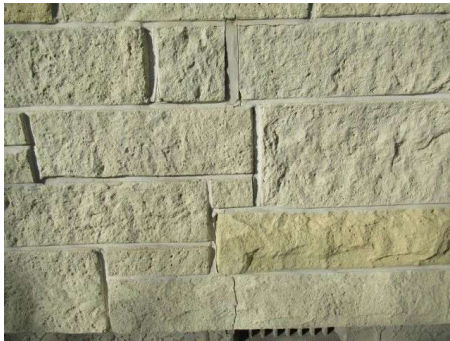
example of step cracking on cladding noted,

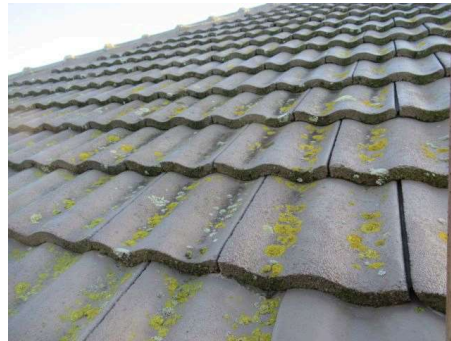
example of lichen on roof ,treat chemically to control

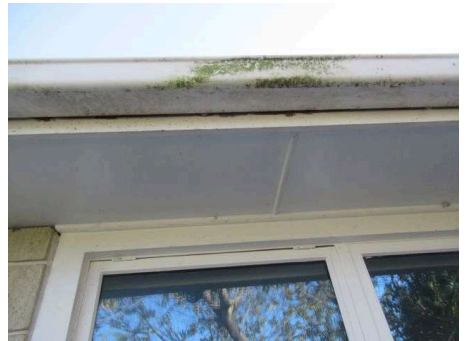
example of borer hole in timber fascia. Treat chemically or replace

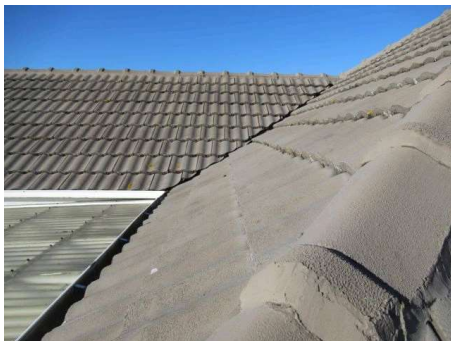
hip tile may need repositioning noted.

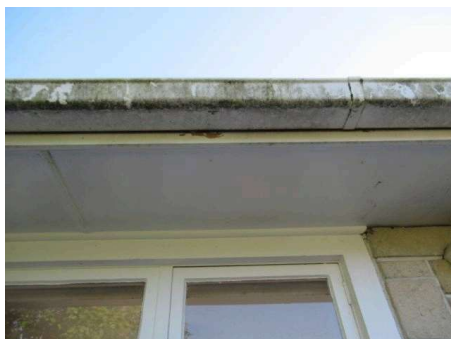
example of paint flaking on timber
fascia, will need painting in future

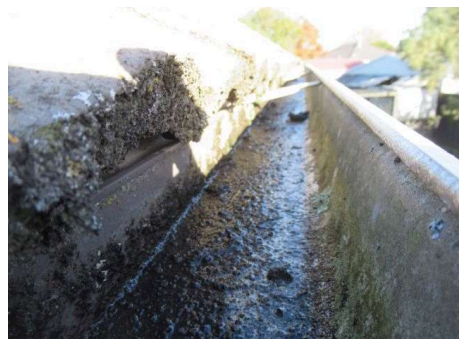
example of spouting requiring cleaned in
areas

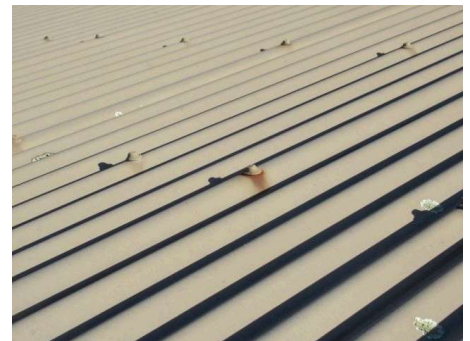
example of garage roof surface
rust/ clean/prime to prolong life,
check fixings

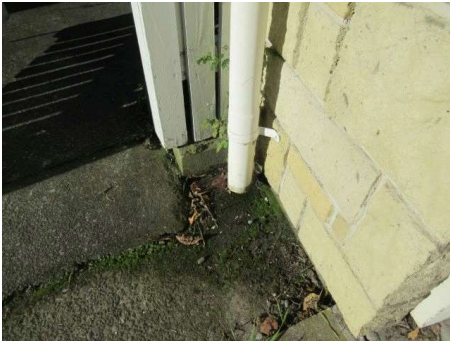
Downpipe at on garage needs directed to a stormwater outlet,

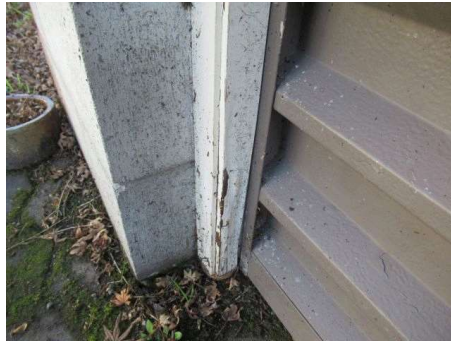
example of soft timber fascia on small garage door, repair/replace noted

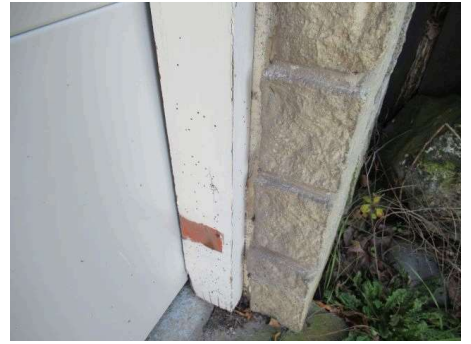
example of borer hole in garage fascia. Treat chemically or replace timber.
