04 September 2025 Job No: 25-122

# RE: STRUCTURAL REPAIR ASSESSMENT 25 FLEMINGTON AVENUE, NORTH NEW BRIGHTON, CHRISTCHURCH.

Structural Repair Assessment – 25 Flemington Avenue, North New Brighton, Christchurch

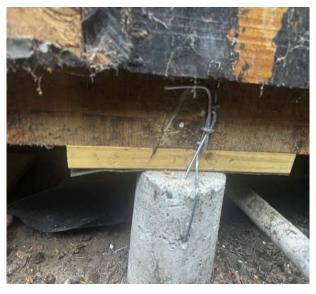
The over-pinning detail to the area have perimeter foundation has been observed, the steel bracket with spacing of 900mm, DPC, and proper timber packers have been observed.

The concrete perimeter foundations have been relevelled by over-pinning to the concrete foundation walls in accordance with manufacturer's specification and as per Cephas rock Relevelling design.

Photo Over-pinning connection detail observed.

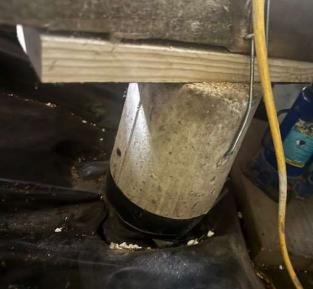
12/06/2025 - Internal pile jacking and packing details have been observed, the DPC, screws and straps connection have been observed as per CR design.

The timber floor has been relevelled by jacking and packing to internal piles. Adequate fixing of packing, installation of DPC, and pile-to-bearer connections has been observed to all affected piles as per MBIE guidelines. At the same time, some internal piles replacement has been carried out as per Cephas Rock Relevelling design.

Photo 3. Internal pile packing detail observed. Photo 4. Internal pile packing detail observed.

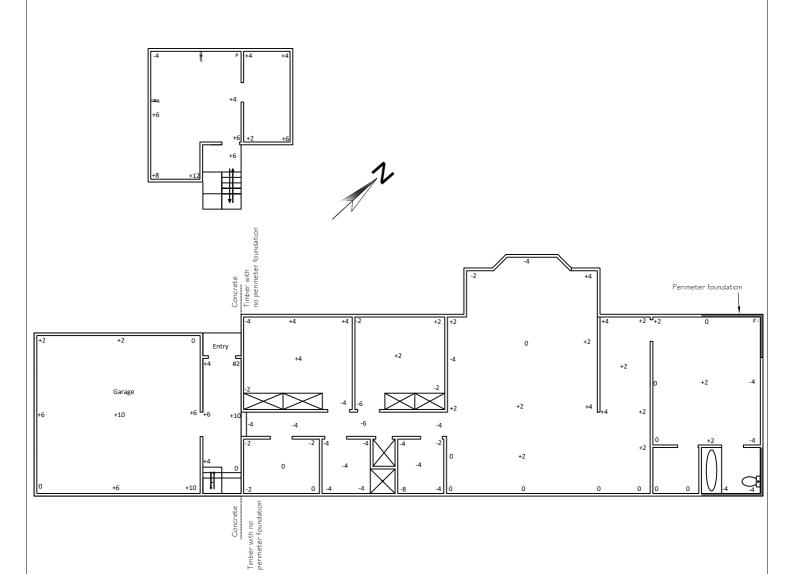
PROJECT:	Final Level Survey Plan				
ADDRESS:	25 Flemington Avenue, North New Brighton, Christchurch				
JOB NO :	25-122	DRAWN BY : ML	SK1		
DATE :	11/07/2025	CHECK BY: JW

We have undertaken a floor level survey of the remediated areas. The overall floor level variations after floor levelling repairs were undertaken were measured to be approximately 10mm (-6, +4) for the ground floor (timber area), 10mm (0, +10) for the garage & entry (concrete area), and 16mm (-4, +12) for the first floor with no apparent local steep slopes exceeding 1v:200H identified. Please refer to level survey plan attached.

The relative floor level differences between the highest and lowest points are: Ground floor (timber area): 10(-6, +4). First floor: 16(-4, +12). Garage & Entry (concrete area): 10(0, +10).
