# RESIDENTIAL PROPERTY INSPECTION

**Inspection Address:** 5C Gilmore Place, Christchurch

**Inspection Date:** Wednesday, 13 August 2025

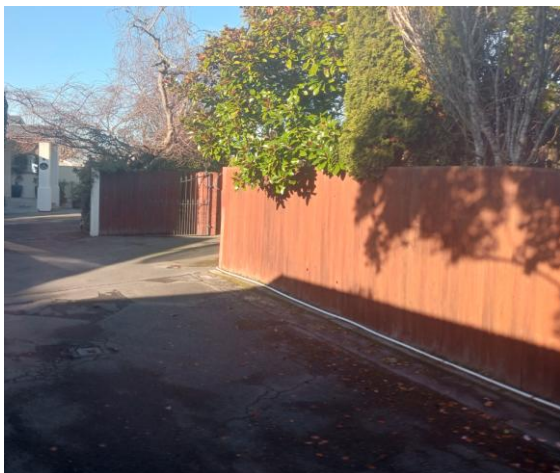
| ITEM ASSESSED | DEFECT | COMMENTS/NOTES |
|---|---|---|
| Steps, Handrails, Paths, Driveway | Minor | Cracking noted on the shared tar-sealed driveway. Damage to the paving at the rear of the dwelling |

Cosmetic cracking to shared drive

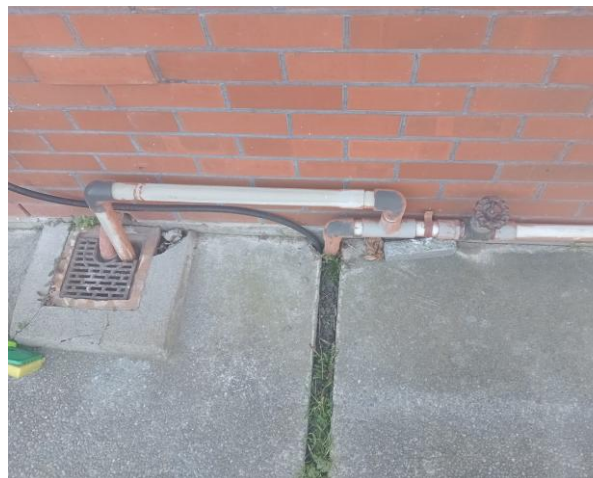
| ITEM ASSESSED | DEFECT | COMMENTS/NOTES |
|---|---|---|
| Swimming Pool/Tennis Court | Minor | Gaps between the concrete slabs outside the pool area |

Gaps in the paving

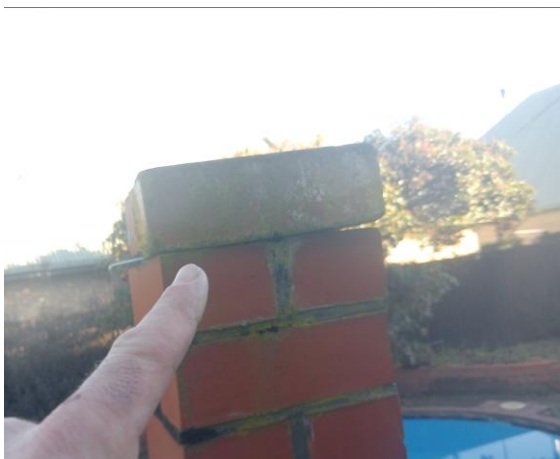
Column cap loose

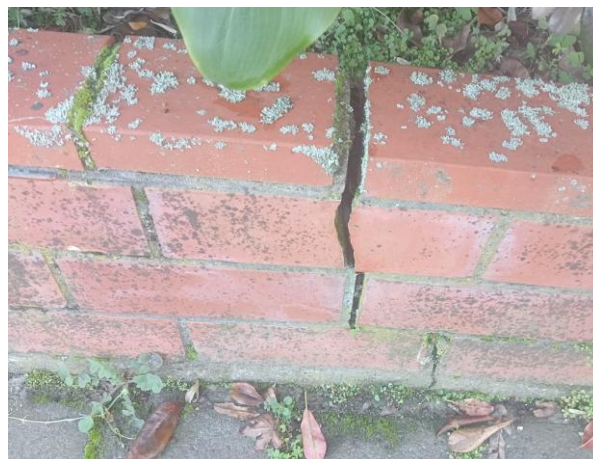
Crack in bed wall

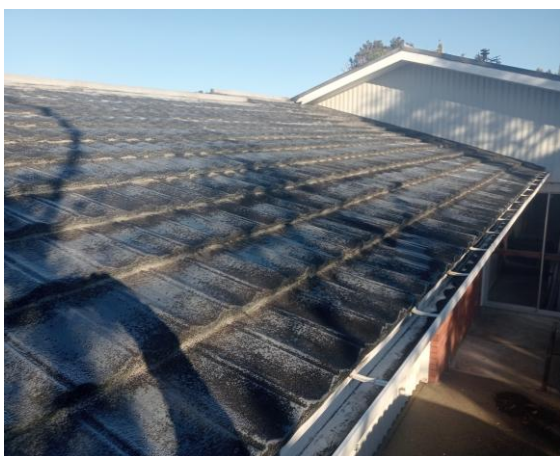
| ITEM ASSESSED | DEFECT | COMMENTS/NOTES |
|---|---|---|
| Roof condition | Moderate | Loss of coating on the decramastic coated steel tiles. Corrosion on barge flashing adjacent to the garage. Surface rust on the barge flashing adjacent to the garage. Corrosion noted at the end of the apron flashing at the rear of the dwelling |

Coating loss to the roof tiles

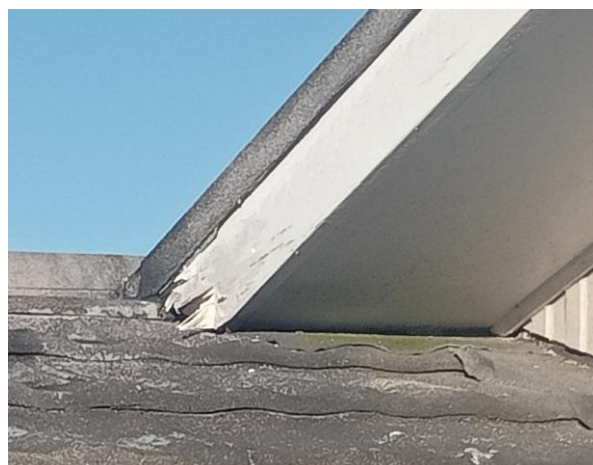
| ITEM ASSESSED | DEFECT | COMMENTS/NOTES |
|---|---|---|
| Eaves/Fascia/Soffits | Minor | Paint maintenance required on fascia boards, some deterioration noted where the fascia meets the roof. |

Fascia has paint peel and decay

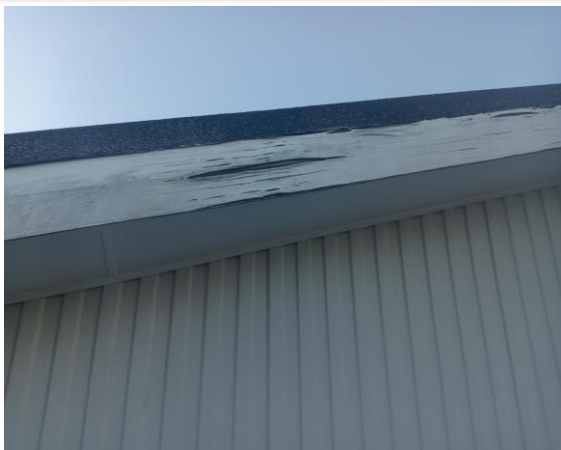
Fascia decay

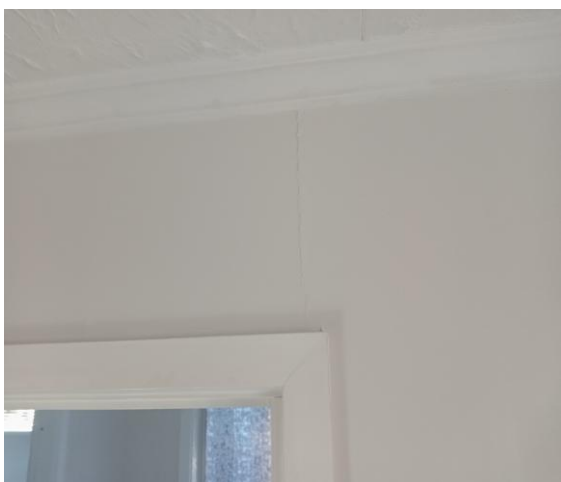
The interior walls are in worn condition, maintenance required. Some cracking noted at weak points in the plasterboard lining, i.e. above windows. Crack above the doorway in the living area. Wallpaper lifting in the WC. Damage to the wall lining in the laundry

Cracking to the head at door heads

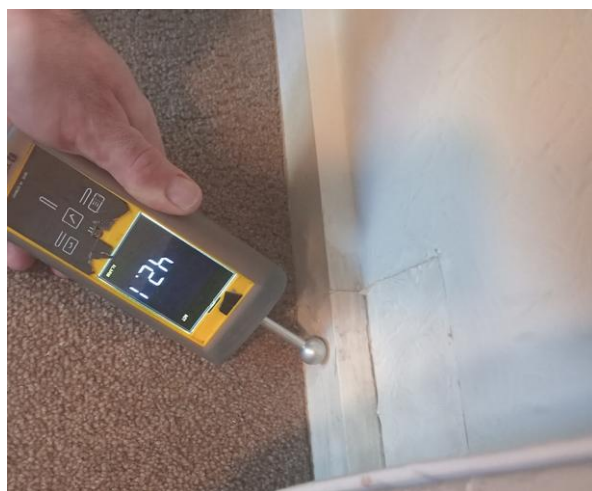
Patch on wall, join on skirting

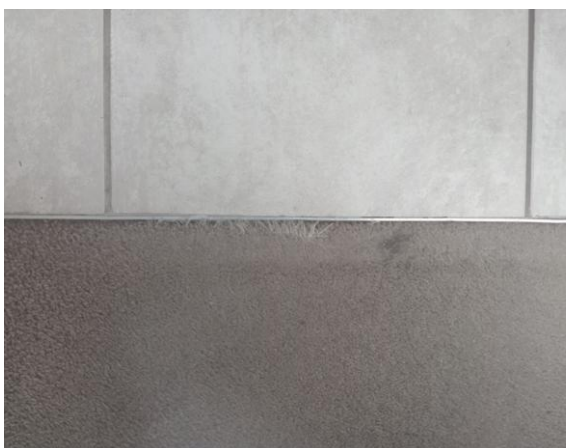
In worn condition, possible carpet beetle damage. Small piece of mortar missing between the tiles in the main entrance. Cracked tile at the threshold in the main entrance. Damage to the floor covering in the laundry

Carpet wear

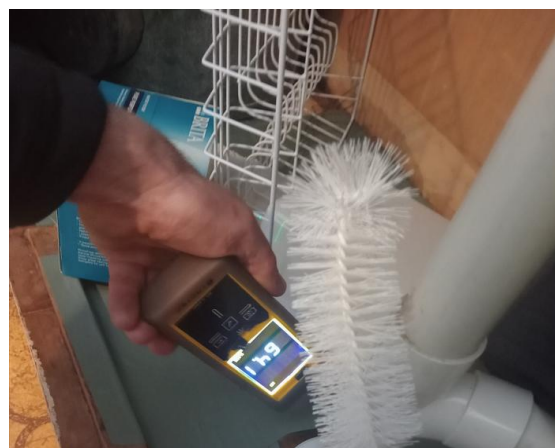
Elevated moisture readings below the kitchen sink

Elevated moisture readings under the kitchen sink

Further investigation should be undertaken to determine the cause of the elevated and wet moisture readings and any remedies.

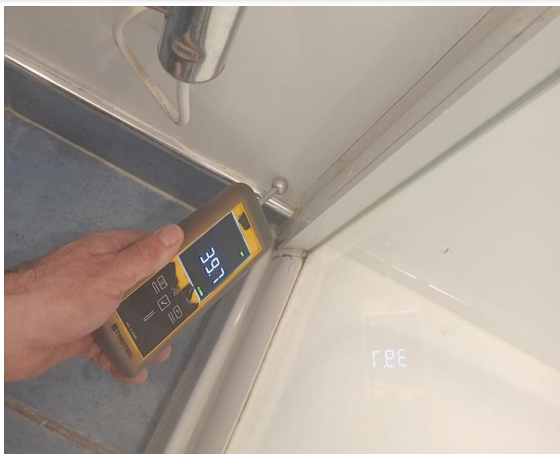
Moisture testing adjacent shower – dry range

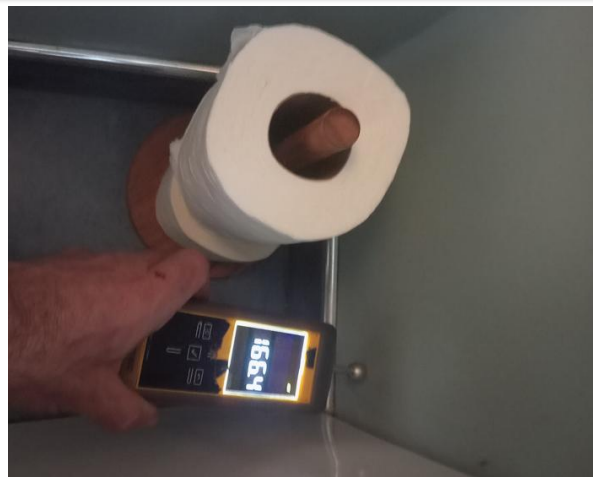
| ○ Cistern, Pan (Bidet if Applicable) | Moderate | Wet moisture readings adjacent to the toilet |

Wet moisture readings behind the toilet - LHS

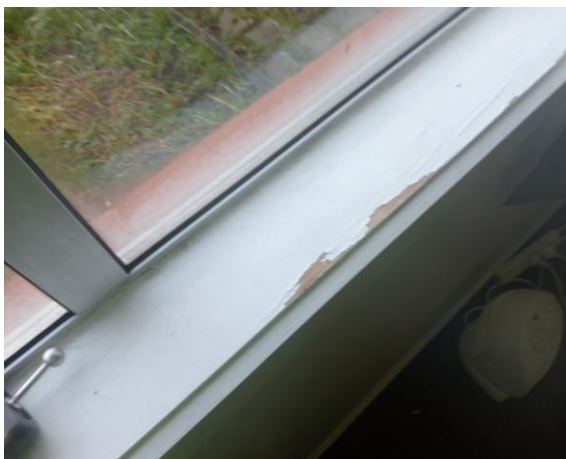
| Inside of Windows (catches & condition)<br>Single or double glazed | Minor | Single glazed, some paint maintenance required on the timber reveals. A gap between the reveal and the window frame has been filled with sealant in the lounge. |

Paint peel to the windowsills

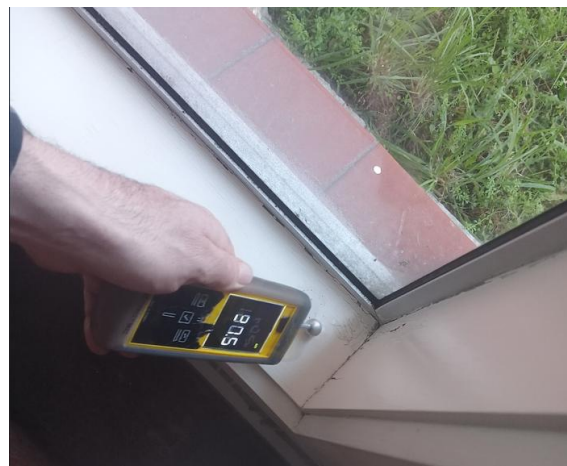
Elevated moisture readings taken on the reveal of the small window of the main bedroom, and on the skirting board below the window.

Wet moisture readings on windowsills
