## BUILDING INSPECTION REPORT

## 41 Parnwell Street, Burwood

17/09/2025

Property Inspected by Adam Brownie 027 914 9087  
Adam@inspectedresidential.co.nz Qualified builder and  
Licensed Building Practitioner  
National Certificate in Carpentry  
This inspection was carried out in accordance with  
NZS4306:2005

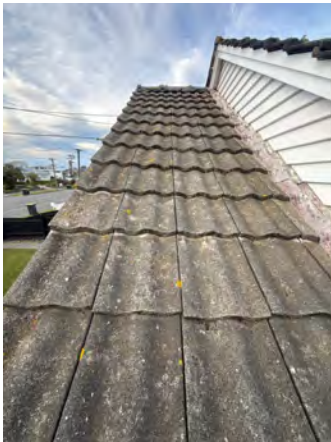
Example - check over tiles above barge boards and replace the popped nails with suitable roofing screws.

Silicone seal fixing holes in these replaced tiles.

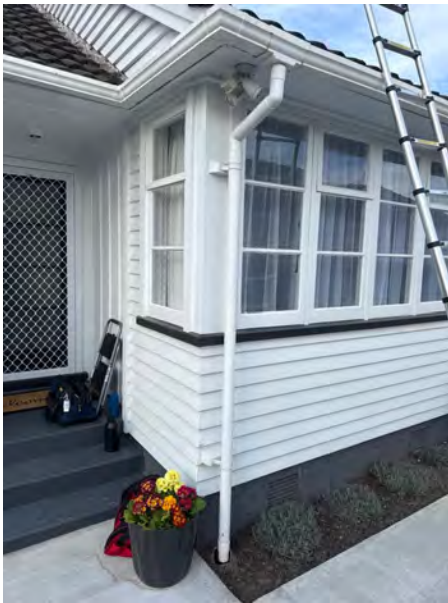
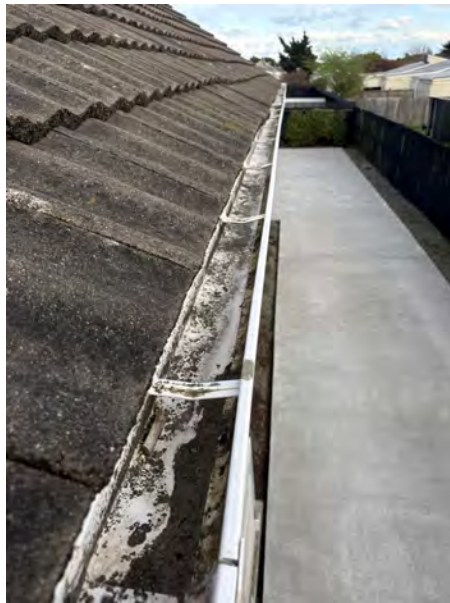
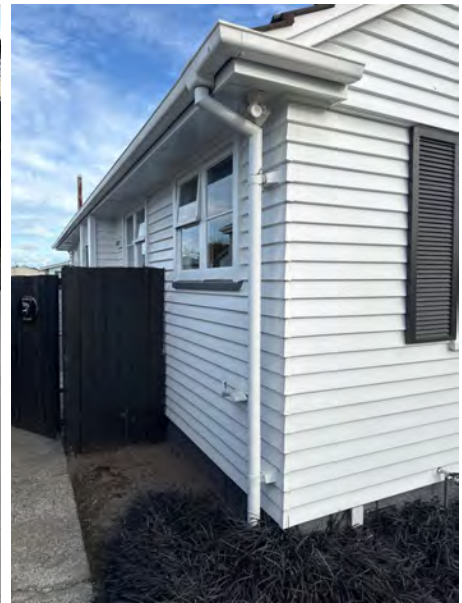
Downpipes and gutters fixed well in place and not loose. Downpipes on the main dwelling discharge into ground risers. It is noted that the stormwater risers visible are earthenware/clay piping; earthenware pipes are more susceptible to damage from seismic activity than PVC. Seismic activity can cause some breakages or cracks to occur in the pipes under the ground. The two ground risers are damaged above ground.

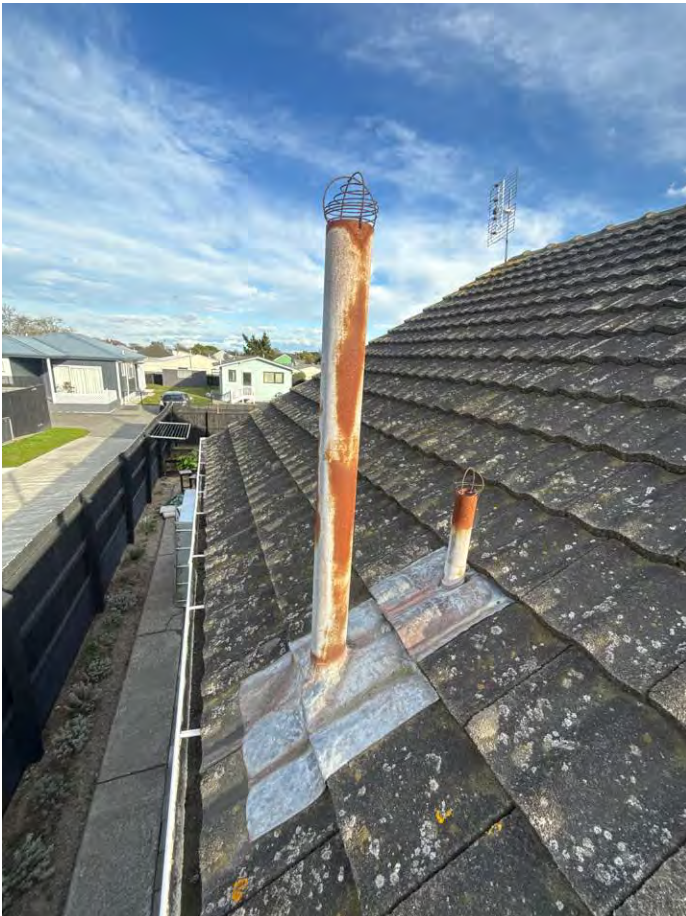
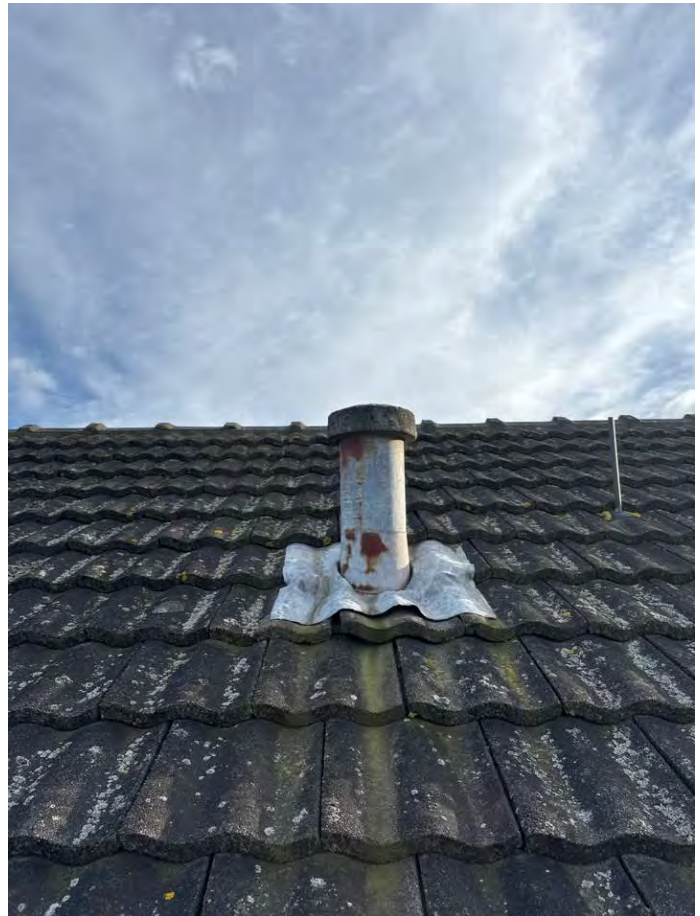
Some general rusting to plumbing waste stacks and penetrations. These could either be treated, primed and painted or replaced.

This is obsolete and could be removed.

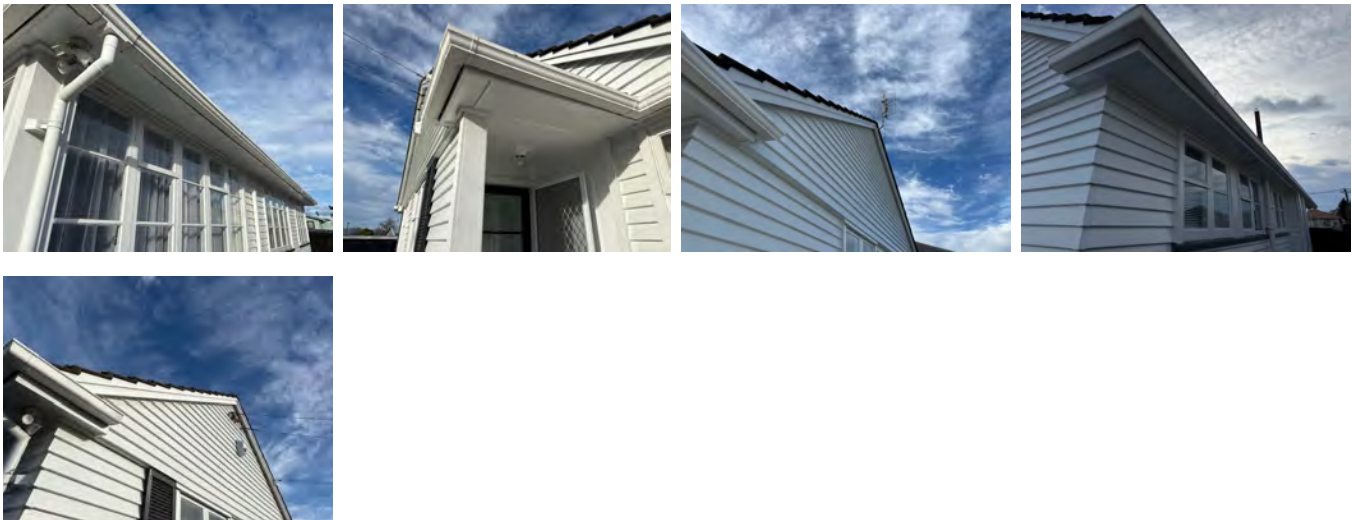
Please note, due to the era this home was constructed, it is possible that this soffit contains asbestos, but this was not tested or confirmed during this inspection. Fascia fixed well to structure. Some typical aging but the fascia's appear generally fine. Painting behind the gutters should be done to cover the remaining timber fascia. No general issues with soffits.

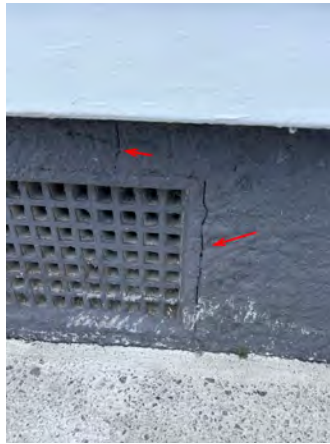
Some superficial cracks noted, but nothing concerning or unexpected. Vents installed to help airflow and keep subfloor dry. Lower the organic ground slightly in areas so it is not at the sub floor vent level.

Example - some typical movement cracking around some sub floor vents.

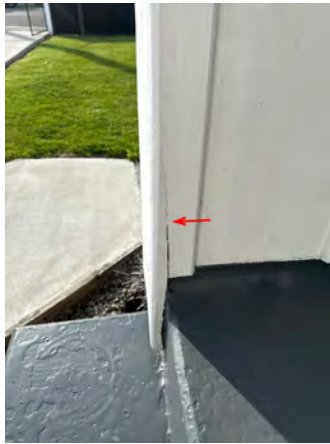
Cracked batten.

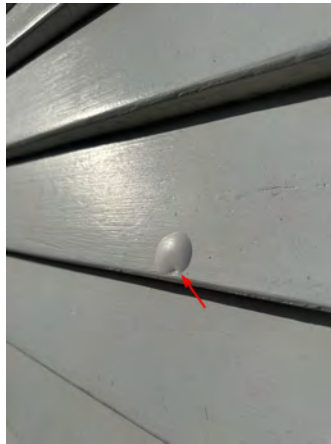
Example - paint bubbling in some spots. Strip back and touch up.

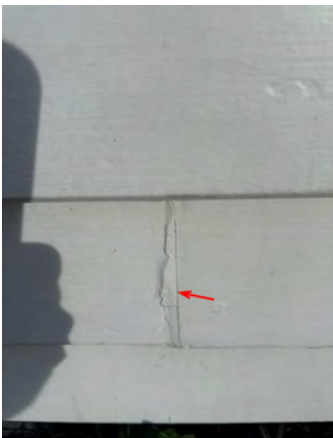
Example - check over and gap fill any weatherboard joins that have re-cracked. This will help protect the boards from moisture intrusion.

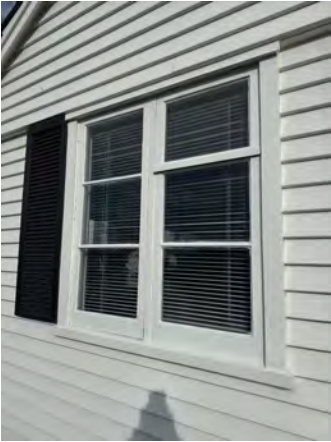
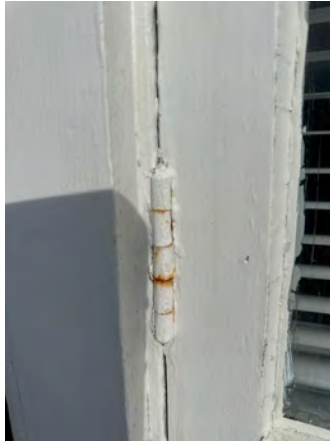
Example - typical rusting to some hinges. Some window hinges have been replaced.

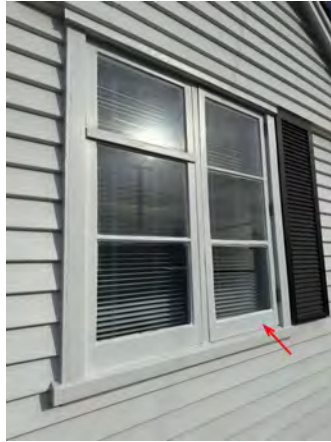
Some rot to this frame has been filled eastern elevation.

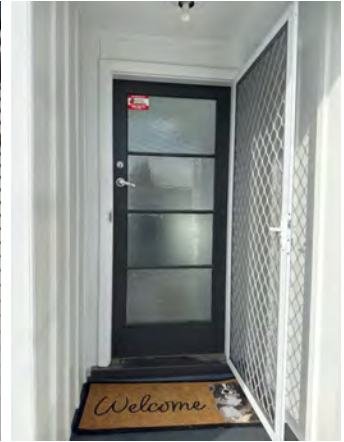
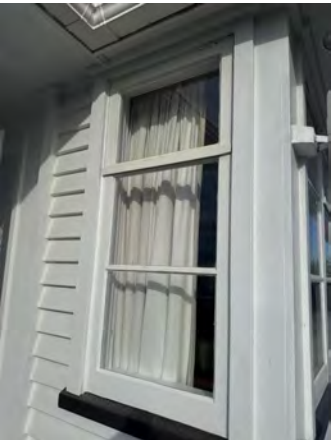
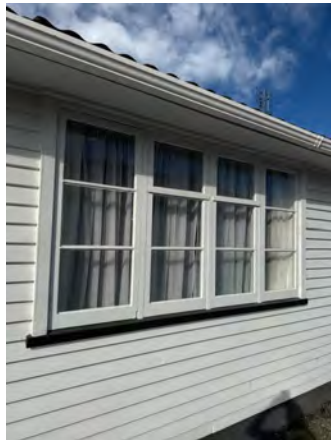
A lot of filler has been used on these western window frames. This indicates previous or current rot.

Exterior joinery comments are based on a visual assessment only; testing of the joinery function is found in the interior section of this report. Several joinery frames have had heavy filler use or have current rotting. Check over and replace any frames that have rotted or have has significant filler used on them.

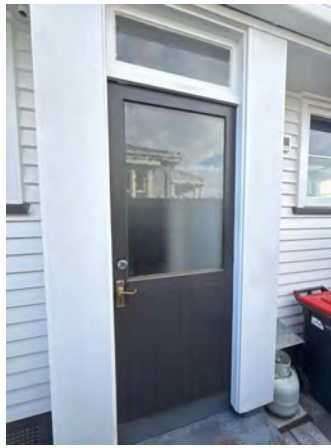
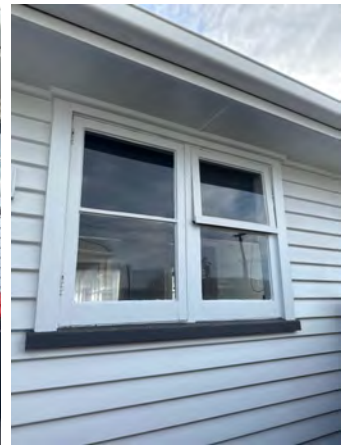
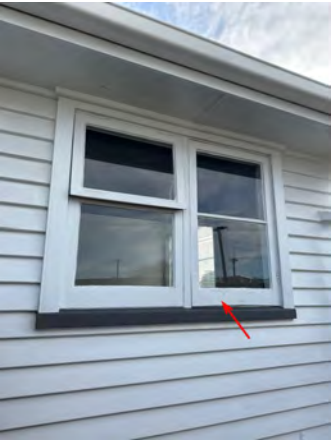
Rot.

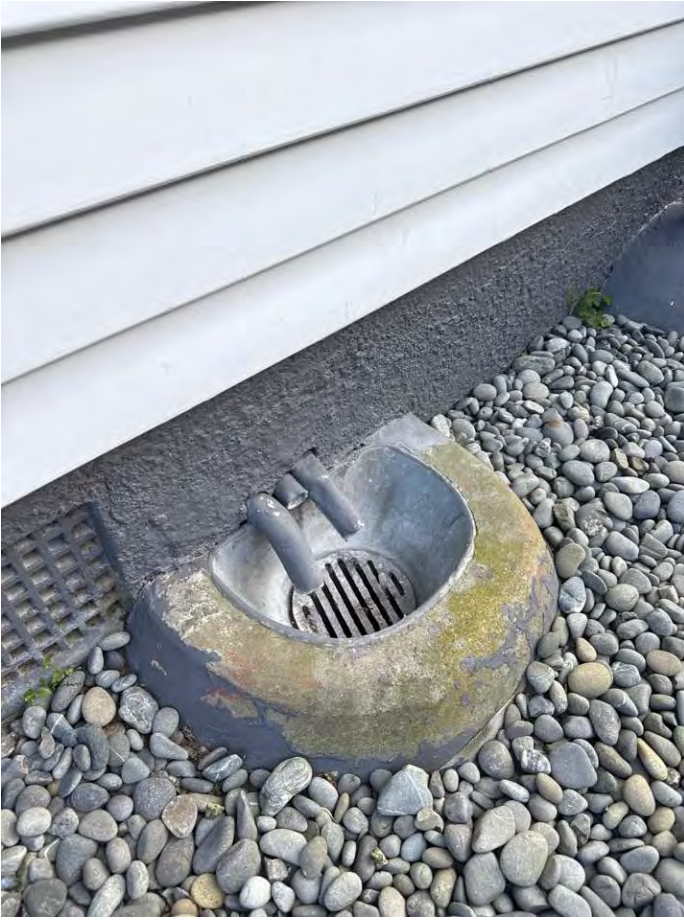
These gully trap pipes are above the grate and could be extended below the grate.

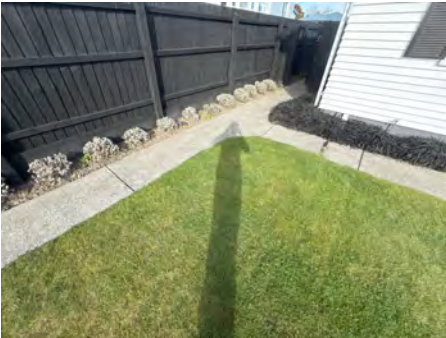
Some cracking and settlement to pathways.

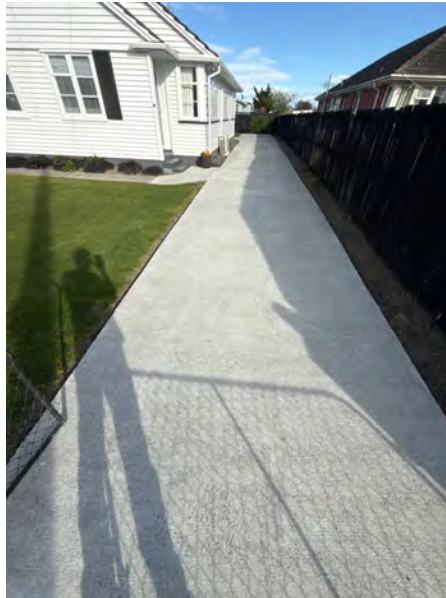
Expansion cuts should be installed along this first section of driveway to prevent cracking. Some minor cracks have been noted.

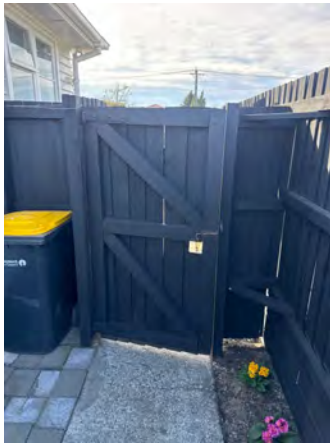
This fence needs repairs and maintenance.

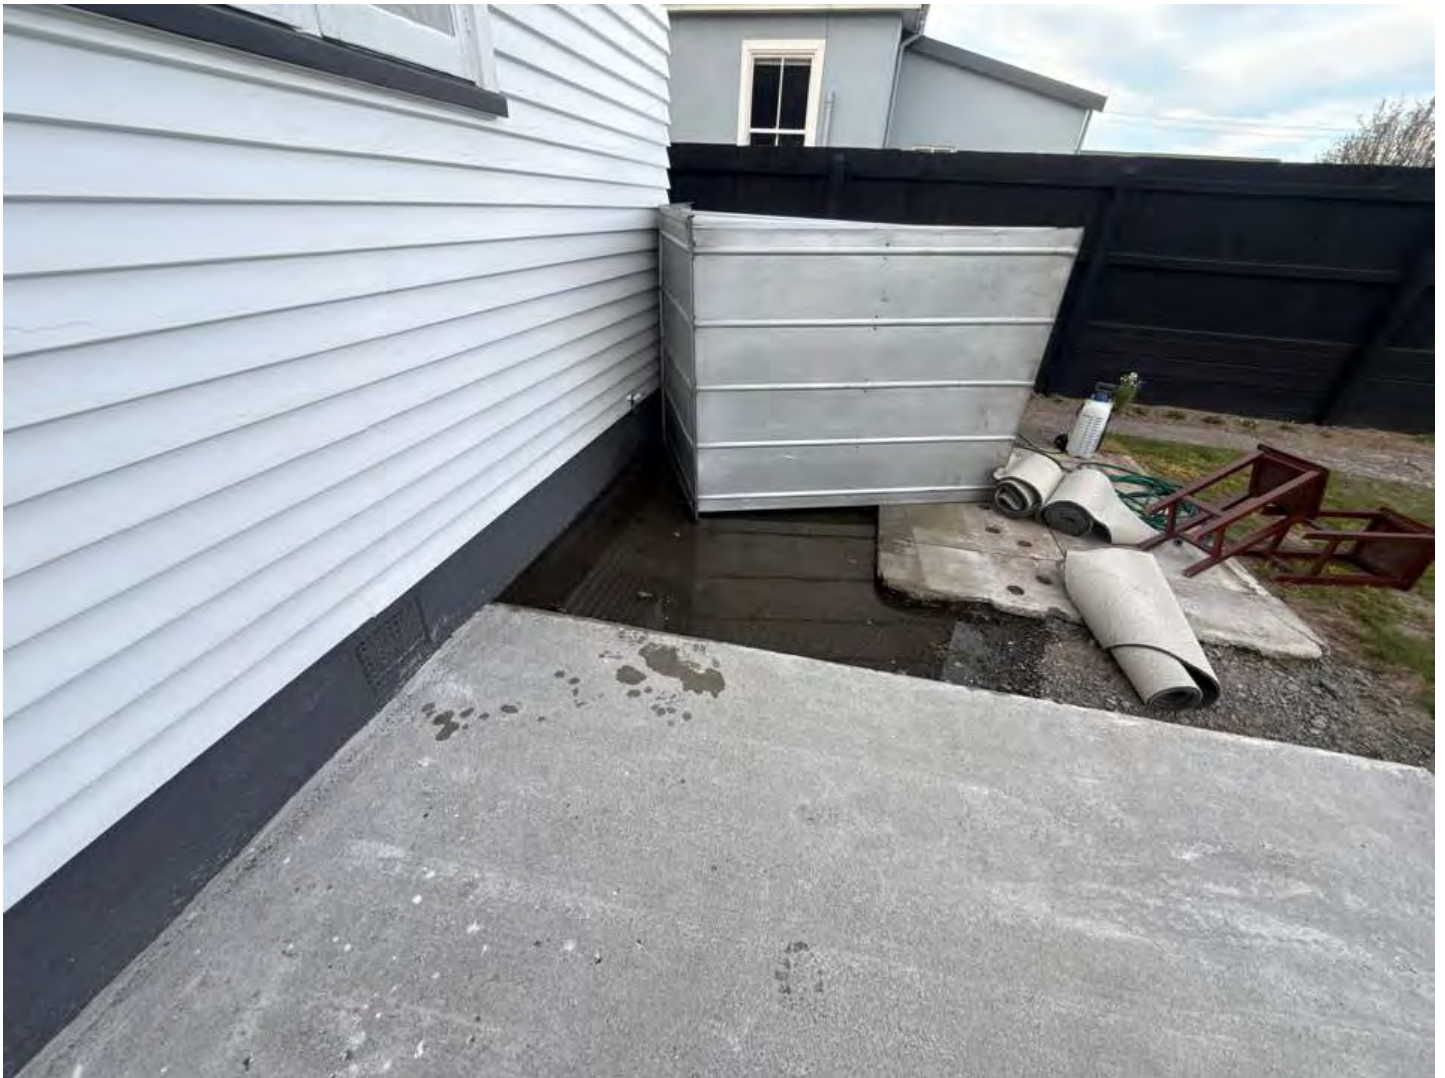
A tap had been turned on by a garden shed being knocked over onto it causing some flooding to the rear. It is unknown how long this has been left unchecked for and may have caused some flooding in the sub floor space. This is not a persistent concern and we are simply noting this.

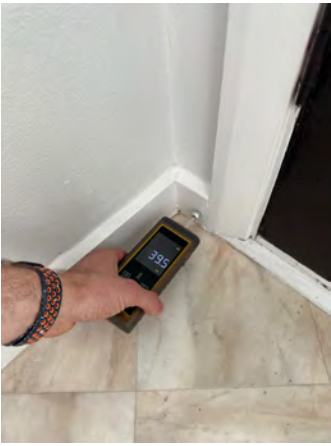
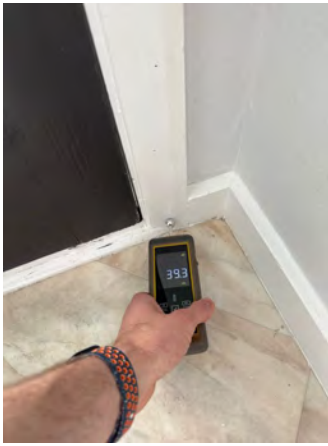
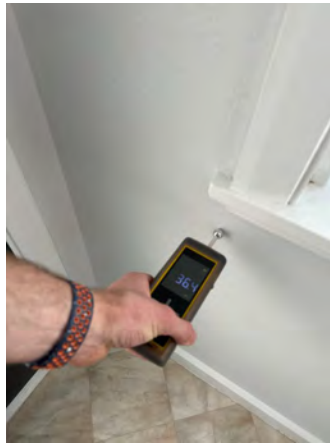
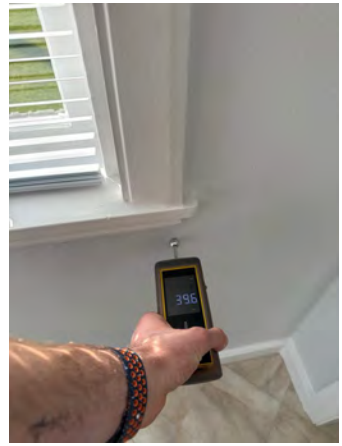
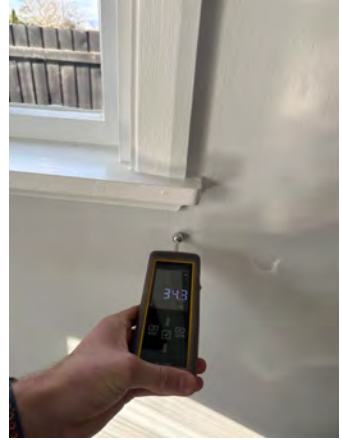
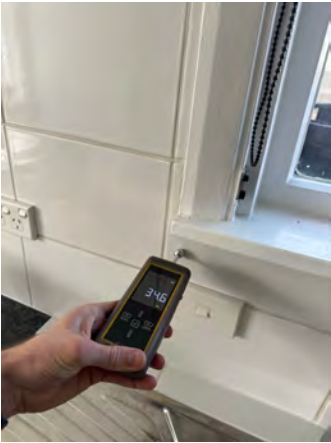
Slightly damp either side of rear door. Fit a better seal around here to help mitigate this. The timber is also likely drawing some excess moisture from the concrete. No other elevated readings taken.

Slightly damp either side of rear door.

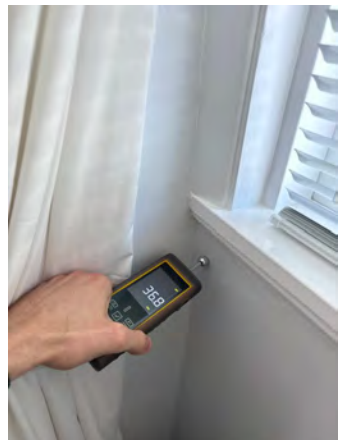
Some evidence of some previous water damage here.

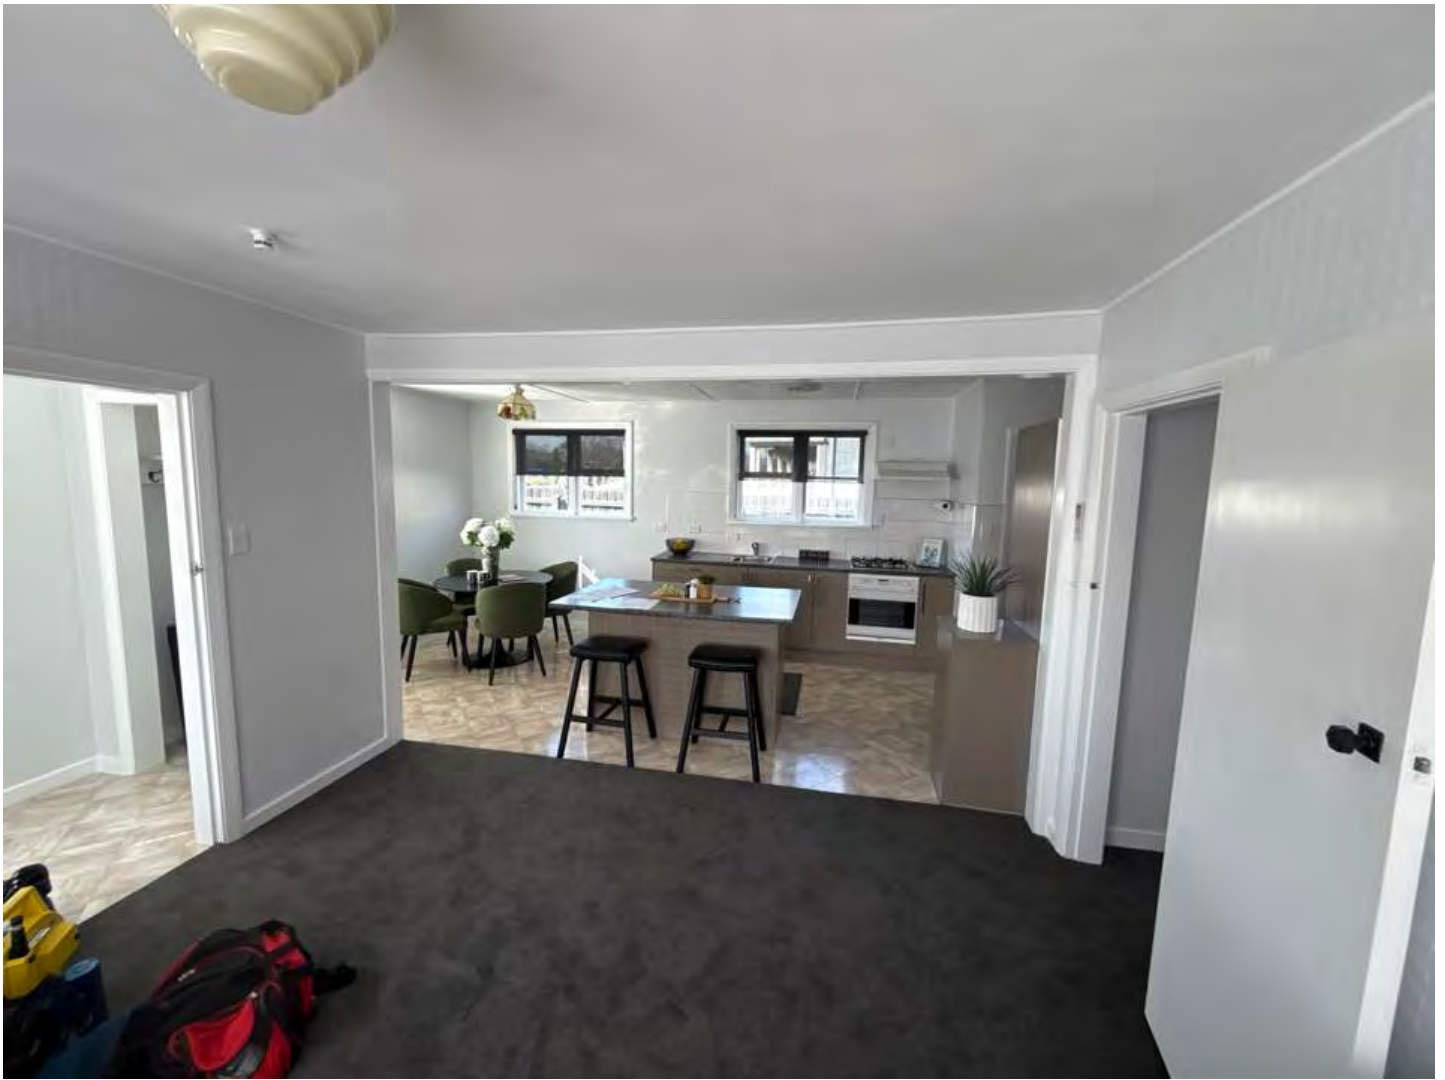
A load bearing wall looks to have been removed through the open plan living room. Review council records to confirm compliance of this alteration. This would have required a consent. The owner has noted that a retroactive COA was achieved but we did not sight or confirm this. This should be confirmed.

Location where load bearing wall looks to have been removed.

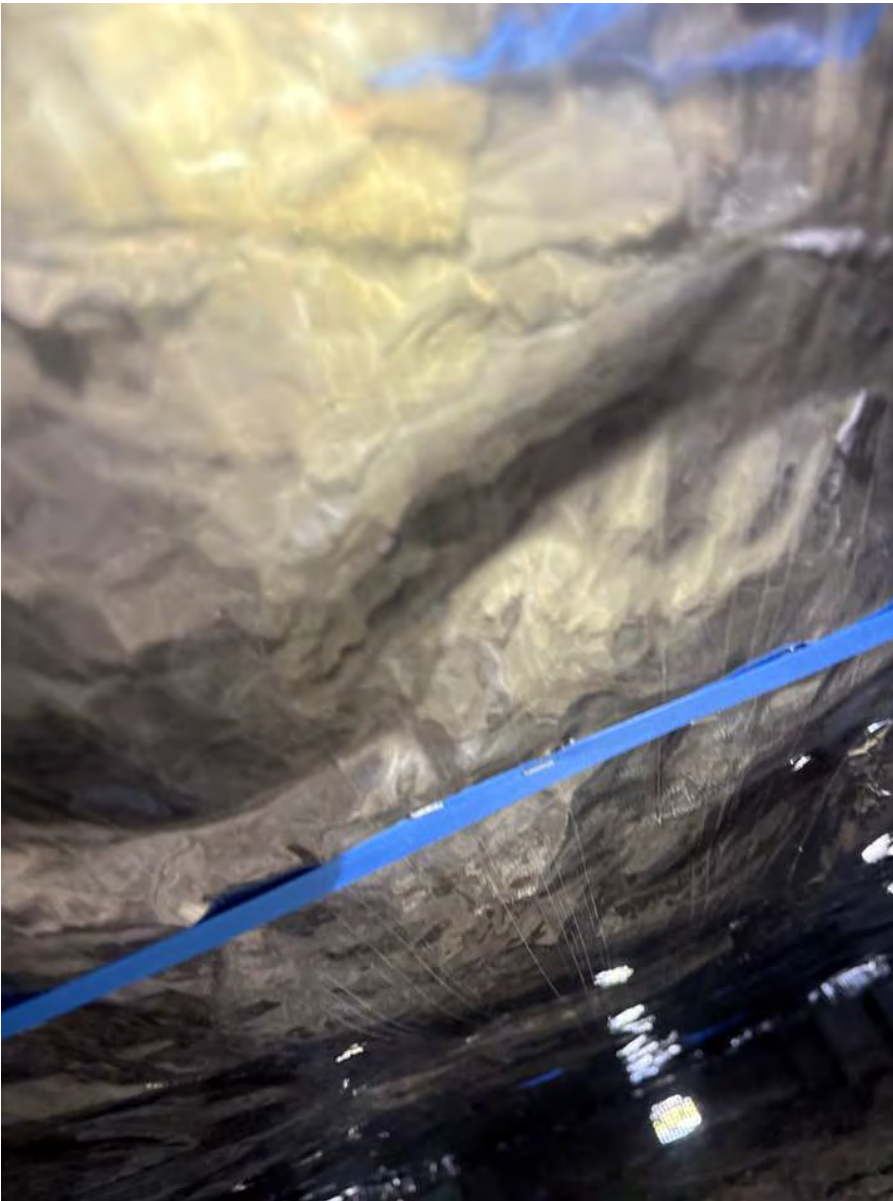
Foil insulation was a common type of insulation used in this era of home; however, it is no longer allowed to be installed or repaired, as working on it is an electrical hazard. This is because if a damaged or exposed power cable that has a live power supply comes into direct contact with the foil, it can make the whole foil covering electrically live. It is a good insulator but is best replaced with a different form of insulation.

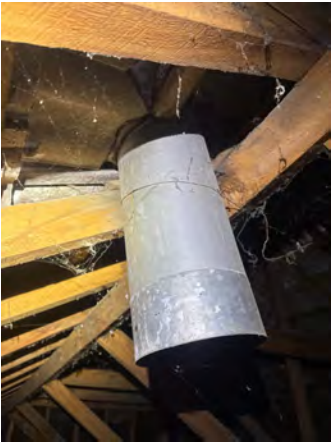
Obsolete flue could be removed.

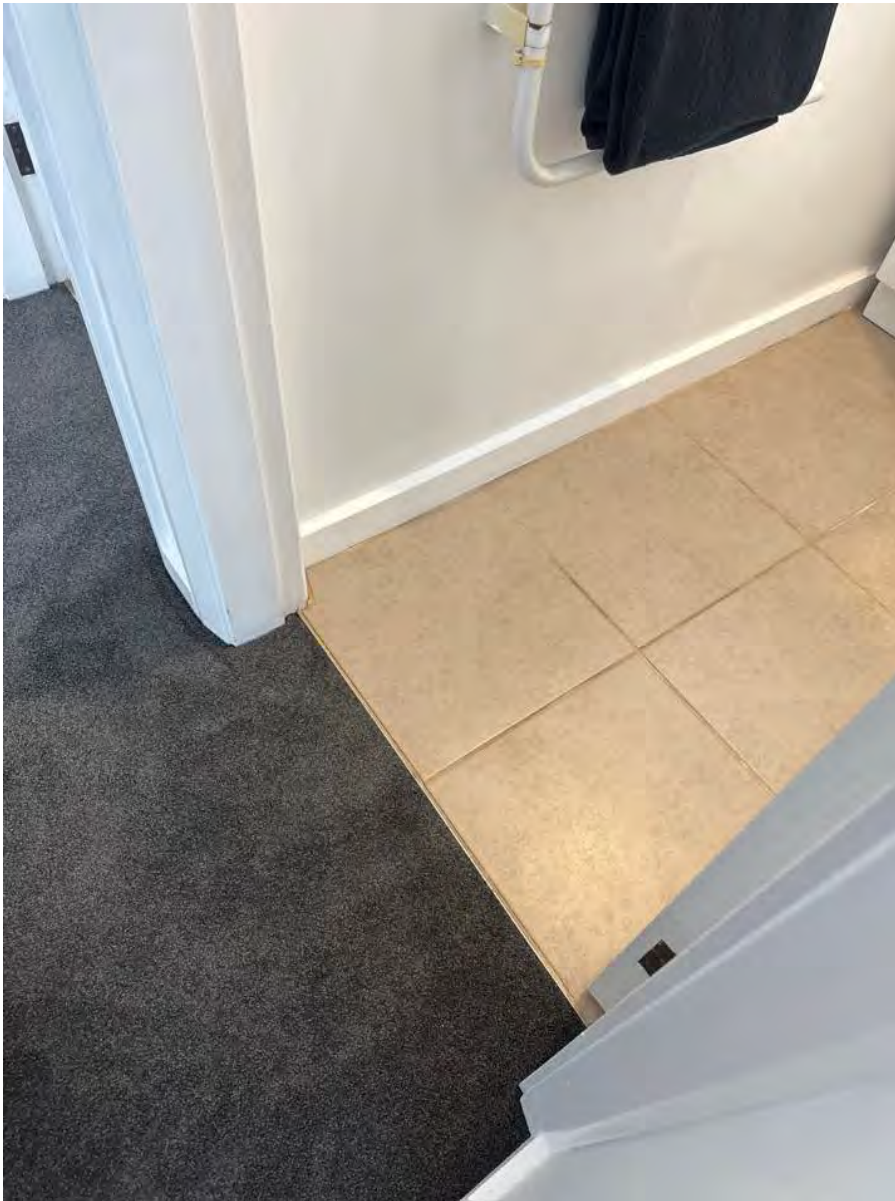
Some cracking to grout to bathroom tiles.

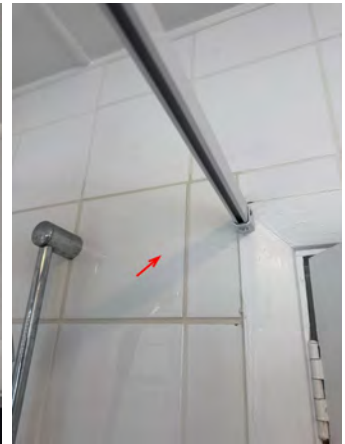
Two cracked tiles. Replace these.

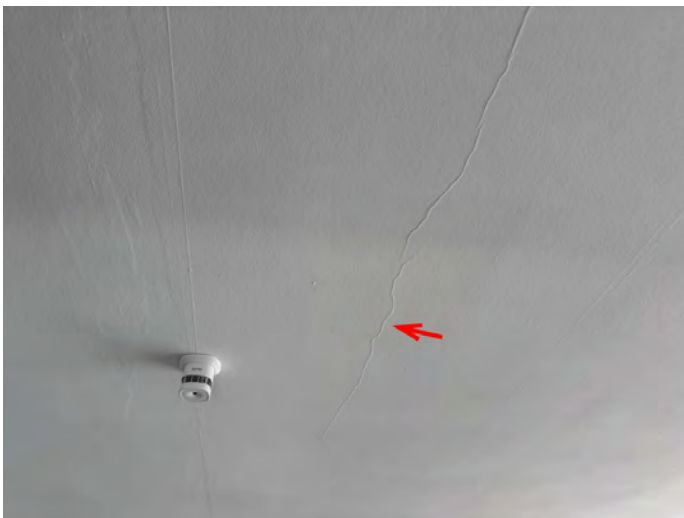
There is some general cracking behind the wallpaper and paint in places throughout the ceiling to the lath and plaster. This should be properly repaired.

Example of cracking to lath and plaster found in many places.

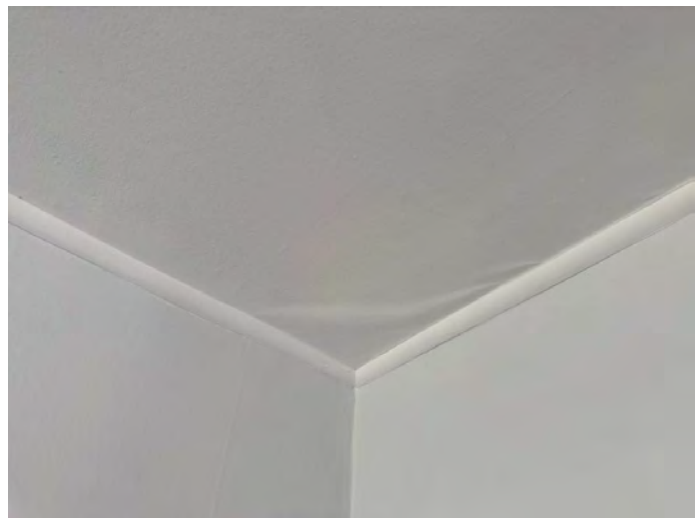
Ripples in wallpaper.

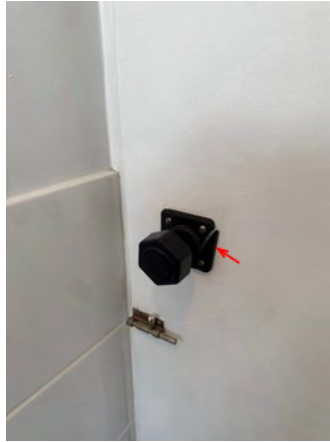
Cracked door knob in separate toilet.

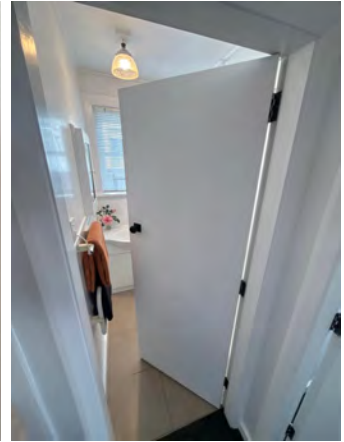
Tighten up door knob.

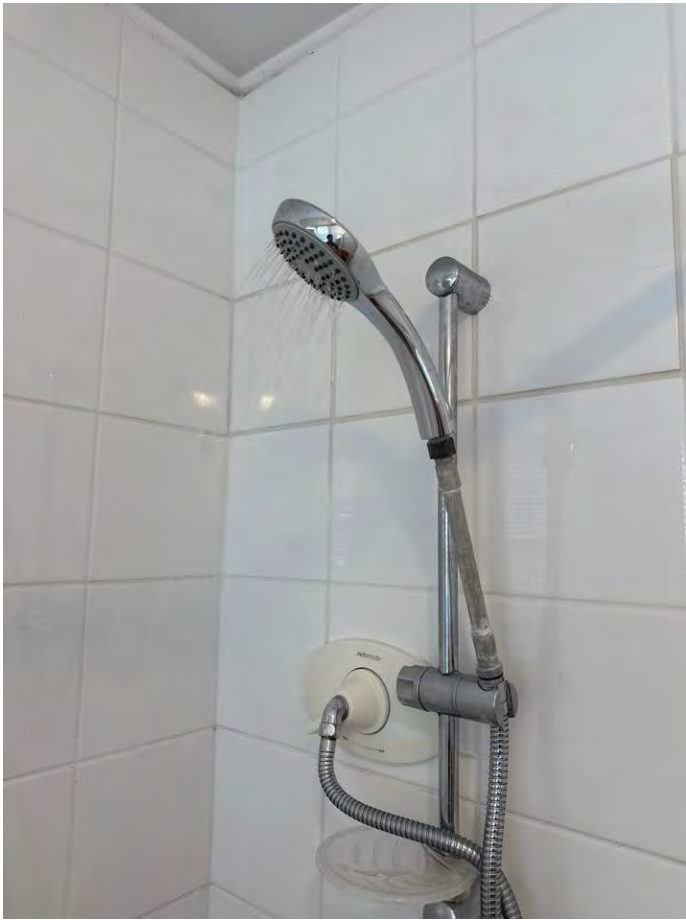
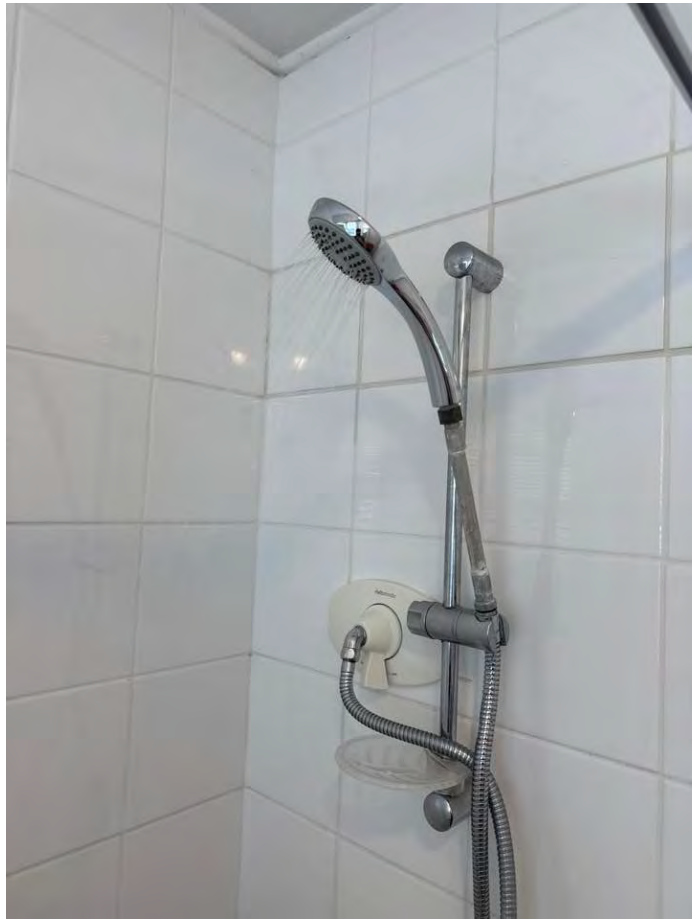
Rusty water is coming out of some of the taps; this is due to these taps having galvanised water supply piping. These can become rusted over time; they are best replaced with modern water supply piping to avoid this.

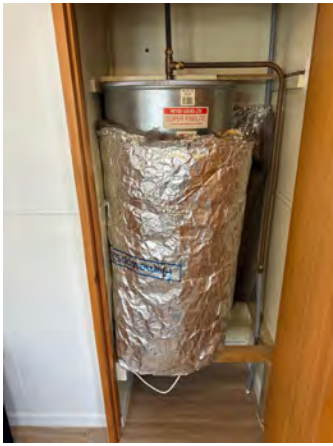
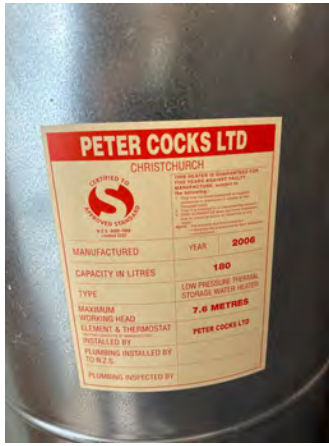
No leaks observed. The cylinder is very dated and should be periodically inspected. Cylinder needs proper seismic restraints installed to prevent it tipping over in the case of an earthquake. Cylinders, particularly older cylinders, can corrode inside and become compromised when harsh water is run through them; this is particularly evident when the water is chlorinated. Often, this cannot be physically sighted off a non-invasive check. Even if a leak is not picked up at the time of inspection, sudden leaks can occur where corrosion to a fitting or the cylinder suddenly gives way. Ensure cylinders are periodically inspected for their condition and any leaking.

Corrosion to fitting.

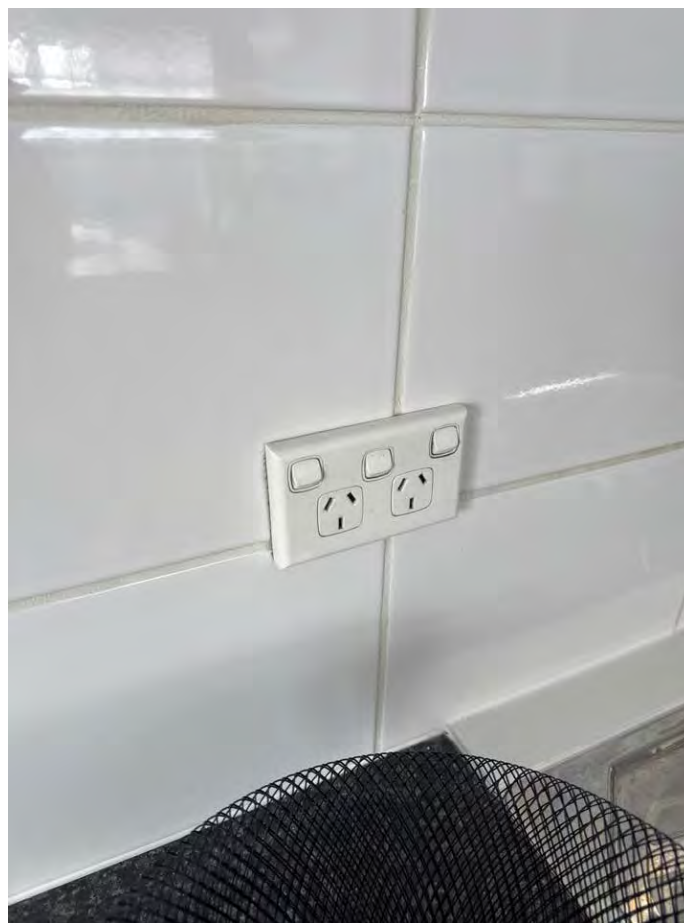
Socket is loose and needs tightening.
