# Independent Builders Report

Total Home Inspection Services Porirua City Ltd

Fri 21 Feb 2025

**21 Matai Rd, Raumati South, Paraparaumu, 5032, New Zealand**

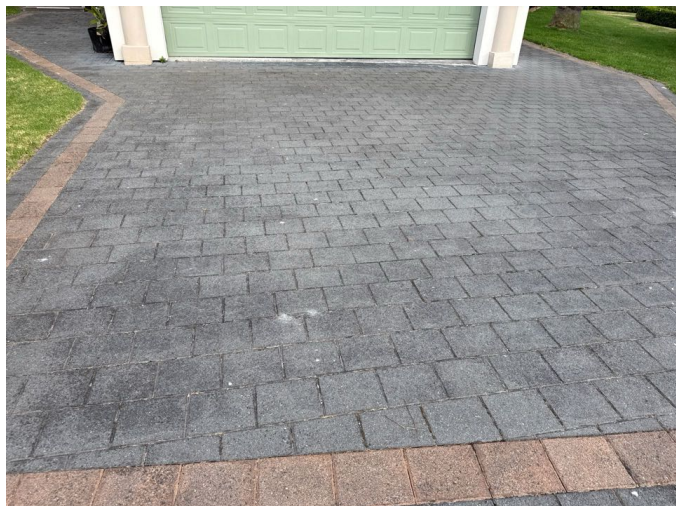
The paved driveway is mostly flat and in good condition

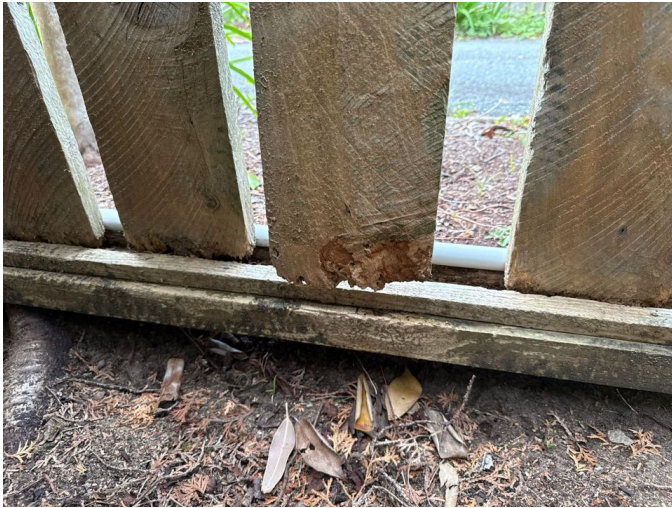
Example, south side. The timber fencing is deteriorating in some areas. Mostly intact at the time of inspection. Maintenance required to some areas in the future.

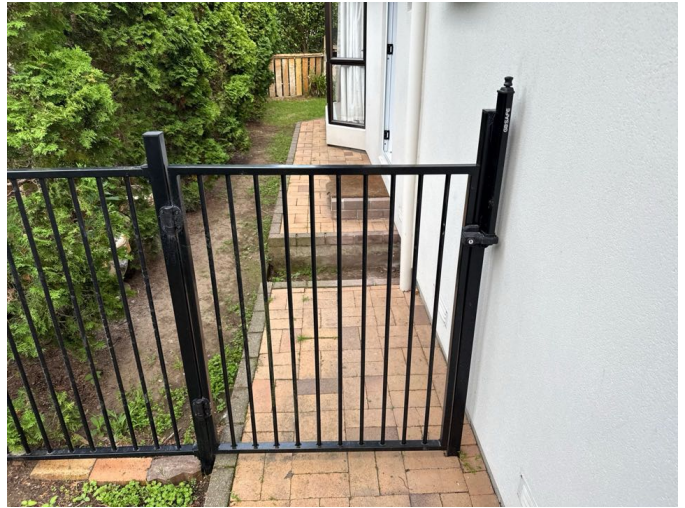
The gates are functional

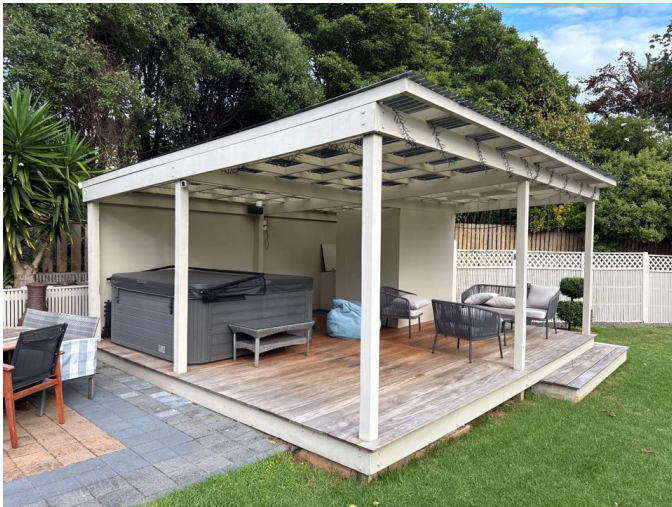
The deck and roof structure to the rear of the section is visibly in good condition and is constructed to a good standard

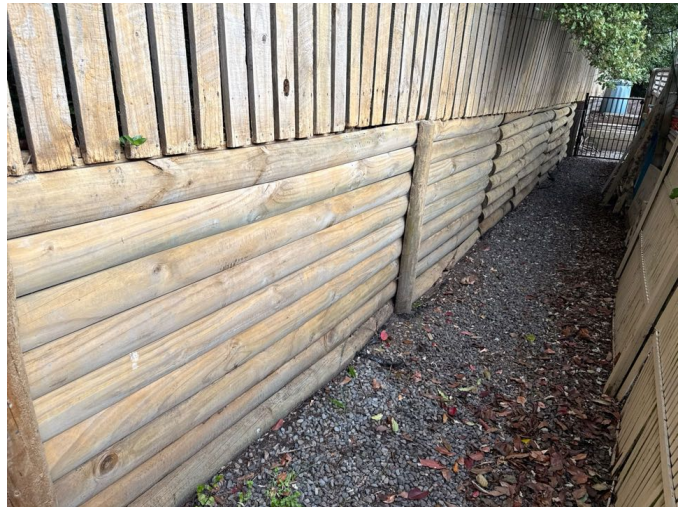
The condition of the retaining walls is consistent with the age of the property.

The retaining walls will require ongoing monitoring. No sign of significant damage or movement at the time of inspection.

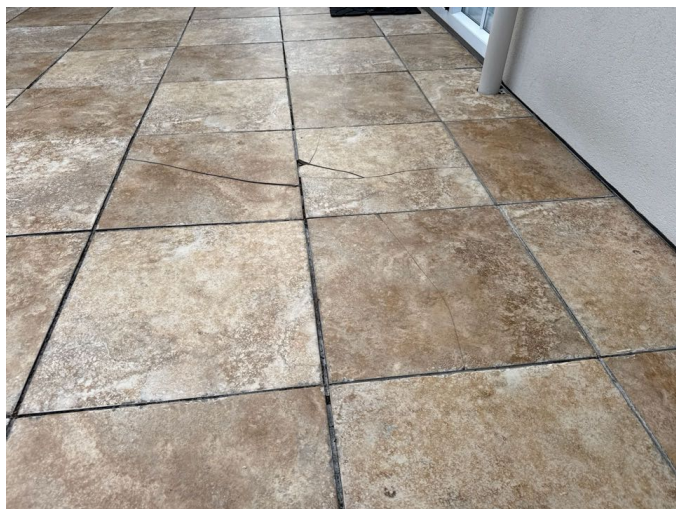
Damaged tiles to the north side should ideally be replaced

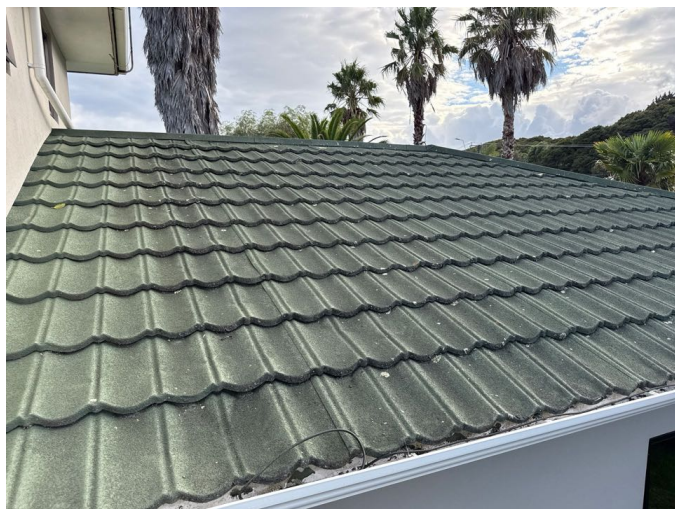
Some Decramastic tiles prior to 1990 can potentially contain Asbestos fibres in the glues used to adhere the stone chips. There are no risks associated with pressed metal roof tiles containing Asbestos if they remain in good condition and left undisturbed. There are a number of specialists roof coating companies, qualified to advise on maintenance and remedial work in the future when required.

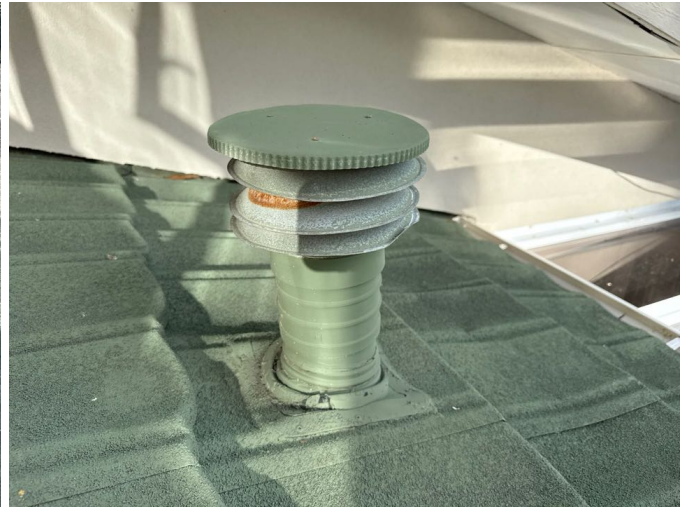
The small steel flue has some isolated surface rust that would be treated with rust converter. The roof penetrations are effectively sealed. The perimeter of the boot flashing at the base is finished with silicone which has a limited lifespan. The condition of the silicone seals should ideally be checked periodically and some replacement should be expected over time.

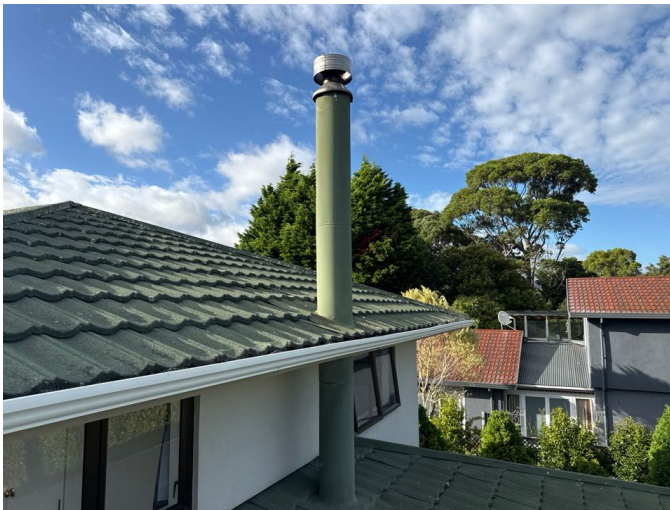
The main steel flue appears to be secure. Isolated surface rust requires attention.

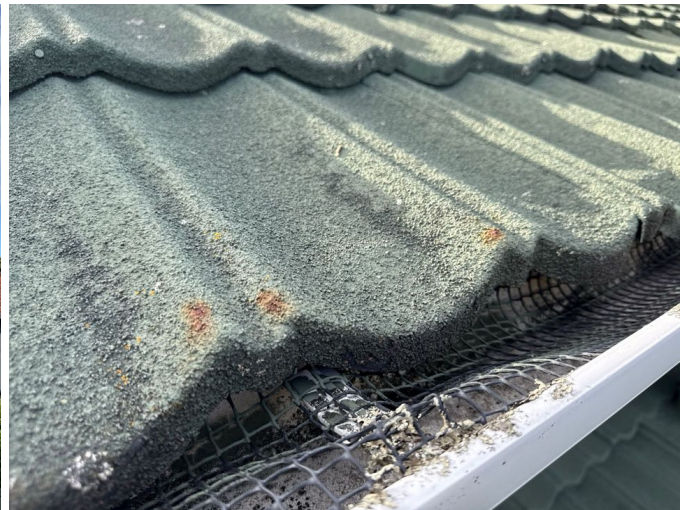
A small amount of surface rust to the tiles on the upper west side

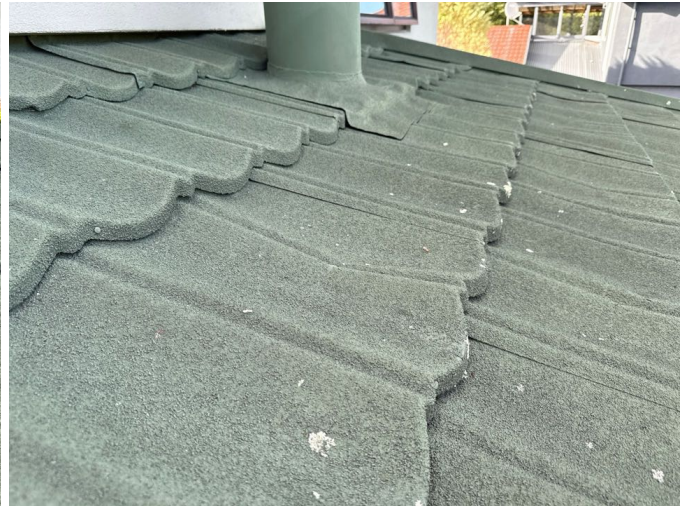
Dented tiles to various locations. The dents are not currently affecting the performance of the roof however they are prone to splitting and should not be walked on.

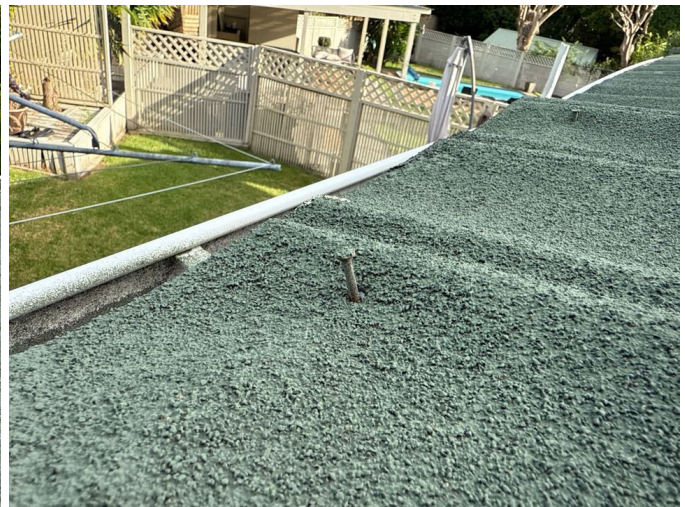
Example, west side lower roof near washing line. The nails have failed at various locations along the bottom row of tiles. These should be replaced with a more effective fixing type.

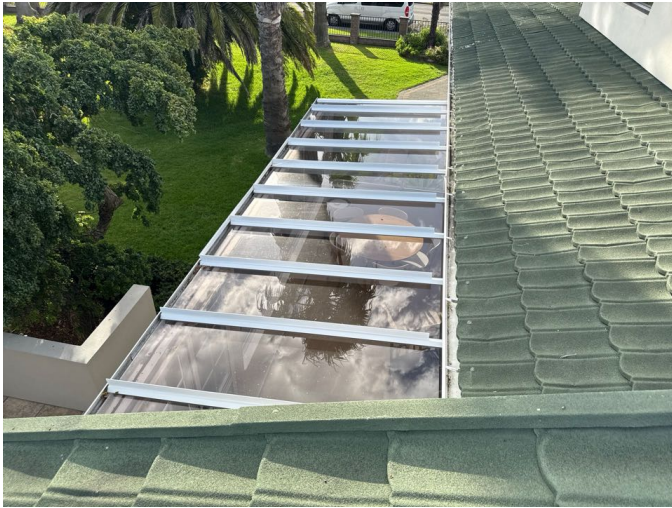
The glass roof is intact and was showing no evidence of leak issues at the time of the inspection

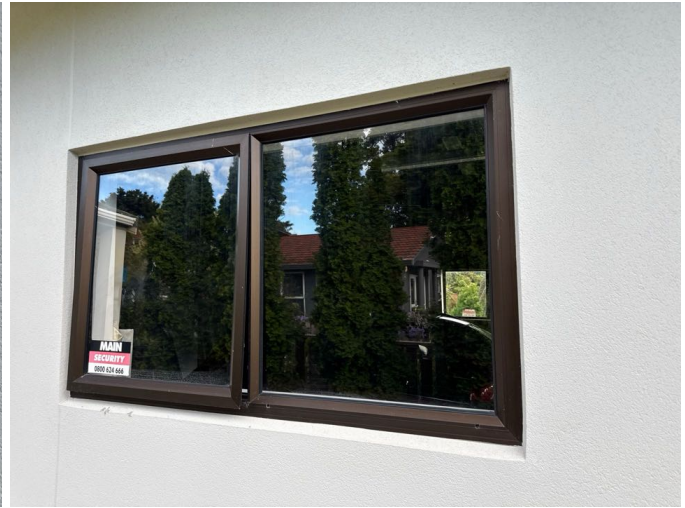
The typical single glazed aluminium window (EIFS) detail is rebated into the cladding with a specific flashing system, most of which is concealed. A head flashing appears to be installed however T.H.I.S is unable to confirm the presence of sill or side flashings.

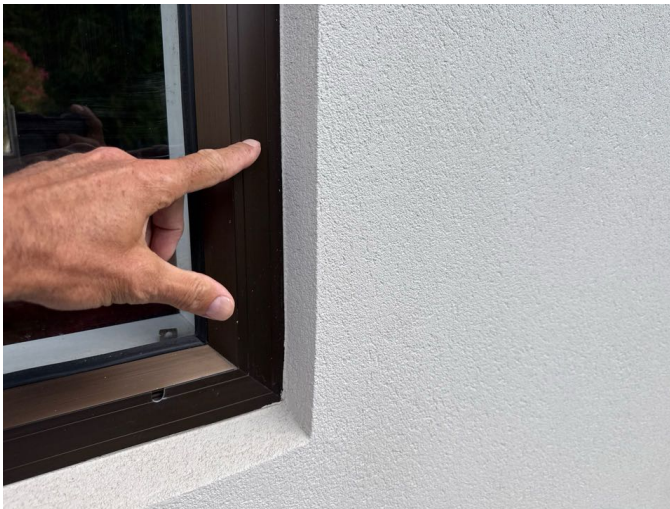
The window edges are reliant on the paint finish and the sealant for weather proofing. This is considered a weather tightness risk area. Cracking can occur along the edges of the joinery and result in the ingress of water into the interior of the framing cavity. Applying a silicone type sealant joint to the edges of the windows and doors can aid in preventing water ingress. These seals have a functional life span and need to be replaced at intervals. This is considered only a temporary measure to prevent water ingress.

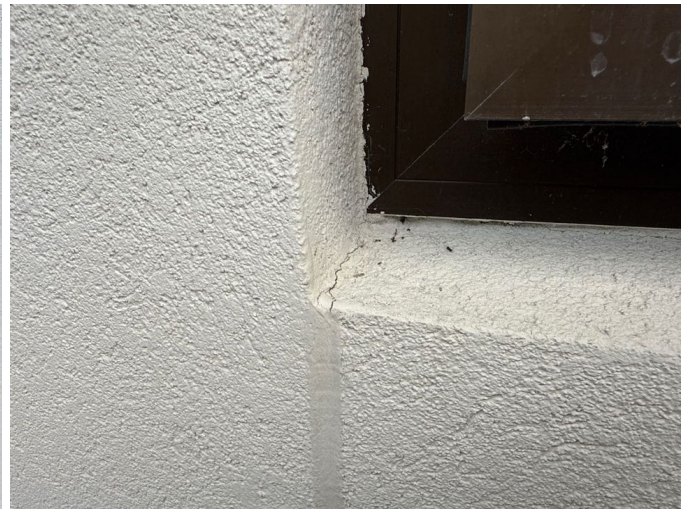
Hairline cracking to the sills indicates that maintenance is due. Cracks like these can sometimes allow moisture inside the structure. This can be very difficult to detect during a standard non invasive inspection.

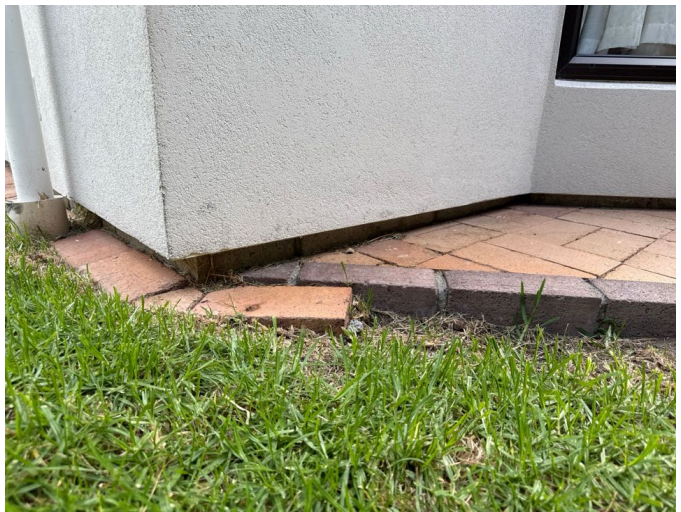
Poor ground clearance can sometimes result in moisture ingress via capillary action, a particularly high risk due to the bottom plate being at risk of decay. The current building code requires a 150mm clearance between the internal floor height and the sealed ground and 225mm to unsealed ground. At the time of the inspection all non invasive moisture tests completed to the bottom plate at these locations presented within the acceptable range.

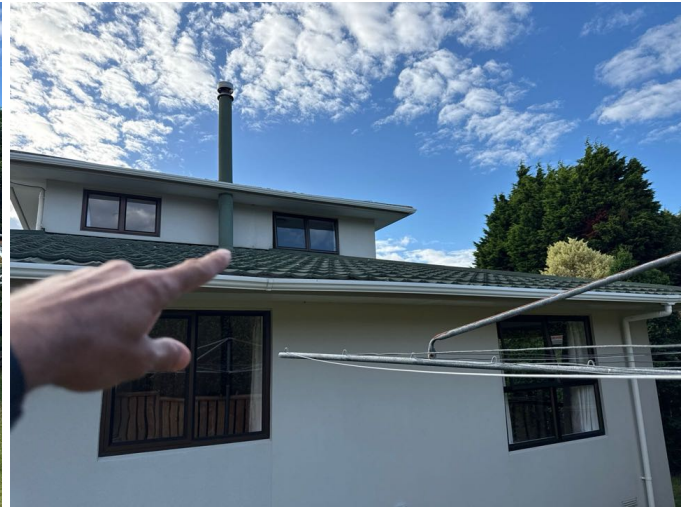
Damage to the cladding requires professional repair

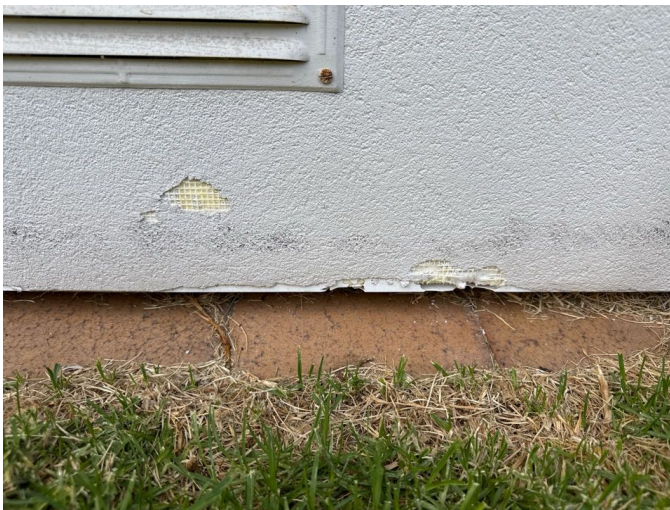
Further surface damage requires repair

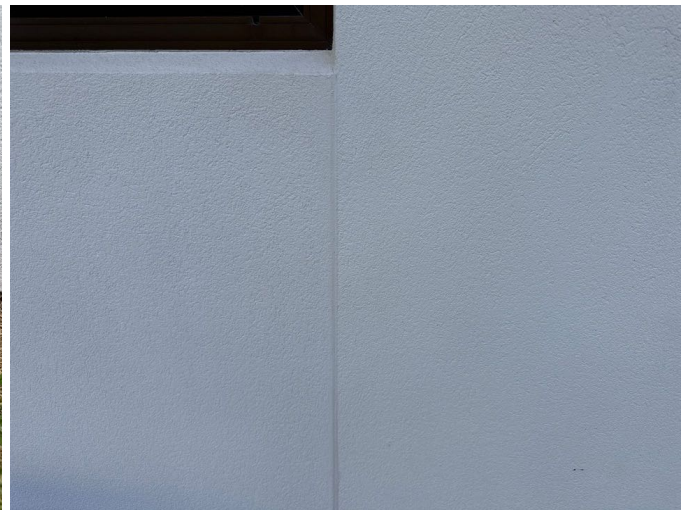
The sealed joints appear to be at the sheet joints and don't appear to be expansion joints which would allow movement.

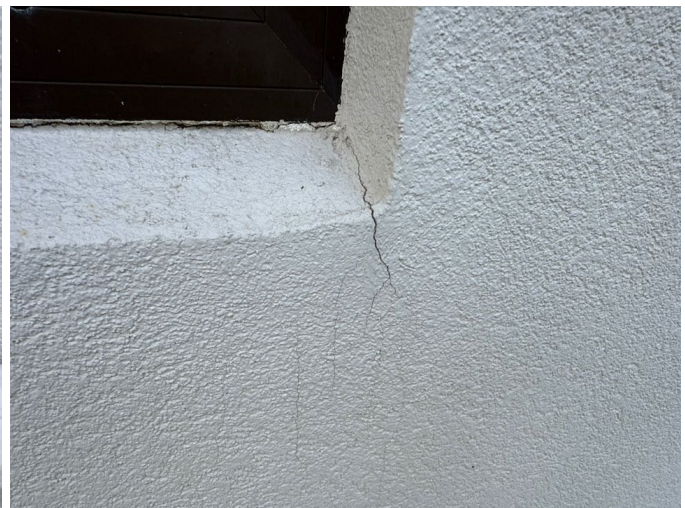
The hairline cracking is commonly the first sign that a paint upgrade is required

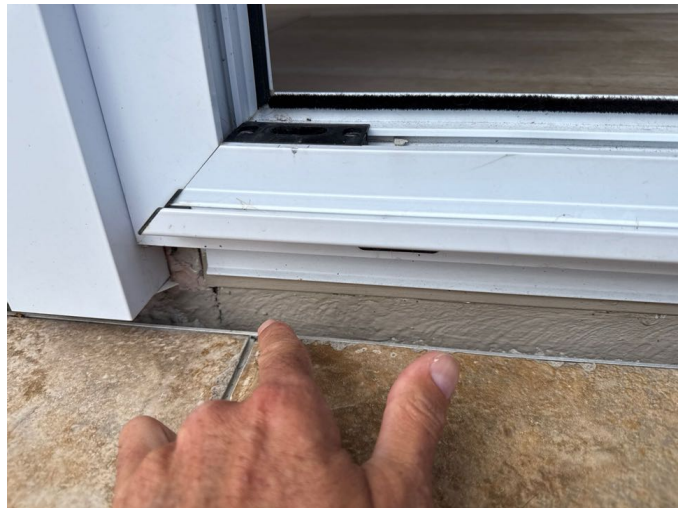
This appears to be evidence that the cladding is installed directly over the original fibre cement sheets

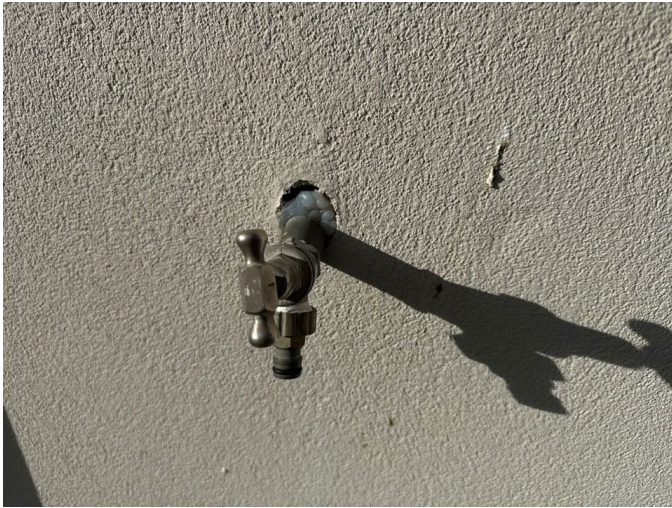
Example. Poorly sealed penetration. Improvement required. Weather-tightness in these areas relies solely on a good seal between the item and the cladding. Sealing improvements recommended to prevent the risk of internal damage.

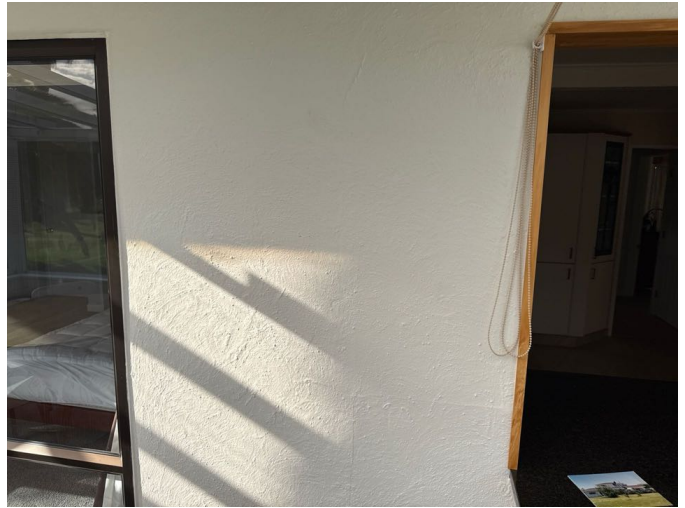
The cladding in the conservatory is likely still to be present underneath the EIFS cladding. This type is a plastered fibre cement (stucco type finish).

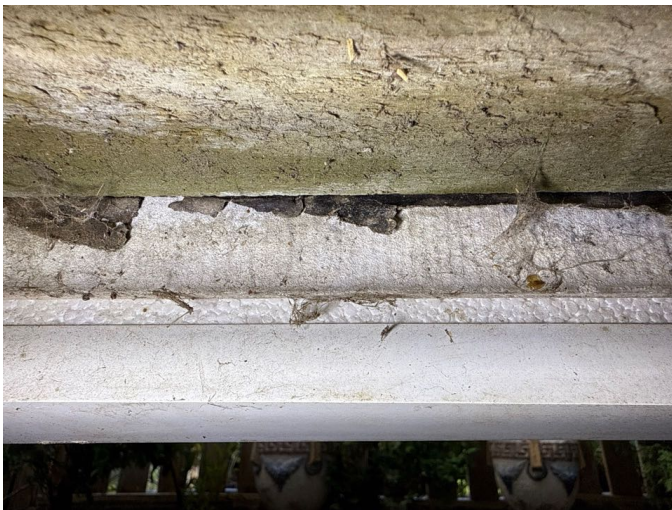
Example, Sub floor. The original fibre cement sheets appear to be still in place with the EIFS cladding installed directly over them.

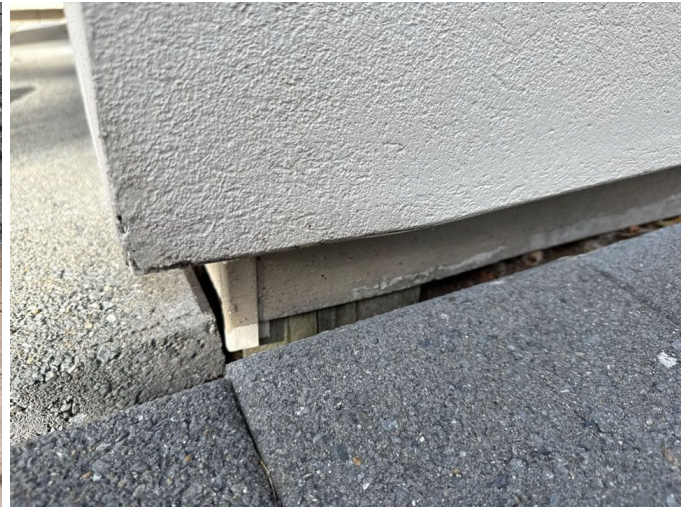
Timber piles support the conservatory. There is no access beneath this area therefore it was not inspected.

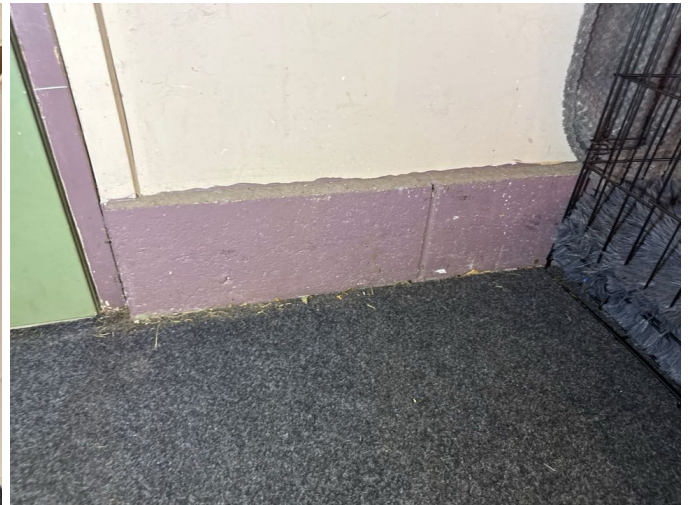
The concrete block perimeter is raised in the garage which has effectively lifted the timber framing above the ground. Although I am unable to comment on the presence of this detail at all locations, the raised framing is a good detail where the ground levels are elevated.

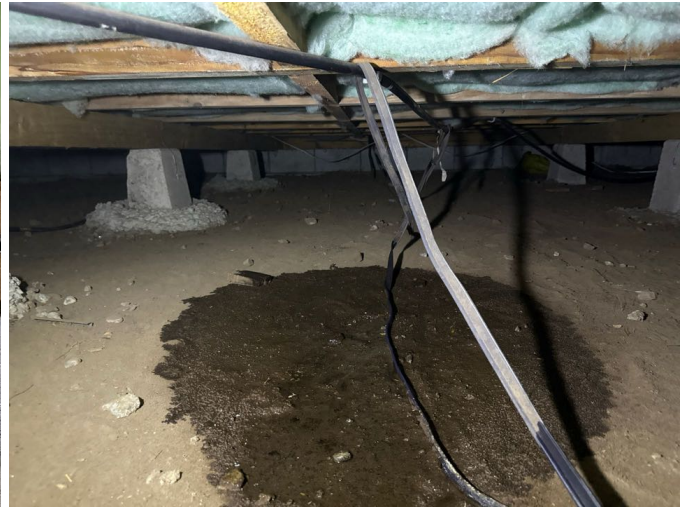
The leaking Dux Qest pipe should be replaced. Dux Qest pipes in service. T.H.I.S recommends full replacement of this plumbing type. Dux Qest was commonly used in the 70's and 80's and is a failed building product which has the potential to cause damage if left in place. NOTE: The owner advised that the Dux Qest has now been replaced (23/09).

Plumbing/Dux Qest - A plumber should be engaged to replace the leaking pipe in the sub floor and ALL other Dux Qest in the property. NOTE: The Dux Qest has been replaced since the original inspection (disclosed by owner).

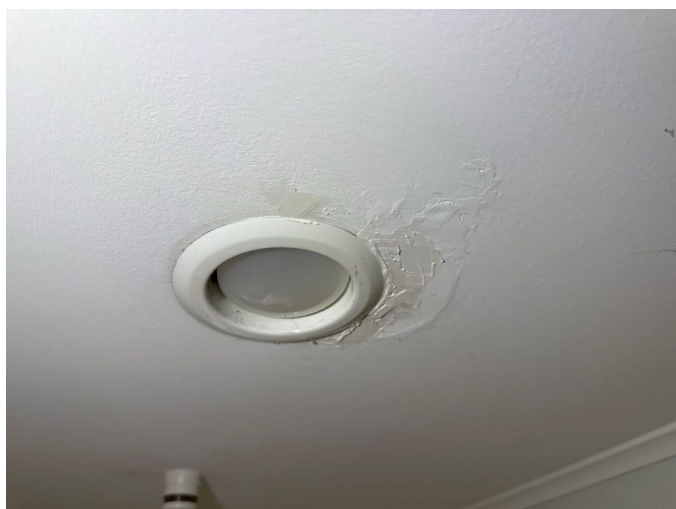
Example. Upper level hallway ceiling. Minor cosmetic wear noted.

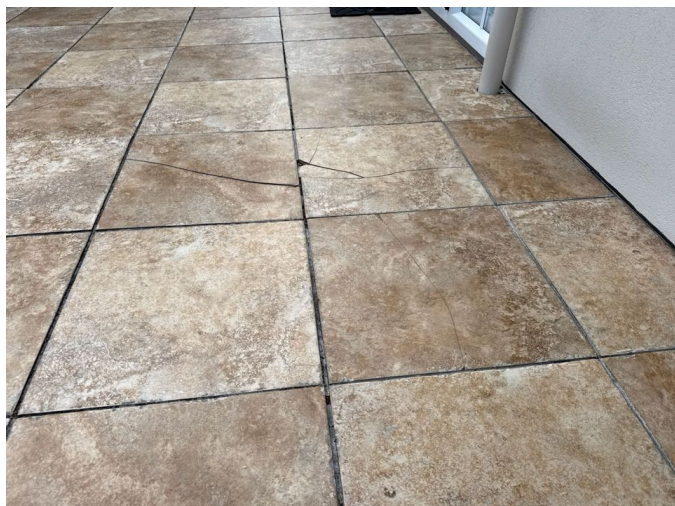
Damaged tiles to the north side should ideally be replaced
