# Land Information Memorandum

2 Mallard Place

LIM number: H09338949

REPORT

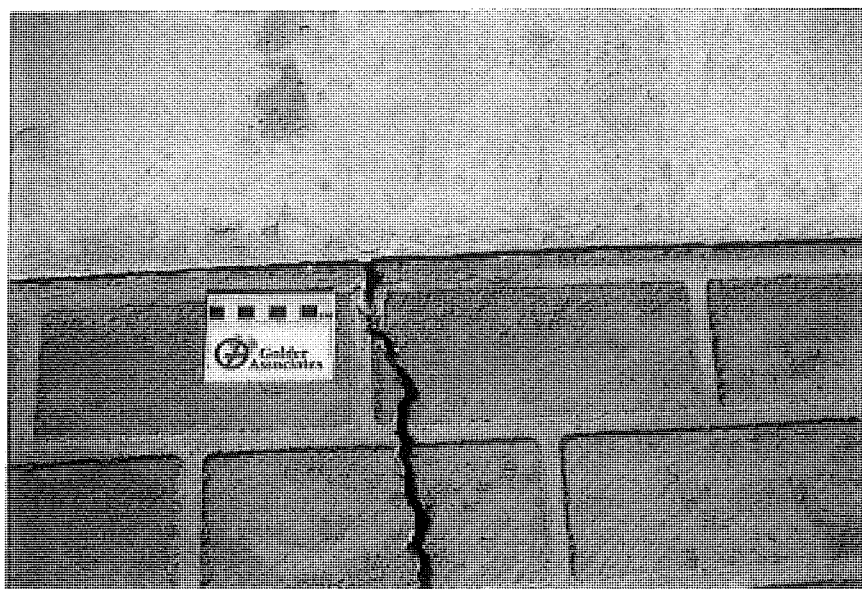
**Photograph 1**

Evidence of ground cracking in front brick driveway.

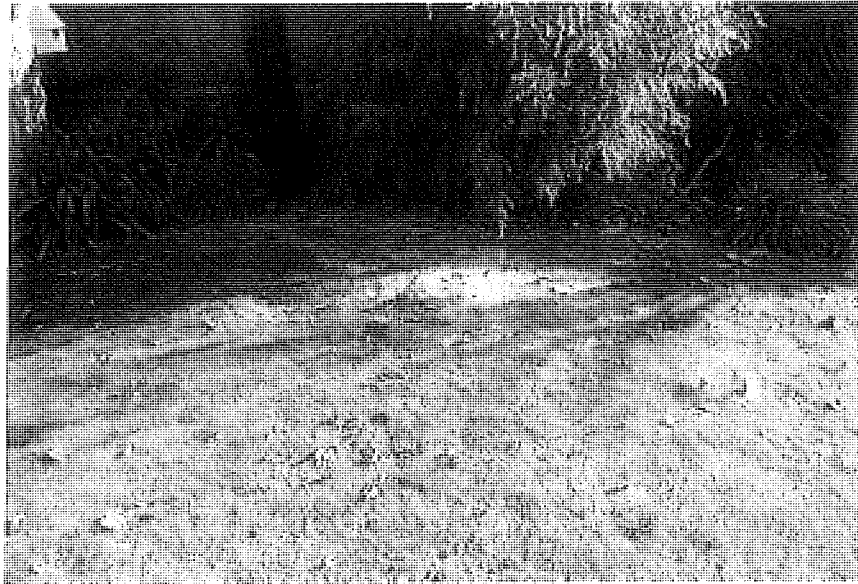
**Photograph 2**  
Evidence of liquefaction ejecta in back garden.
