## Executive summary

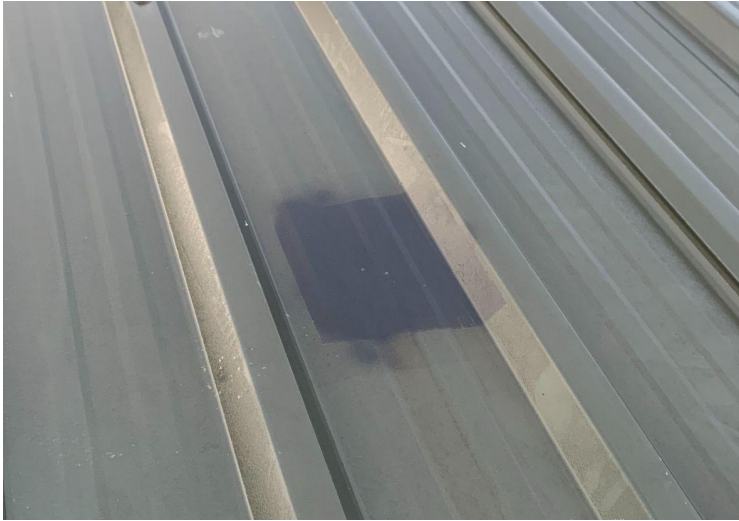
Photo 4: Sanded and painted a spot where rust had developed in 2023.

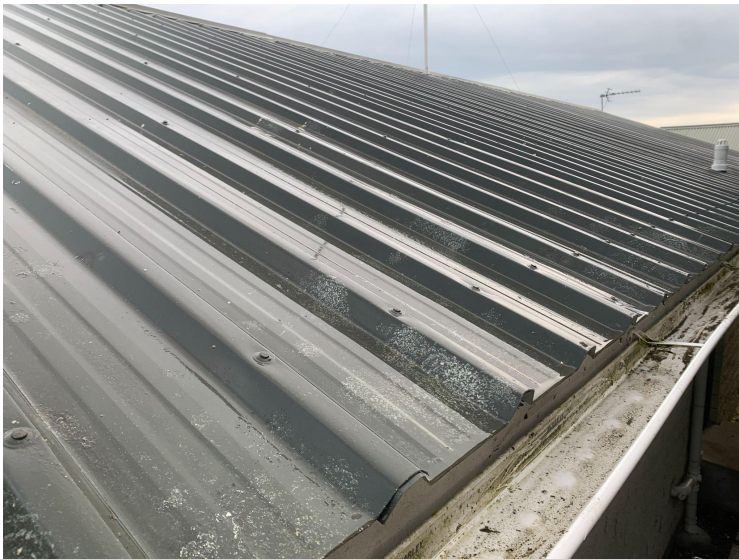
Photo 9/10: Obstructions removed from guttering.

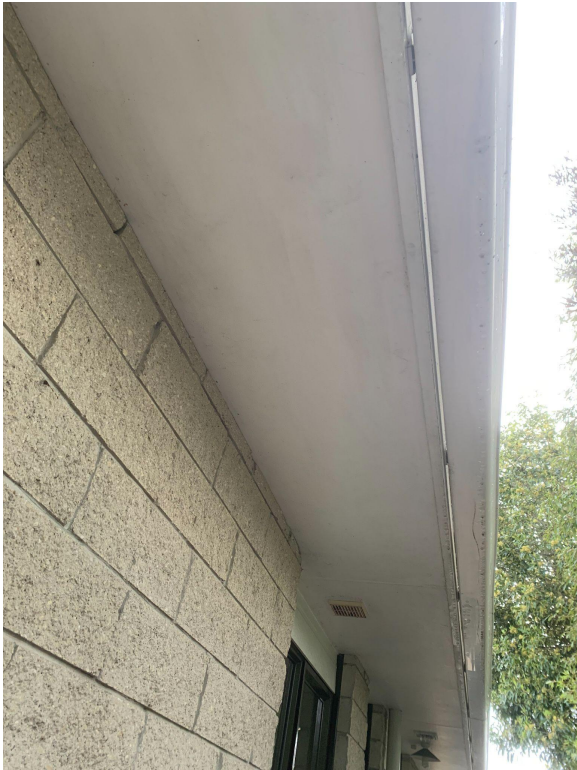
Photo 11: Soffits cleaned.

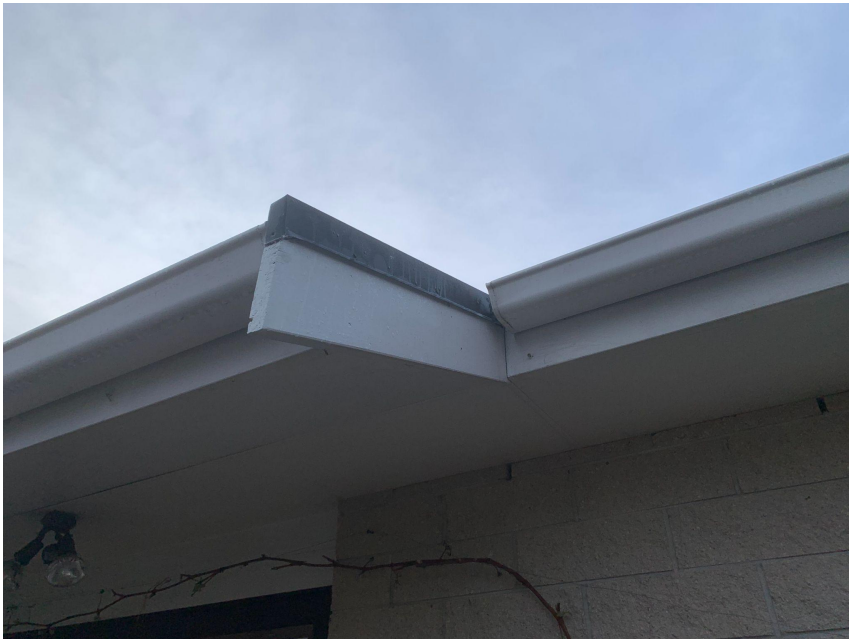
Photo 12: Ends of barge boards sanded and repainted.

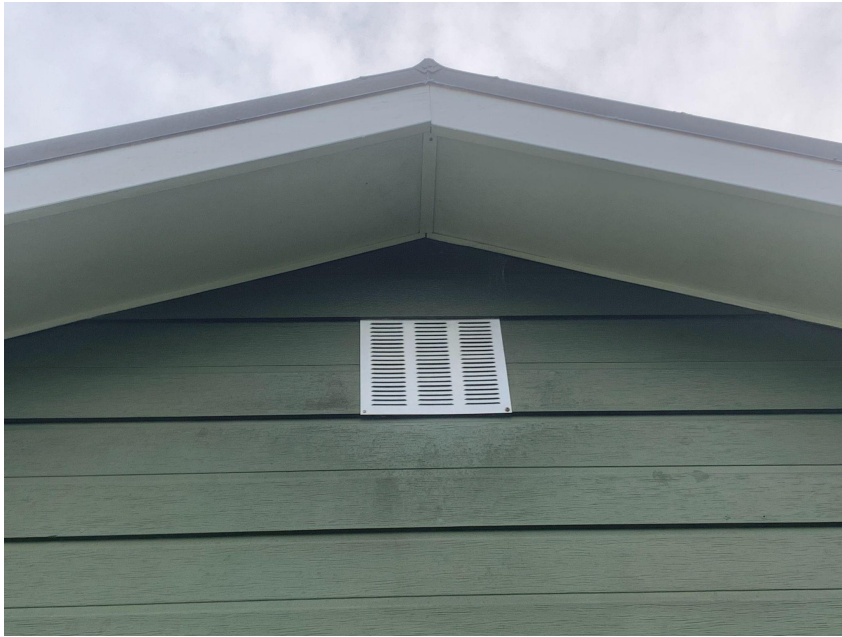
Photo 13: Fascia sanded and repainted, jointer capping replaced.

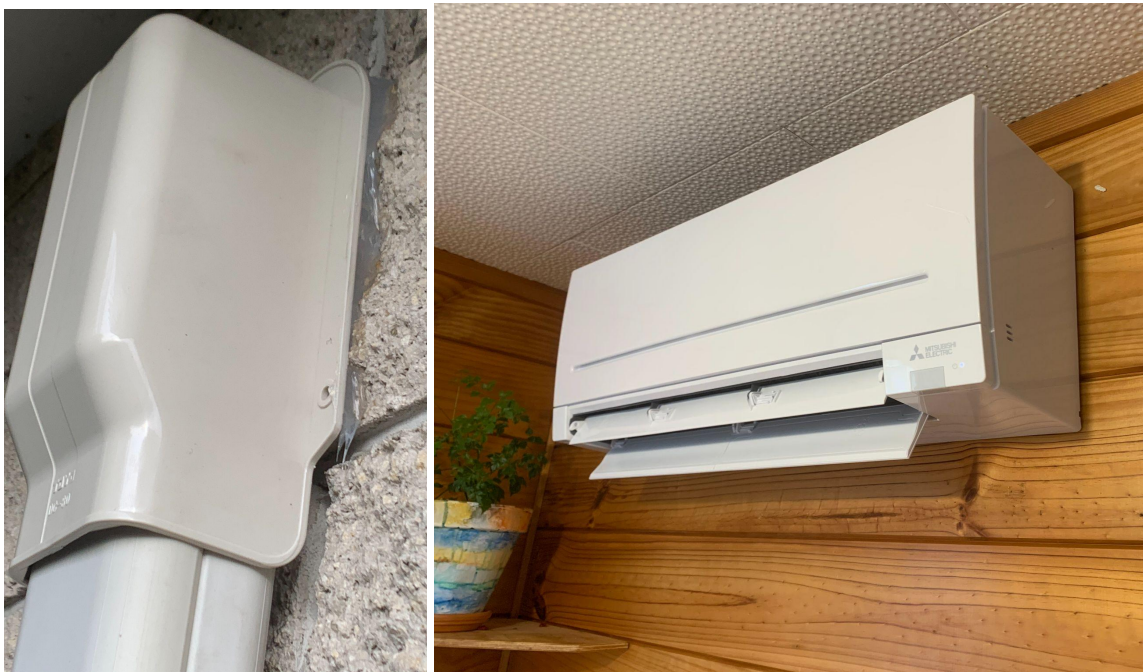
Photo 20: Heat pump has been replaced since this inspection, both internal and external unit.

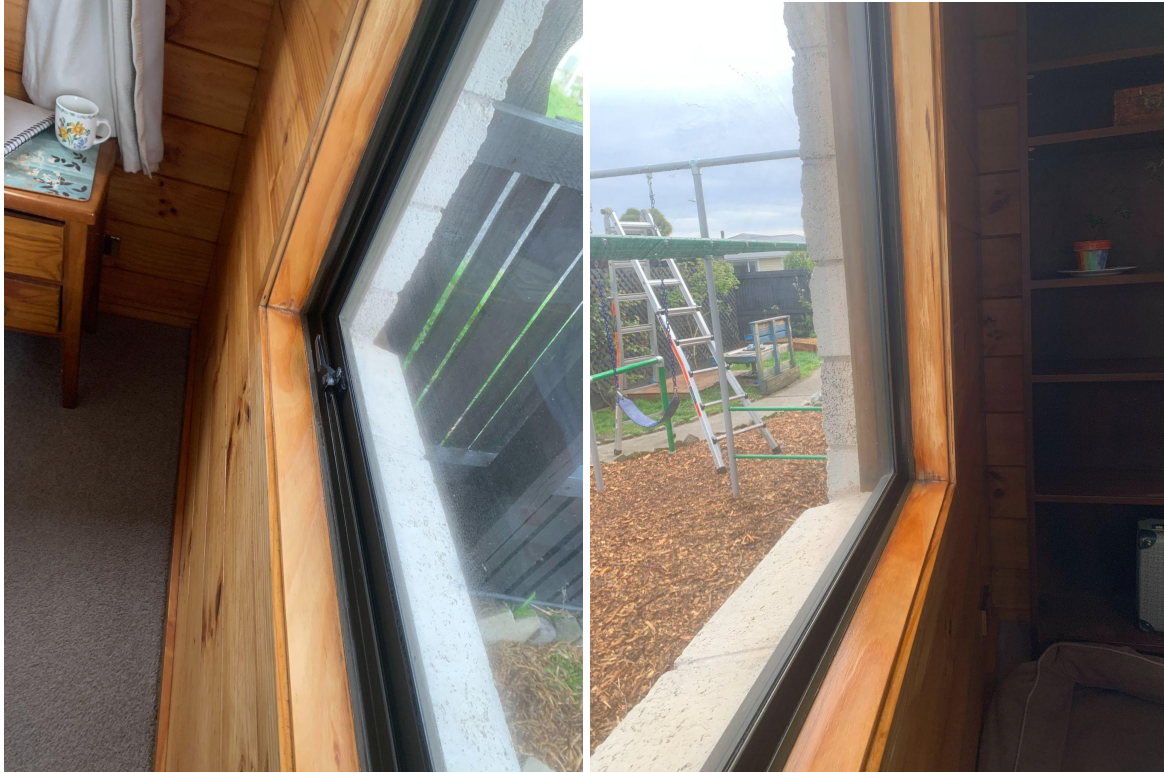
Photo 23/4: Affected window sills and reveals have been sanded and revarnished with 3 coats of oil-based polyurethane. Process completed on windows in all bedrooms, lounge, dining and kitchen. Not done in laundry, toilet, or bathroom.

Sanded and re-varnished affected reveals with 3 coats of oil-based polyurethane, removed blockages.

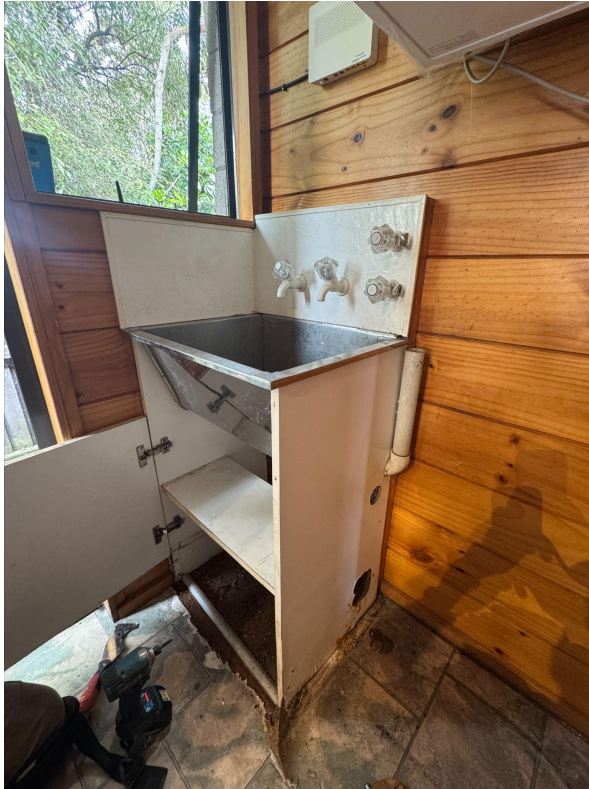
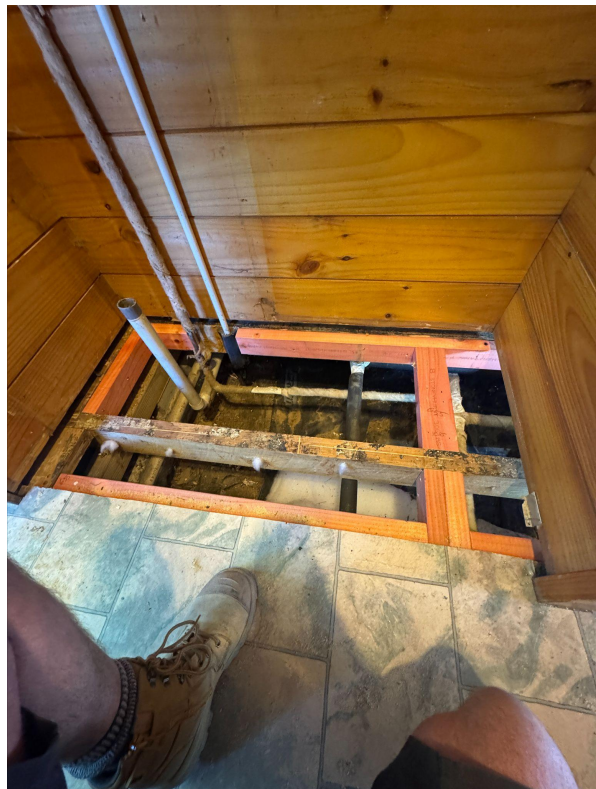
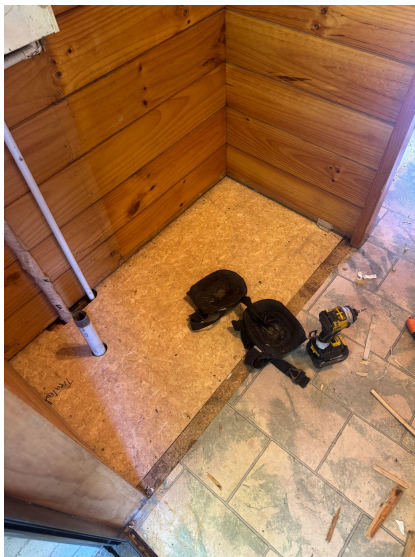
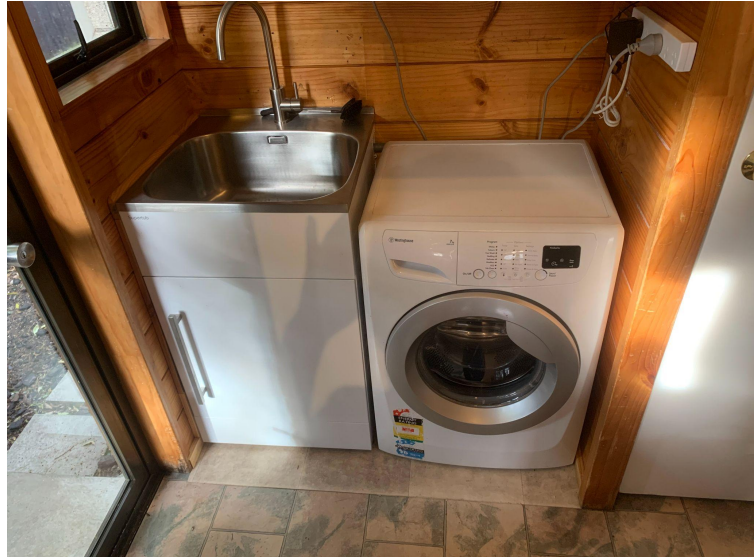
Photo 34: Further investigation of this wet reading revealed gradual water damage sourced from the laundry tub. Water damage to the floor under the tub, washing machine and laundry cupboard. Floor has been replaced (with new bracing), new vinyl flooring installed, and a new laundry tub installed.
