## BUILDING INSPECTION REPORT

## Building Inspection Report

51 Wayside Avenue, Burnside

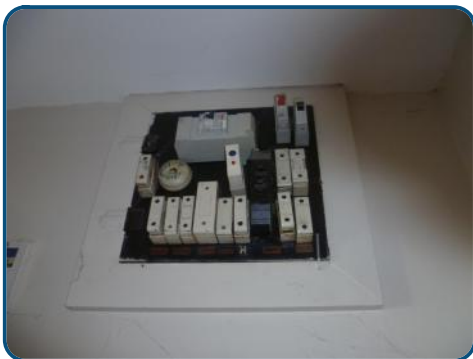
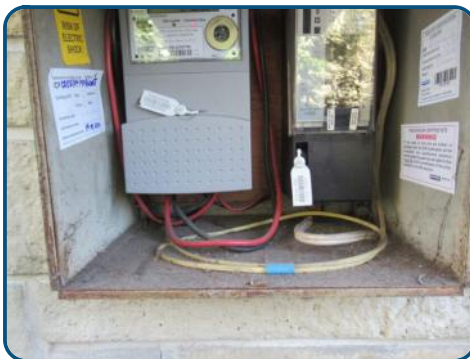
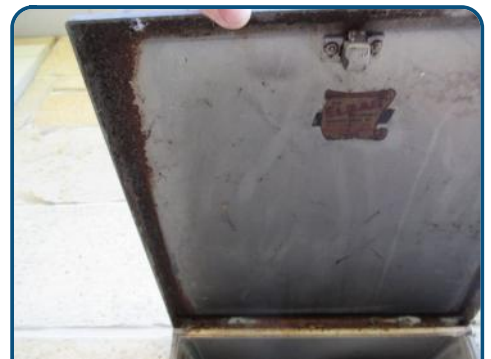
surface rust to cover noted,  
clean/treat and paint to protect

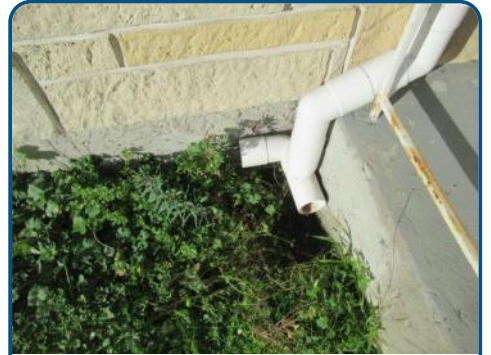
example of downpipe needing directed to appropriate outlet noted.

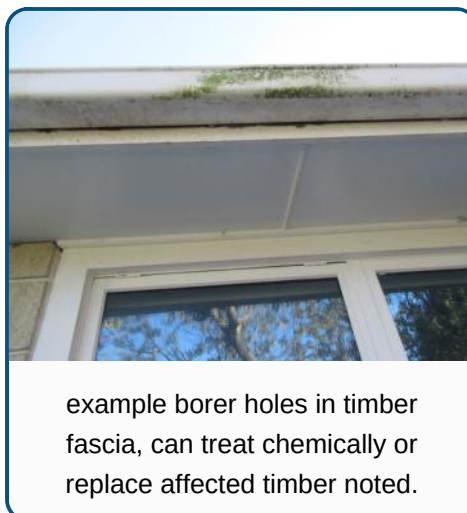
| Cladding | minor amount of borer holes sighted. |
| Comments | borer can exist in other timbers without being visible. control with regular applications of a suitable borer insecticide, or replace affected timbers. |

example borer holes in timber fascia, can treat chemically or replace affected timber noted.

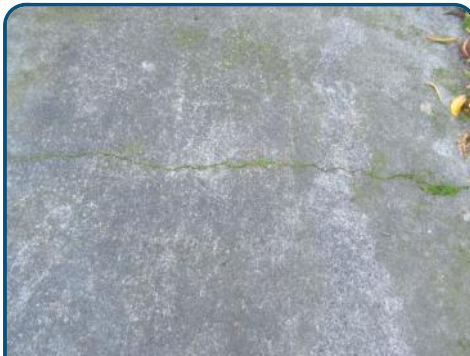
example of cracking to paths  
appears sound.

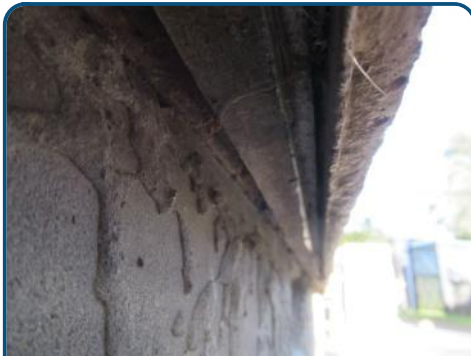
| Comment | cracking noted, unable to confirm the condition of timbers behind cladding. |

view of bottom of cladding, unable to sight all.

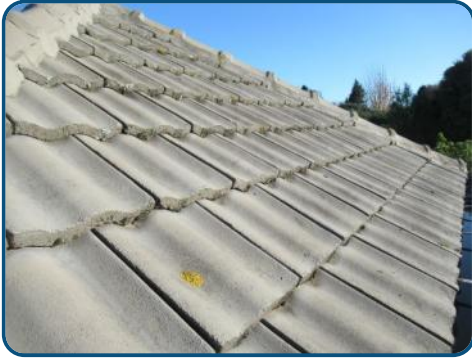
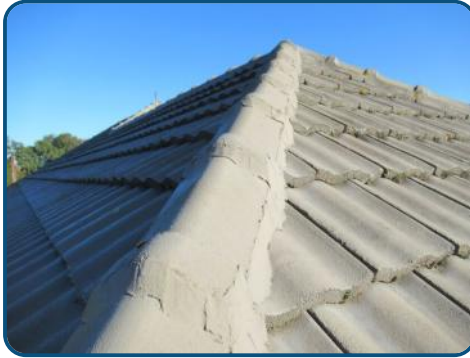
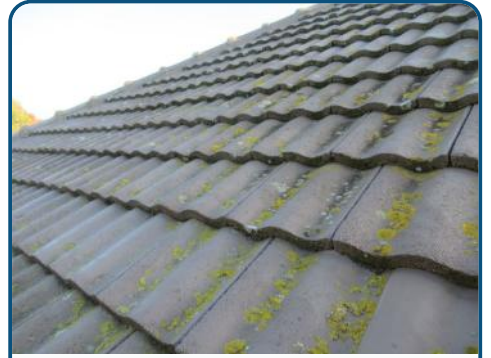
example of lichen, can treat chemically to control noted.

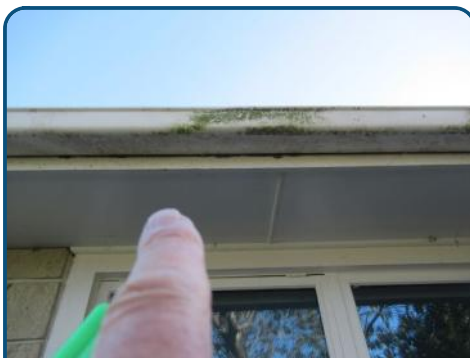
| Condition | borer holes noted, can treat chemically to control/replace affected timber. |

borer holes noted, can treat chemically to control/replace affected timber.

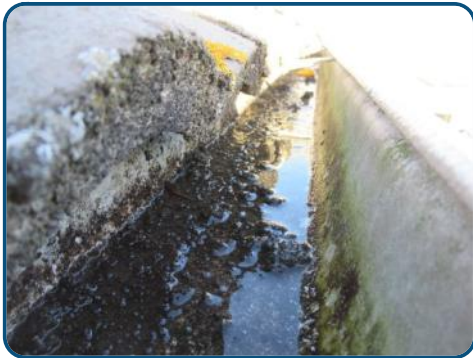
| Comment | needs clean in areas noted. |

spouting needs clean in areas noted.

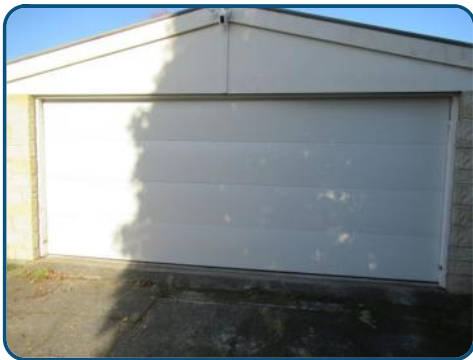
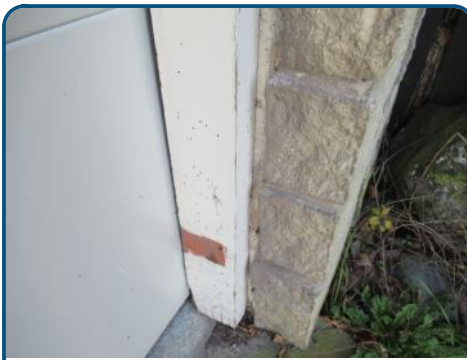
example of borer holes in garage  
timber trims noted

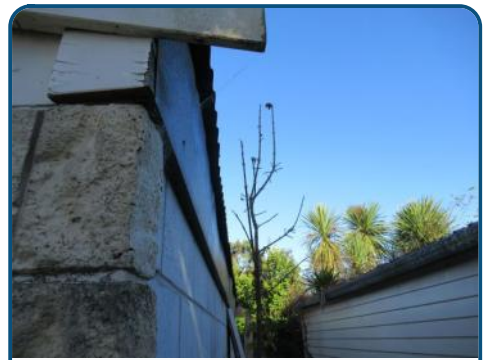
no spouting noted

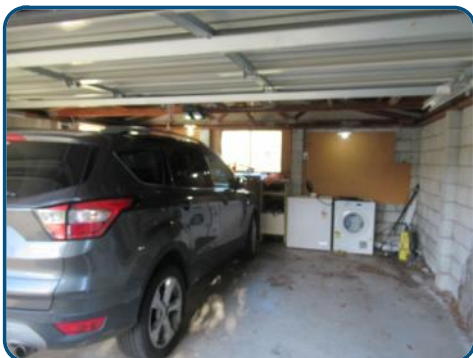
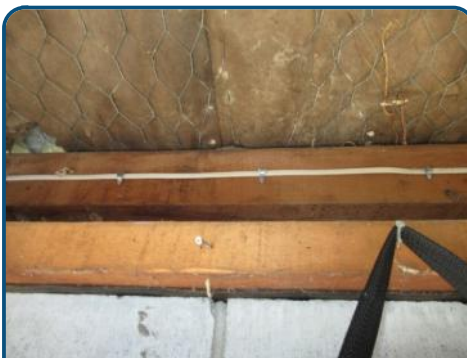
example of borer holes in garage  
timber trims noted

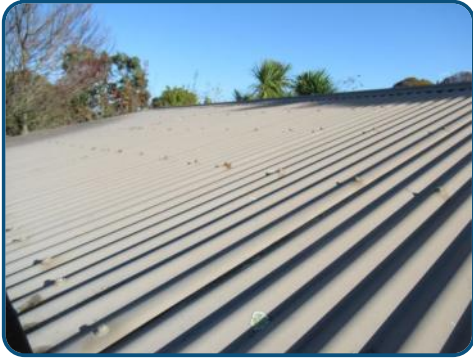
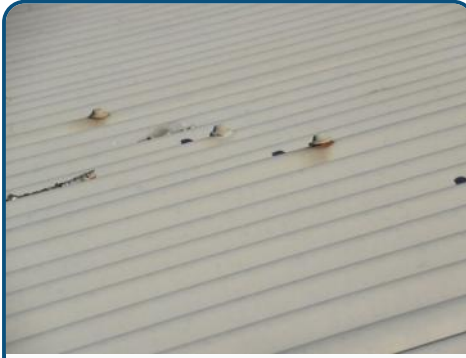
example of surface rust to roof  
fixings noted

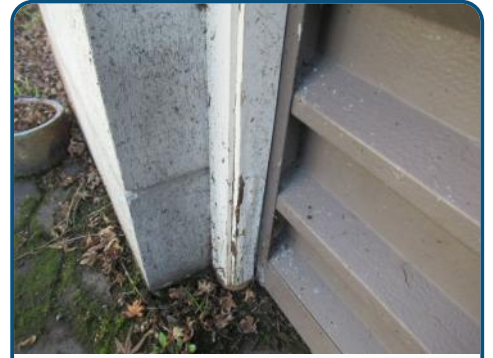
example of soft timber trim on  
garage at small door noted.

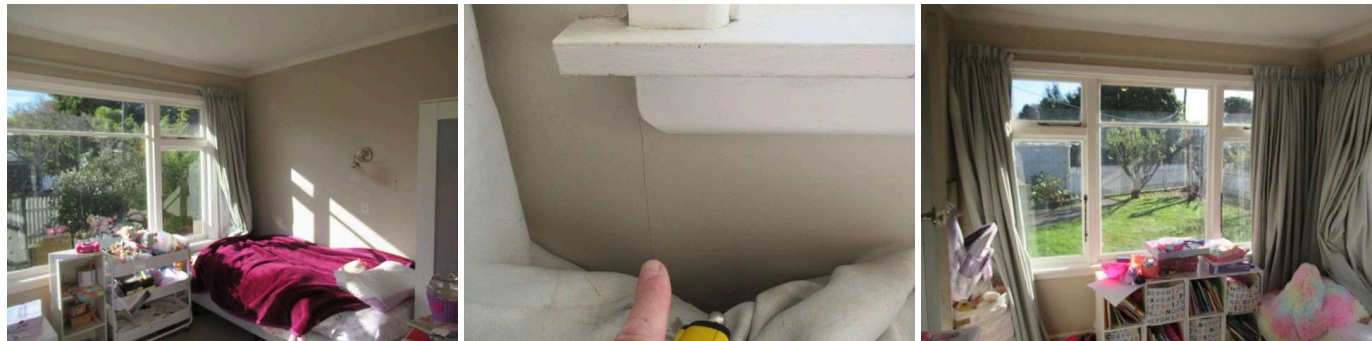
sheet joint movement noted

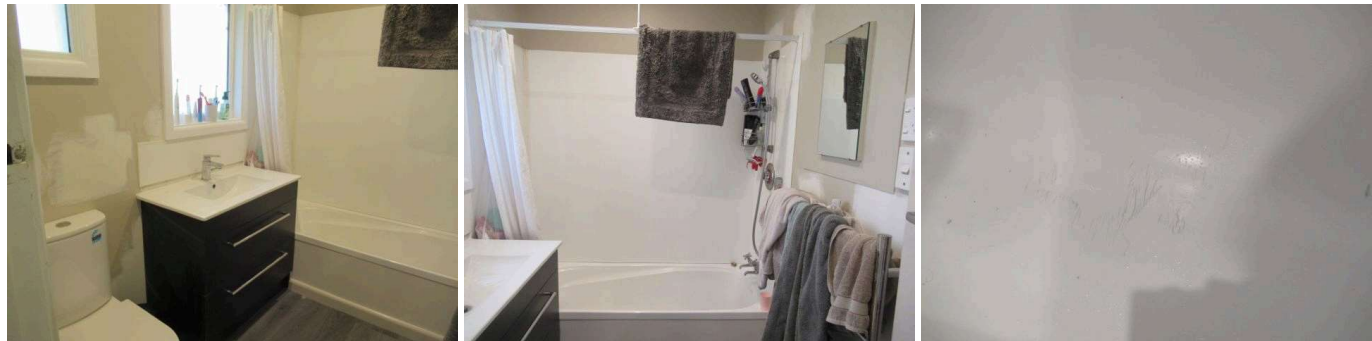
wear to bath surface noted
