## RED LBP PRE-PURCHASE REPORT

**Company:** Property Support Ltd trading as RedLBP Kapiti Porirua  
**Client:** Charlotte Ross  
**Date of Inspection:** 7th October 2025  
**Site Address:** 53 Tiromoana road Raumati south  
**Inspector:** Trevor Garrett  
**Qualifications:** MSc, LBP, Advanced Trade Cert Carpentry, Nat Diploma Construction Management. Member of NZIOB.

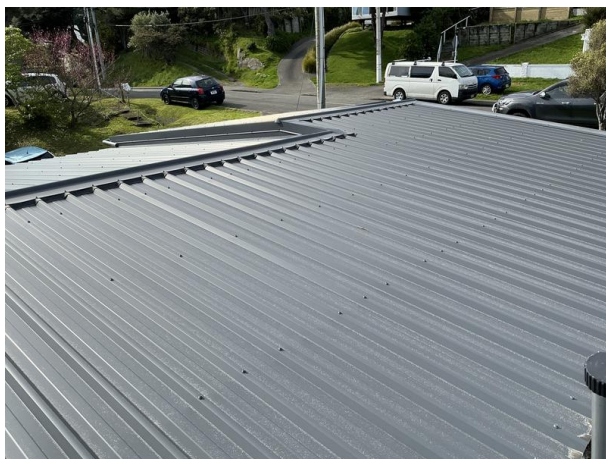
**Photo 3**

Roof is in serviceable condition.

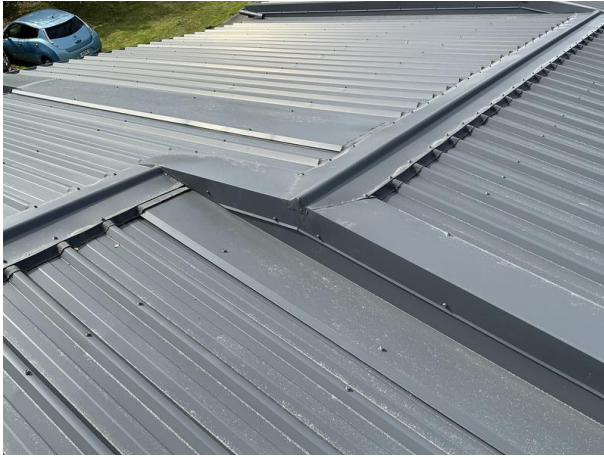
**Photo 4**

Ridge/barge and apron junctions.

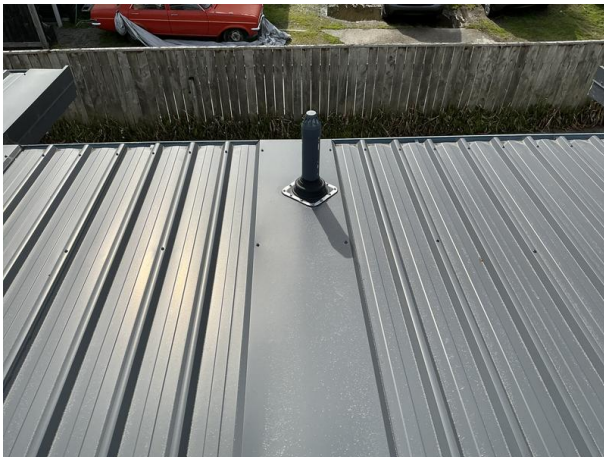
**Photo 5**

East side penetration.

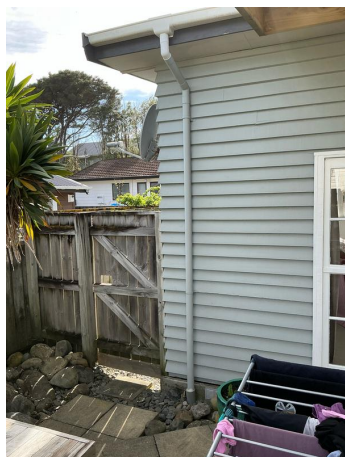
**Photo 6**

No issues with the downpipes.

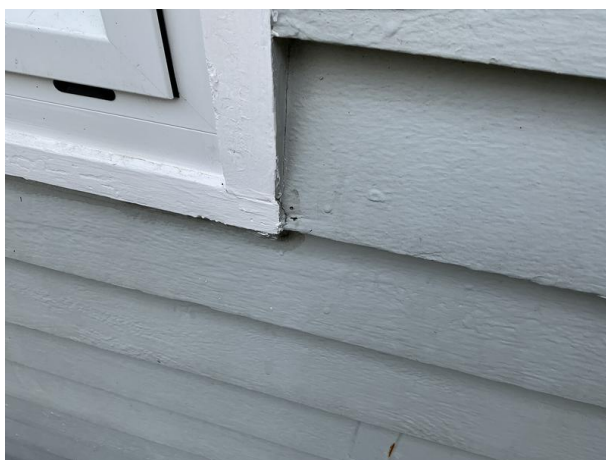
**Photo 7**

Areas of rot - Areas noted (refer to photos).

West side rot to weatherboard.

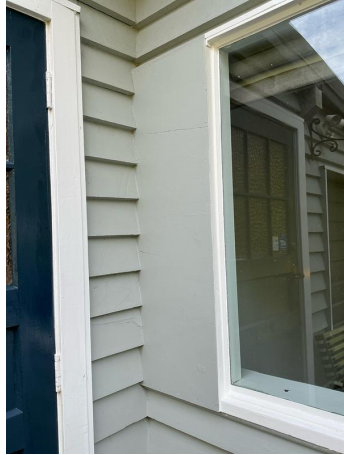
**Photo 8**

West side wall has a plywood infill.

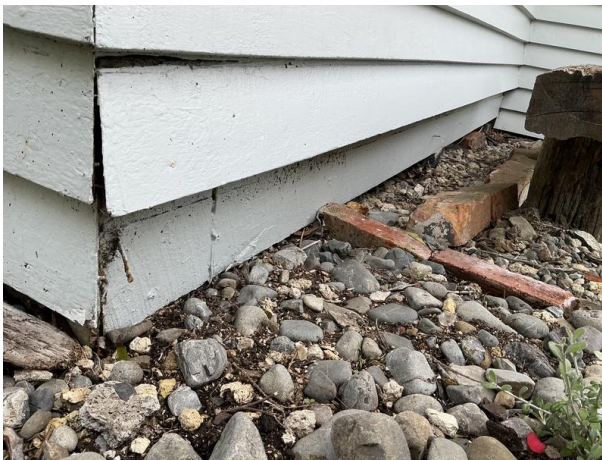
**Photo 9**

South side has reduced ground clearance with a board missing exposing the the sub floor bearer to the atmosphere although, it has been painted.

In some areas, minimum ground clearances are compromised due to hard landscaping or gardens. This reduced clearance can lead to accelerated weathering of the cladding and increase the risk of moisture-related damage. To mitigate this, it is recommended to lower the ground levels where feasible.

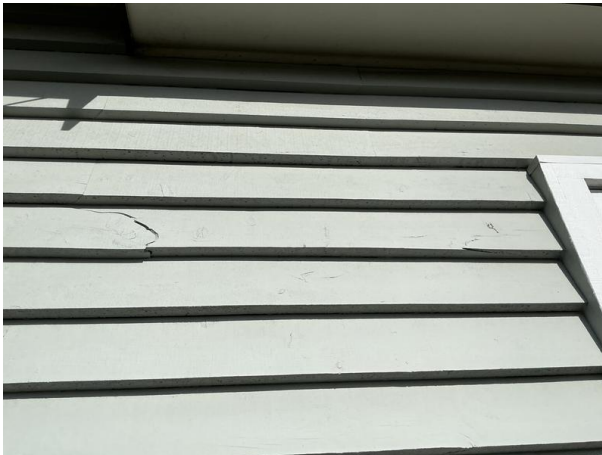
**Photo 10**

East side cracked weatherboards.

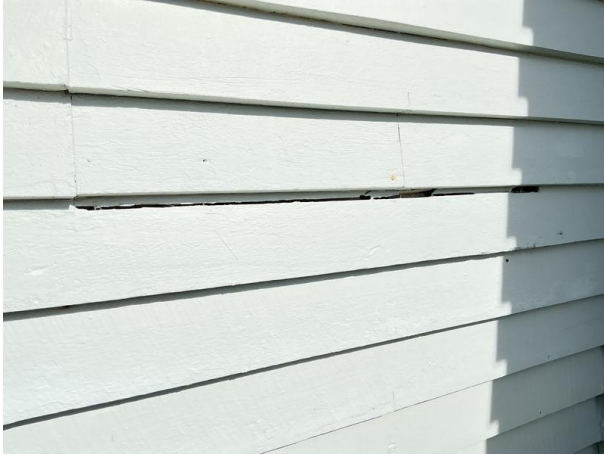
**Photo 11**  
East side gaps to the weatherboard.

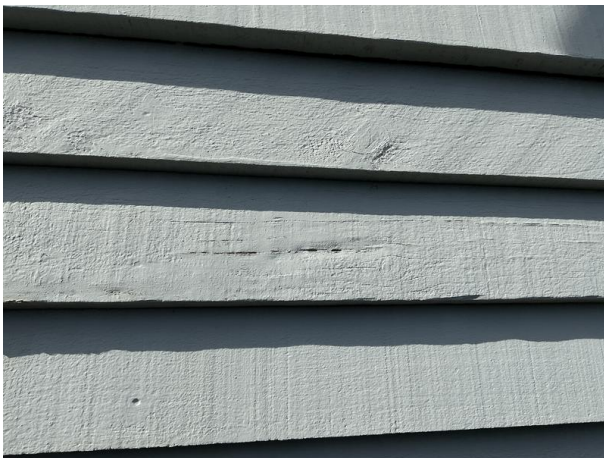
**Photo 12**  
Northside rot to weatherboard.

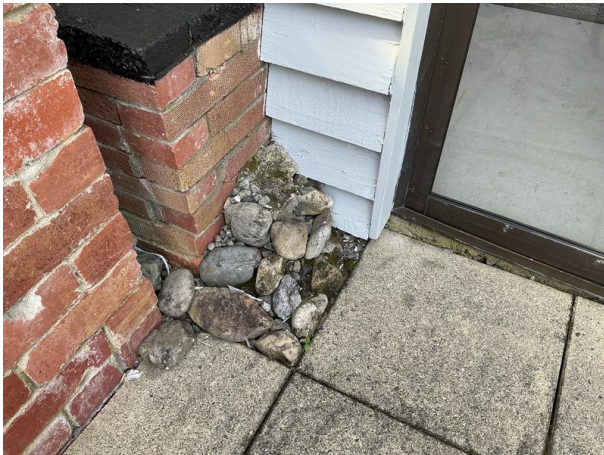
**Photo 13**  
Northside stone in contact with the weatherboard.

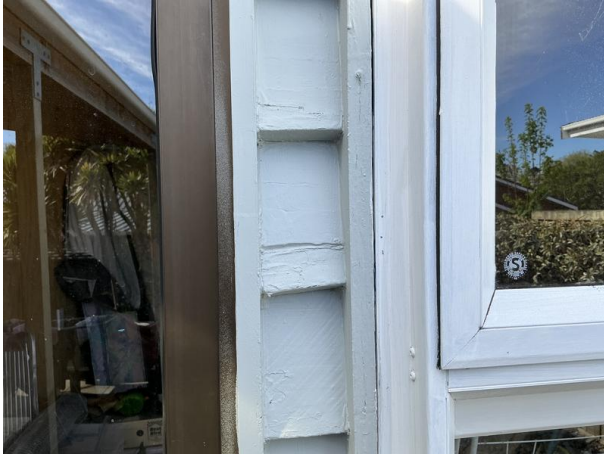
**Photo 14**  
North side split boards.

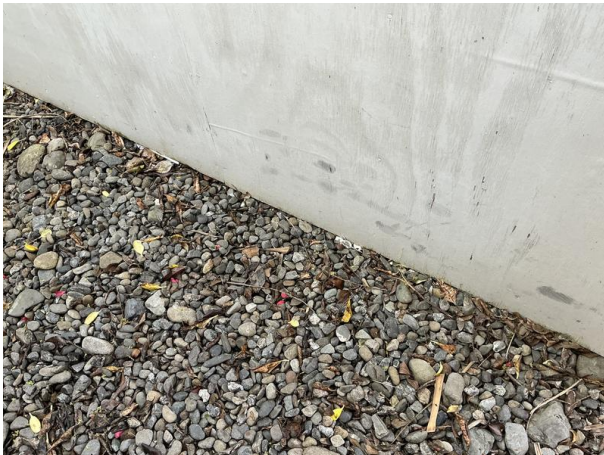
**Photo 16**  
Plywood is in contact with the ground.

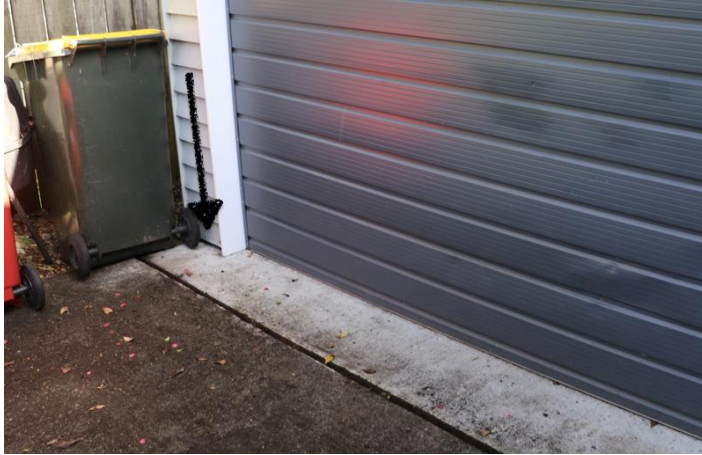
**Photo 17**

Refer to the wall framing section for moisture testing to this area.

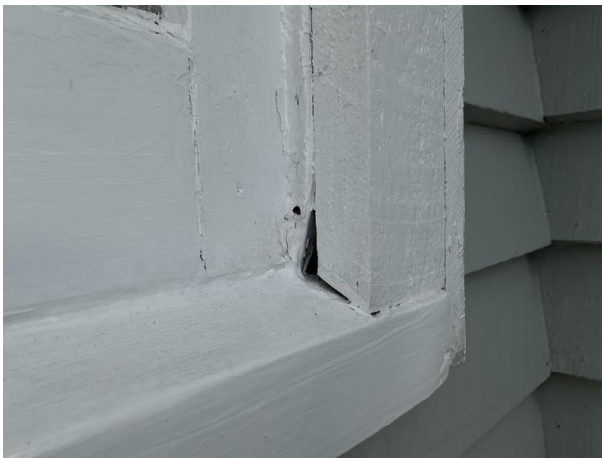
**Photo 20**  
East side hole to the side of the window.

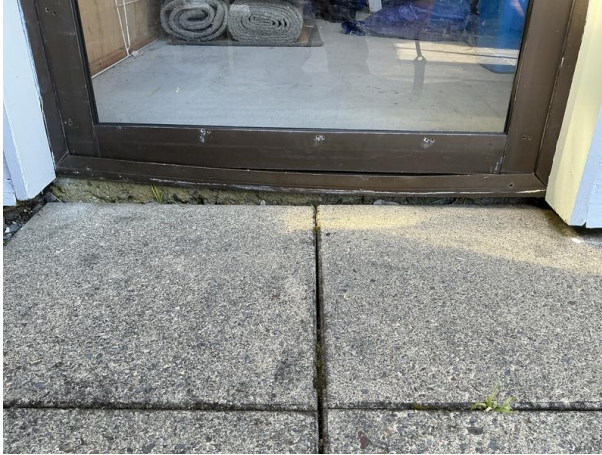
**Photo 22**

West side garage door sill is bent and not supported.

Recommend repairs to the garage north door.

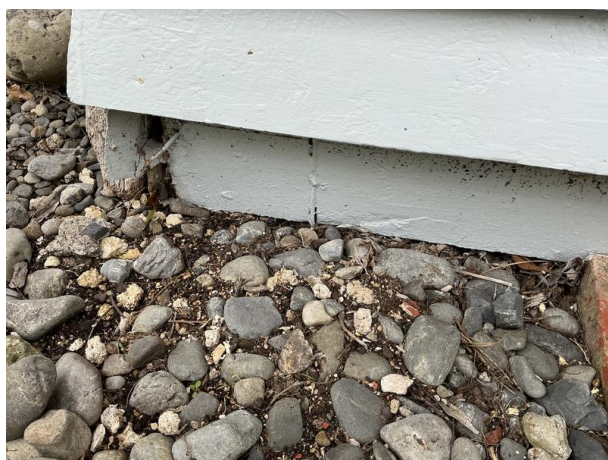
**Photo 23**

South side bearer is in contact with the ground.

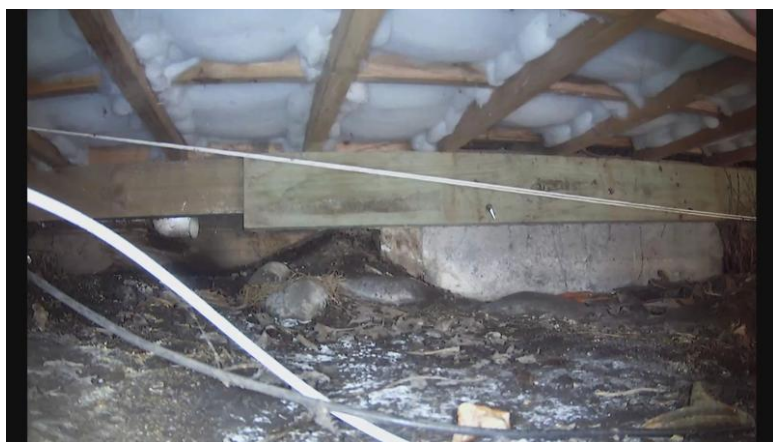
**Photo 25**

Ground condition - Damp.

Downpipe discharging under the house.  
Ground is damp in this area.  
Unsupported wires visible.

Refer to the drainage section for downpipe recommendations.

It is recommended to ensure that all downpipes are properly connected to an approved stormwater drainage system. This helps to direct rainwater away from the building's foundation, reducing the risk of water pooling, erosion, or potential moisture-related damage to the structure. Proper stormwater management also helps to comply with local regulations and maintain the overall integrity of the drainage system.

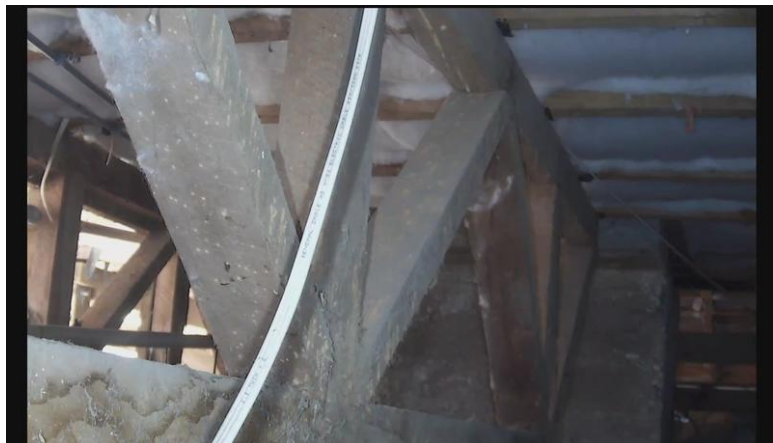
**Photo 26**

Sub-floor timbers, type and condition - Signs of borer.

Borer visible to subfloor framing.  
Unsupported wires visible.

Borer activity has been identified in the subfloor area. It is recommended that a pest control specialist conduct a thorough investigation to assess the extent of the infestation and provide appropriate treatment. Due to the limitations of this non-invasive inspection, the full extent of internal timber damage cannot be determined.

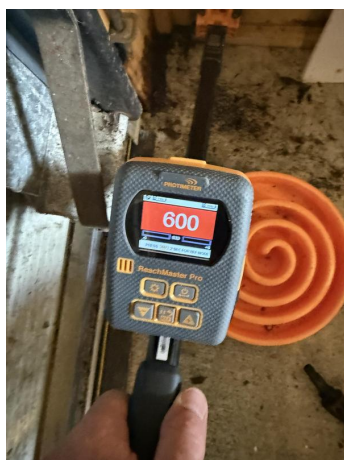
**Photo 29**

Indications of elevated moisture readings were detected to the side of the garage door.

Side of the garage door has indications of elevated moisture.

Indications of elevated moisture were detected to the side of the garage door. Recommend an LBP in carpentry reviews and advises remediation solutions.

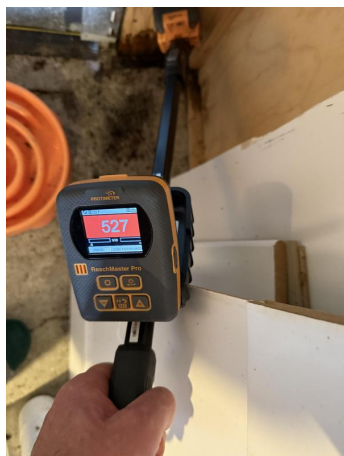
**Photo 30**

Side of the garage door has indications of elevated moisture.

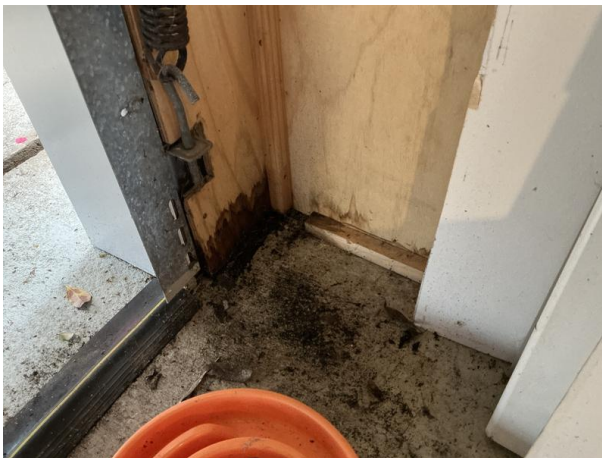
**Photo 41**  
Visible moisture to the side of the garage door, refer to the wall framing section for moisture testing.

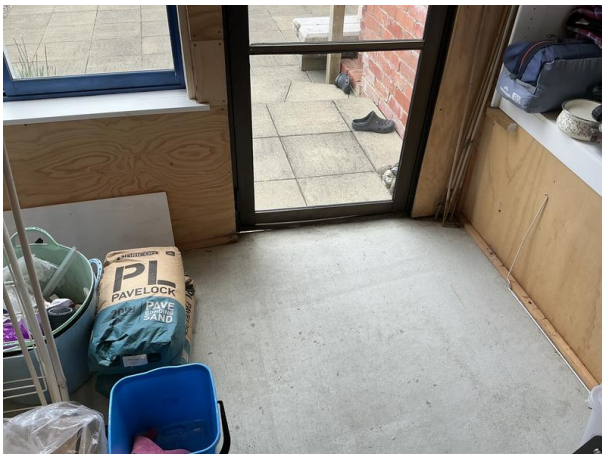
**Photo 42**  
Wall is out of alignment.

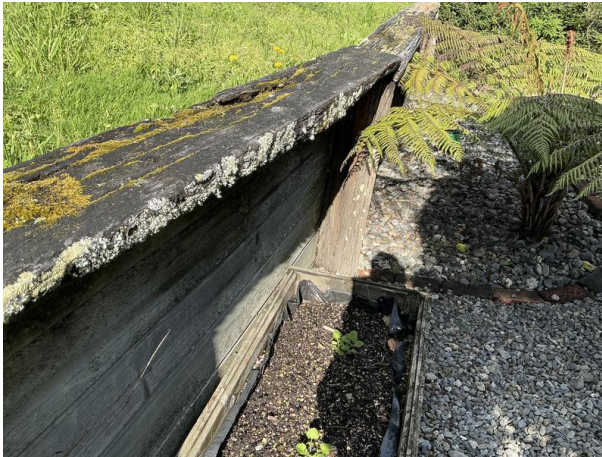
**Photo 53**

South side wall is rotated.

Future maintenance/repairs should be expected.

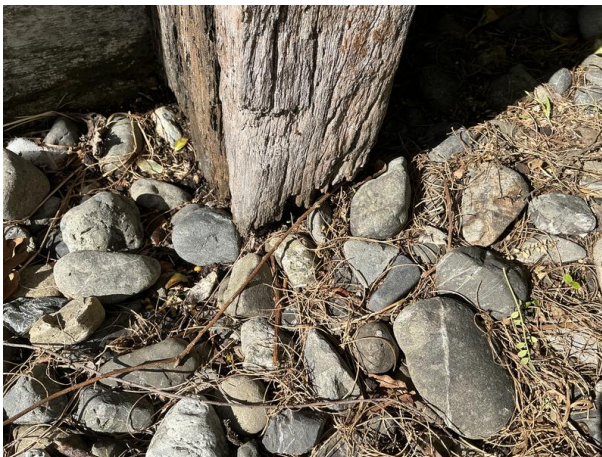
**Photo 54**

South side wall posts have rot at the ground level.

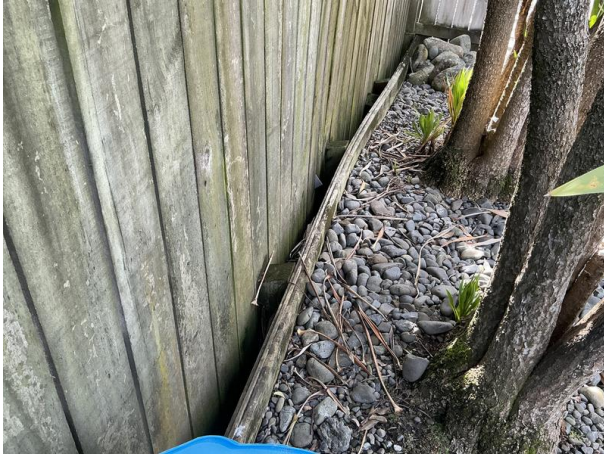
**Photo 55**  
Rotated wall on the north side, limited  
visibility.

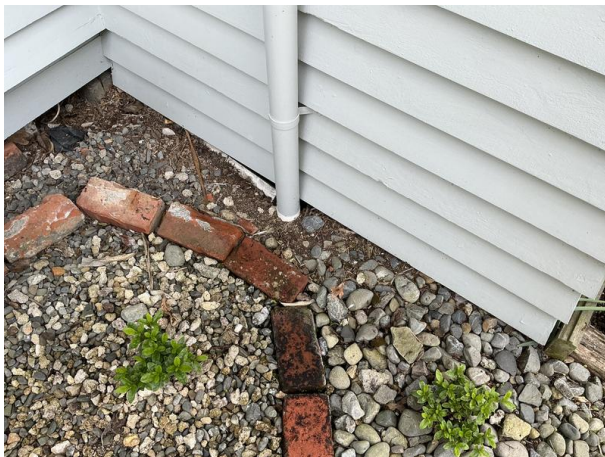
**Photo 62**  
South side downpipe connection not  
visible.

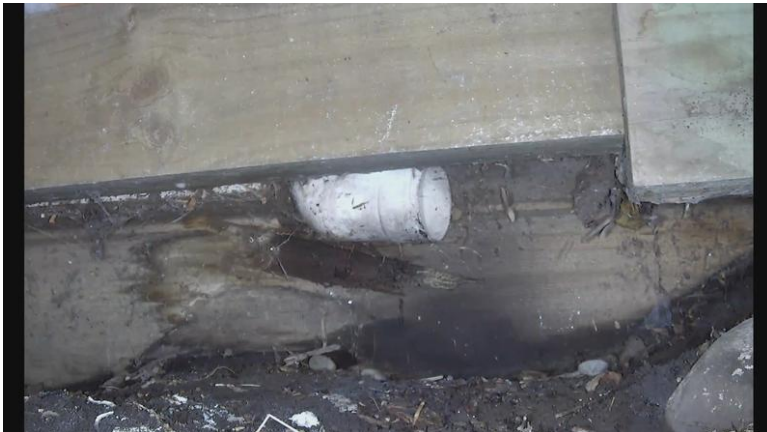
**Photo 65**  
South side downpipe discharges under the house.
