All Building Inspections Limited

Building Report

14 Allen Road
Raumati Beach

Building Consultant:	Ian Hall, NZIBI
Present for inspection:	Ian Hall / Carol Saxton
Weather at time of inspection:	Fine 29-Oct-2025
Date/s of inspection:	26-Sep-2025
Type of inspection:	Building Inspection
Name of property inspected:	14 Allen Road Raumati Beach
Report prepared for:	Carol Saxton

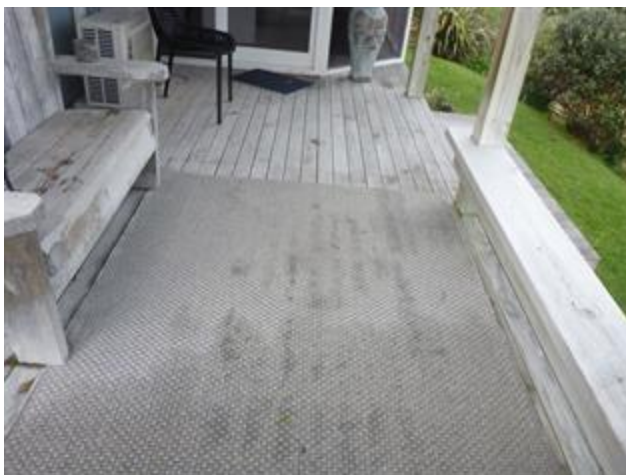
The decking is fastened to the dwelling with direct fixing through the cladding without a flashing in place. Moisture retention between the bearer and the cladding can become an issue with this construction and a flashing would direct moisture away from the cladding and bearer.

Decking direct fixed

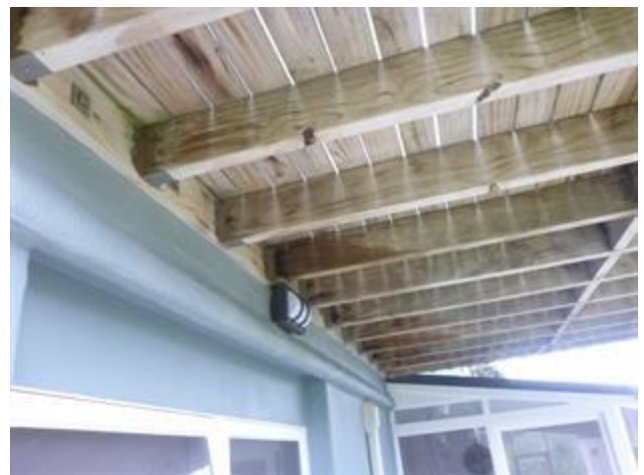
Moisture retention between the decking and the cladding can become an issue as the decking is in contact with the cladding. Creating a 12mm clearance between the two materials could be considered

Decking in contact

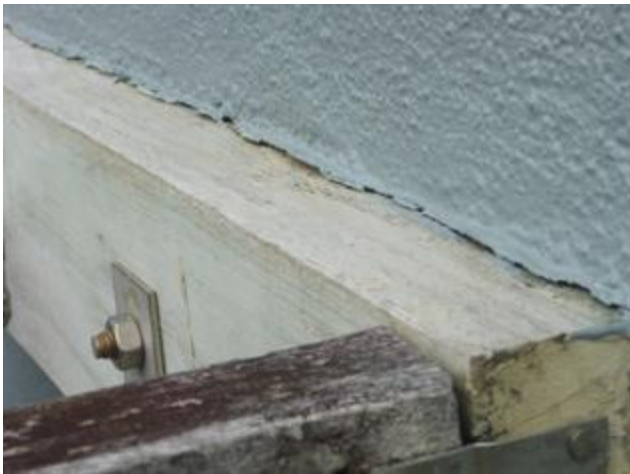
The pergola is also direct fixed through the cladding, which can allow moisture retention that can contribute to progressive damage. A gap between the cladding and the pergola is recommended.

Pergola direct fixed

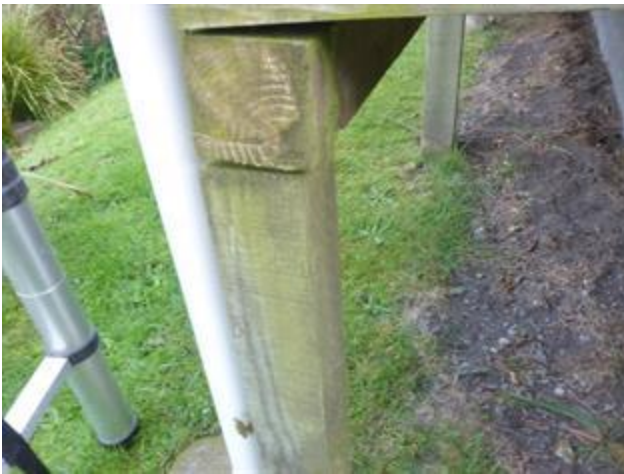
Metal ties recommended

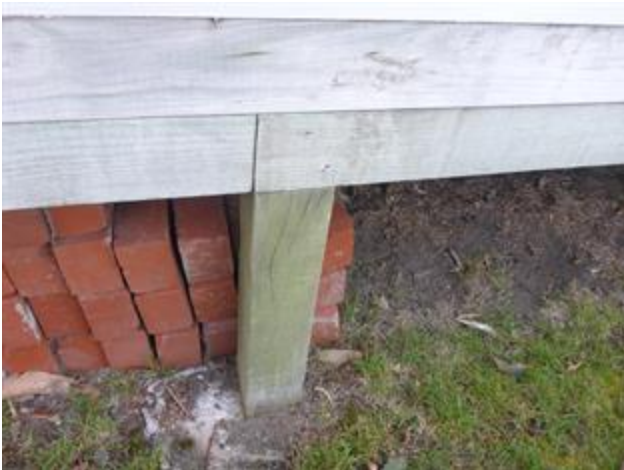
Additional fasteners are recommended with an additional support to the bearer junction to the front where the bearer is currently cantilevered.

Additional support to bearer join

***Update 29/10/25 Additional fasteners have been fitted.**

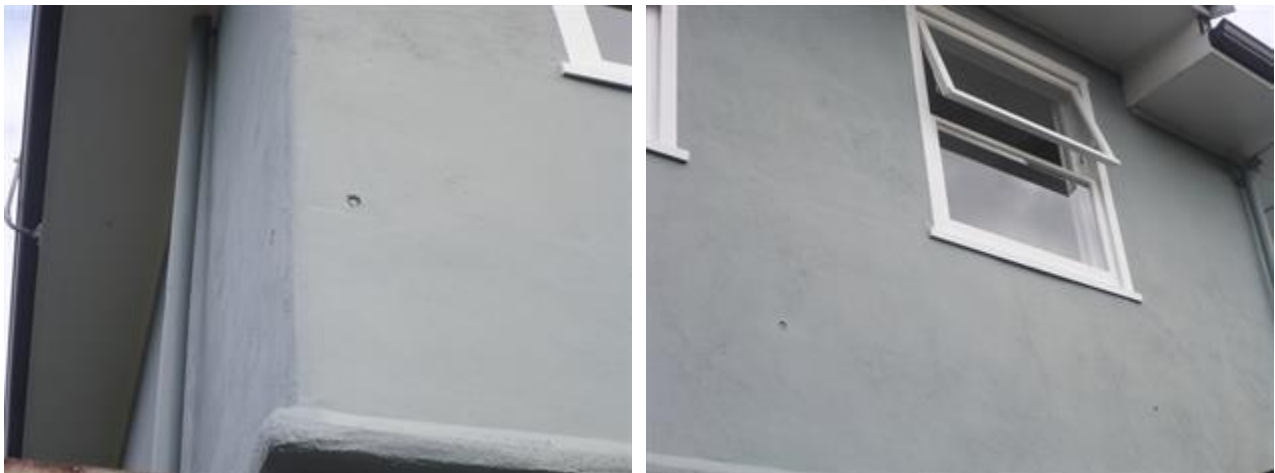
Scaffolding bolts were noted to the sides of the dwelling. These are no longer recommended due to health and safety requirements and as the bolts are a penetration that can allow moisture ingress. Sealing the penetrations is recommended after the bolts have been removed.

Scaffold bolts penetrations

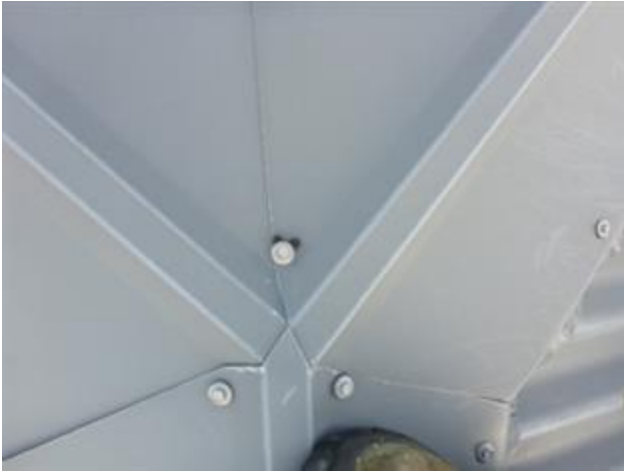
There were several overtightened screws and distorted rubber washers that require replacement as the damaged washers are unable to perform their function of preventing water ingress.

Distorted washers

I recommend that all fasteners showing signs of deterioration be replaced with compatible fasteners to prevent progressive damage. If there is oxidation to areas below the fasteners the deterioration will have to be removed before new fasteners are fitted.

***Update 29/10/25 A roofing contractor has replaced all corroded fasteners and distorted washers.**

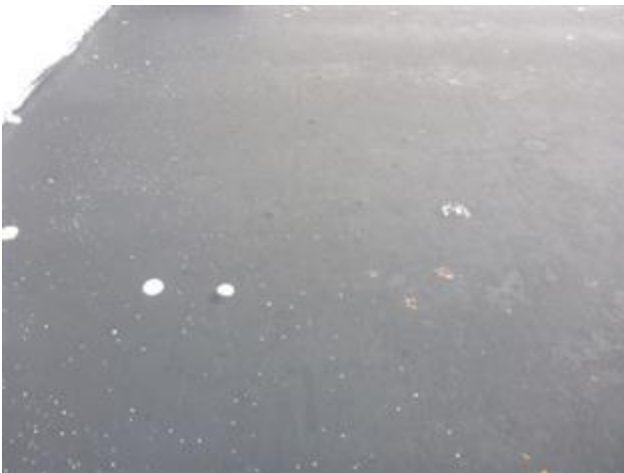
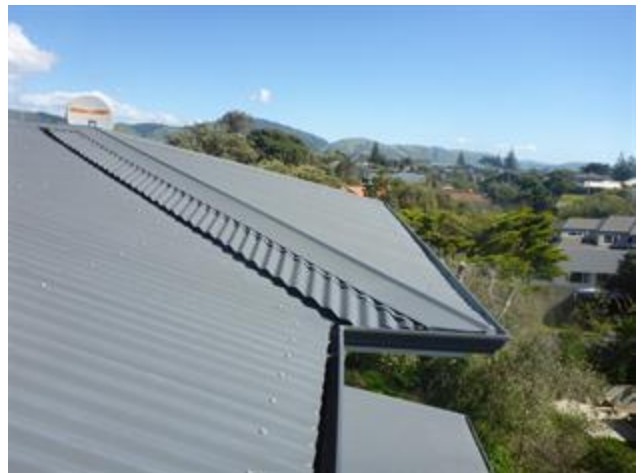
***Update 29/10/25 repairs carried out**

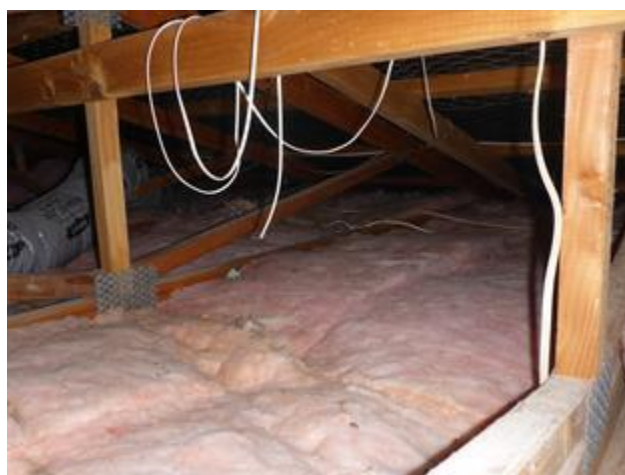
There was a small area identified in the attic space where the insulation could be fitted better. To gain maximum benefit from the insulation it needs to cover like a blanket as any gaps will cause heat loss. Filling the gaps would benefit the dwelling and the occupants.

Insulation gap

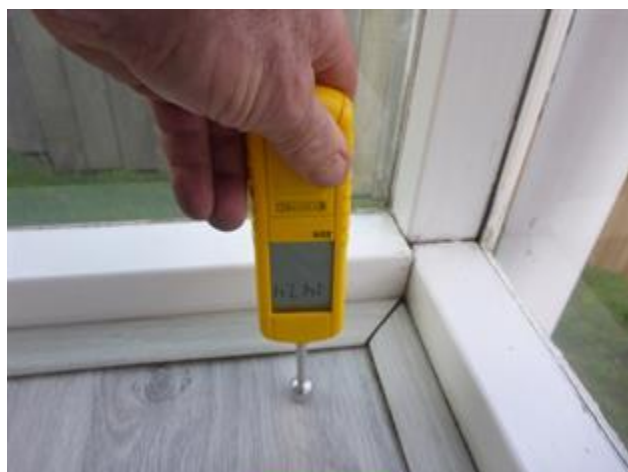
All moisture readings were within acceptable parameters except to the floor lining to the southwestern corner of the conservatory. As moisture retention can lead to decay, I recommend further invasive appraisal of the area showing high moisture levels.

High moisture levels
