# EARTHQUAKE RECOVERY (EQR) DOCUMENTATION

# EQR Property Overview Report

## Assessment of Property at 63 TAUWI CRESCENT, HEI HEI, CHRISTCHURCH 8042 on 14/03/2012

**EQC Repair works 63 Tauwi Crescent, Hei Hei**  
**Claim No: 2010/015493**

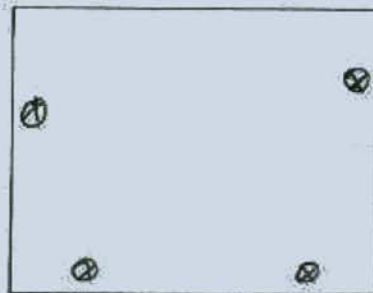
Foundation

**General Comments:** Unpainted concrete ring found, plastered .4m high. Cosmetic cracks to ring found on north face. Some repairs to ring found present on south face.

| Foundations Damage: | Timber: <u>Concrete Ring</u> Concrete Slab Other (Specify):<br>Minor Moderate Severe<br>House moved off foundations?:<br>Concrete slab cracked? Crack width: 1-2mm Crack length: 4x4 |

| Item | Event<br>Damage | Repair Strategy |
|---|---|---|
| Foundations<br><i>[Signature]</i> | Y | Grind out and epoxy fill.<br>E + S + W + N walls |
