Brian Marsh Property Inspection

17 Victoria Street
Foxton
Manawatu

Inspection Overview

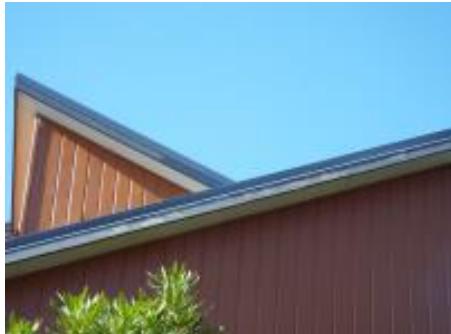
timber fascia due for painting

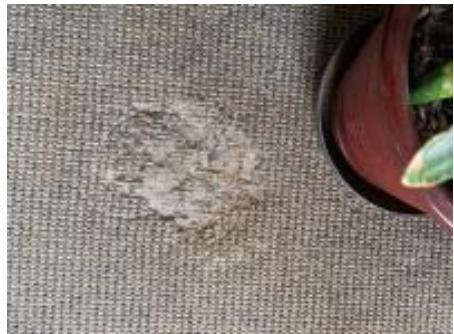
wear and tear to carpet in some areas

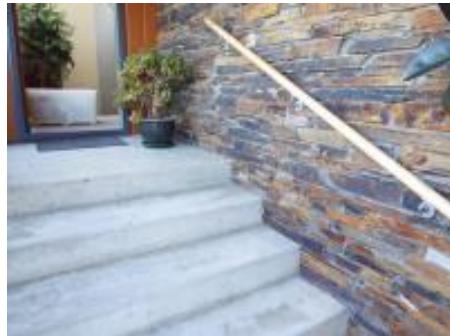
good order

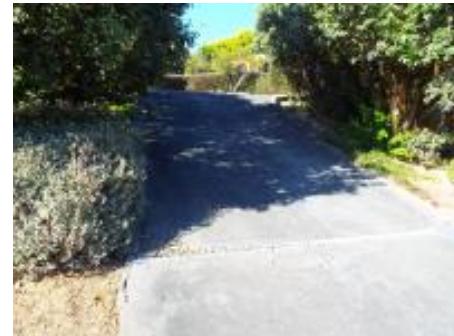
drive in good order

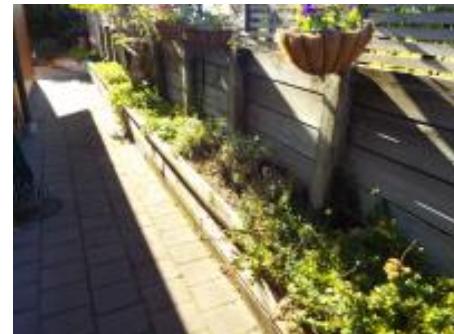
retaining wall appears fine

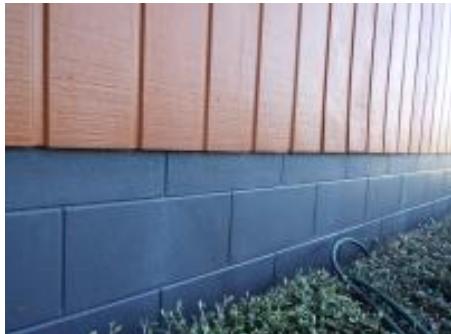
foundations in good order

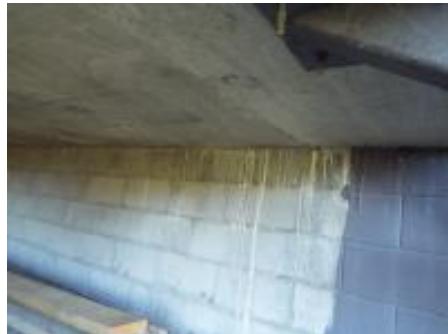
good order

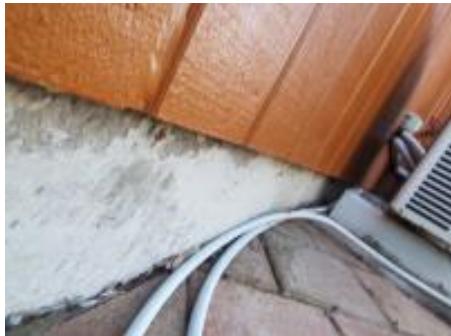
no issues

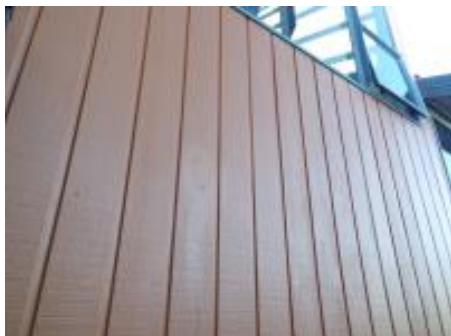
exterior appears well painted

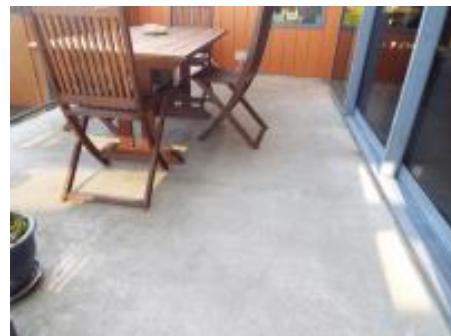
balcony in good order

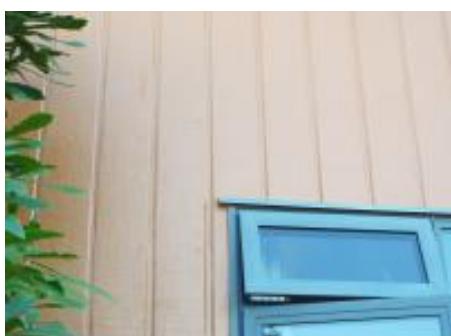
good flashing detail

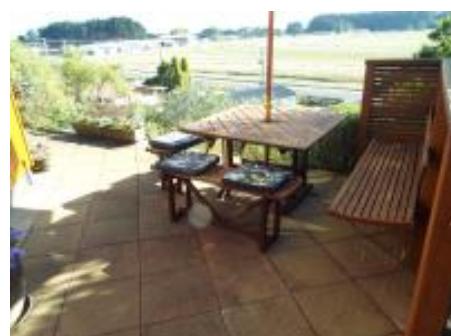
pavers in good order

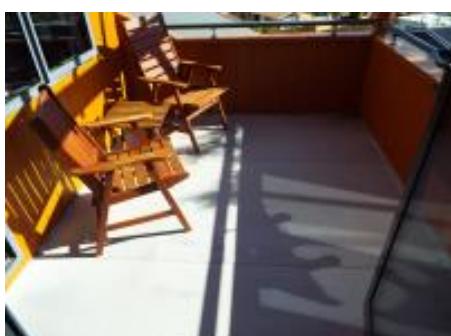
butynol balcony appears in good order

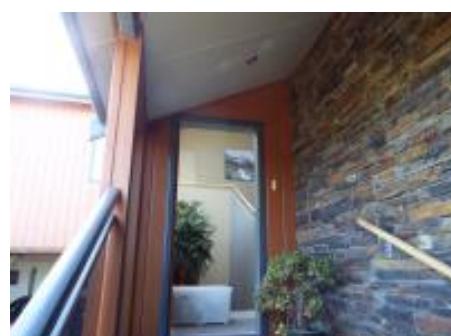
joinery in good working order

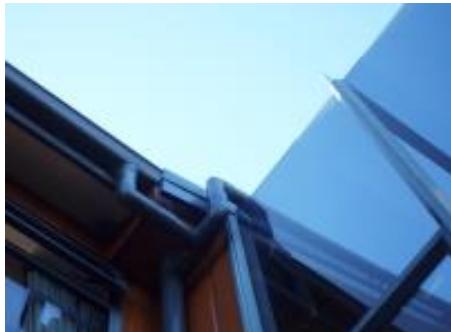
no issues

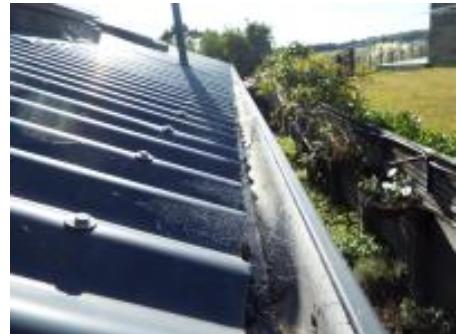
gutters clean at the time of inspection

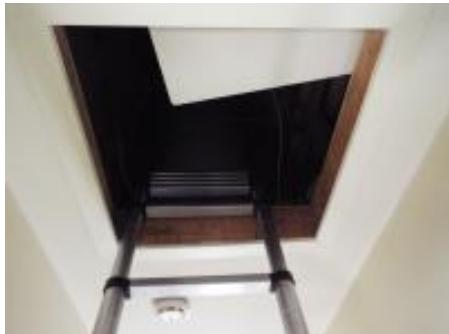
good access

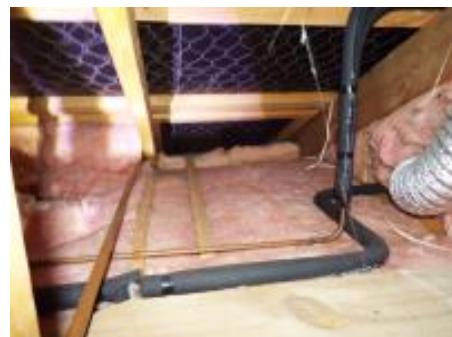
no issues with the plumbing at the time of inspection

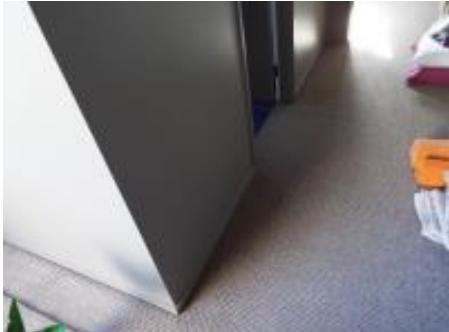
floor coverings in good order

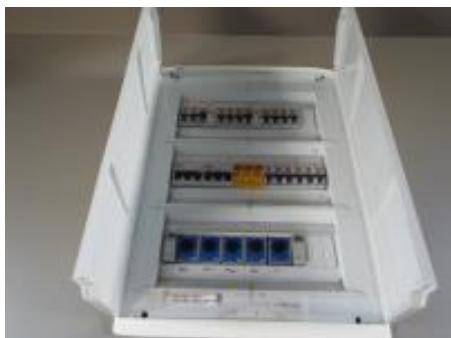
good order

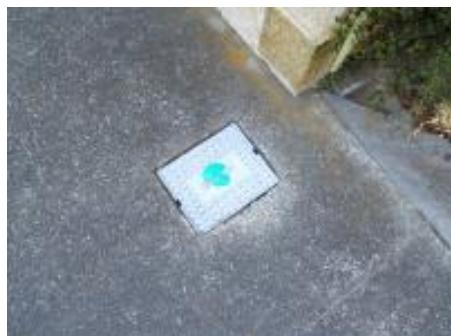
toby in front of the property

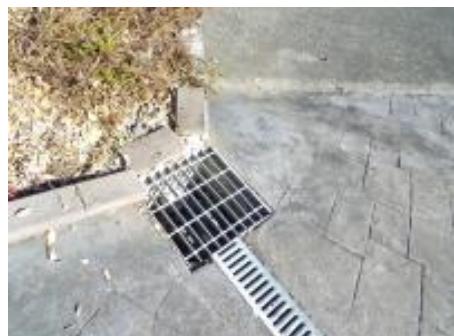
drains clean at the time of inspection

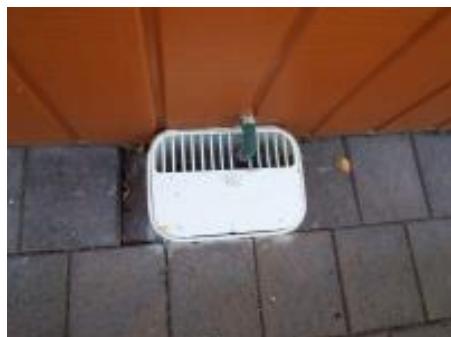
all clean

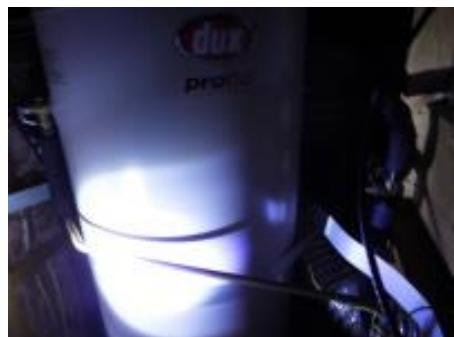
cylinder appears in good order

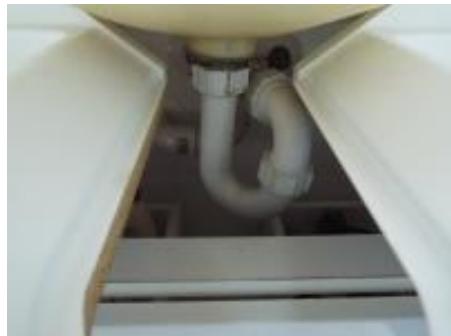
no issues with the plumbing at the time of inspection

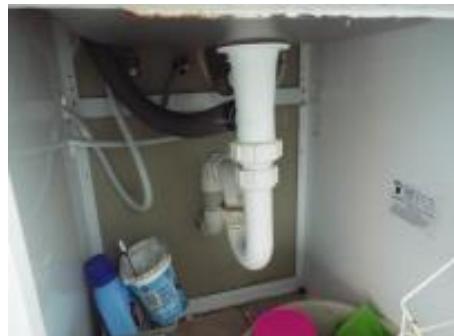
no issues

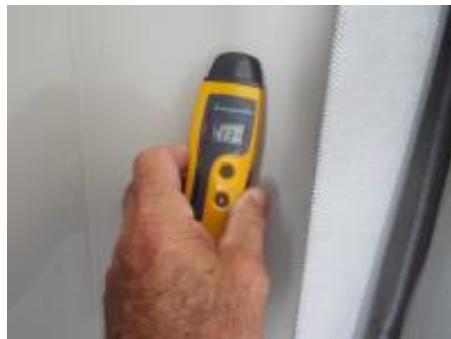
13.9%

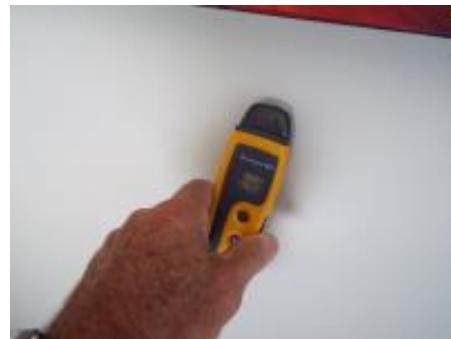
14%

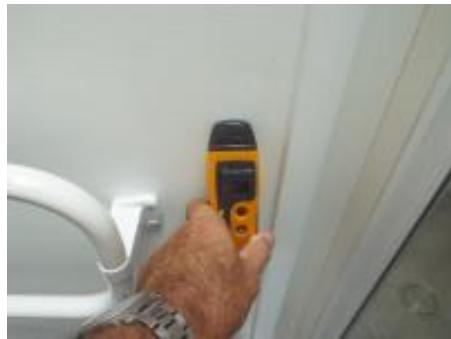
13.8%

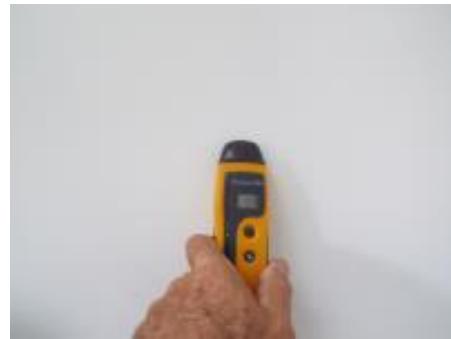
13.9%

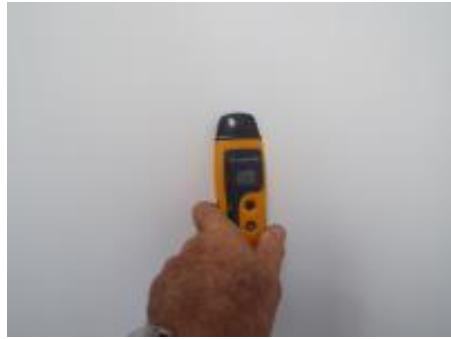
13%

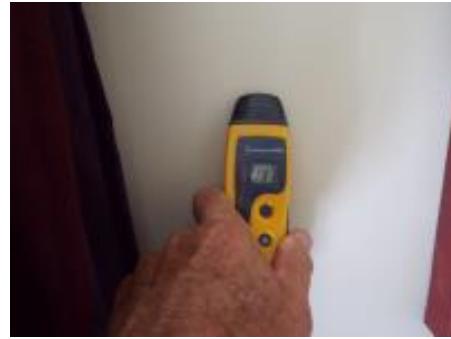
13.3%
