## BUILDING INSPECTION REPORT

## RED LBP PRE-PURCHASE REPORT

**Company:** JBC Builders Limited Ltd trading as RedLBP Christchurch North  
**Client:** Simon McSherry  
**Date of Inspection:** 27th October 2025  
**Site Address:** 10 Sophora Place, Parklands, Christchurch 8083  
**Inspector:** Jamie Chapman  
**Qualifications:** National Certificate in Carpentry

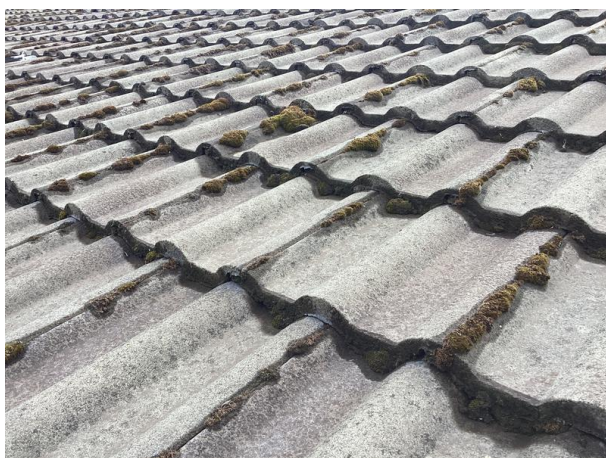
**Photo 4**

Surface fading and signs of moss, mould or lichen were visible on the roof system.

Due to the amount of cracked and chipped Masonry tiles noticed around the roof system, as well as the surface fading and moss, mould, or lichen visible, it is recommended to have a licensed roofer advise further on the roof system.

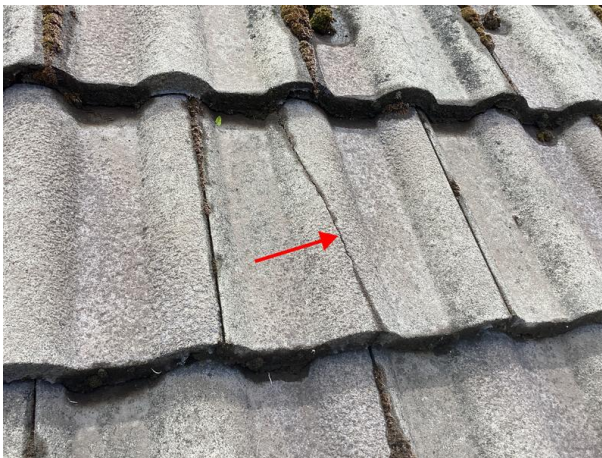
**Photo 6**

A couple cracked masonry tiles were also noticed in a couple locations.

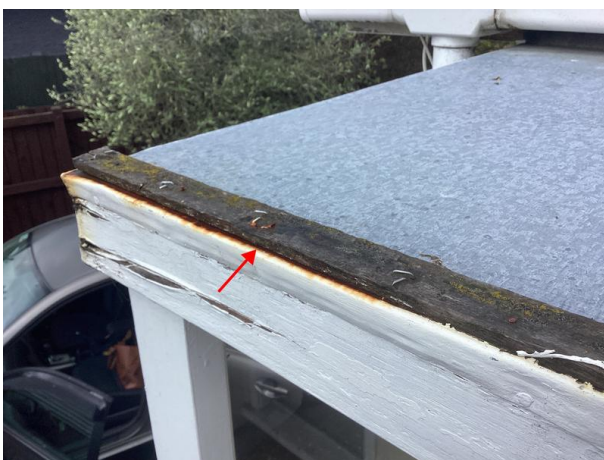
**Photo 9**

Corrosion was visible under this timber located on the flat metal roof above the back entrance.

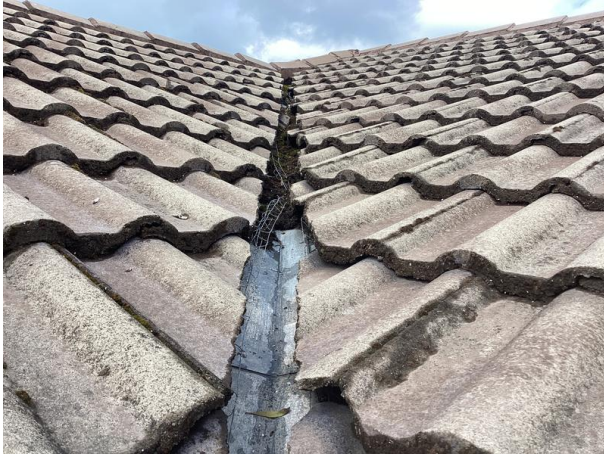
**Photo 10**

Dirt and debris was visible inside the north side metal valleys. Keep the valleys clean and clear for sufficient water flow.

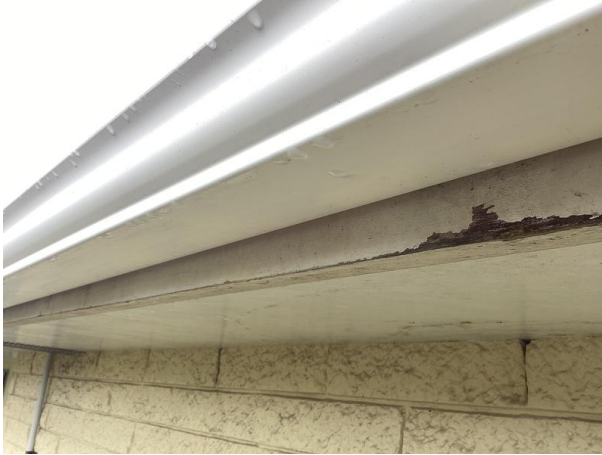
**Photo 12**

Paint flaking and ageing was noticed on the timber fascia and barge boards. Due for maintenance.

There are areas of the timber fascia and barge that require sanding back any loose flakey paint, apply a sealer coat then redecoration to prevent further deterioration. Some sections may require replacing above the back entrance.

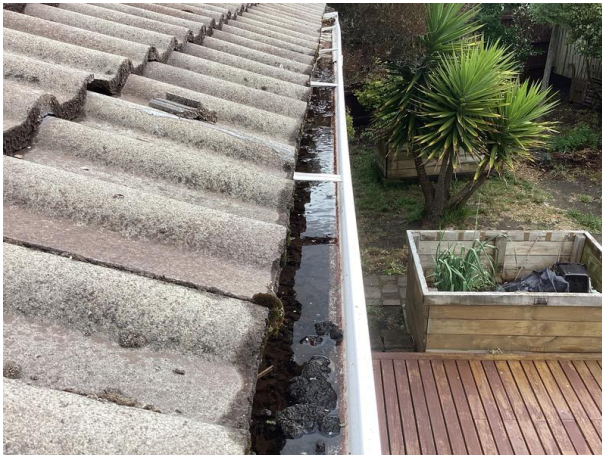
**Photo 14**

Water ponding in the north side gutter system is visible. Recommend cleaning this gutter of debris to check for water flow.

The guttering system has areas where water is ponding. Ponding water can lead to premature wear, corrosion, and potential overflow during heavy rainfall, increasing the risk of water damage to the property.

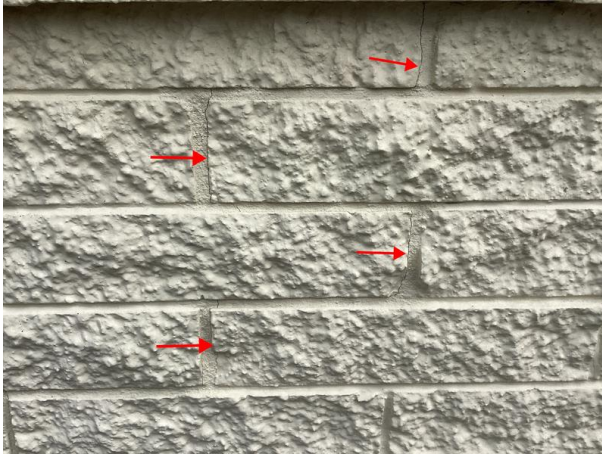
**Photo 18**

Minor mortar step cracking is visible on the East and West side of the dwelling.

Regular inspection and maintenance of the brickwork are essential to preserve durability and weathertightness. Repoint or repair areas where mortar joints have deteriorated or eroded to prevent moisture ingress. Remove any organic growth, moss, or lichen from the brick surfaces using a suitable cleaning method to prevent ongoing decay. Ensure all flashings, control joints, and sealants at junctions and penetrations are intact and maintained. Repainting or sealing should only be undertaken with vapour-permeable coatings appropriate for masonry construction to allow the wall to breathe and minimise the risk of trapped moisture.

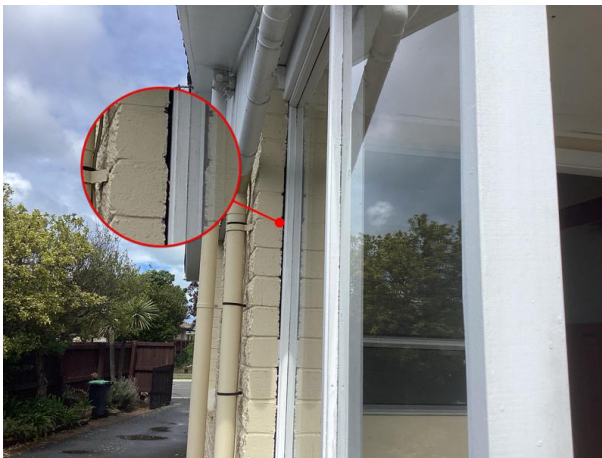
**Photo 19**

It is recommended to seal this junction on the North/East corner of the dwelling as some gaps were noticed.

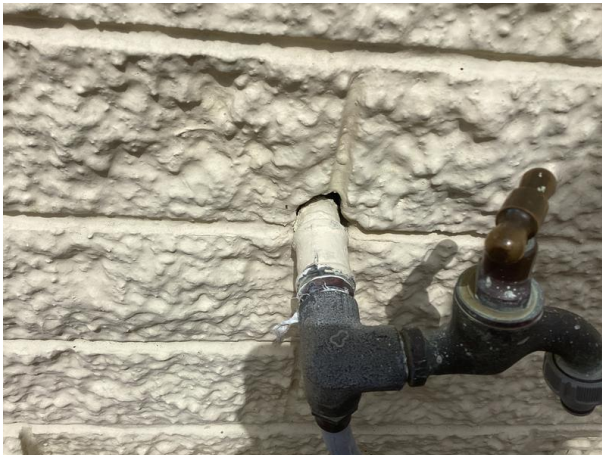
**Photo 20**

There were a couple unsealed penetration holes noticed around the dwelling. It is recommended to seal these.

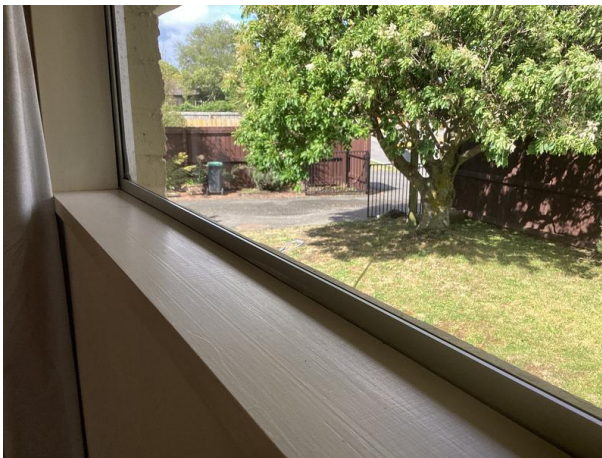
**Photo 30**

Due to the age in style of these windows, no condensation channel or weep holes are installed. It's important to keep moisture to a minimum and the reveals well maintained.

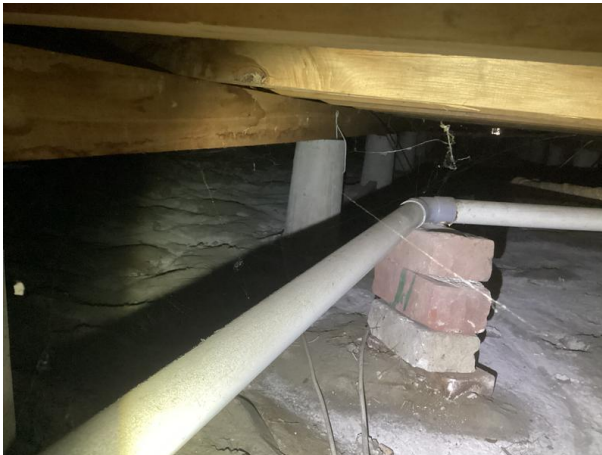
**Photo 36**

It is recommended to sufficiently support this waste pipe located near the manhole so it is not relying on these bricks.

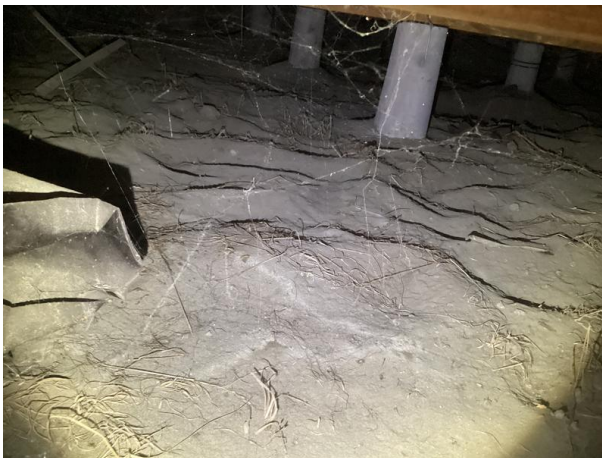
**Photo 38**

Future maintenance could include installing a ground moisture barrier in the subfloor.

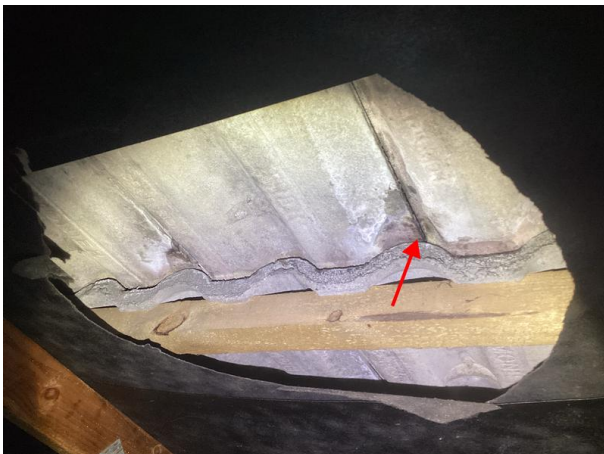
**Photo 42**

With signs of moisture staining noticed on the bottom of the masonry tiles.

As detailed in the photos below and in the roof system section of this report, masonry tile cracking and chipping was noticed around the roof system. When viewed inside the roof space, signs of moisture staining was noticed in a couple locations. It is recommended to have a licensed roofer to inspect and advise further.

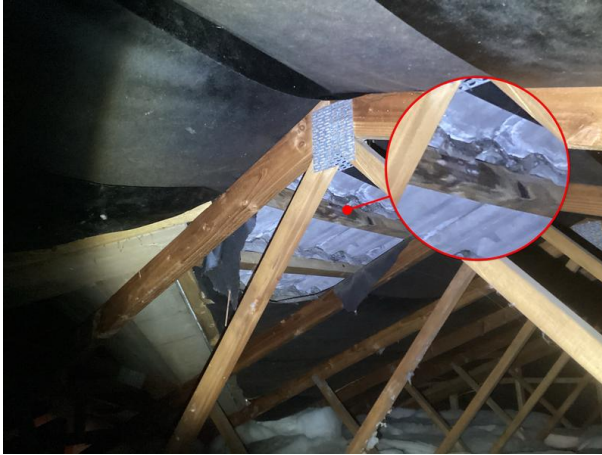
**Photo 43**

Moisture staining was also noticed on the timber purlins. Refer back to the recommendations for more information.

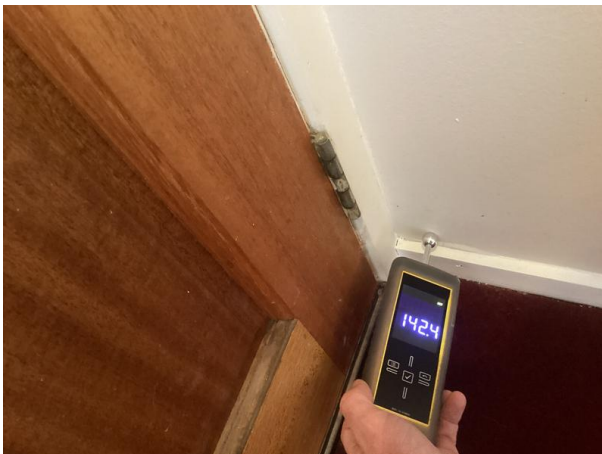
**Photo 49**

With indications of elevated moisture detected beside the entrance door and either side of the shower enclosure. This is detailed further within this report.

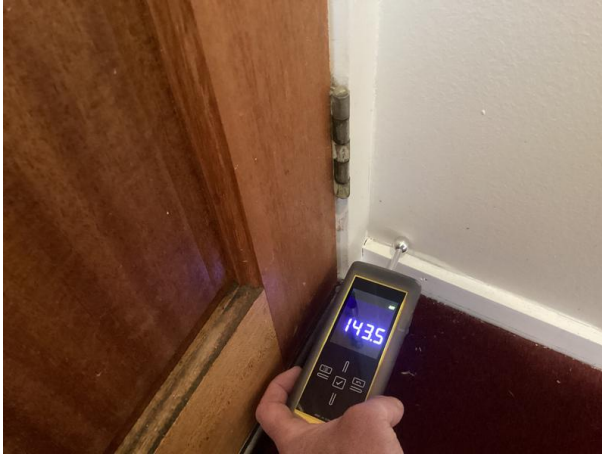
**Photo 51**

Indications of elevated moisture were detected on the right hand side of the entrance door.

As detailed in the photos below, indications of elevated moisture and thermal abnormalities were discovered on the right-hand side of the entrance door. Moisture testing and thermal imaging were done on the other side of this wall in the bedroom, one wardrobe, with no visible issues identified during the inspection. It is likely that driven rain or cold, damp air may be getting through the entrance door and the reveal junction. It is recommended to have a qualified builder advise further.

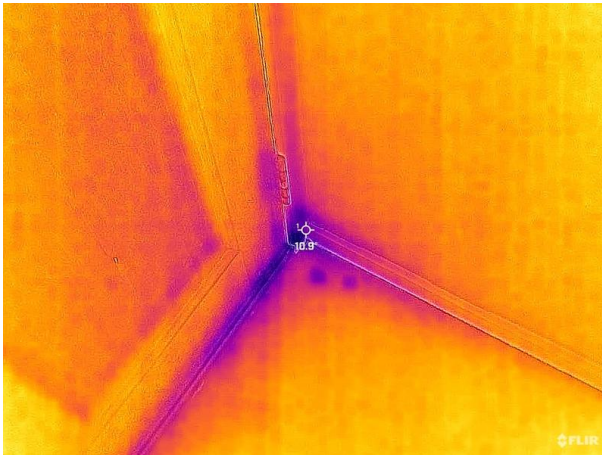
**Photo 53**

Thermal imaging was done during the inspection with thermal abnormalities discovered beside the entrance door.

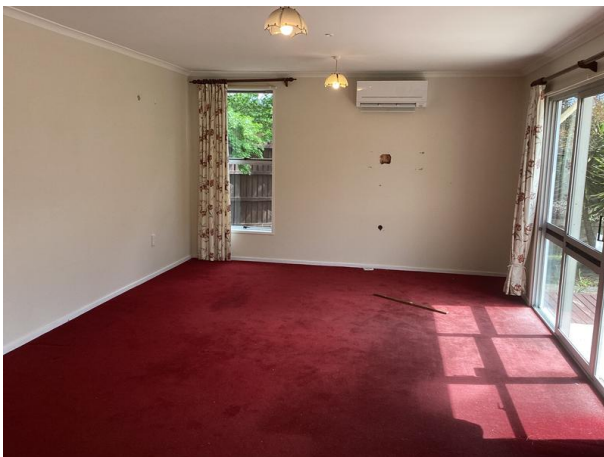
**Photo 55**  
Living room, wall damaged/holes were visible in the living room.

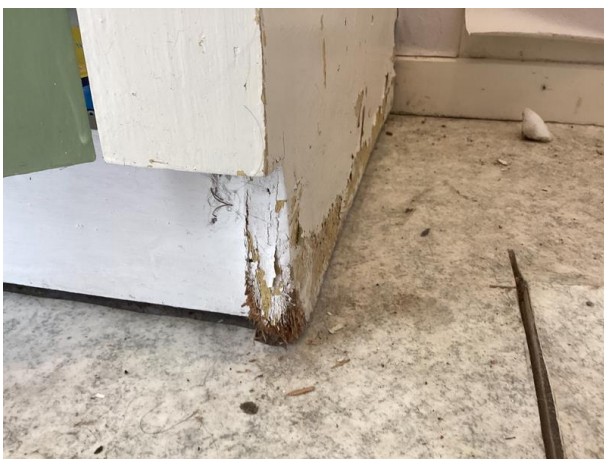
**Photo 58**  
Swollen cabinetry was visible at the bottom of the laundry cabinet. Likely due to normal laundry use as no elevated moisture readings were detected at the time of the inspection.

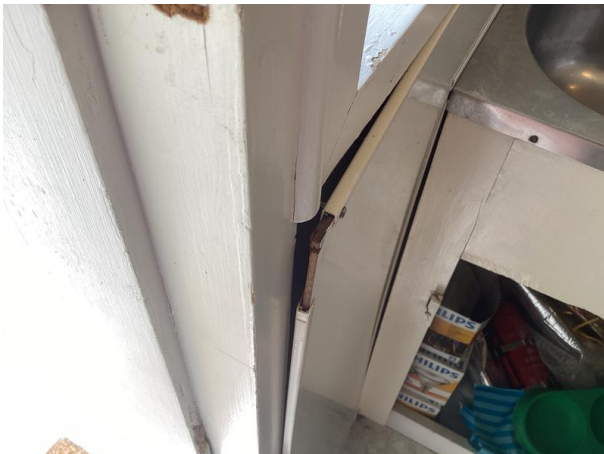
**Photo 59**

Areas of the wet lining sheeting were detaching.

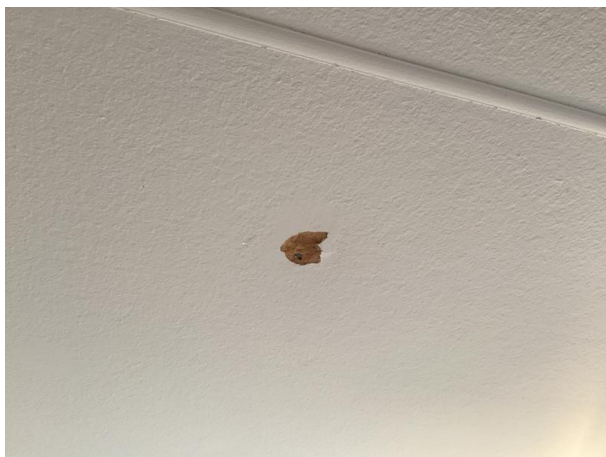
**Photo 63**

A popped ceiling fixing was visible in bedroom 3.

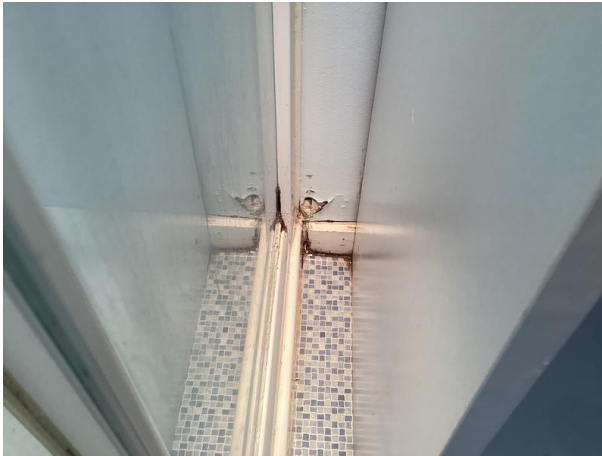
**Photo 65**  
Moisture damage was visible either side of the shower.

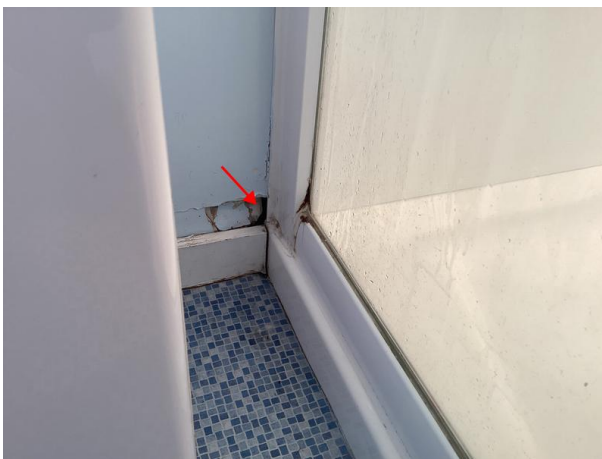
**Photo 66**  
When testing the shower for visible leaks, water was noticed coming out of this junction beside the shower enclosure.

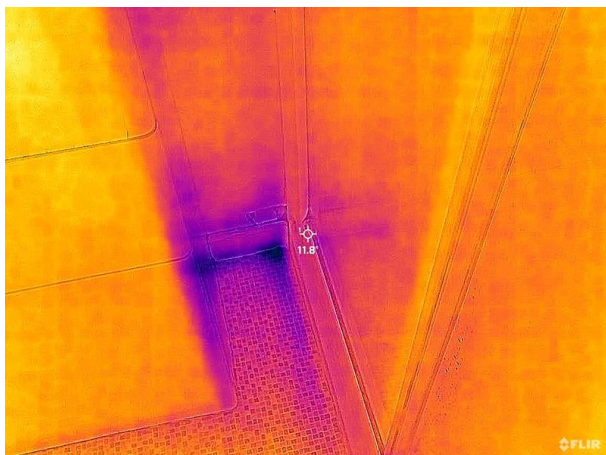
**Photo 67**

Thermal abnormalities were discovered beside the shower enclosure.

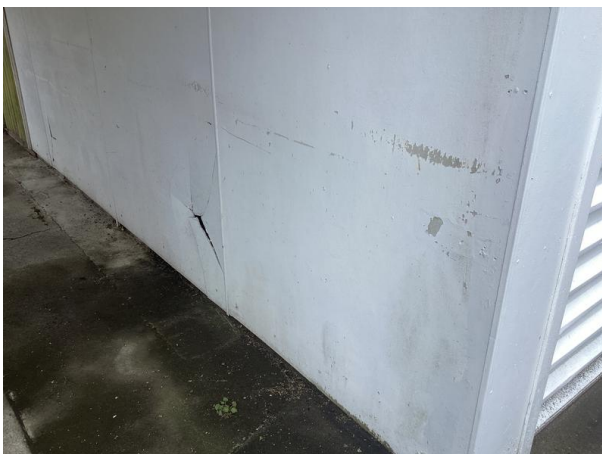
**Photo 69**  
Fibre cement sheet damage and defects were noticed around the garage.

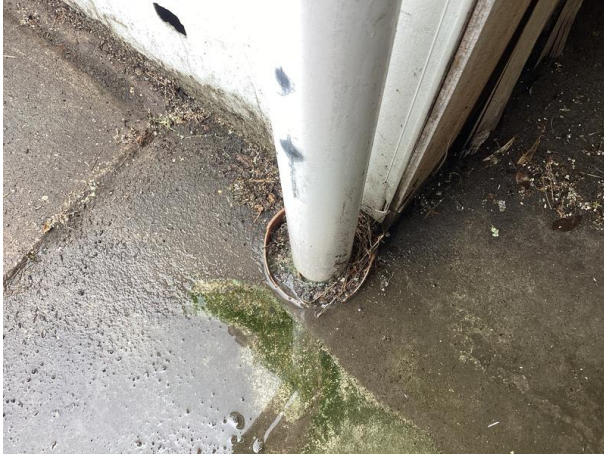
**Photo 70**

It is recommended to clear the stormwater riser as it appears to be blocked.

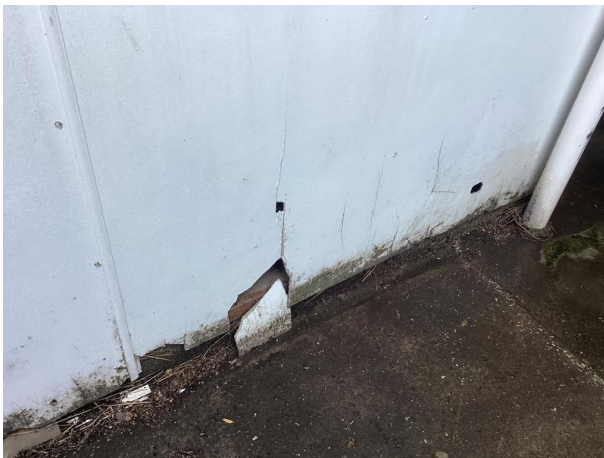
**Photo 71**

Example of the visible fibre cement sheet damage.

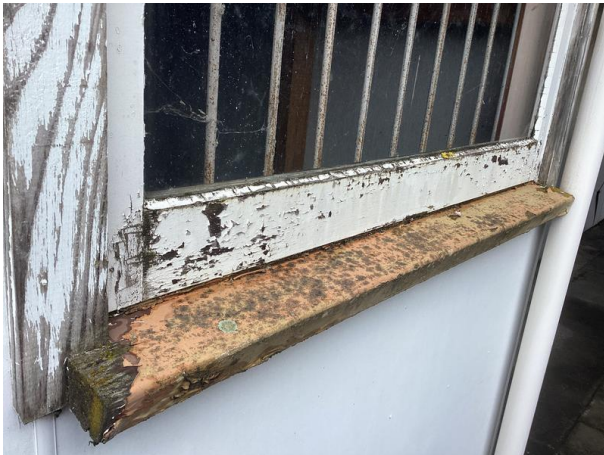
**Photo 72**

The garage window joinery is overdue for maintenance and repairs.

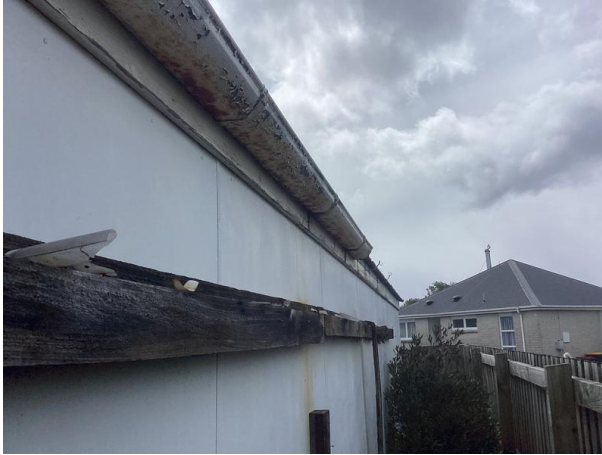
**Photo 73**

Corrosion and missing gutters were noticed on the east side of the garage.

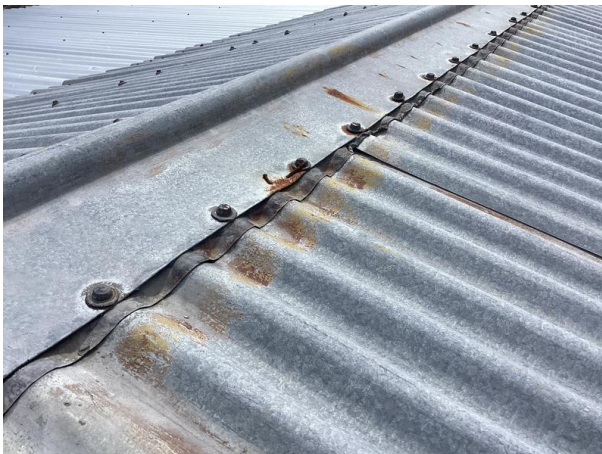
**Photo 75**

Areas of corrosion were visible on the garage roof system.

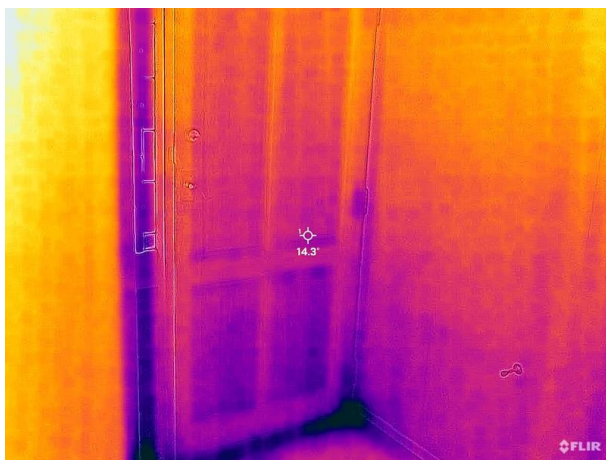
**Photo 77**

Entrance. As detailed in the entrance section of this report, thermal abnormalities were discovered below and beside the entrance door.

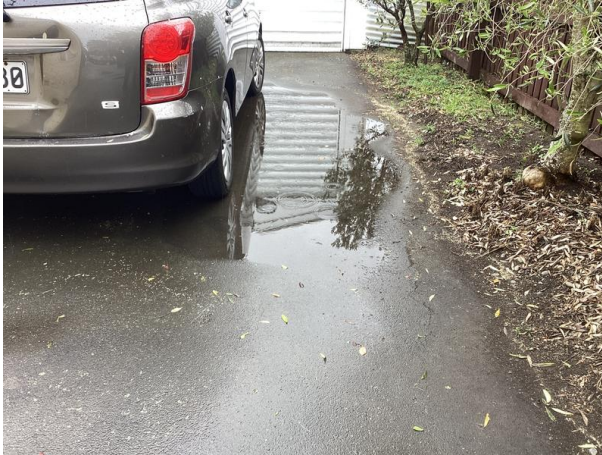
### Photo 86

Asphalt driveway, water ponding was noticed near the garage indicating inadequate falls.

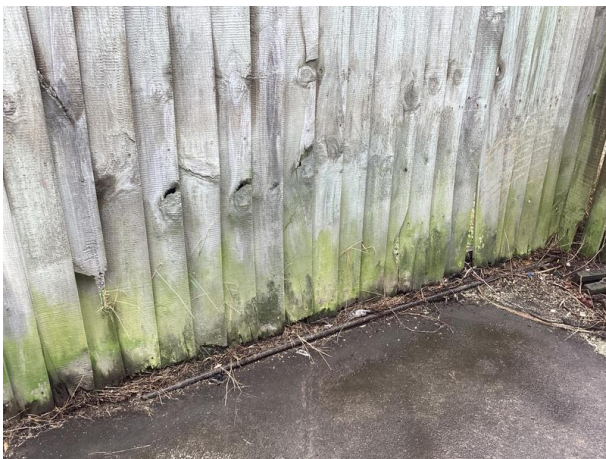
**Photo 87**

A few broken and loose timber palings were noticed on the north side fence.

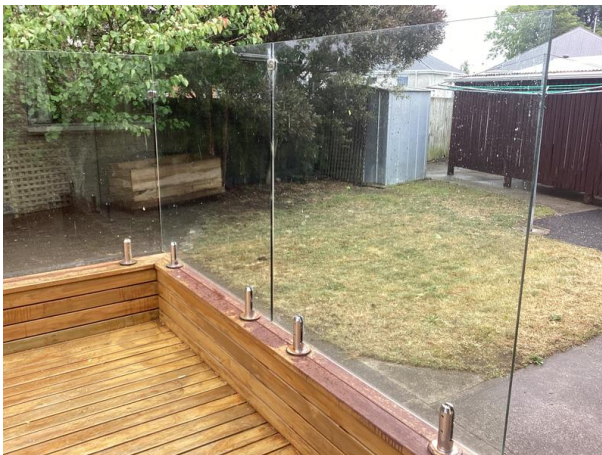
**Photo 90**

The glass panels were relatively secure however, did wobble.

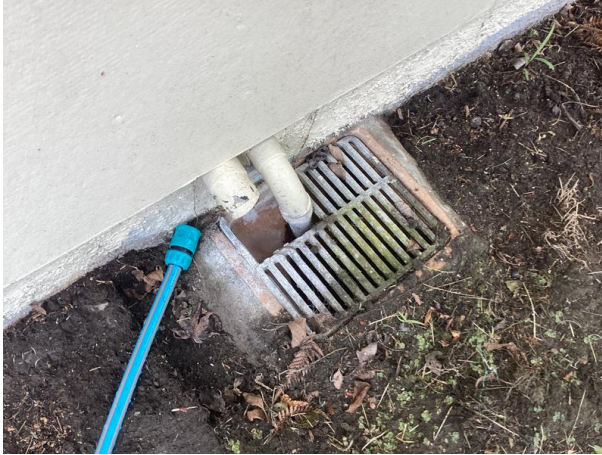
**Photo 95**

Surface water needs to be prevented from flowing into a trap by ensuring that the rim of the gully dish is at least: 25 mm higher than a paved surface and/or 75 mm higher than an unpaved surface. As per G13 AS2

South side gully trap. Refer back to the recommendations regarding gully trap heights.

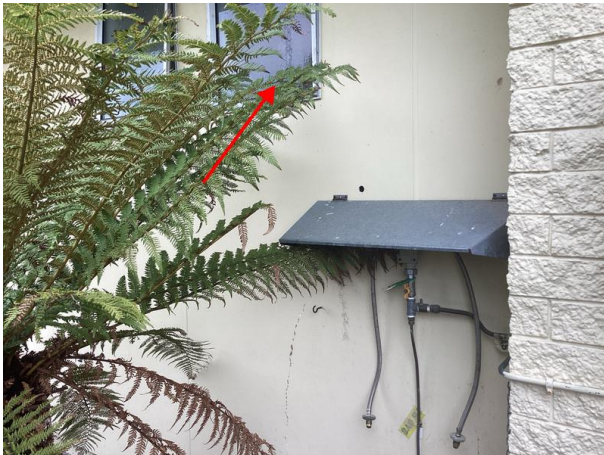
**Photo 100**  
The gas bottle station has been installed within close proximity to an opening window. Recommend having a certified gas installer to advise on this, and its compliance.

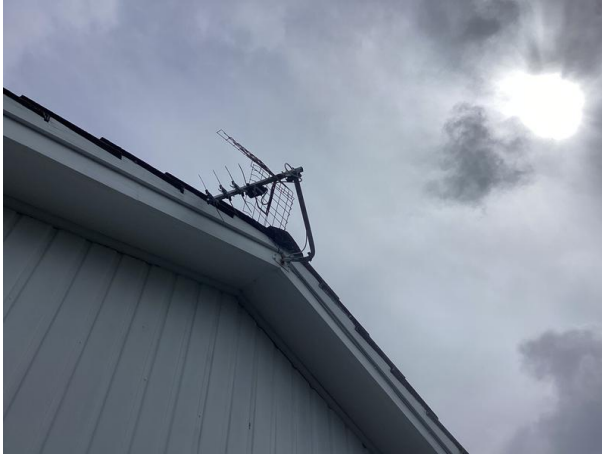
**Photo 103**

The east side antenna has corroded and folded over.
