RESIDENTIAL HOUSE INSPECTION COPY

37 Sugden St
Christchurch, Canterbury Region 8024

23/10/2025

Inspector
Aaron Krahagen
Kiwi House Inspections
[+64275522004](tel:+64275522004)
aaron@kiwiinspections.nz

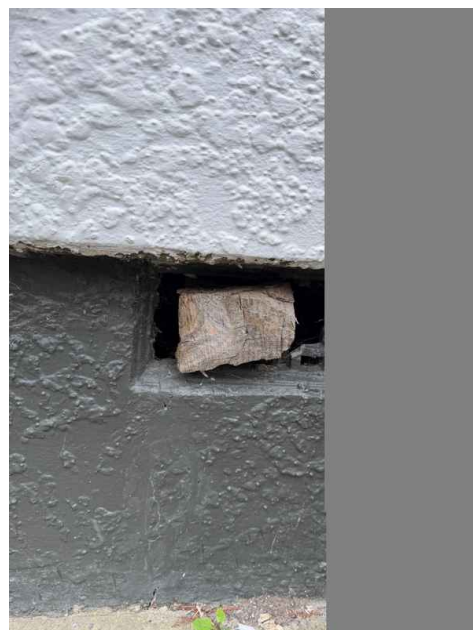
4.1.1 Foundation

VENT MISSING AND OR DAMAGED

A foundation vent is missing or damaged, it is recommended that this is replaced to prevent animals and vermin entering the subfloor space.

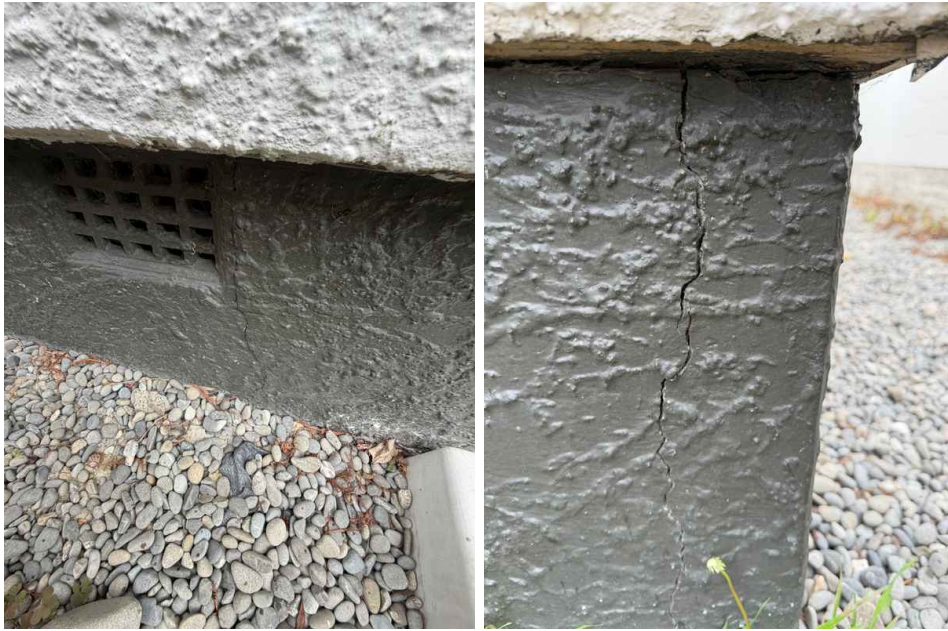
4.1.2 Foundation

CRACKS TO RING FOUNDATION OBSERVED

Cracking to the ring foundation observed.

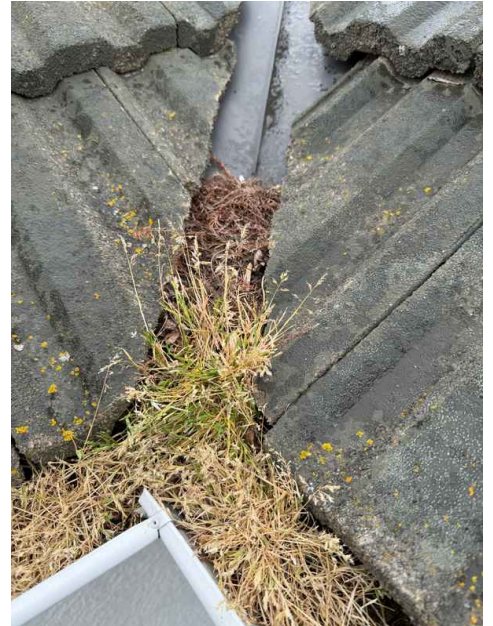
GUTTER DEBRIS

It is recommended that the spouting is cleared of debris.

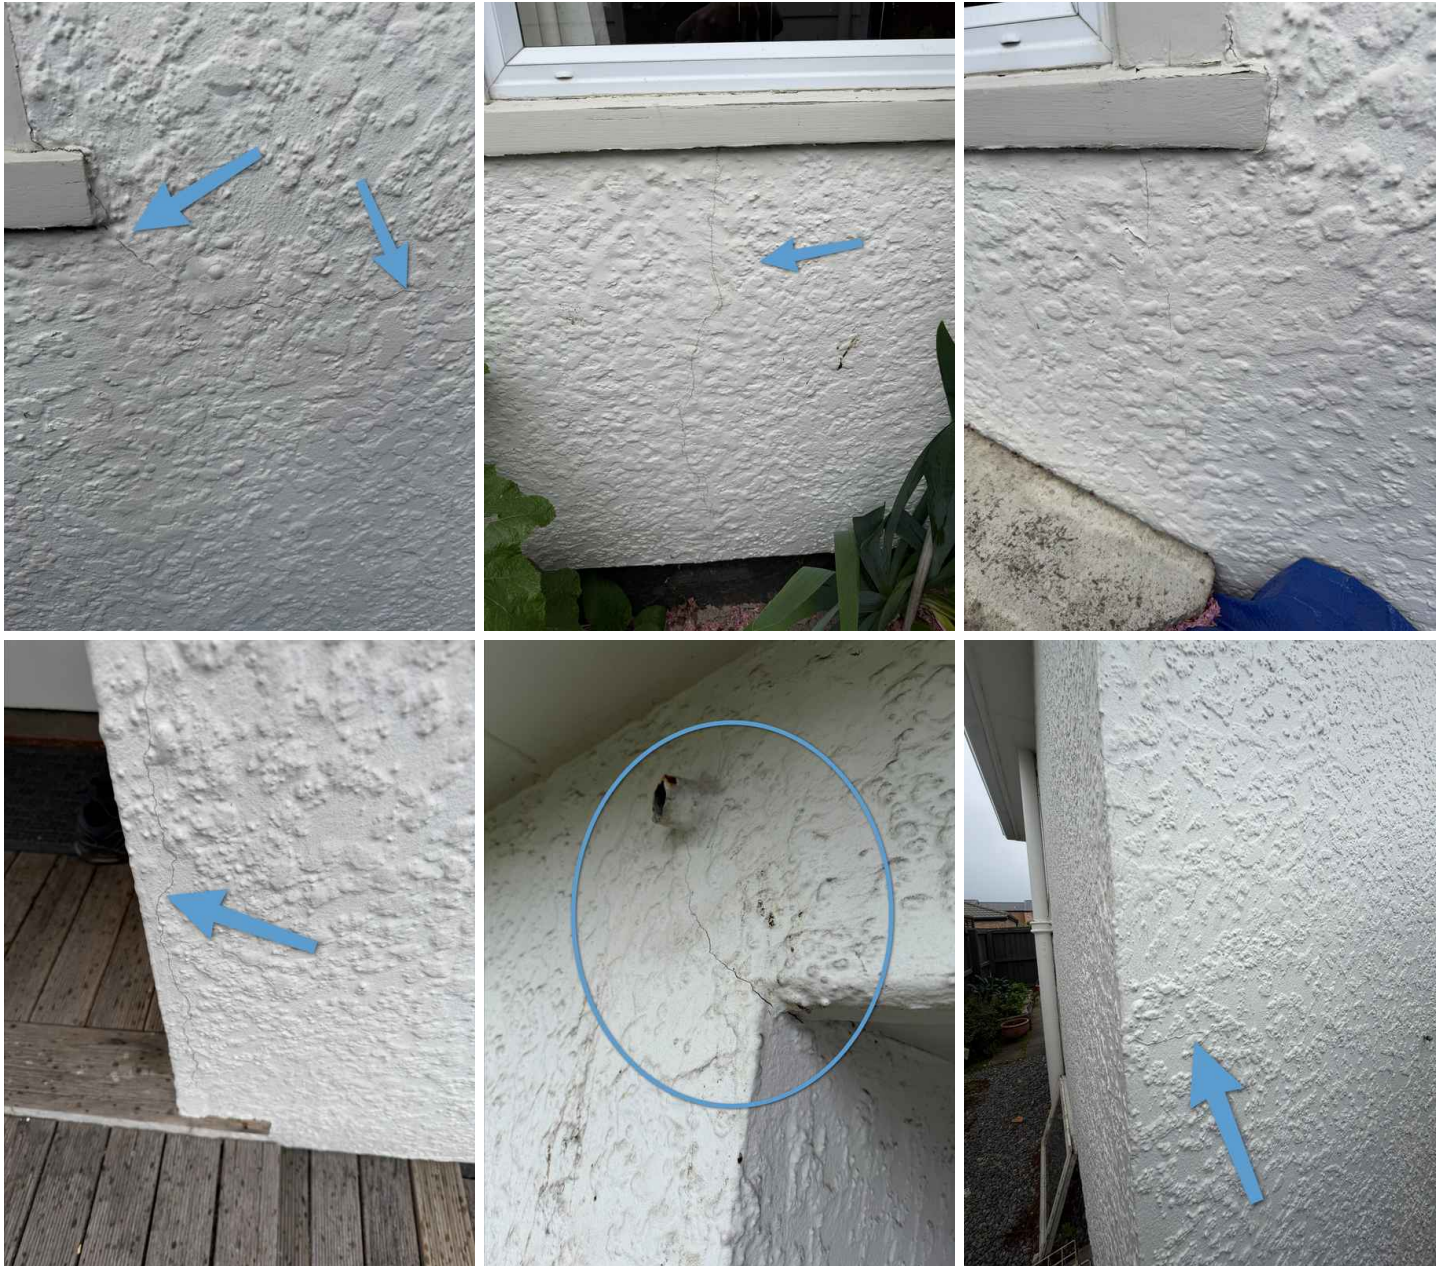
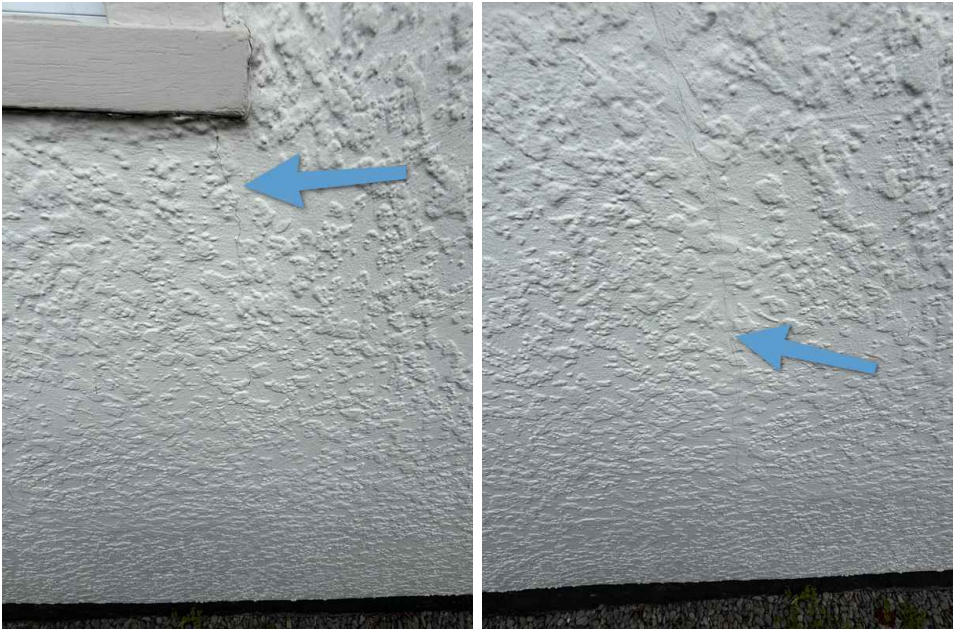
7.2.1 Plaster System

**CRACKING TO THE PLASTER SYSTEM HAS BEEN OBSERVED.**

Cracking to the plaster system has been noted, it is recommended that a cladding specialist is engaged to repair as required.

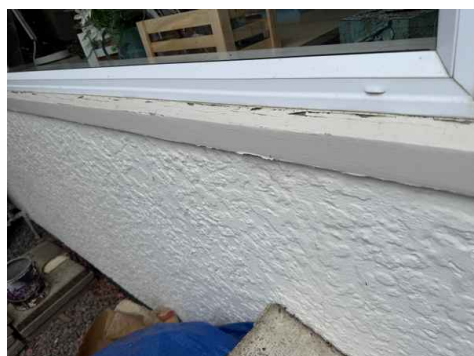
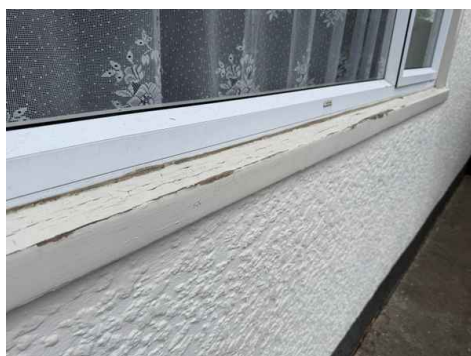
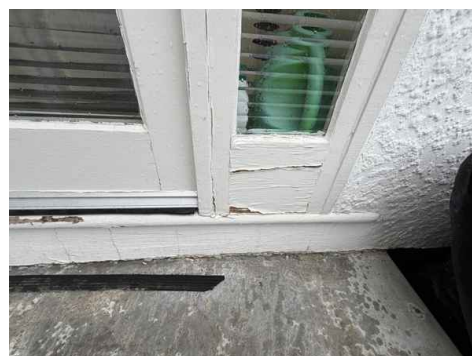
Timber coatings are worn and or deteriorated, maintenance to the paint system is recommended.

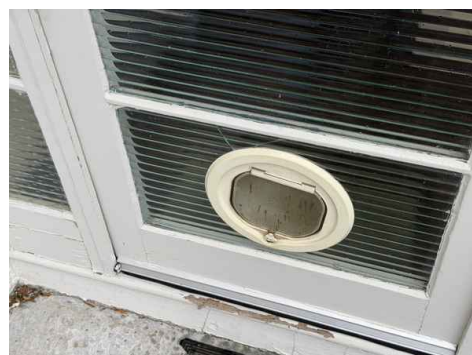
8.1.2 Exterior Joinery

CRACKED OR DAMAGED GLAZING

It is recommended that cracked/damaged glazing is replaced as required.

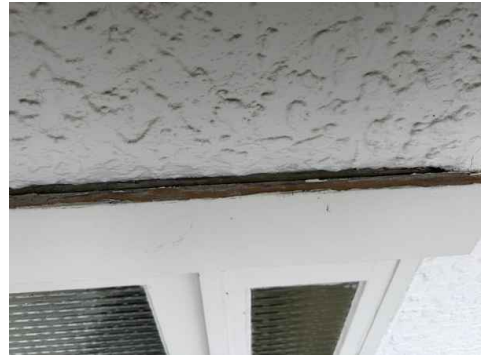
8.1.3 Exterior Joinery

DECAY TO TIMBER WINDOW FRAME

Decay is noted to the timber window frame, maintenance to the damaged area should be completed.

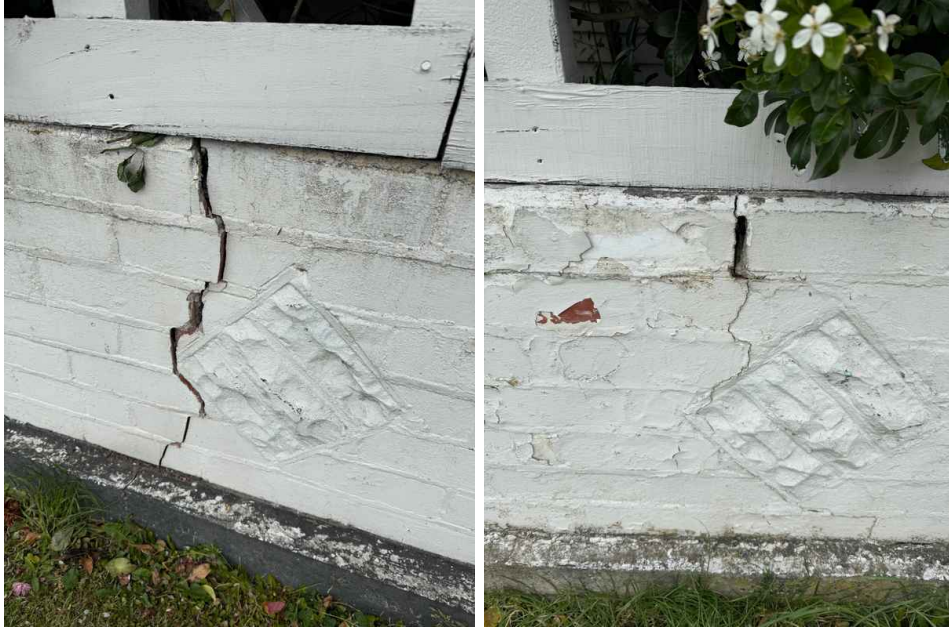
9.1.1 Fences

STEPPED CRACKING TO BRICK/BLOCK FENCE NOTED.

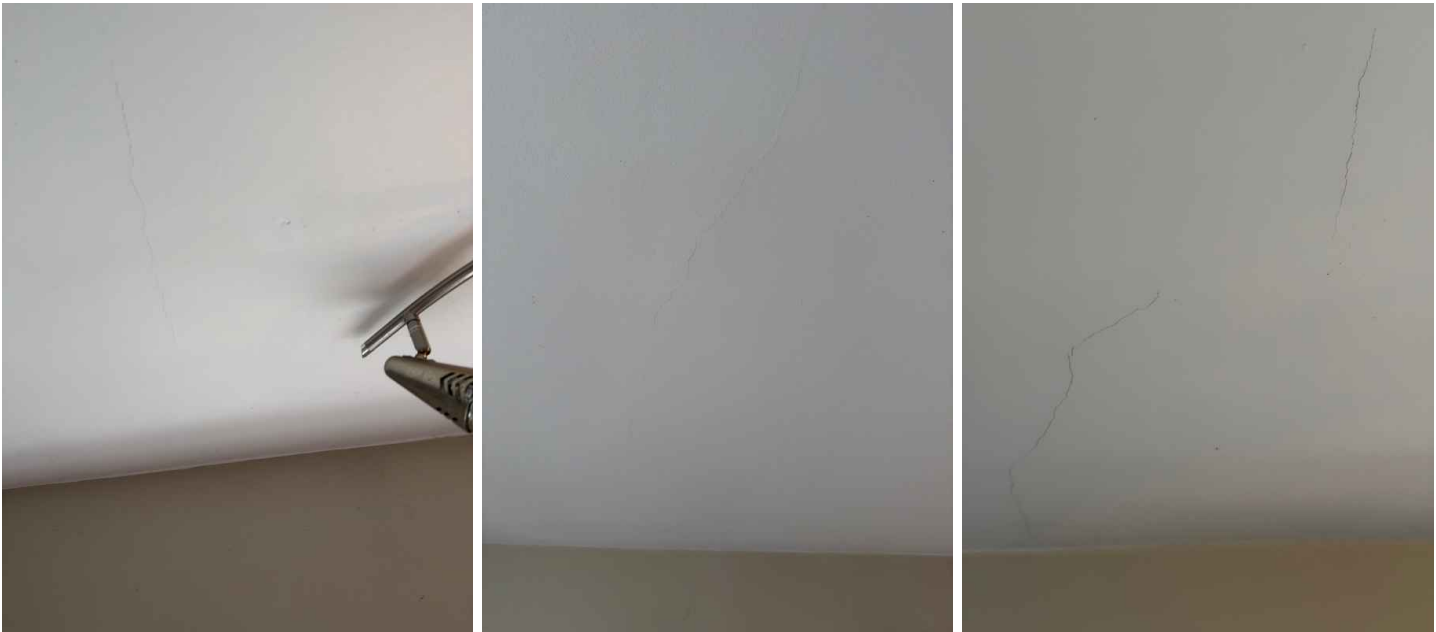
15.1.1 Internal Linings
COSMETIC CRACKING TO THE CEILING HAS BEEN NOTED
BEDROOM

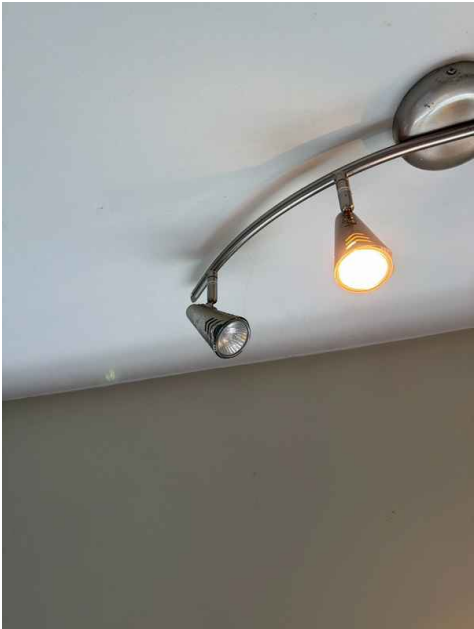
15.2.1 Electrical
LIGHT BULB NOT WORKING
Replace as required

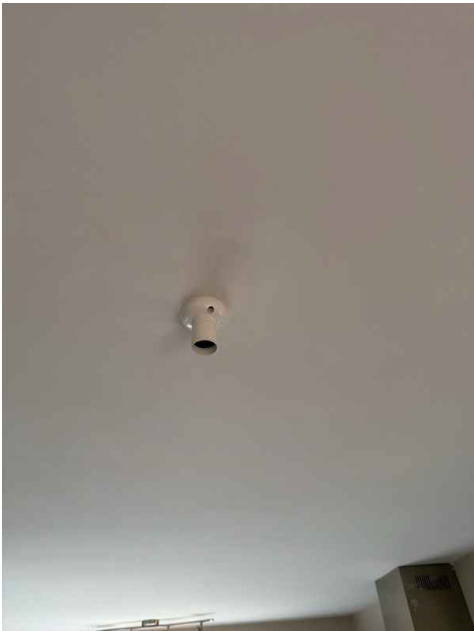
15.2.2 Electrical
LIGHT BULB REMOVED

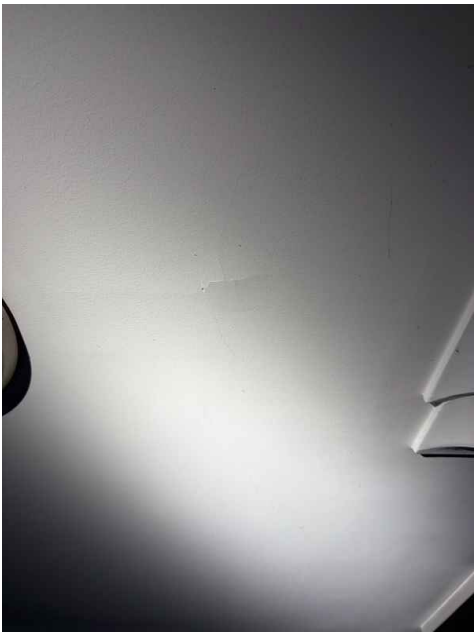
16.1.1 Internal Linings
**COSMETIC CRACKING TO THE
CEILING HAS BEEN NOTED**

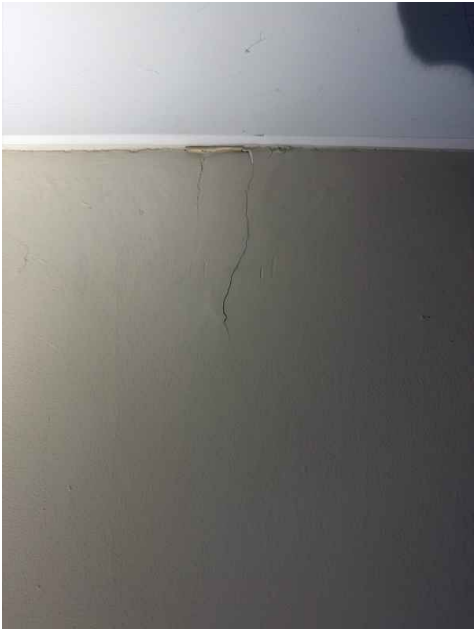
16.1.2 Internal Linings

WEAR & TEAR TO WALLS NOTED

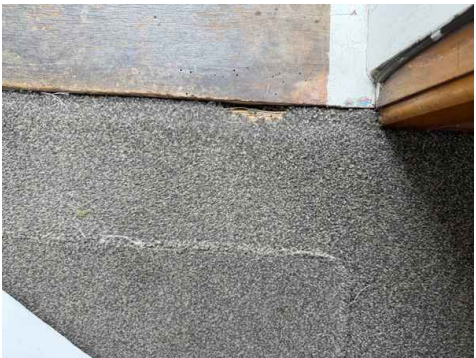
17.4.1 Floor Coverings

WEAR & TEAR NOTED TO THE FLOORING SYSTEM

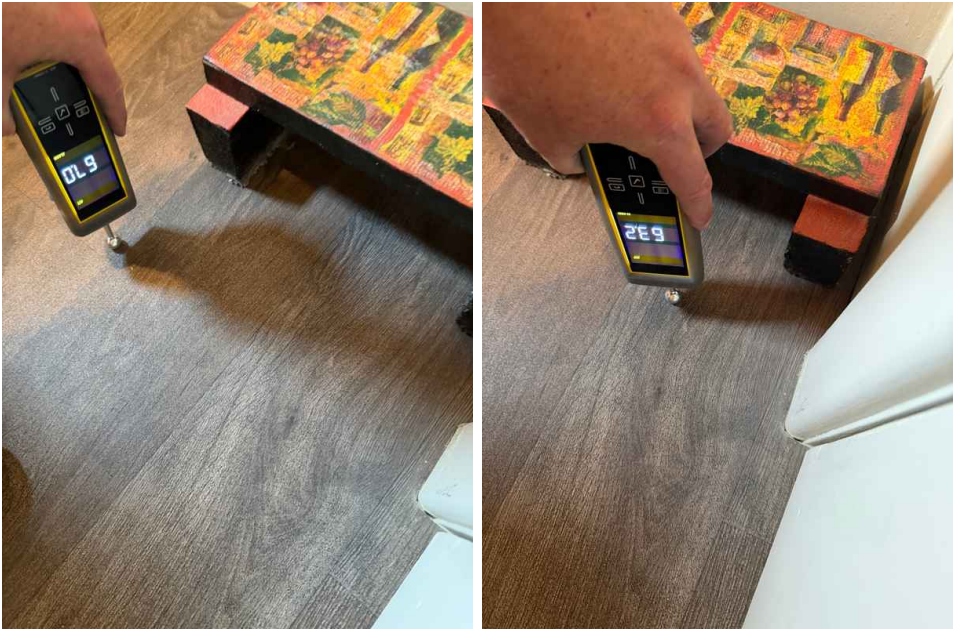
24.1.1 Moisture

Elevated moisture was located to the: rear door laundry area, unable to determine cause.
