EARTHQUAKE RECOVERY (EQR) DOCUMENTATION

EQR Property Overview Report

EQC Property ID	Property Address	Vulnerable?	Property F Status	Property Finalisation Indicator		
2010042534	37 SUGDEN STREET, SPREYDON		F3 - Complete & Finalised	Some Finalisation has taken place		
Main Contractor:	CLOSED OUT-Maintain Canterbury Limited ***** (S241)		Property F2'd By:	System Generated Finalisation	F2 Completed Date:	28-04-2015
Cont Managing Hub:	<MULTIPLE>	Not Vulnerable	Property F3'd By:	System Generated Finalisation	F3 Completed Date:	07-05-2015

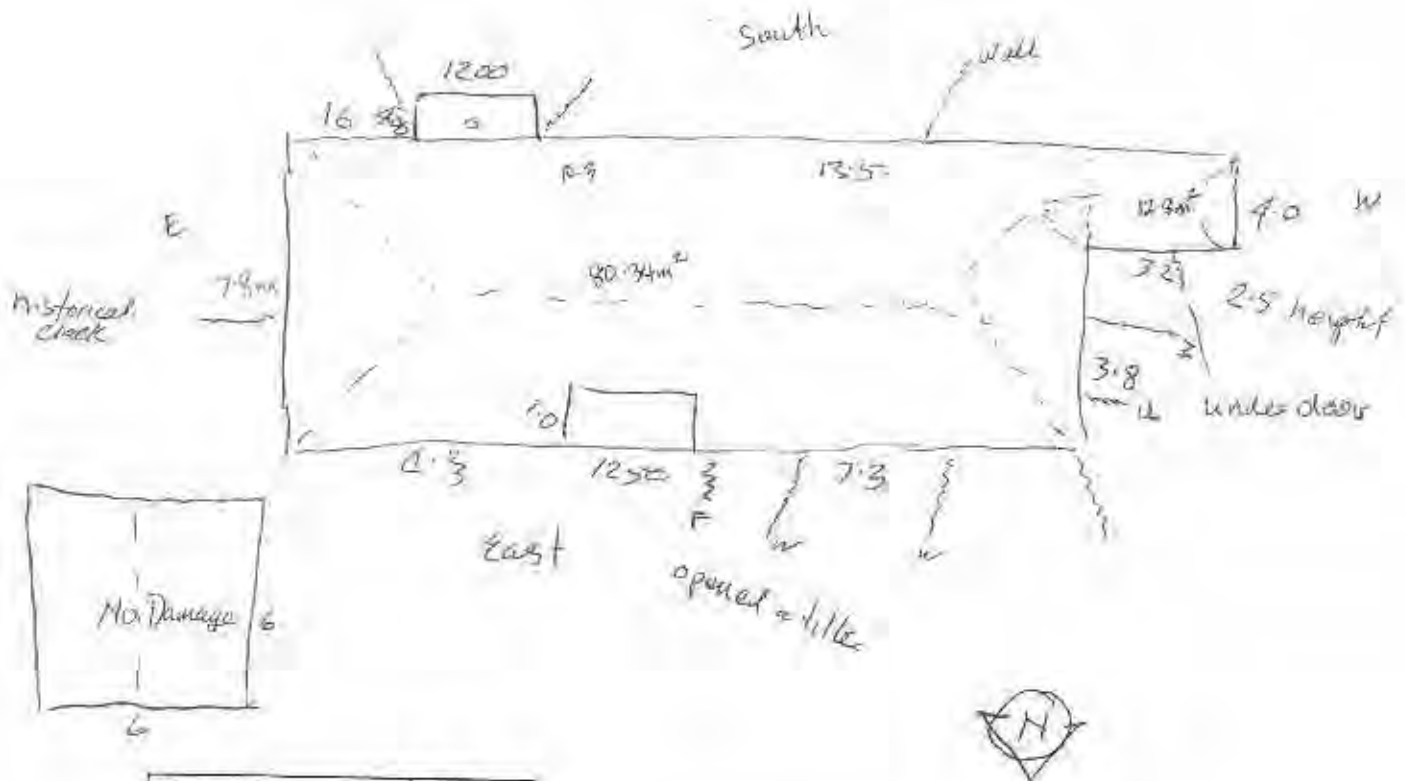
Area m2:	94
Stud Heights:	2.4
Wall Finish:	Wallpaper Plastered <u>Paint finish</u>
Other	
Services:	Specify damage:
Chimneys:	Construction type: <u>Concrete</u> Height: <u>4.0</u> Damage description: Above Roof Below Roof <u>Total Repair</u>
Foundations Damage:	Timber <u>Concrete Ring</u> Concrete Slab Other (Specify): <u>Minor</u> Moderate Severe House moved off foundations?: <u>NO</u> Concrete slab cracked? Crack width: <u>N/A</u> Crack length: <u>N/A</u>
Roof:	Framed Trussed Type: Clay Tiles <u>Concrete tiles</u> Metal tiles Rolled Metal Other Damage:
Cladding Type:	Weatherboard Brick Veneer Hardi Plank <u>Other STUCCO</u>
