# Independent Builders Report

Total Home Inspection Services Porirua City Ltd

Mon 3 Nov 2025

**73 Langdale Ave, Paraparaumu, Kāpiti, 5032, New Zealand**

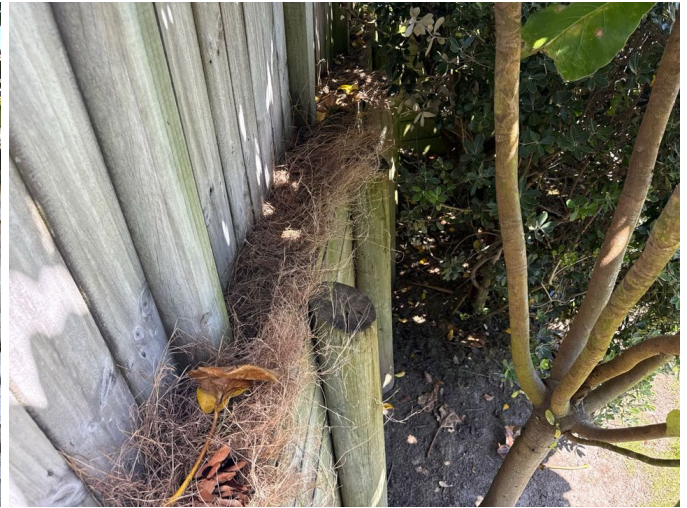
The condition of the retaining walls is consistent with the age of the property.

The retaining walls will require ongoing monitoring. No signs of significant damage or movement at the time of inspection.

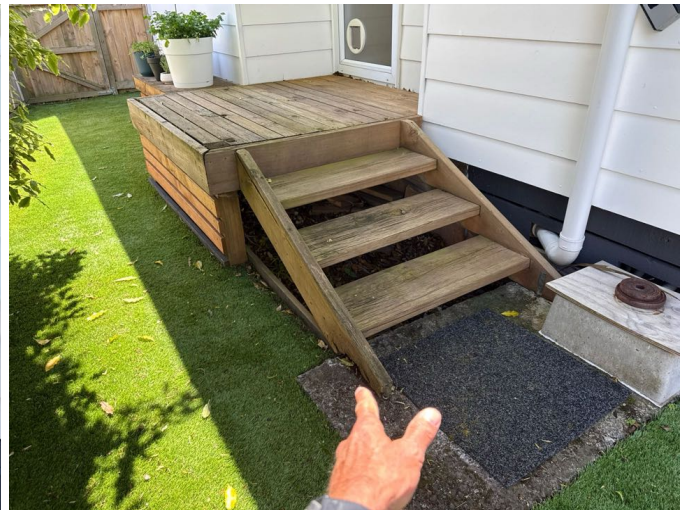
Deterioration to the rear stairs will need to be monitored closely. Expect repairs or at least partial replacement in the short term.

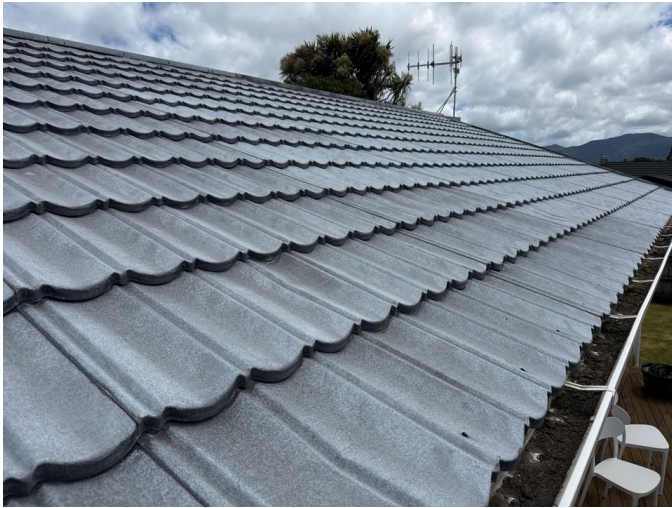
The paint has worn off the tiles

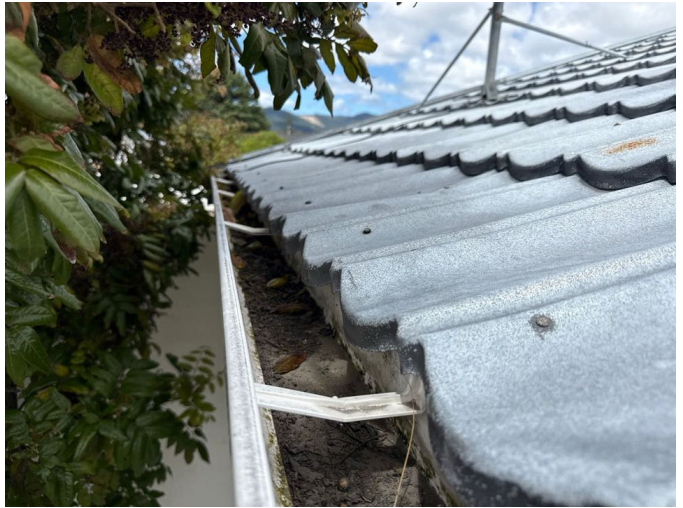
The spouting is in need of a clean out which will help prevent the risk of blockages and overflows. The effectiveness of the spouting will need to be checked during rainy periods. Due to the dry conditions that were evident on the day of our inspection we cannot comment on any leaks that maybe evident to the spouting or down pipes.

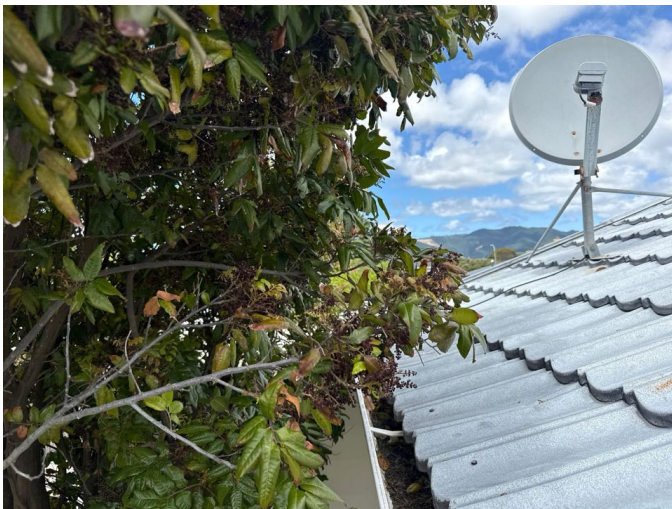
Trees overhanging the roof should be trimmed back to prevent the risk of blockages to the spouting.

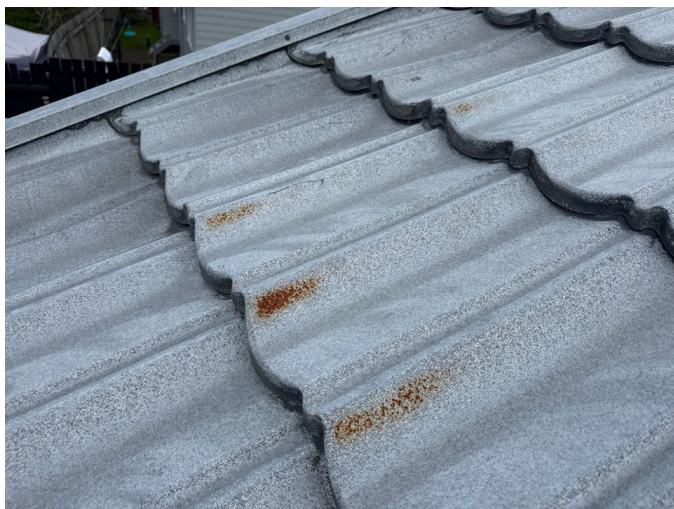
There is some surface rust which should be treated with rust converter and painted

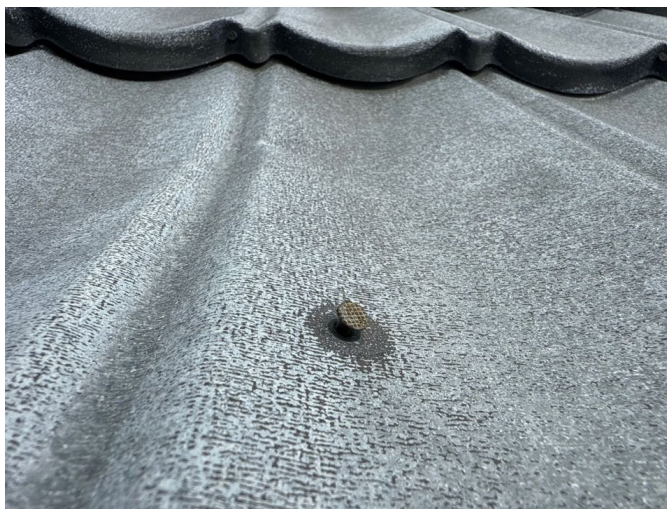
Any nails that are lifting around the bottom row of tiles should be replaced with a more effective fixing. Risk of water ingress where the nails are loose.

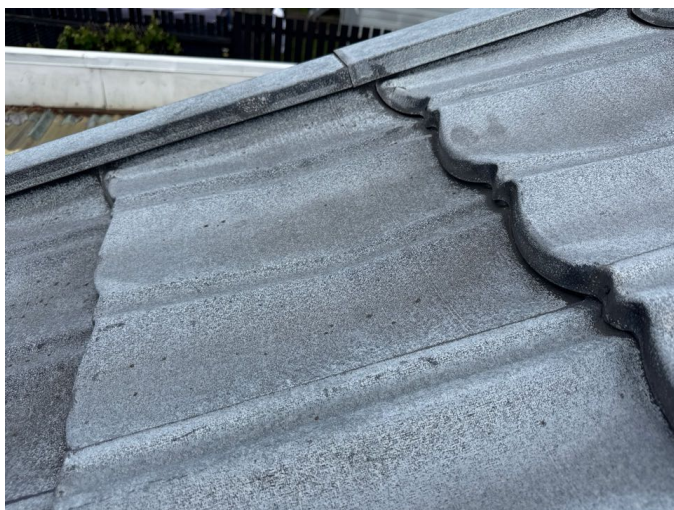
Dented tiles to a few locations. The dents are not currently affecting the performance of the roof however they are prone to splitting and should not be walked on. Dented tiles are less effective at deflecting water and will degrade at a faster rate.

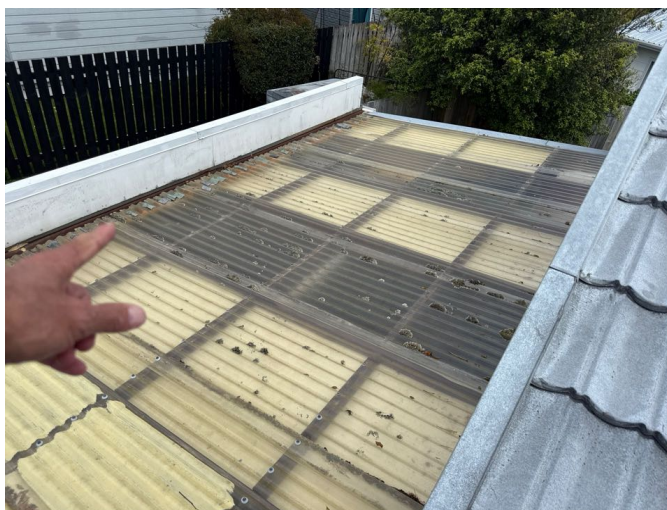
The plastic garage roof has been patched at various locations and should be replaced. Removing the parapet wall would be a good weather tightness improvement (recommended by T.H.I.S).

The plastic garage roof is deteriorating and should be replaced (the owner disclosed leak issues).

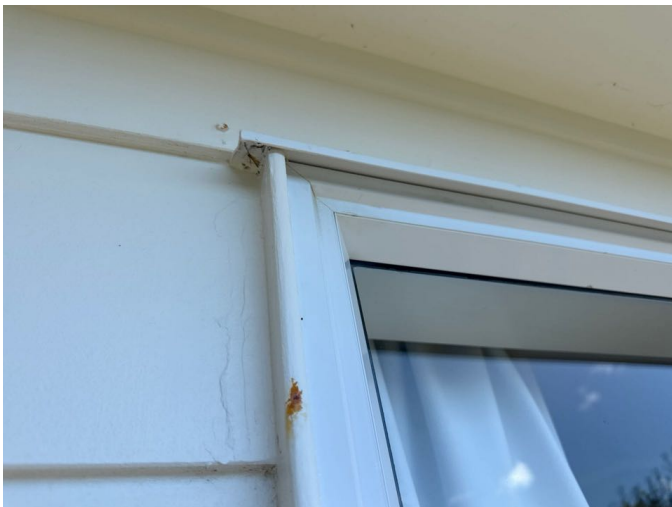
Example. Rust affected nails need to be treated with rust converter and painted.

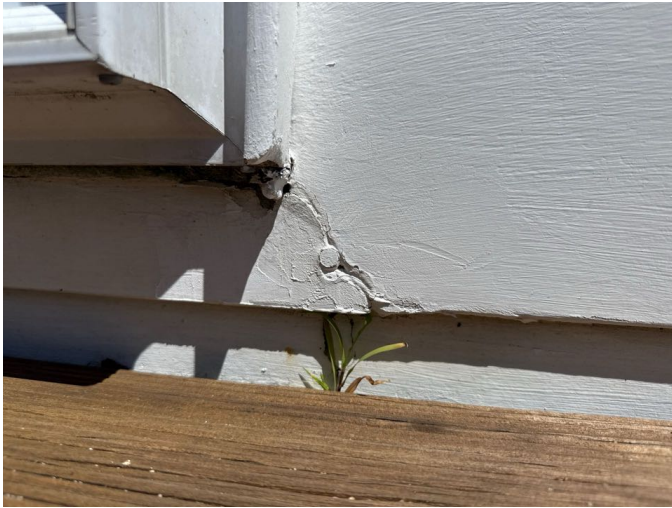
Example. Damaged weatherboards such as this should be flashed or replaced to prevent the risk of water ingress issues.

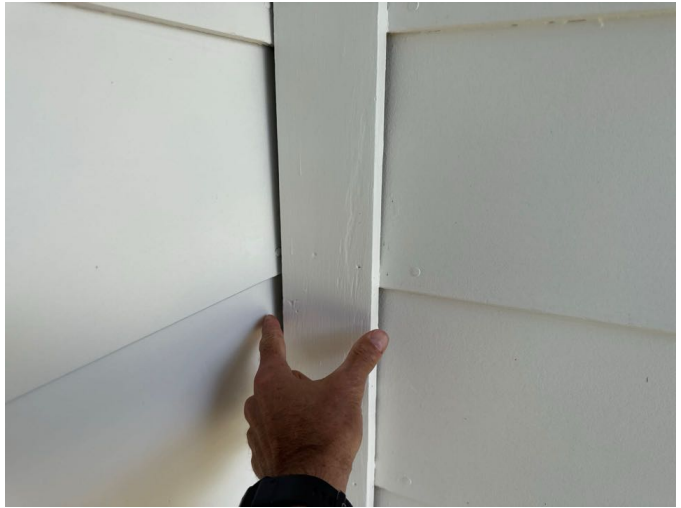
Scribers should be installed at the garage junction to prevent the risk of water ingress.

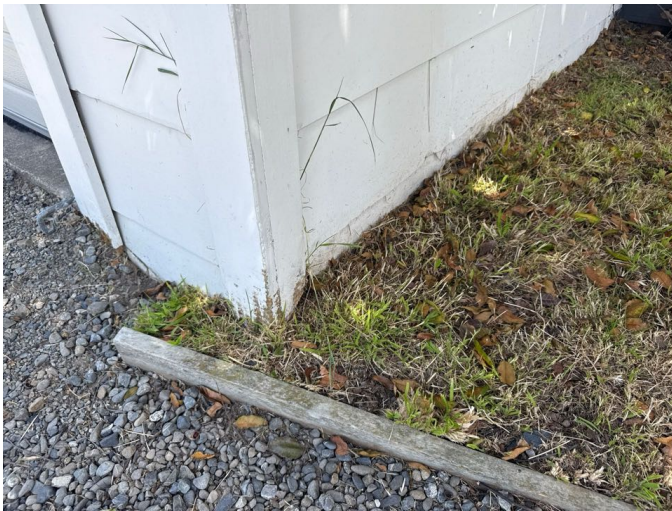
Poor ground clearance can result in moisture ingress via capillary action, a particularly high risk due to the bottom plate being at risk of decay. The current building code requires a 150mm clearance between the internal floor height and the sealed ground and 225mm to unsealed ground. The ground levels should be lowered around the garage.

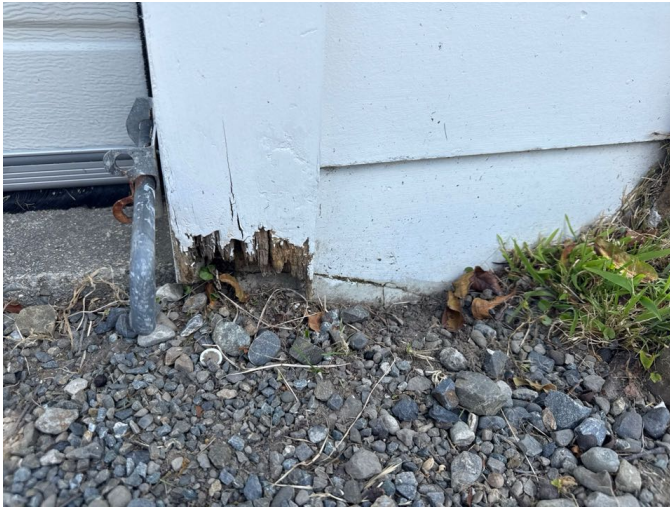
Damage to the timber facings and bottom weatherboard. Replacement recommended.

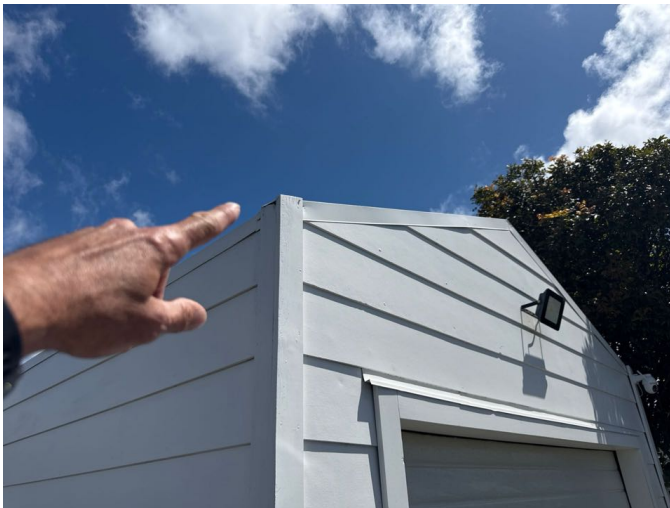
The corner facings have been poor detailed and are a weather tightness risk at the top. A licensed builder should be engaged to improve this detail.

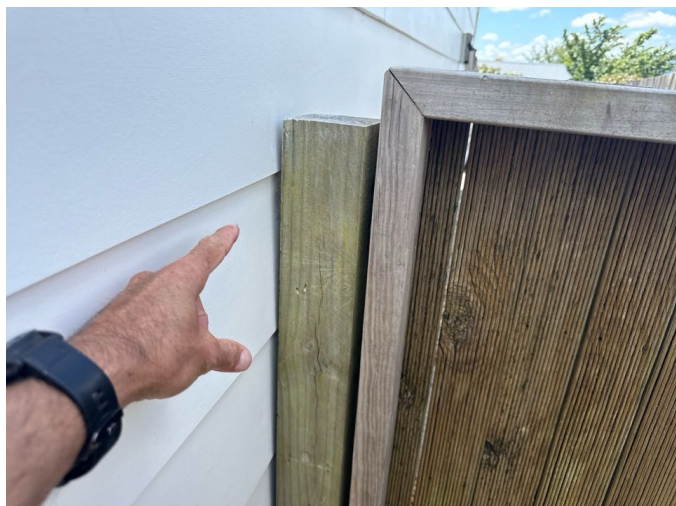
It is not recommended to directly fix objects through the cladding as the fixing points are a weather tightness risk. Either weather tightness improvements required at the fixing points or removal of the fixings.

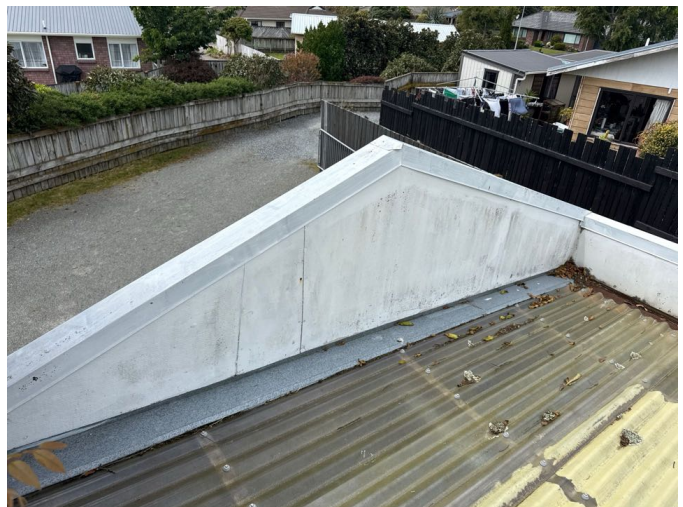
The cladding to the parapet walls have no flashings at the joins and are a weather tightness risk. A licensed builder should be engaged to improve the overall weather tightness of the parapet walls and garage.

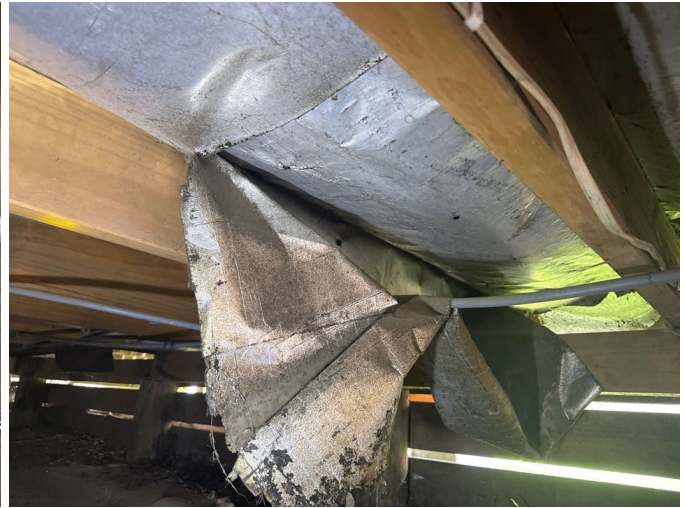
Foil type 'insulation' installed under the floor. Repairs and maintenance to this type of underfloor 'insulation' has been banned as the foil can become an electrical conductor. A good improvement would be to replace the foil with a blanket type insulation which will be more effective at preventing heat loss. Note: The power main will need to be turned off to undertake the works.

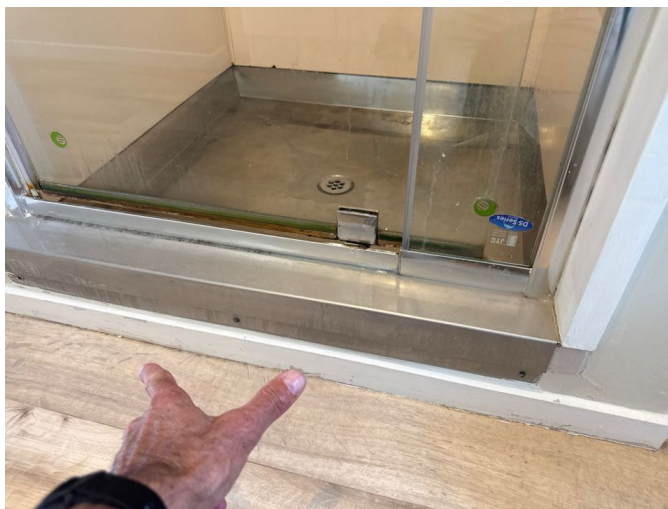
The flooring/shower base junction should be sealed with a suitable wet area sealant which will help prevent the risk of deterioration to the timber and flooring

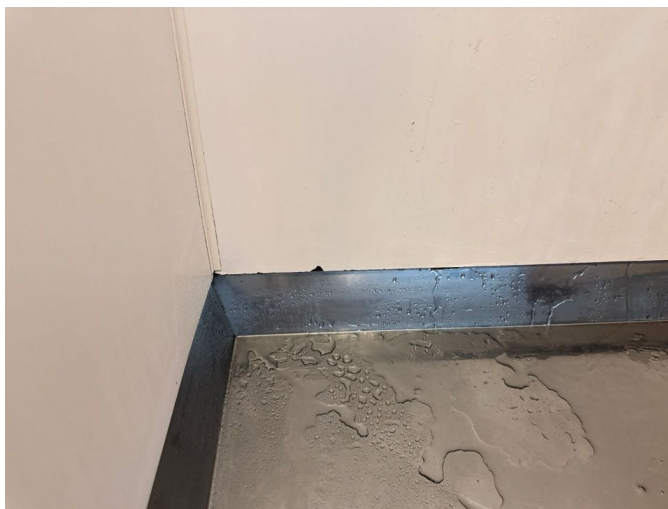
Wear to the base of the shower linings will need to be monitored

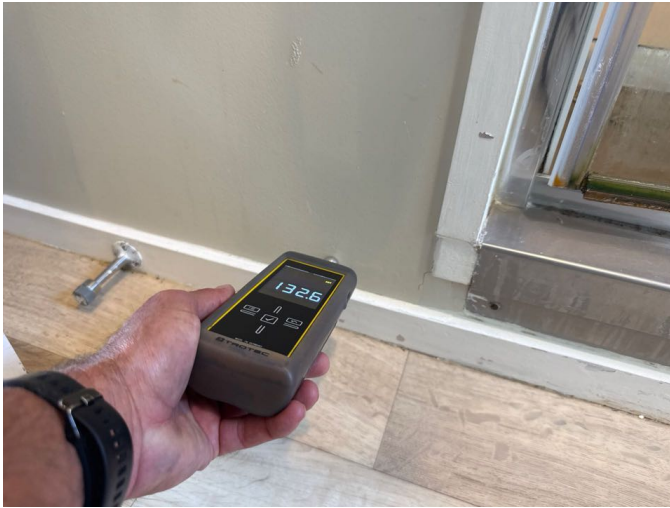
Elevated moisture readings to the left side of the shower frame. This has likely been caused by normal use and water dripping off the stainless steel tray. There is no evidence of current damage and there are no water pipes in the area. There was no evidence of damage under the shower in the sub floor. The area should be monitored and kept dry over time.

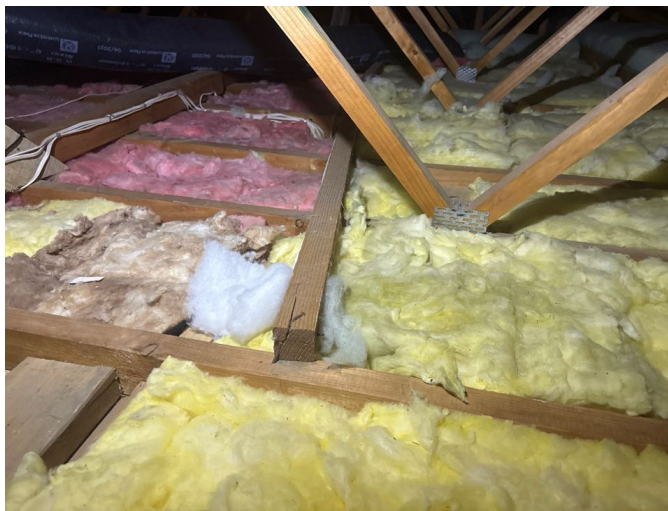
The insulation is thin and is unlikely to be very effective. Consider an additional layer to reduce heat loss.

T.H.I.S recommend installing an additional insulation layer to reduce heat loss

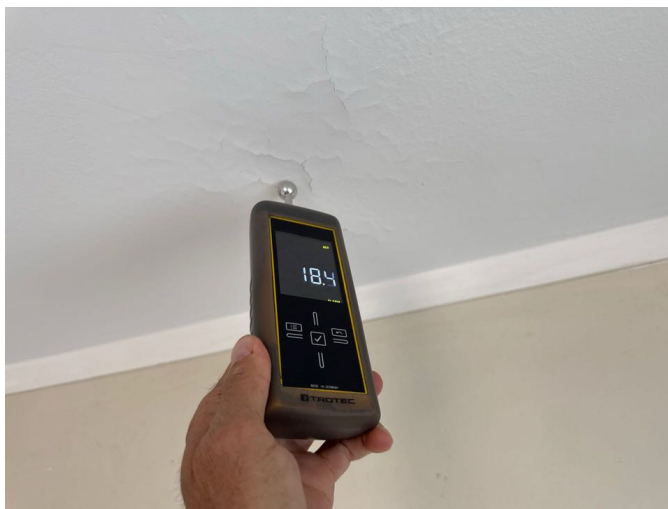
Deterioration to the ceiling lining above the oven does not appear to be moisture related. Possibly caused by a lack of extraction.

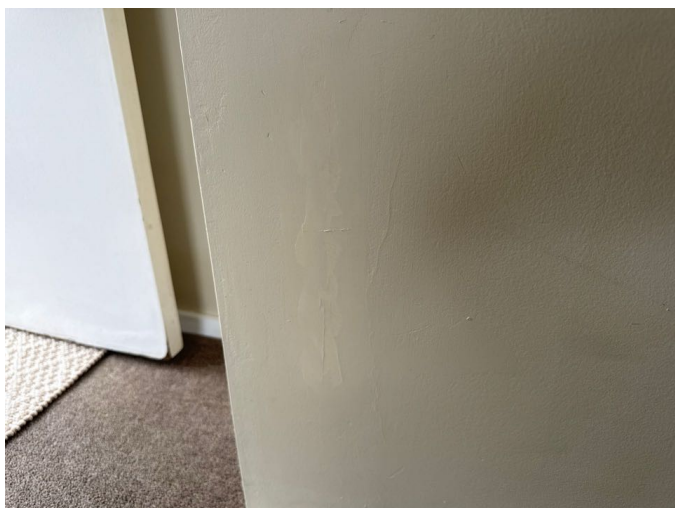
Example. Minor cosmetic defects noted. The ceiling in particular will require a paint upgrade in the short term.

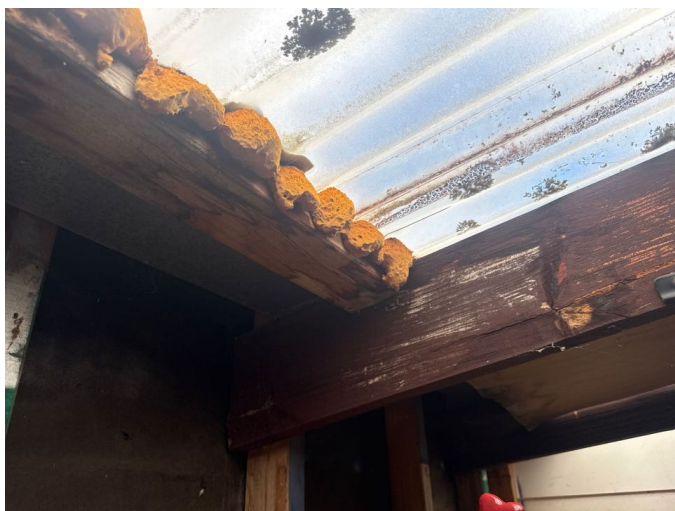
Moisture staining around the roof and wall framing at various locations. Expanding foam to the underside of the internal gutter.

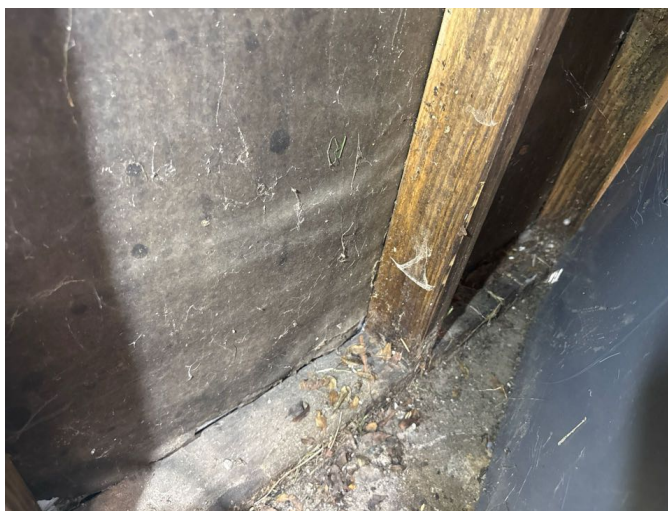
Rot damage to the back corner framing requires further investigation and remediation

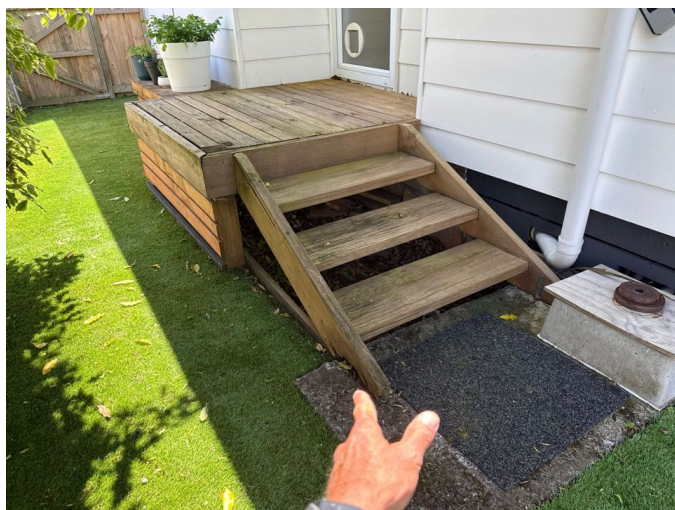
Deterioration to the rear stairs will need to be monitored closely. Expect repairs or at least partial replacement in the short term.

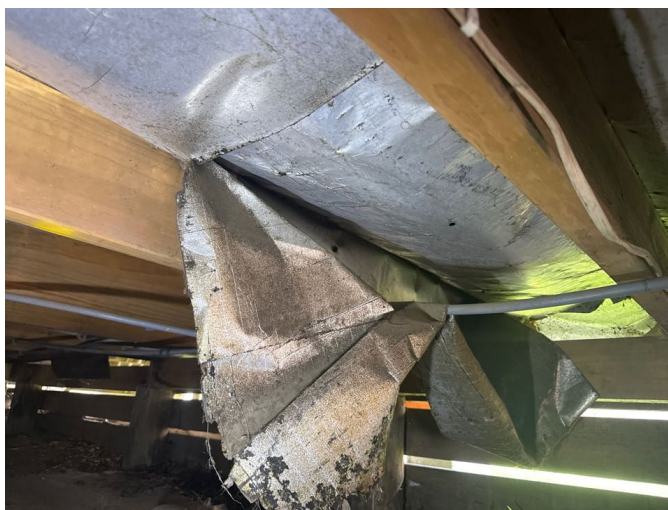
Sub floor.  
Foil type 'insulation' installed under the floor. Repairs and maintenance to this type of underfloor 'insulation' has been banned as the foil can become an electrical conductor. A good improvement would be to replace the foil with a blanket type insulation which will be more effective at preventing heat loss.  
Note: The power main will need to be turned off to undertake the works.
