# BUILDING REPORT

## RED LBP PRE-PURCHASE REPORT

# PRE-PURCHASE

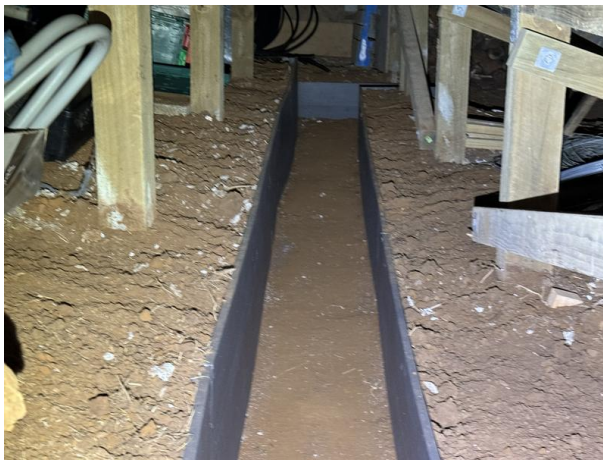
Photo 5

Path with timber retaining wall through the subfloor. Inadequate timber sizing has been used. This is a structural alteration as the soil around the piles has been removed.

Recommend having an LBP in carpentry report on the remedial work required to the retaining walls in the subfloor.

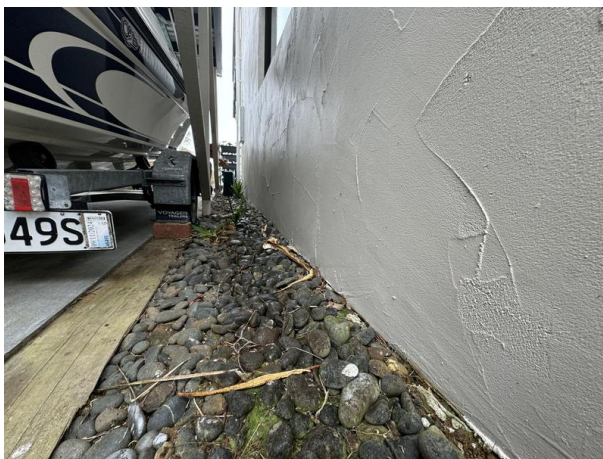
Photo 6

No ground clearance to the cladding on the northwest garage wall.

Recommend having a building contractor report on the remedial work required to the ground clearances.

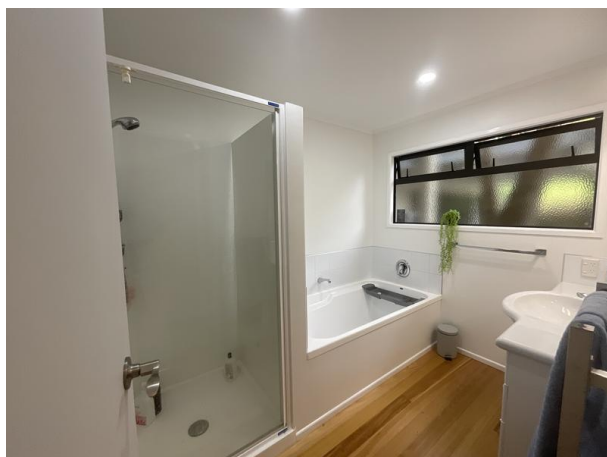
Photo 25

Bathroom.

There is no externally vented mechanical ventilation system installed in the bathroom. It is recommended to install a suitable system for the rooms requirements.

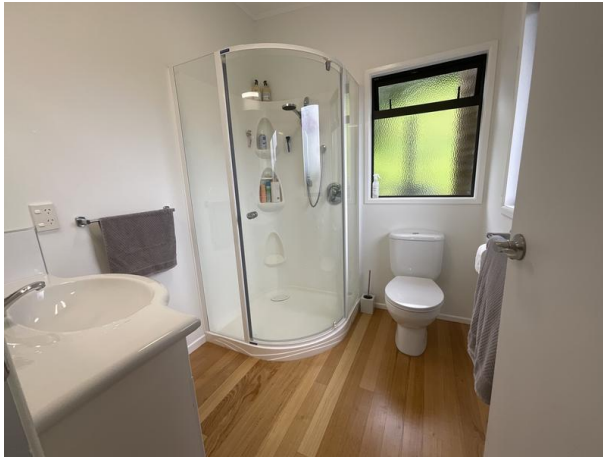
Photo 33

Bathroom.

There is no externally vented mechanical ventilation system installed in the bathroom. It is recommended to install a suitable system for the rooms requirements.

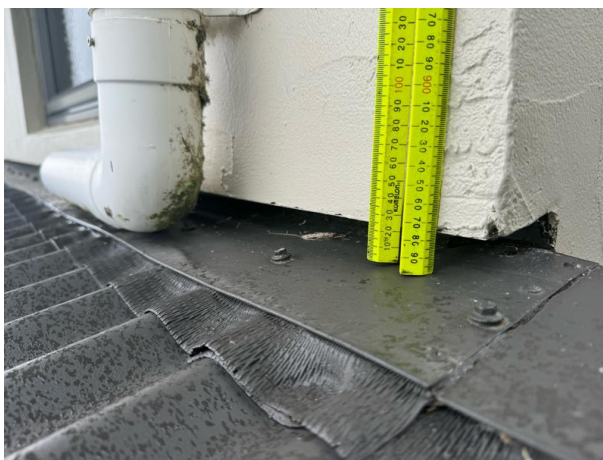
Photo 44

Some areas of the roof to wall junctions are under the minimal clearance required. Recommend monitoring these areas and keeping free of debris.

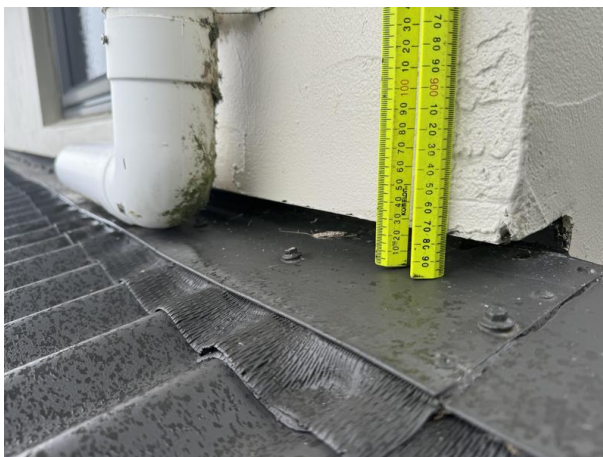
Photo 47

Some areas of the roof to wall junctions are under the minimal clearance required. Recommend monitoring these areas and keeping free of debris.

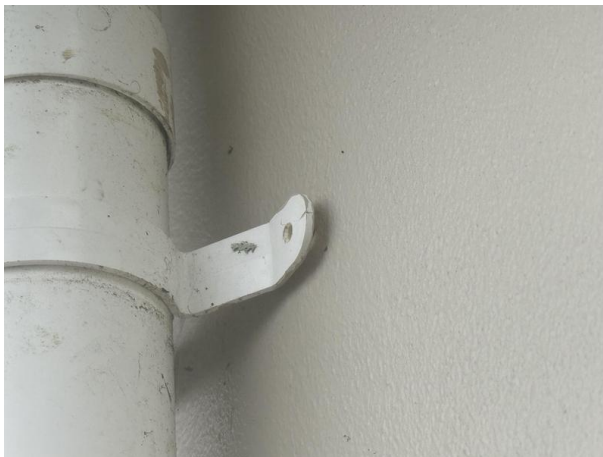
Photo 51

Recommend sealing and re-attaching the northeast downpipe bracket.

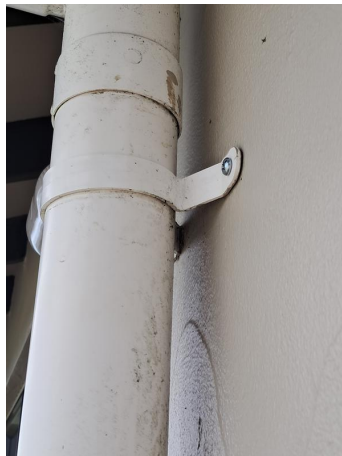
Photo 52

Update - 20/11/24 - Vendor has sealed the downpipe penetration.

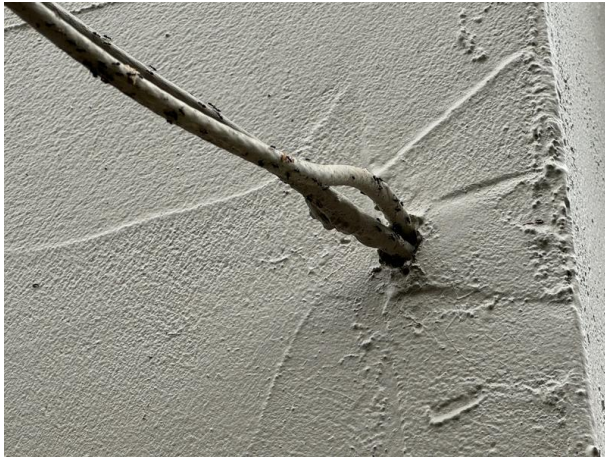
Photo 55

Wire penetration on the northwest wall above the garage is unsealed. Recommend sealing to stop water-ingress.

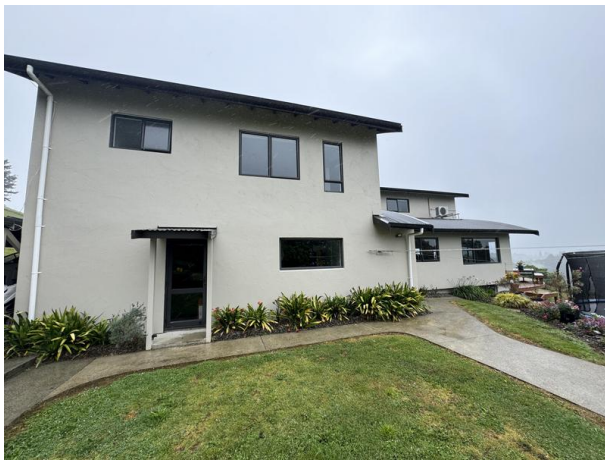
Photo 56

Southwest elevation. Recommend clearing the vegetation away from the cladding.

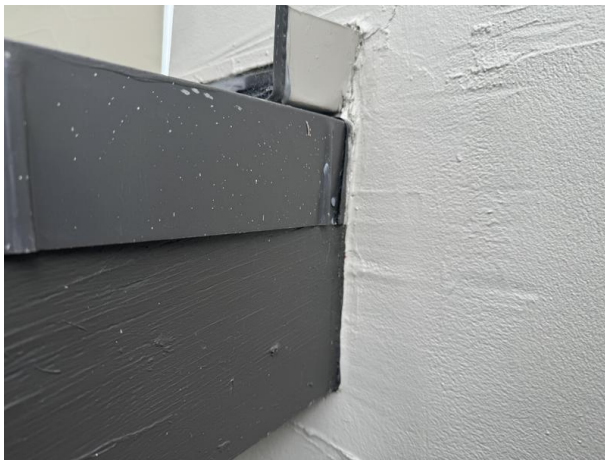
Photo 59

Example of a roof to wall junction. Fascia penetrates the cladding. Recommend monitoring and maintaining the sealer.

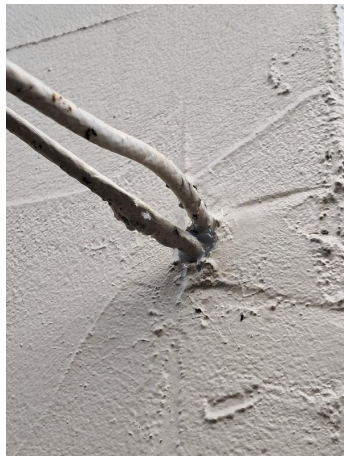
Photo 60

Update - 20/11/24 - Vendor has sealed around the wires.

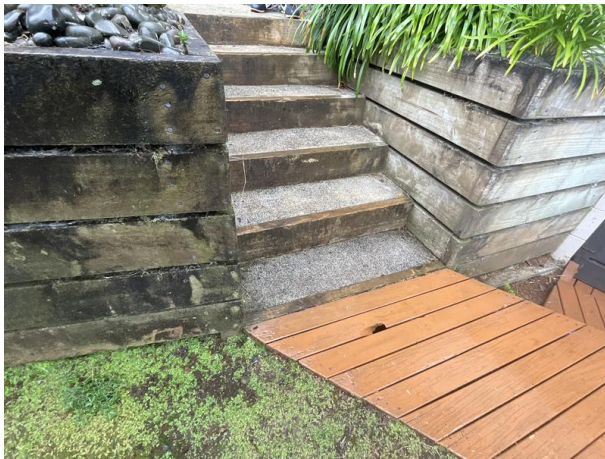
Photo 71

Concrete stairs with timber edging on the southwest side of the dwelling. Recommend installing a handrail.

To ensure safety and compliance, it is recommended to install handrails on any access steps in the home that have three or more steps.

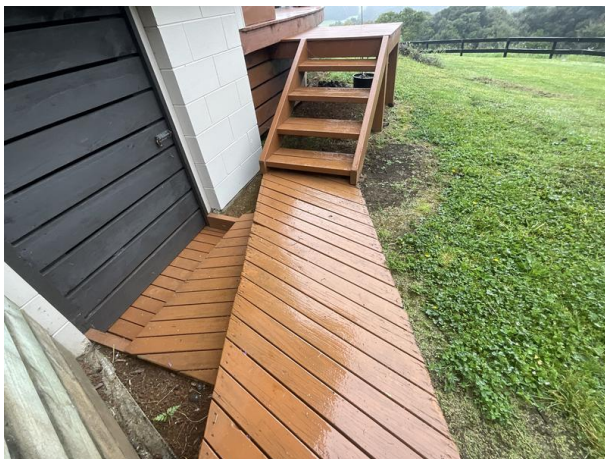
Photo 74

Timber decking platform and stairs leading to the subfloor and southeast deck on the southwest side of the dwelling. Recommend installing a handrail.

To ensure safety and compliance, it is recommended to install handrails on any access steps in the home that have three or more steps.

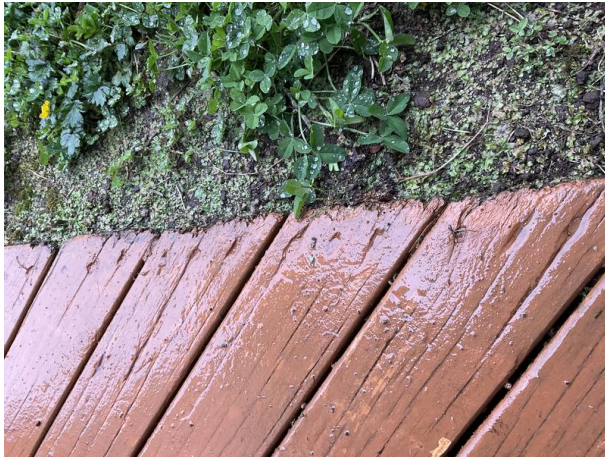
Photo 75

Visible rot on the ends of the timber platform where they have ground contact.

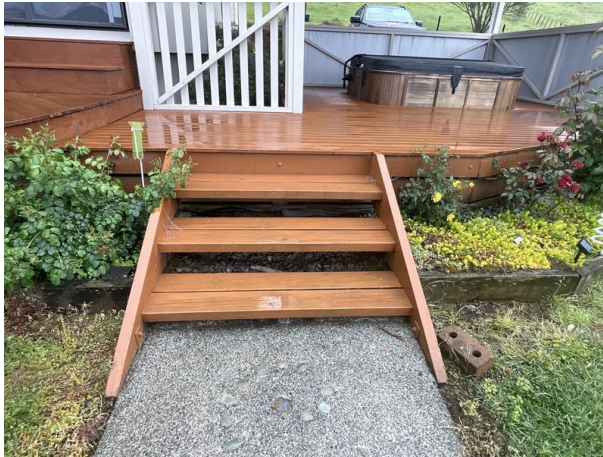
Photo 81

Timber stairs off the northeast deck. Recommend installing a handrail.

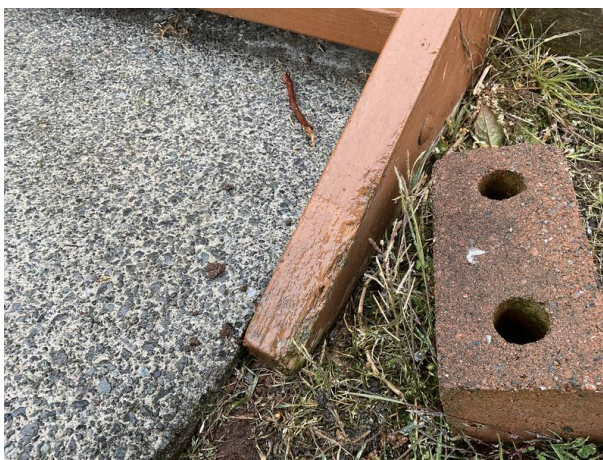
Photo 82

Visible rot on the bottom of the stringer where it has ground contact.

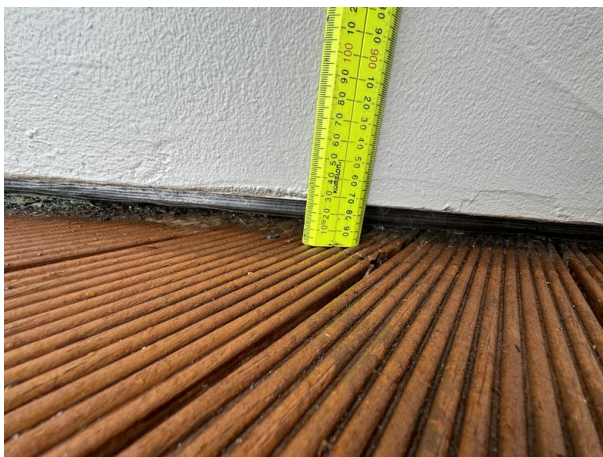
Photo 83

Minimal clearance to the cladding. Recommend monitoring and keeping free of debris.

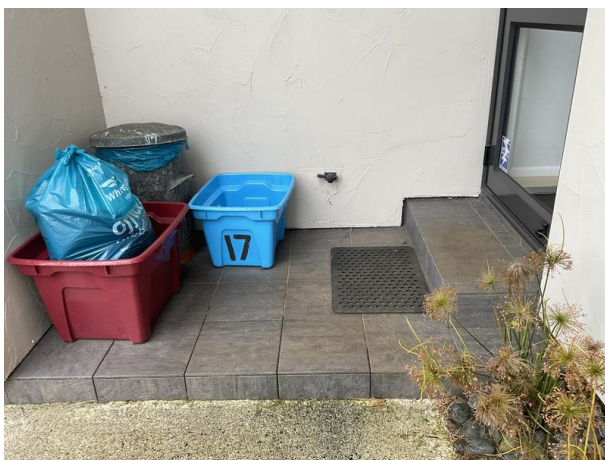
Photo 84

The concrete patio has no clearance to the exterior cladding, While there was no issues observed during the inspection. This configuration may lead to moisture issues due to capillary action. It is advisable to regularly monitor this area for potential issues and ensure it remains free of debris.

Covered tiled patio and step off the front entrance and laundry on the northwest and southwest side of the dwelling.
