**SUBJECT: STRUCTURAL INSPECTIONS AND SIGN-OFF FOR REPAIR / RE-LEVEL TO EXISTING RESIDENTIAL BUILDING AT 38 VIVIAN STREET, BURWOOD, CHRISTCHURCH 8083.**

## STRUCTURAL REPAIR ASSESSMENT

Project Number 24338

38 Vivian Street, Burwood, Christchurch 8083

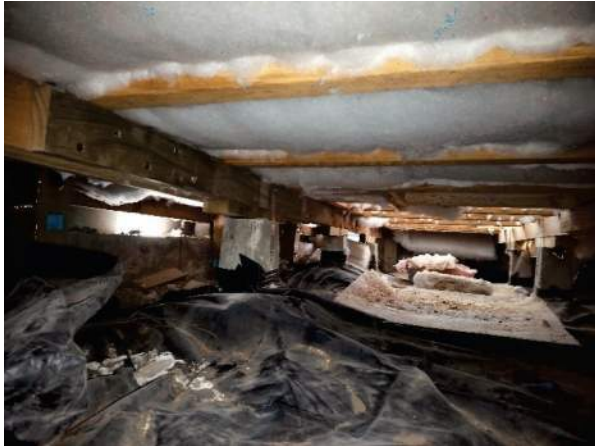
Photo 1. View of the re-levelled (raised) floor by mechanical lifting method.

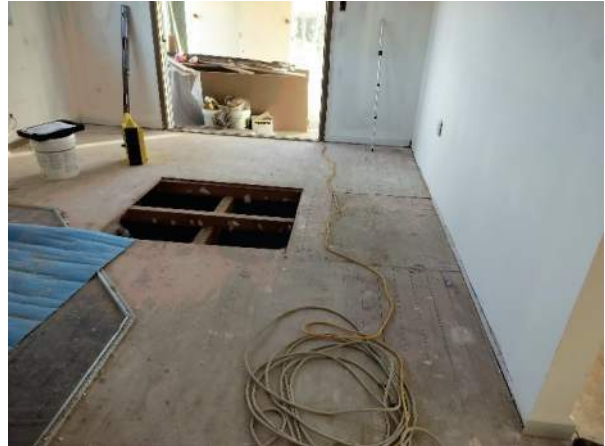
Photo 2. View of the re-levelled (lowered) floor by bearer notching method.

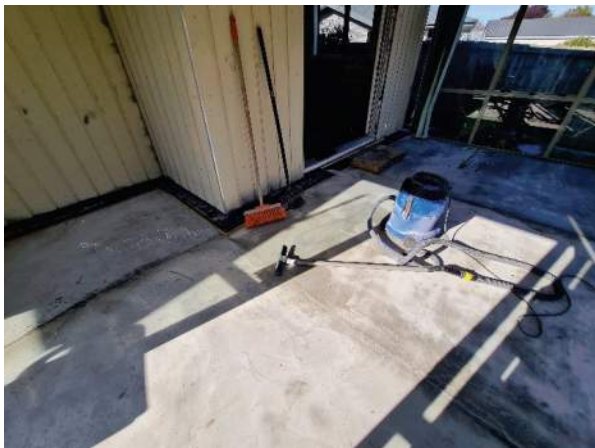
Photo 3. View of the re-levelled (raised) floor by FLC method.

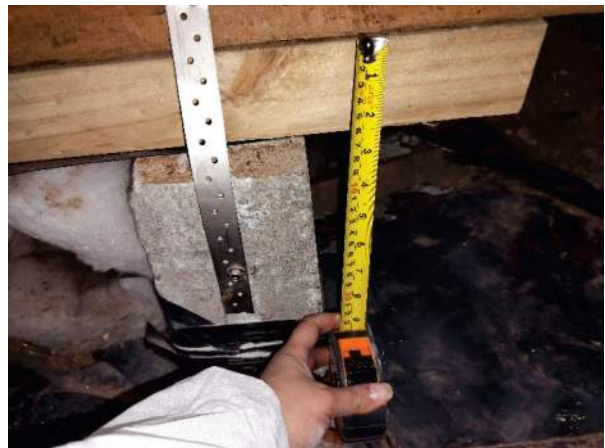
Photo 4. View of the existing concrete pile, sub-floor connection, and packer (2).

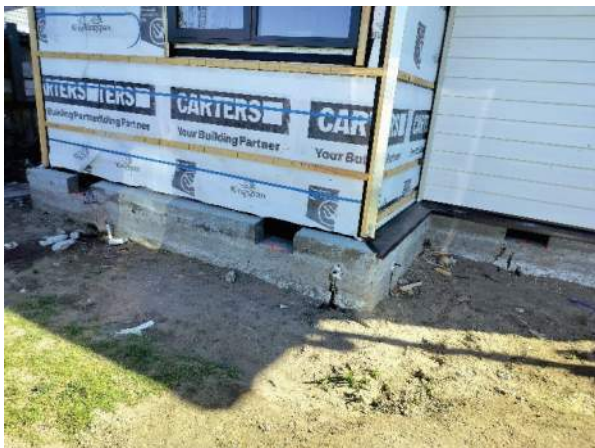
Photo 5. View of the repaired crack on the perimeter foundation (1).

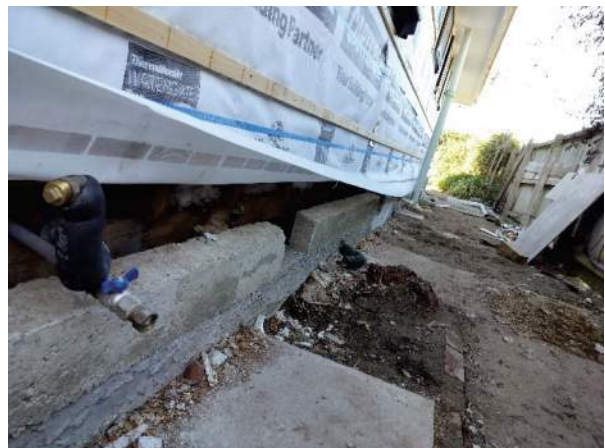
Photo 6. View of the partially replaced foundation.

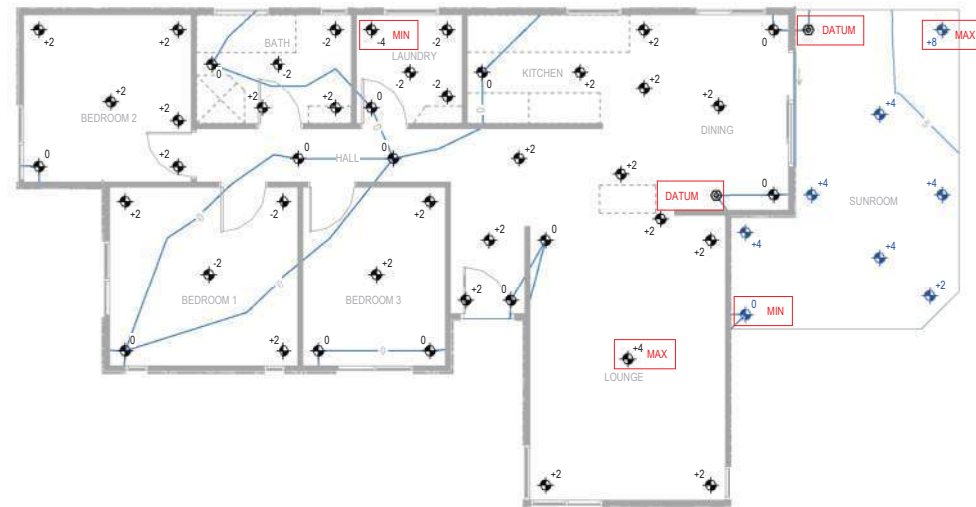
FLOOR LEVEL SURVEY - FINAL

The floor levels after remediation measured across the dwelling footprint showed a maximum floor level variation of 8mm (+4, -4), within the 50mm suggested threshold of “no foundation re-level considered necessary” set out in Table 2.3 of the MBIE Guidance.

The floor levels after remediation measured across the dwelling footprint showed a maximum floor level variation of 8mm (+8, +0), within the 50mm suggested threshold of “no foundation re-level considered necessary” set out in Table 2.3 of the MBIE Guidance.

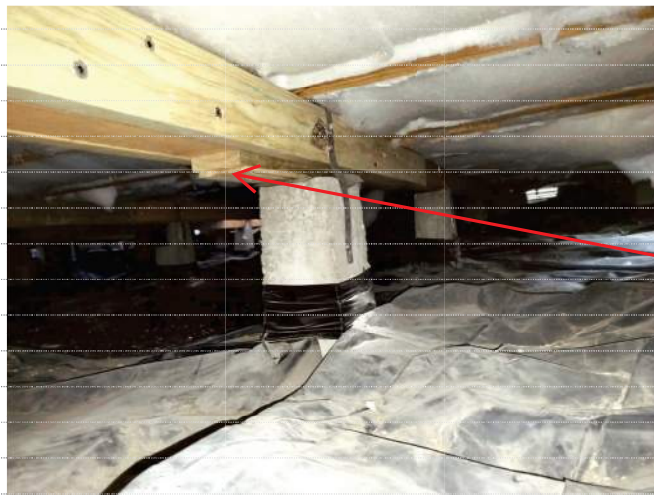
1. Foundation re-levelling was carried out as per our plan.
2. External perimeter foundation partially re-levelled by mechanical lifting (underpinning) and overpinning method.
3. Internal timber floor was partially re-levelled by jacking and packing of piles, pile replacement and bearer notching method .
4. No relevelling work was carried out for the internal slab of Sunroom . **RECTIFY AND REINSPECT**
5. Total floor level variation of 8mm (+4, -4) was observed across the timber floor of the main dwelling foundation post re-levelling .
6. No localised floor slopes exceeding general construction tolerance was observed during our inspection for the timber floor of the main dwelling.
7. Pile with double packer below Bedroom 3 sub-floor was observed. **RECTIFY AND SEND PHOTO**

**PROVIDE SINGLE  
SOLID PACKER  
LESS THAN 100mm**

**for main dwelling subfloor connection**

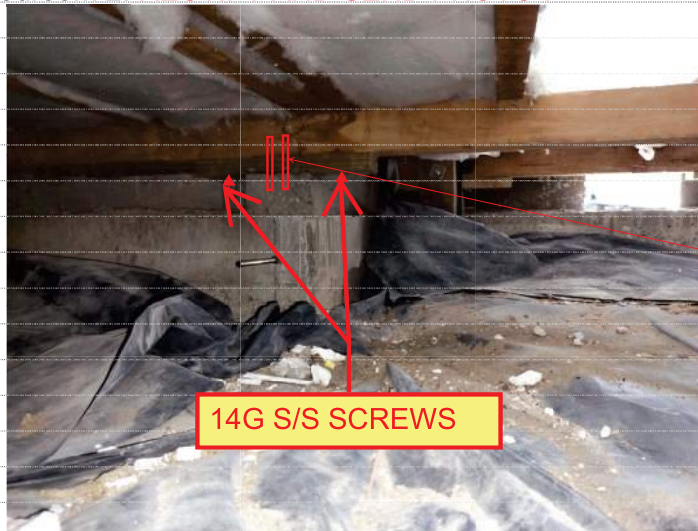
8. Missing bearer to foundation connection was observed for the packer along the chimney base (on both end) below Bedroom 2. **RECTIFY AND SEND PHOTO.**

2/S/S SHEET BRACE  
STRAP WITH 8G  
TEK SCREW INTO  
PILE AND BEARER

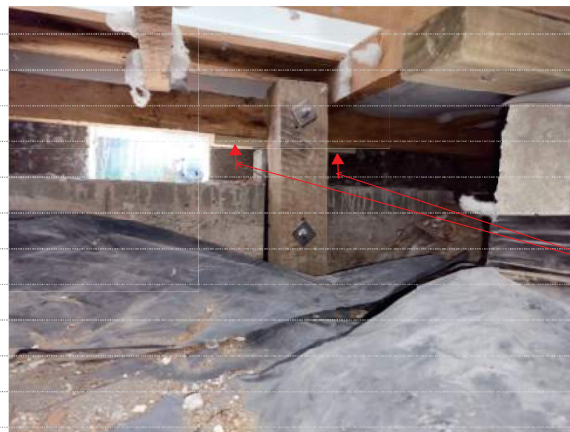
9. Missing bearer to foundation connection was observed for the packer along the perimeter foundation. Contractor to provide the connection as per details provided on sheet S404. **RECTIFY AND SEND PHOTO.**

for all the location  
where we have  
packer along the  
perimeter foundation.

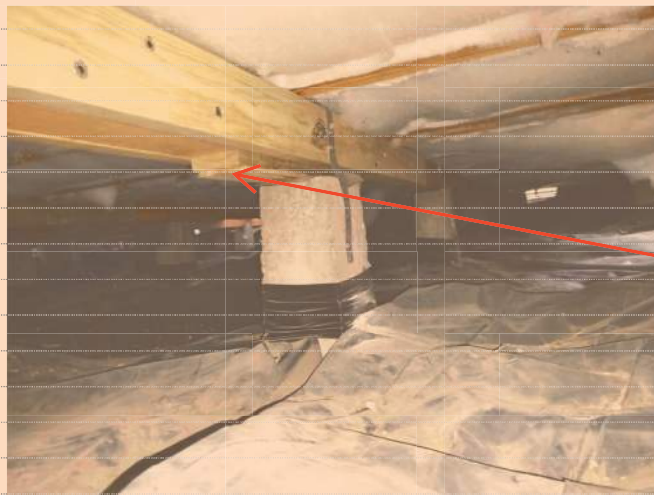
7. Pile with double packer below Bedroom 3 sub-floor was observed. RECTIFY AND SEND PHOTO

Provided on 29/08/2025 - OK

PROVIDE SINGLE SOLID PACKER LESS THAN 100mm

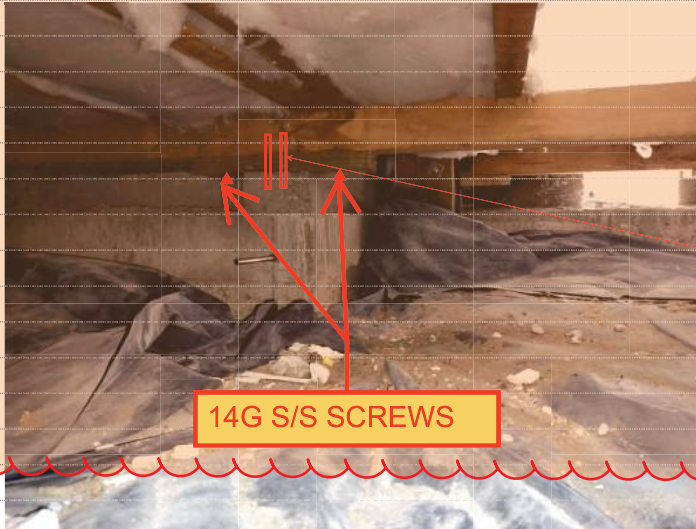
8. Missing bearer to foundation connection was observed for the packer along the chimney base (on both end) below Bedroom 2. **RECTIFY AND SEND PHOTO.**

2/S/S SHEET BRACE STRAP WITH 8G TEK SCREW INTO PILE AND BEARER

14G S/S SCREWS

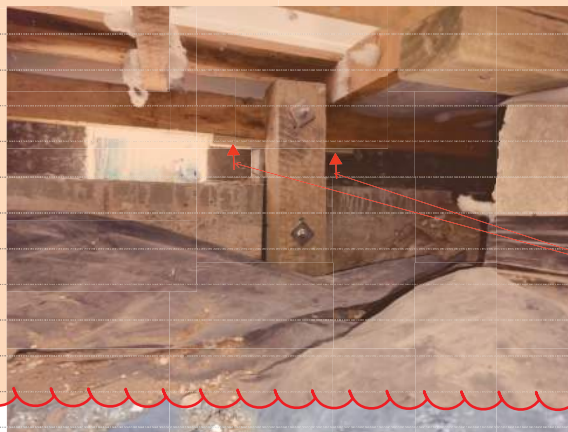
9. Missing bearer to foundation connection was observed for the packer along the perimeter foundation. Contractor to provide the connection as per details provided on sheet S404. **RECTIFY AND SEND PHOTO.**

for all the location where we have packer along the perimeter foundation.
