BUILDING DETAILS

Property address: 26a Garvins Road, Hornby, Christchurch, 8042

Date of assessment: Tue, 18-Aug-20

Assessor name: Clinton Smither

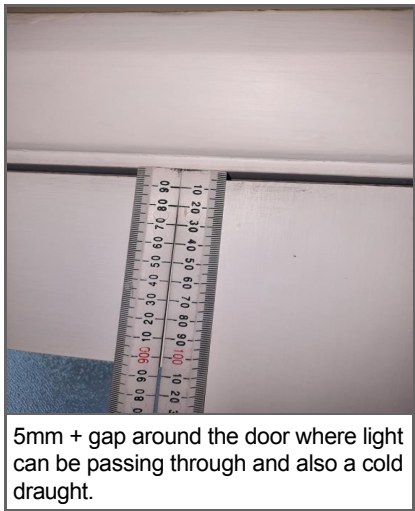
EXTERNAL DOORS 1

Location of door: Front door

Gaps or holes: Yes

Please comment further: 1 x weather seal.

Description	Quantity	Unit Price	Amount NZD
Installed draught stops and draught foam on front and back doors. Replaced faulty backing seals on some opening windows. Replaced alot of window latch striker plates that had broken off. Window hinges that were identified for replacement were stiff and hard to open but didnt need replacing, Managed to adjust hinges and free up with crc hinges and stiff opening latches . Windows all open and close freely now. Installed one new latch to the bathroom window			
Draught strips , seals and hardware	1.00	97.04	97.04
Labour	4.50	59.00	265.50
Travel	1.00	25.00	25.00
Subtotal			387.54
TOTAL GST 15%			58.14
TOTAL NZD			445.68

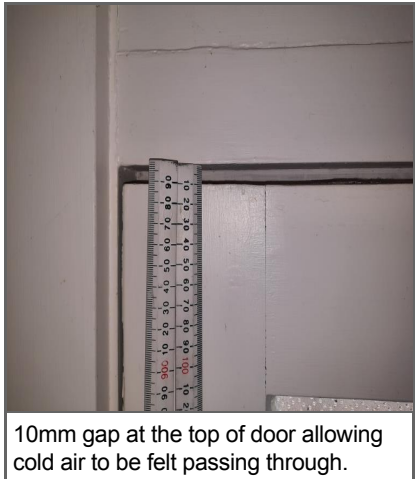
EXTERNAL DOORS 2

Location of door: Back door

Gaps or holes: Yes

Please comment further: 1 x weather seal.

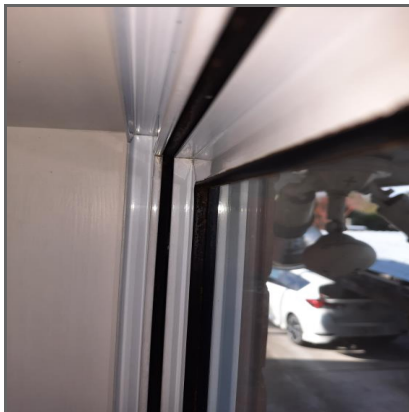
WINDOWS 1

Room: Dining room

Window hinges are worn and not allowing the window to pull tightly against the weather seals. Also the weather seals are incomplete.

Please comment further: 1 x weather seal and hinge replacement.

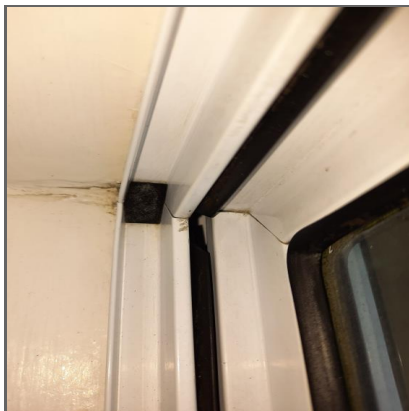
WINDOWS 2

Right hand window has incomplete weather seals which is not sealing the window effectively.

Please comment further: 1 x weather seal and hinge replacement. 1 x weather seal replacement.

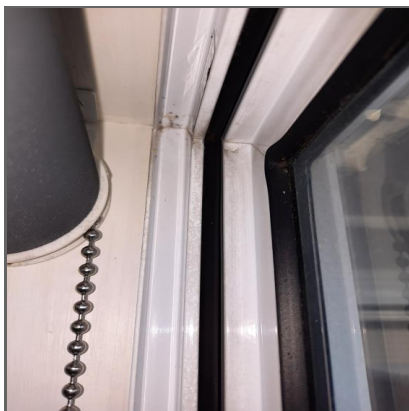
Left hand window above the sink has worn hinges that are not allowing the window to pull tightly against the weather seals and these weather seals are incomplete.

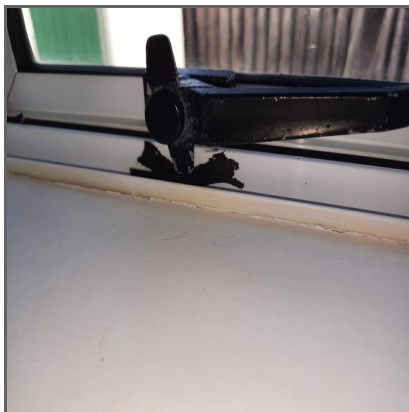
WINDOWS 3

Both handles are worn and not effectively holding the window shut against the weather seals.

Please comment further: 1 x weather seal and hinge replacement. 2 x new handles.

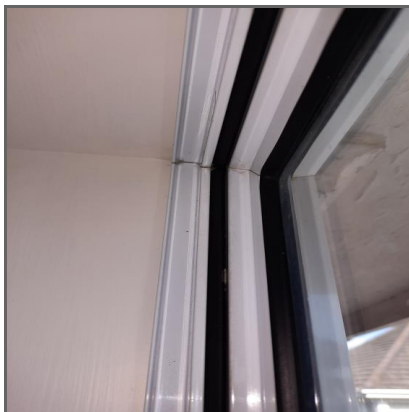
Window hinges are worn and not allowing the window to pull tightly against the weather seals.

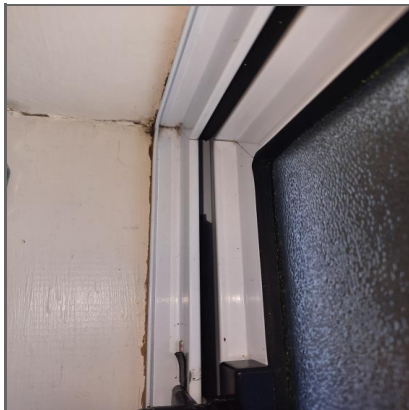
WINDOWS 4

Weather seals are incomplete and this will not seal the window effectively to stop cold air passing.

Please comment further: 1 x weather seal and hinge replacement. 2 x new handles.

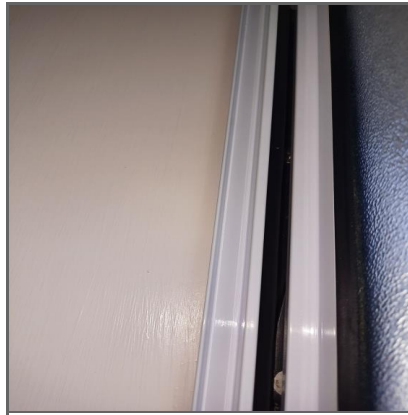
Window hinges are worn and not effectively pulling the window shut against the weather seals. Both window handles are also worn and not effective.

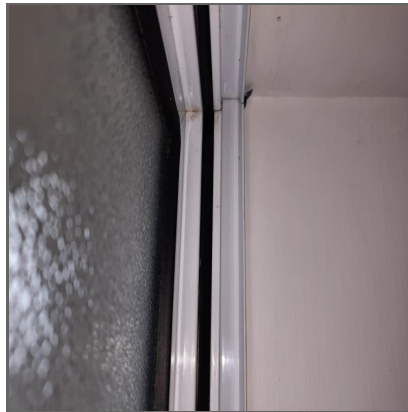
WINDOWS 5

Window hinges are worn and not effectively pulling the window shut against the weather seals.

Please comment further: 1 x weather seal and hinge replacement.

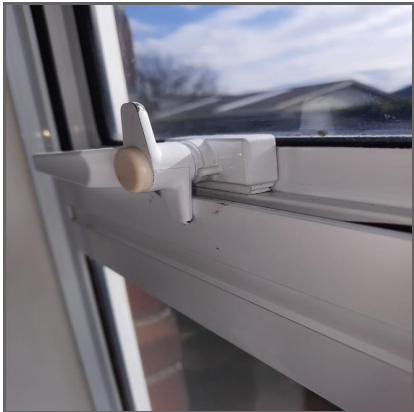
WINDOWS 6

Window handle on the right hand side is missing the catch tongue and not effectively holding the window shut.

Please comment further: 1 x new handle. 1 x weather seal.

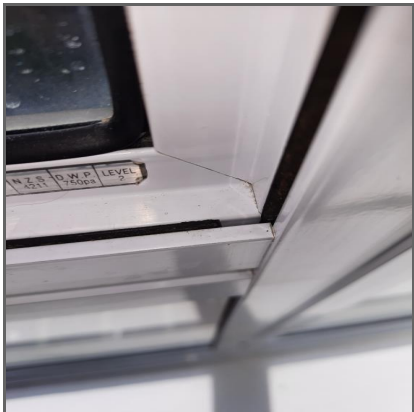
Weather seals are incomplete and not effectively sealing the window.

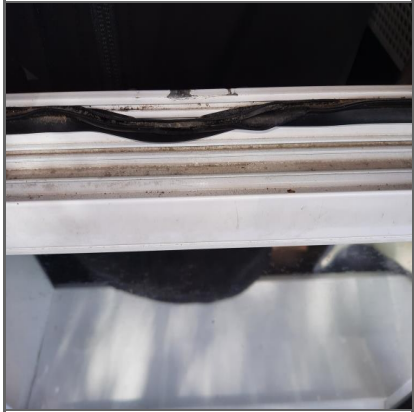
WINDOWS 7

Weather seal is damaged and will need to be replaced.

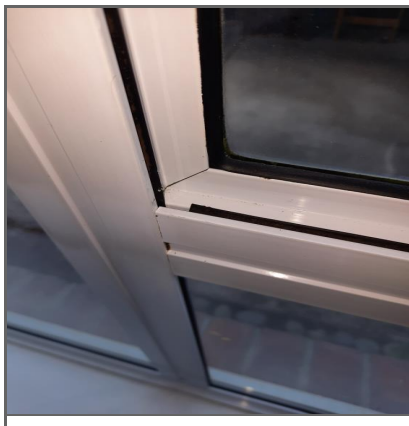
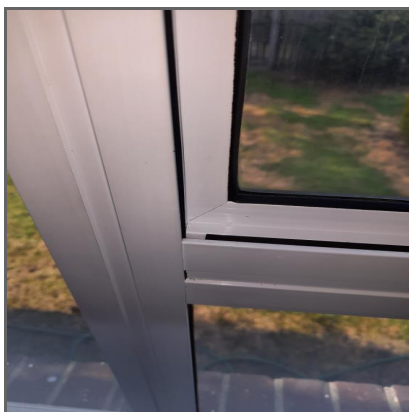
WINDOWS 9

Both windows have incomplete weather seals which is not effectively sealing when in the closed position.

Please comment further: 2 x weather seal.

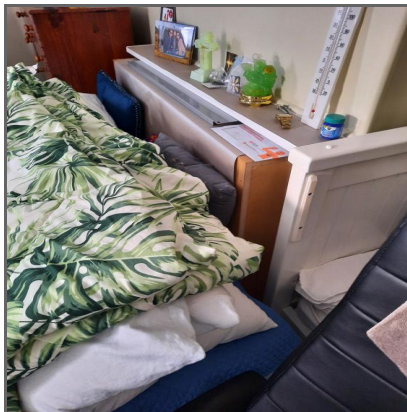
WALLS

Tenants have made a make shift draught stopper for the fire as apparently there is a draught coming through there.

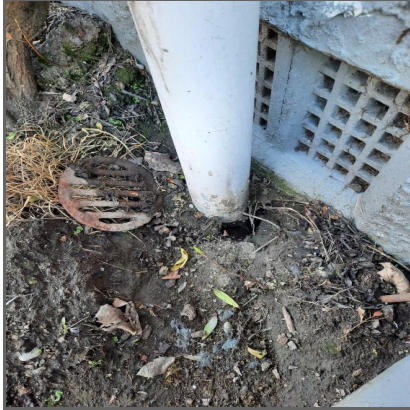
DOWNPIPES CONNECTED TO OUTFALL

There is a down pipe at the rear of the property that does appear to be running to an outfall but is severely blocked and I can not tell if it is in good working order.

Description	Unit	Qty	Unit Price	Total
13th July 2021.				
Completed stormwater repairs at 26a Garvin Road as per quote Q002286.				
Quoted Price - Quote Q002286		1.000	\$904.60	\$904.60
Subtotal:				\$904.60

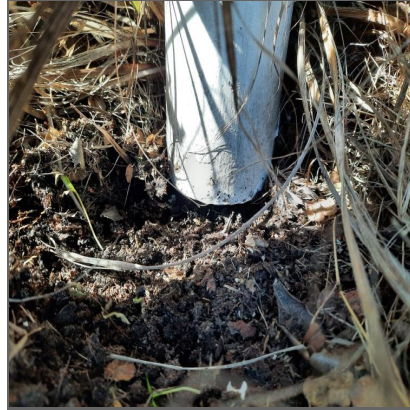
DOWNPIPES CONNECTED TO OUTFALL

There are two gutters present on the property that do not appear to be running to an outfall. This is not compliant and a drain layer will need to quote to have drainage layed.
