KIWI INSPECTIONS LTD

## RESIDENTIAL HOUSE INSPECTION

74 Amyes Rd  
Christchurch, Canterbury Region 8042

23/10/2025

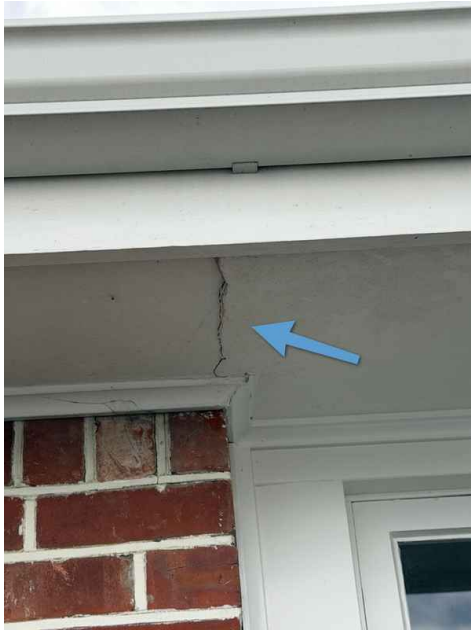
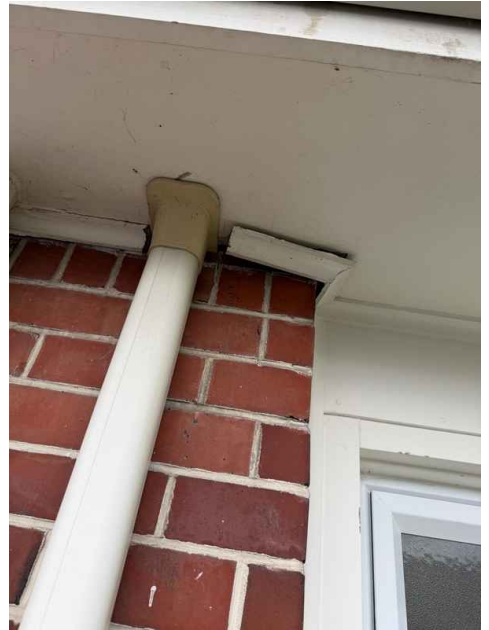
**SOFFIT DAMAGED**

The soffit is cracked/damaged, maintenance is suggested to the damaged areas by way of replacement as required.

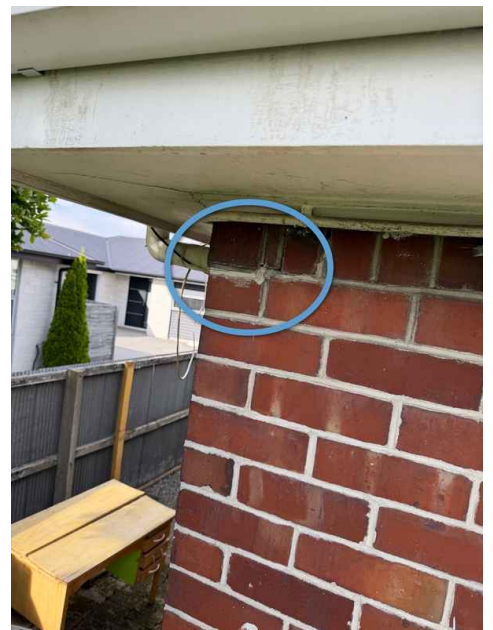
### 7.2.2 Masonry Veneer

#### LOOSE BRICKS

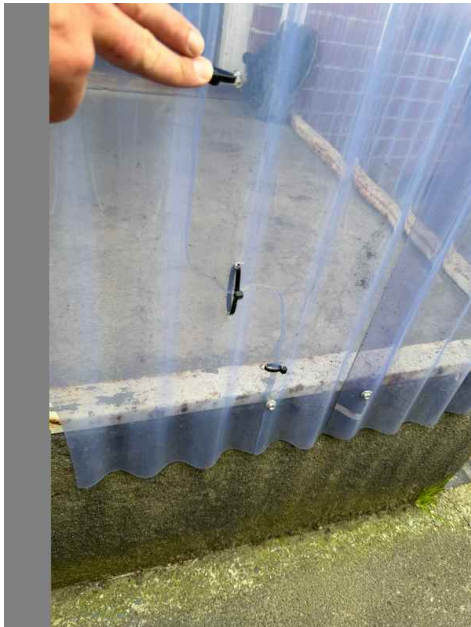
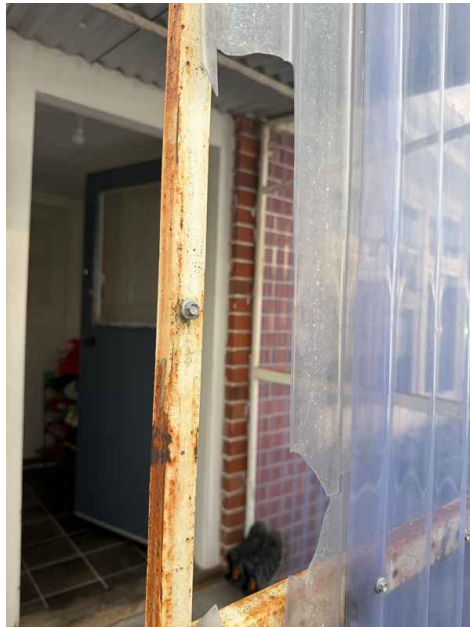
**SHEETS DAMAGED**

replace as required

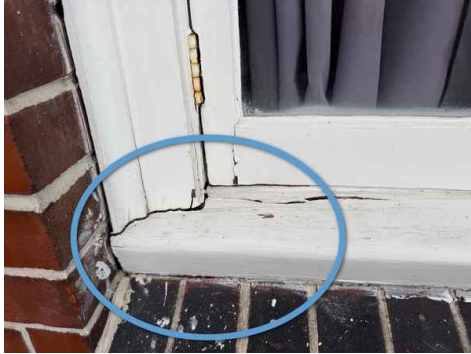
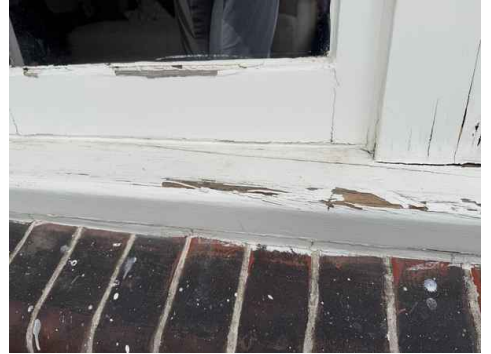
Timber coatings are worn and or deteriorated, maintenance to the paint system is recommended.

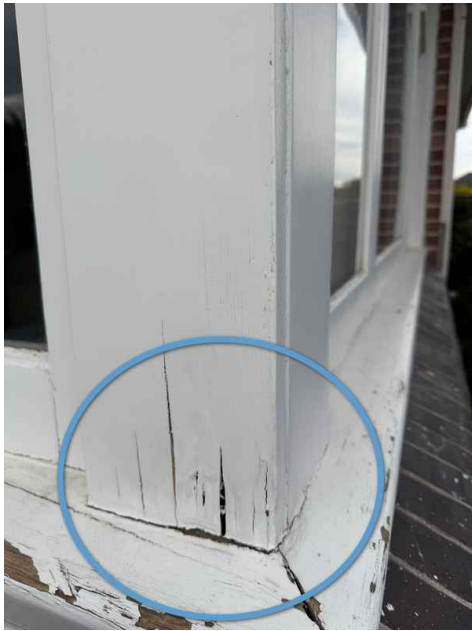
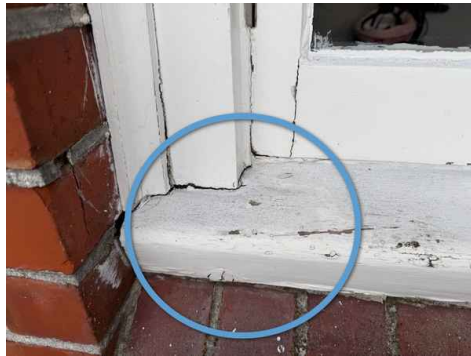
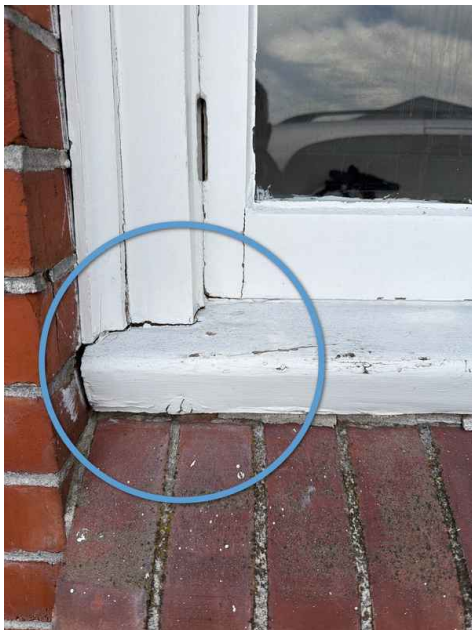
## 8.1.2 Exterior Joinery

**DECAY TO TIMBER WINDOW FRAME**

Decay is noted to the timber window frame, maintenance to the damaged area should be completed.

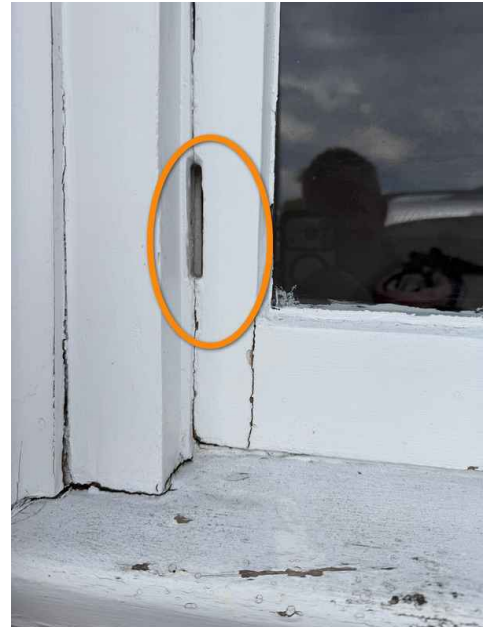
**MISSING HINGE**

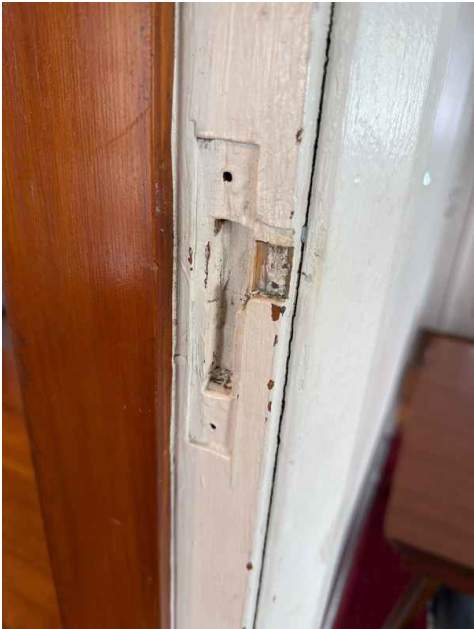
16.3.1 Internal Doors

**LATCH MISSING**

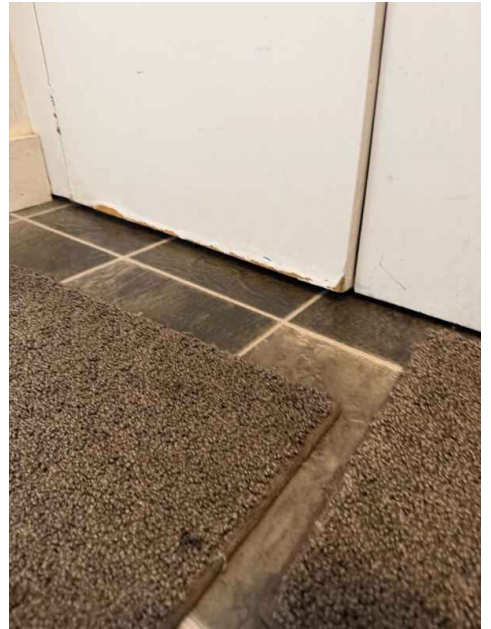
## 18.1.1 Laundry

**MOISTURE DAMAGE TO LAUNDRY  
CABINET NOTED**

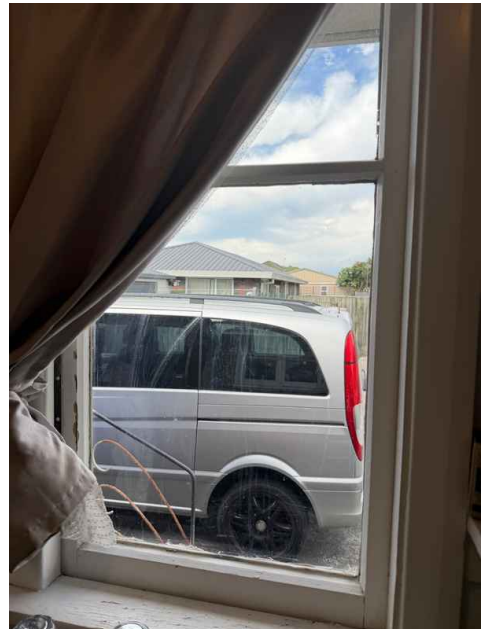
## 18.1.2 Laundry

**WINDOW REQUIRES ADJUSTMENT  
AND OR EASING TO RESTORE FUNCTIONALITY**

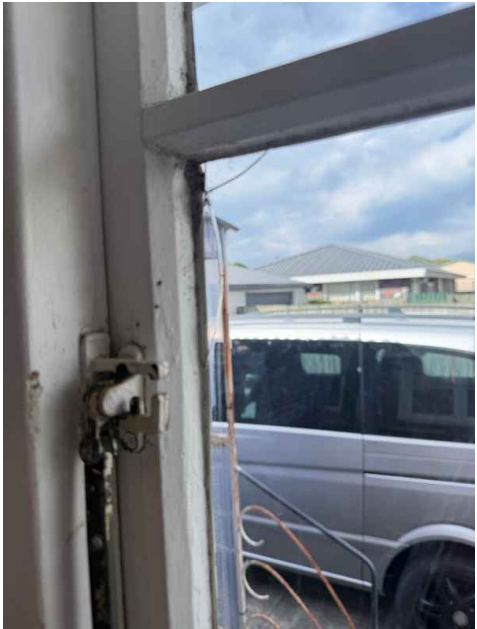
18.1.3 Laundry

**GLAZING CRACKED**

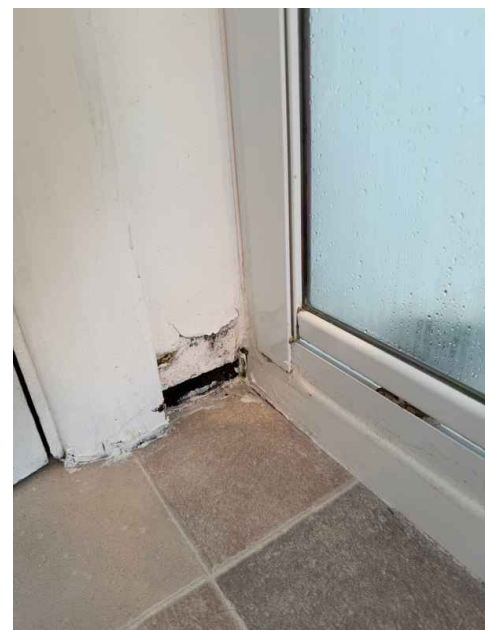
### MOISTURE DAMAGE IN AND AROUND SHOWER

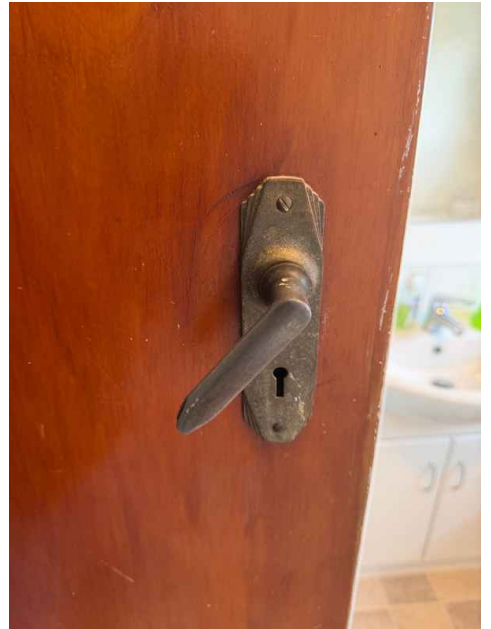
## 20.3.1 Internal Doors

**DOOR HANDLE REQUIRES  
MAINTENANCE**

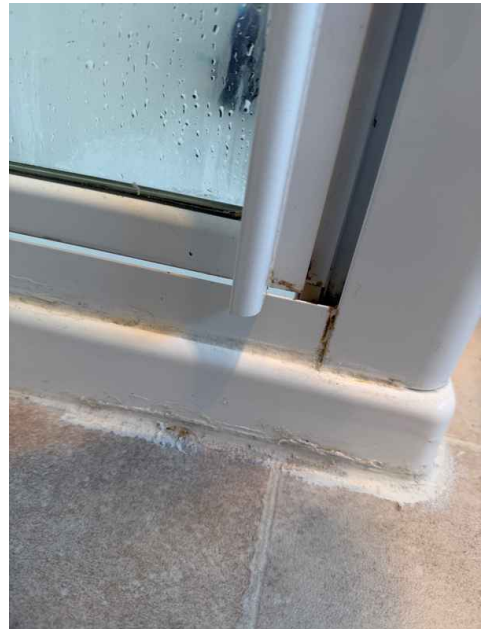
## 20.4.1 Floor Coverings

**SHOWER BASE TO FLOOR SEALANT  
UNTIDY**

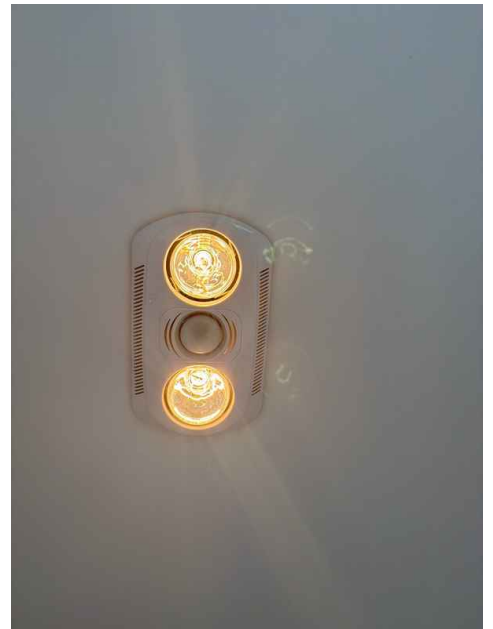
## 20.5.1 Electrical

**LIGHT NOT WORKING**

The light bulb may be blown , it is recommended that this is replaced, if this does not solve the issue an electrician should be engaged to repair and or replace as required.

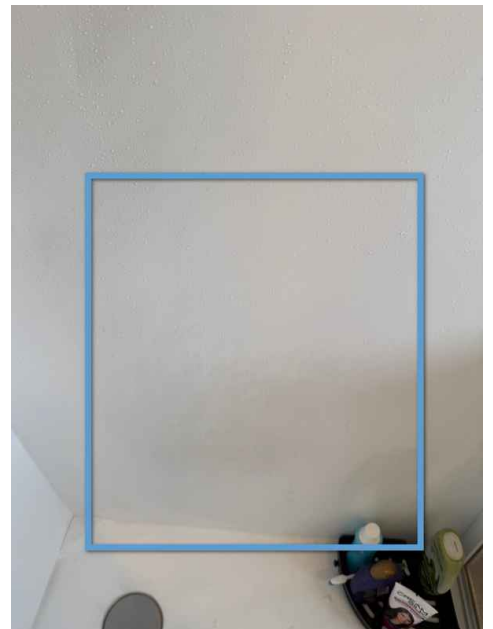
## 20.7.1 Shower

**SHOWER LINER LOOSE TO SOME AREAS**

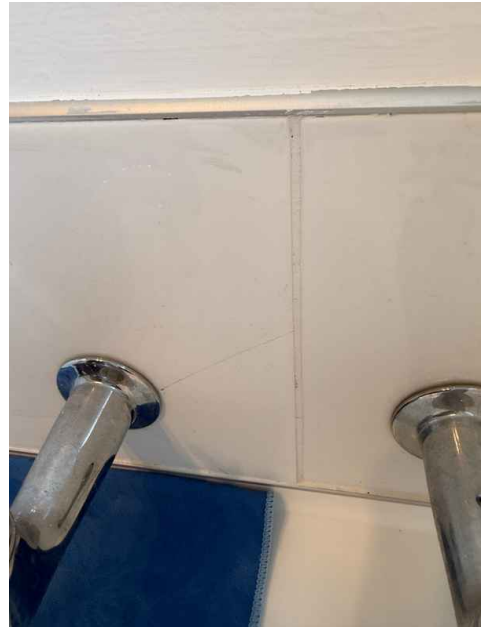
## 20.8.1 Bath

**CRACKED TILES AROUND BATH**

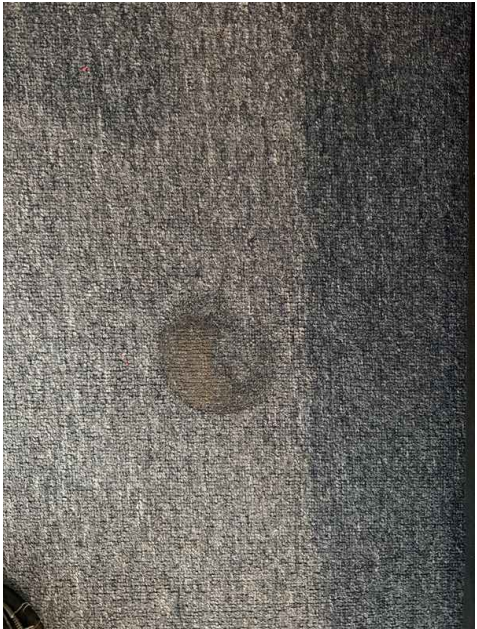
21.4.1 Floor Coverings  
**CARPET DAMAGED**

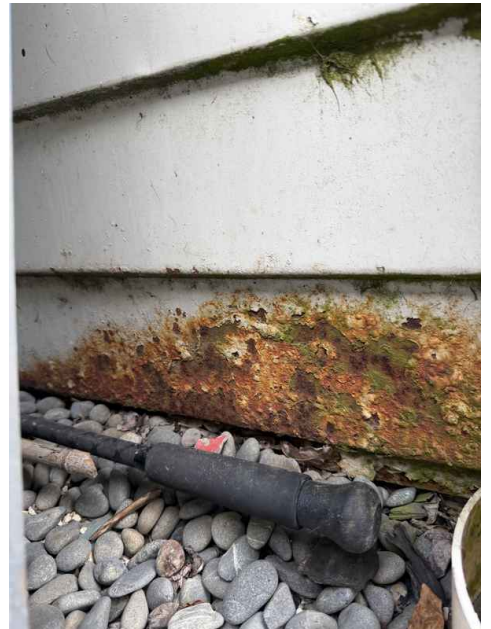
## 25.4.1 Defects Wall System

**CORROSION TO CLADDING NOTED**
