BUILDING DETAILS

Property address: 74 Amyes Road, Hornby, Christchurch, 8042

Date of assessment: Tue, 18-Aug-20

Assessor name: Clinton Smither

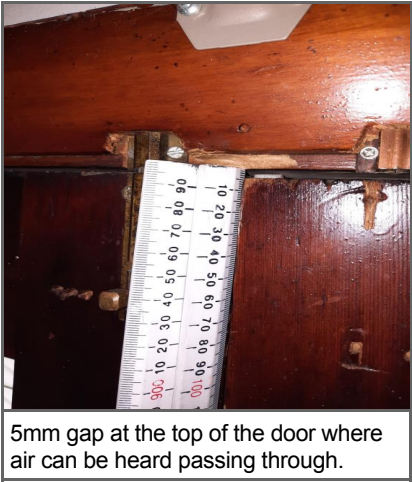
GAP IF NOT COMPLIANT

EXTERNAL DOORS 1

Location of door: Front door

Gaps or holes: Yes

Please comment further: 1 x French door weather seal. 2 x brush seals.

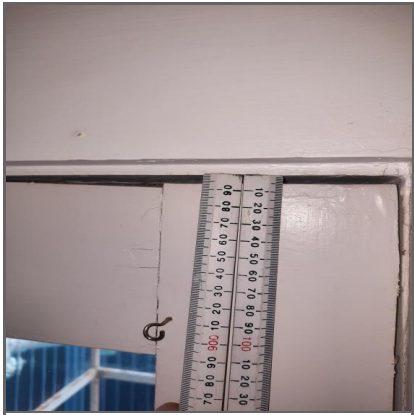
GAP IF NOT COMPLIANT

5mm gap at the top of the door where cold air can be felt passing through.

Please comment further: 1 x weather seal. 1 x brush seal.

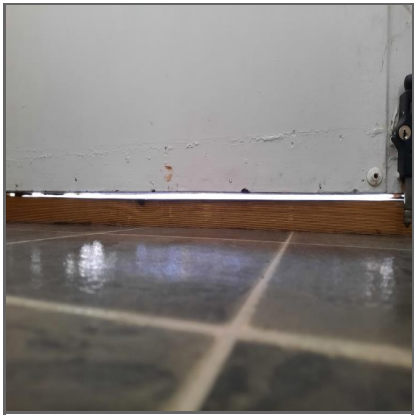
ADDITIONAL PHOTO

Large gap under the door where cold air can be felt passing through.

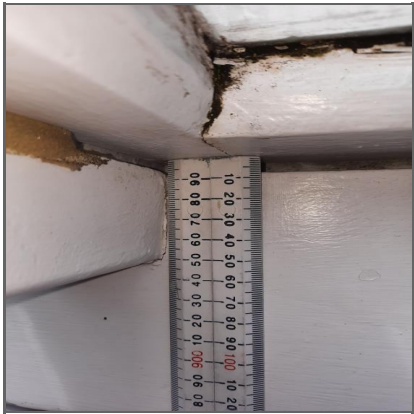
GAP IF NOT COMPLIANT

Bottom right hand casement has non effective existing weather seal and 7mm gap at the bottom. Air can be felt passing through.

Room: Bedroom 1
Gaps or holes: Yes
Please comment further: 3 x weather seal.

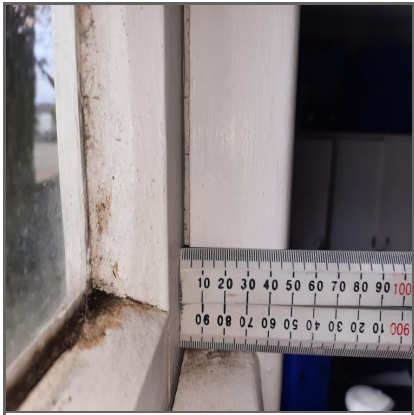
ADDITIONAL PHOTO

Both awning windows have small 3-4mm gaps but air can still be felt passing through.

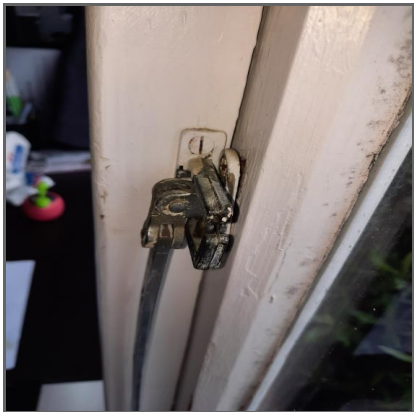
GAP IF NOT COMPLIANT

Right hand window, right hand bottom window casement has a damaged and non effective latch the will need to be replaced.

Room: Bedroom 2
Gaps or holes: Yes
Please comment further: 1 x new latch. 2 x weather seal.

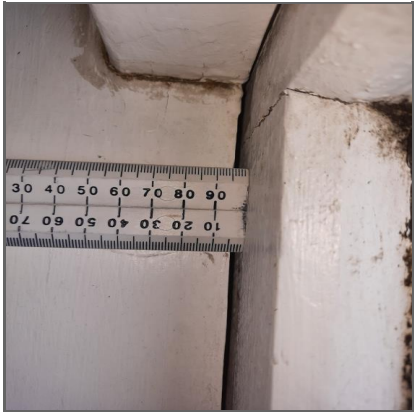
ADDITIONAL PHOTO

Both the bottom right casement and top right awning window on the right hand window have gaps where air can be felt passing through.

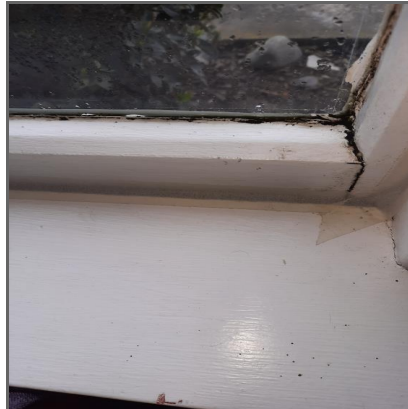
GAP IF NOT COMPLIANT

Left hand bottom casement has been taped shut due to 8mm+ gap. This is partly due to the window latch being non effective and the window being slightly warped.

Please comment further: 2 x weather seals. 1 x new latch.

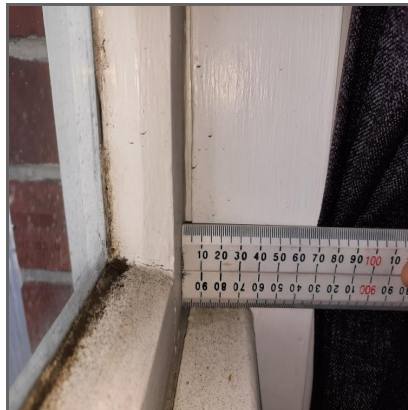
ADDITIONAL PHOTO

4mm gap on the top right awning window allowing air to pass through.

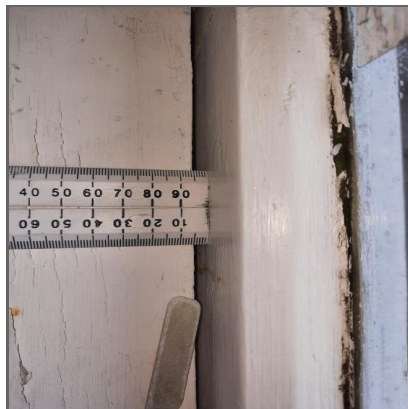
GAP IF NOT COMPLIANT

5mm gap at the bottom the window.

Please comment further: 1 x weather seal.

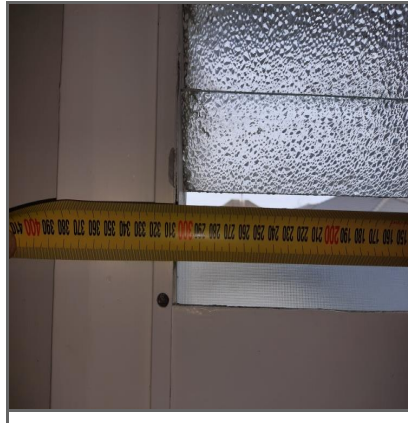
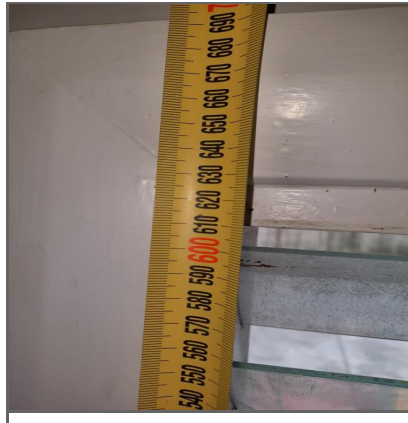
GAP IF NOT COMPLIANT

Please comment further: Louvre windows are no longer compliant and must be replaced. H=610mm W=335mm

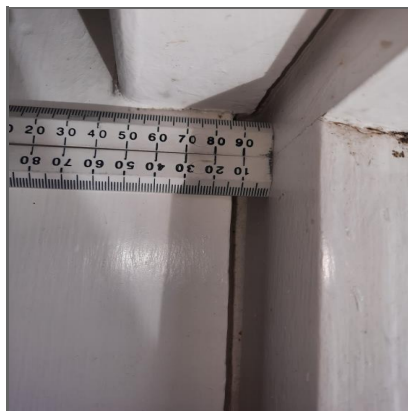
GAP IF NOT COMPLIANT

Both casement windows present large gaps and will also need to be eased so they can close properly against installed weather seal.

Please comment further: 3 x weather seal.

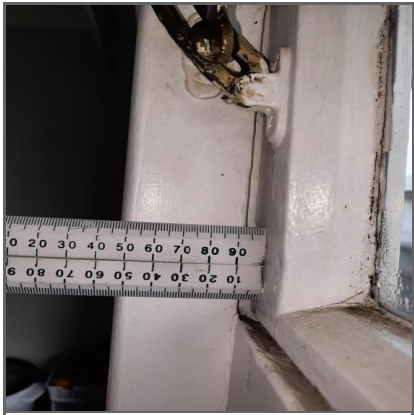
ADDITIONAL PHOTO

Top awning window is the same as the left and right casement windows.

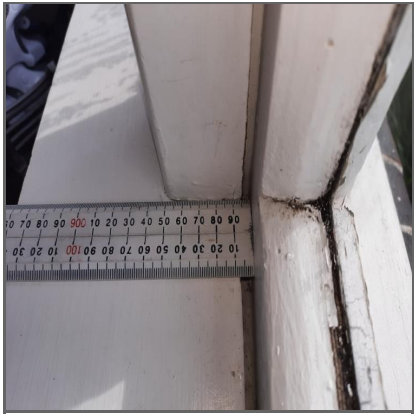
GAP IF NOT COMPLIANT

2 x window casements have large gaps and will need to be eased so they close tightly against installed weather seals

Room: Lounge
Gaps or holes: Yes
Please comment further: 5 x weather seals.

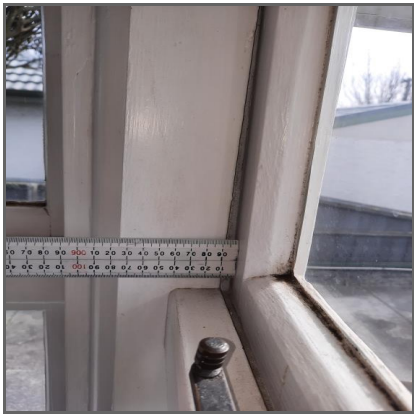
ADDITIONAL PHOTO

3 x awning windows are the same as the casement windows.

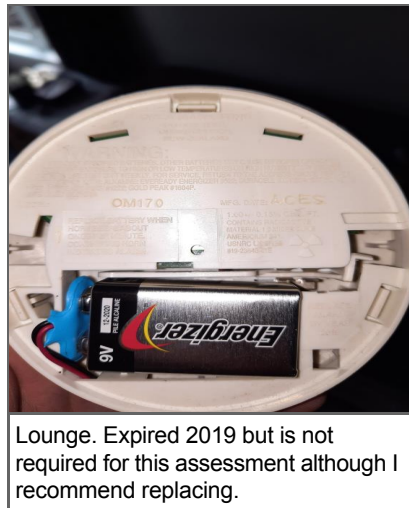
Lounge. Expired 2019 but is not required for this assessment although I recommend replacing.

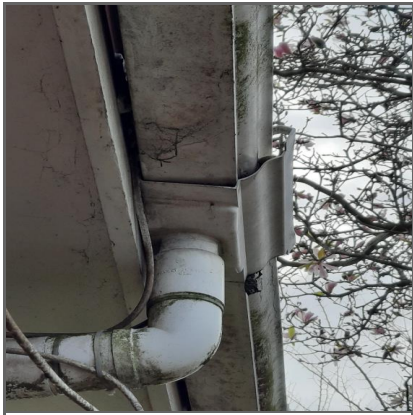
DOWNPIPES

Gutter on the left hand side of the property is disconnected and damaged.

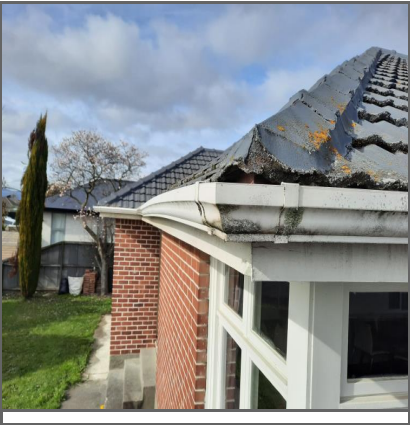
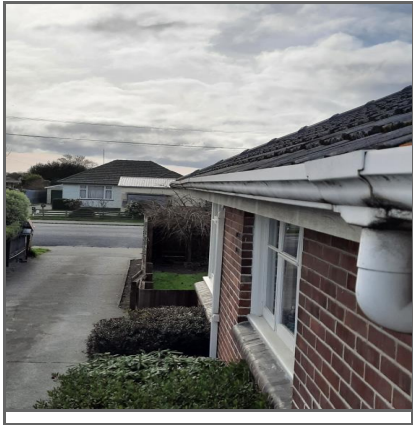
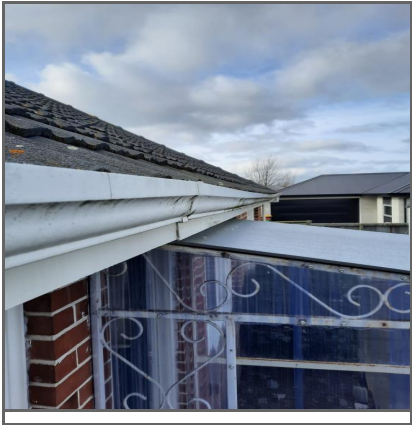
NON-COMPLIANT GUTTER

Gutters present with correct fall: No

Comment further: Gutters around the property are sagging and do not present with the correct fall to the limited amount of down pipes at the property. The gutters are also in poor condition and a full re gutter will be quoted for.
