CASH SETTLED CLAIM(S)

EARTHQUAKE COMMISSION

Statement of Claim Checklist

Situation of Loss: Flat 3/75 Ardour St
Merivale.

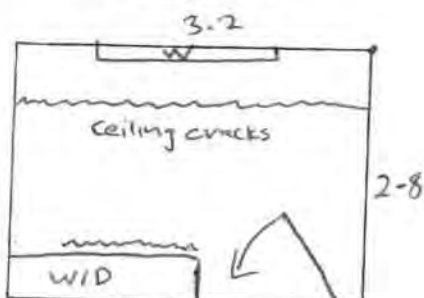
Bed 1

DESCRIPTION: MINOR CRACKS TO CEILING

REPAIR STRATEGY: RAKE OUT CRACKS, TAPE JOINTS, PLASTER, SAND, PAINT

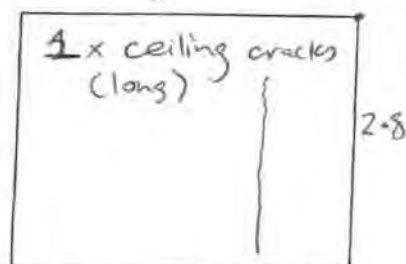
Bed 2

DESCRIPTION: MINOR CRACKS TO CEILING

REPAIR STRATEGY: RAKE OUT CRACKS, TAPE JOINTS, PLASTER, SAND, PAINT

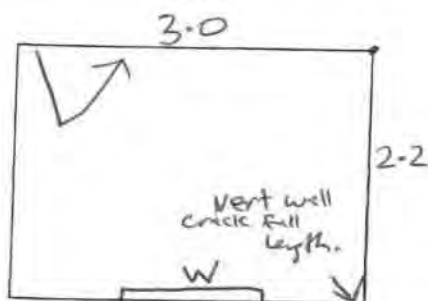
Bed 3

DESCRIPTION: MINOR CRACKS TO WALLS

REPAIR STRATEGY: RAKE OUT CRACKS, TAPE JOINTS, PLASTER, PAINT WALLS.

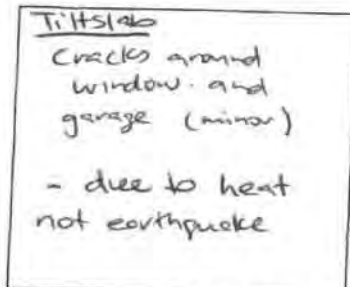
East Ext (back)

Item		Event Damage	Description of Damage	Appoint Engineer
		Y / N	Y / N	
Roof		N		
External Walls	North	N		
	South	N		
	East	Y	Minor cracks in tilt slab panels, thermal	
	West	Y	Minor cracks in tilt slab panels, thermal.	
Decks		N		
Chimney	Base	N/A	N/A	
	Ceiling Cavity	N/A	N/A	
	Above Roof	N/A	N/A	
	Fireplace	N/A	N/A	
Foundations		N		
Piling		N/A	N/A	
Services		N		
Other Dwelling Items		N/A	N/A	
Outbuildings		Y	1m crack in slab, crack above back door.	
Land & Retaining Walls		N/A	N/A	
(Discuss with Supervisor)

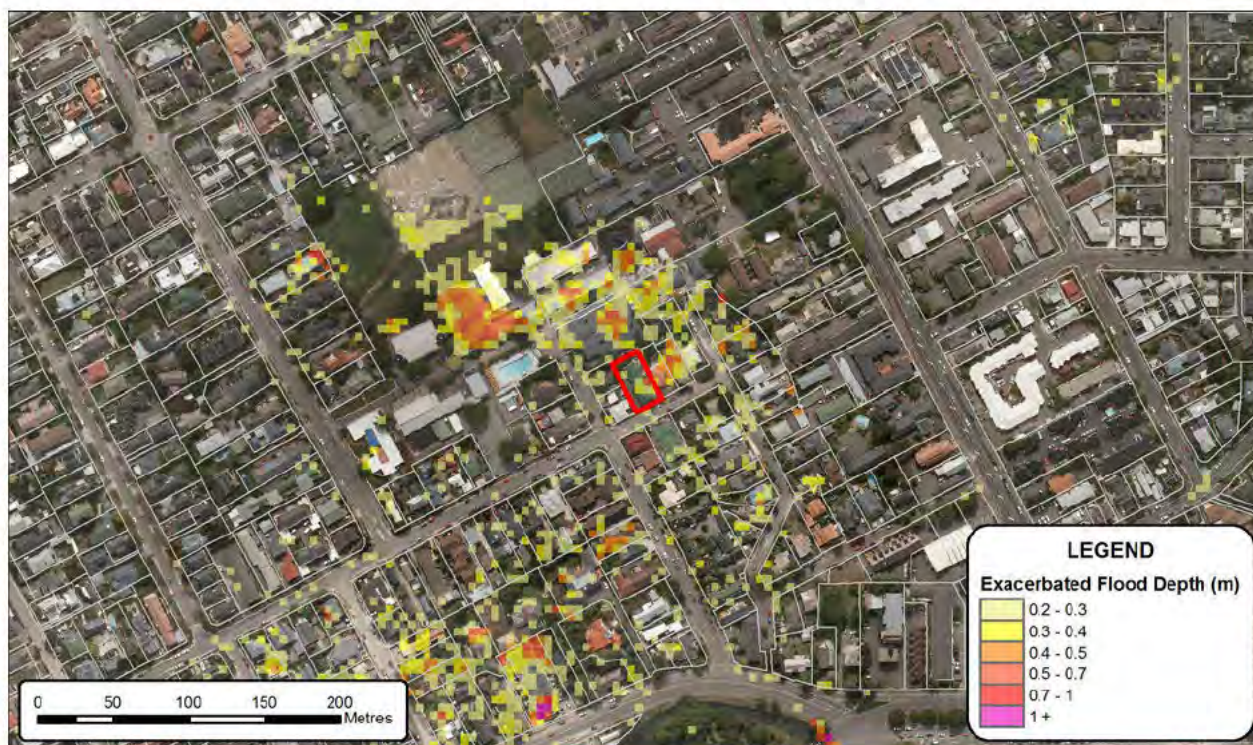
Map 1: Exacerbated flood depth 1 in 100 year flood event

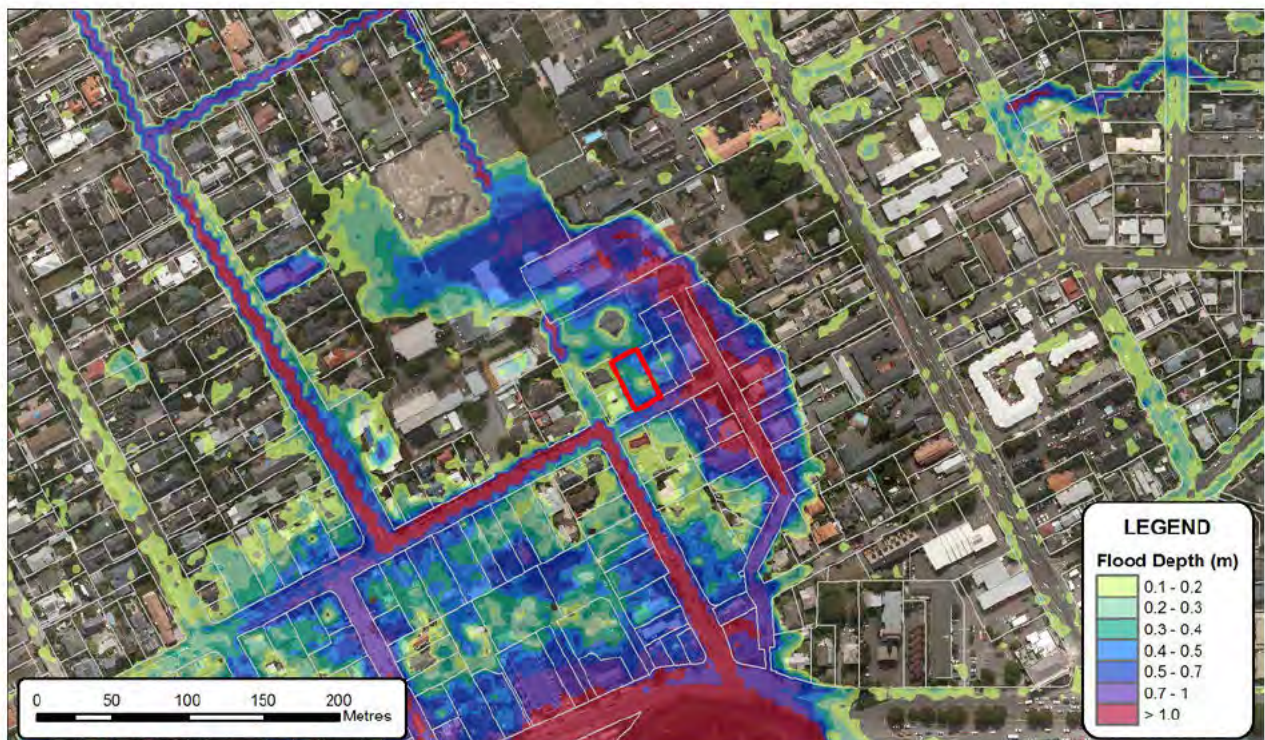
Map 2: Modelled flood depths for a 1 in 100 year flood event before Canterbury earthquake sequence

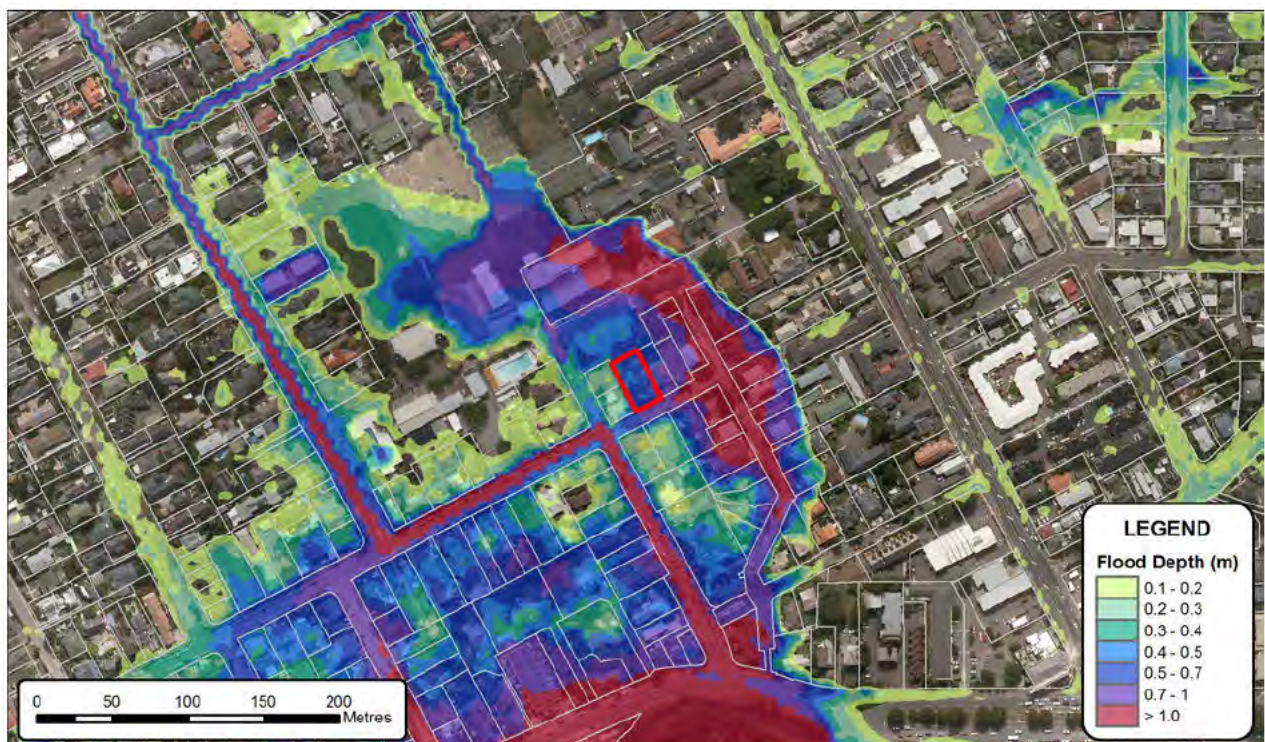
Map 3: Modelled flood depths for a 1 in 100 year flood event after the Canterbury earthquake sequence

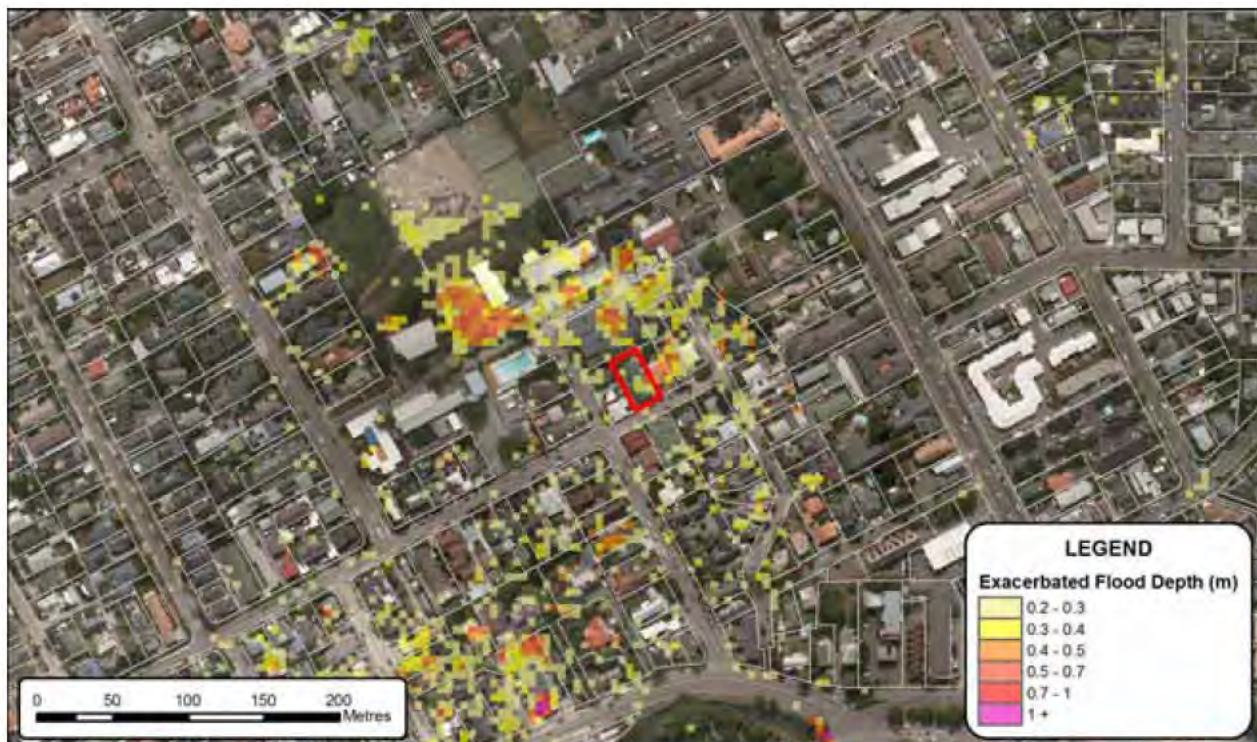
Map 1: Exacerbated flood depth 1 in 100 year flood event

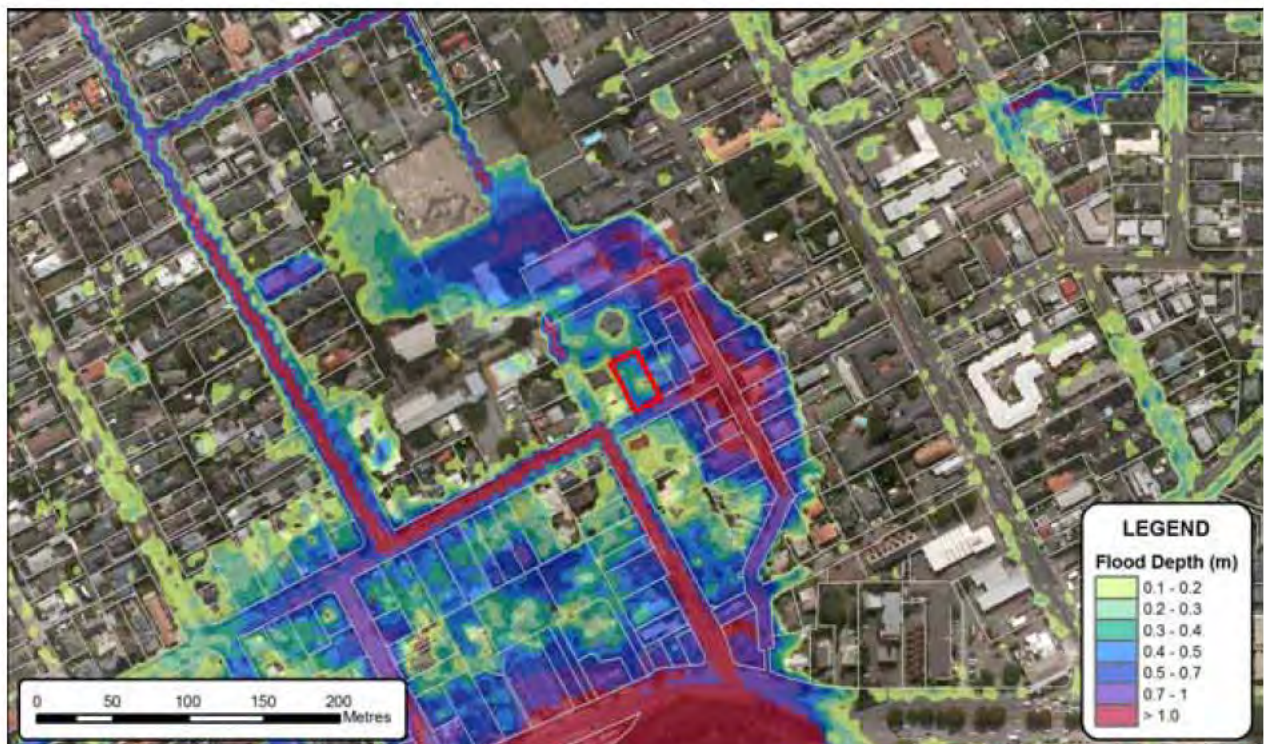
Map 2: Modelled flood depths for a 1 in 100 year flood event before Canterbury earthquake sequence

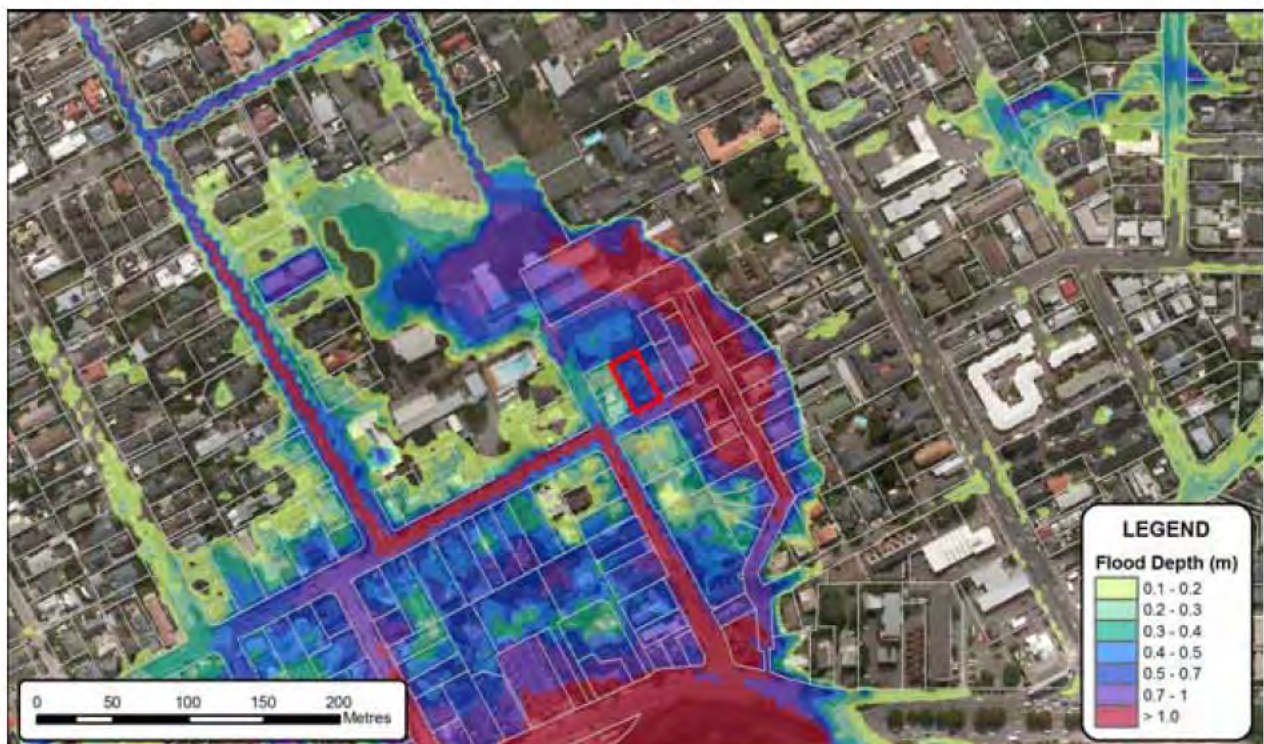
Map 3: Modelled flood depths for a 1 in 100 year flood event after the Canterbury earthquake sequence

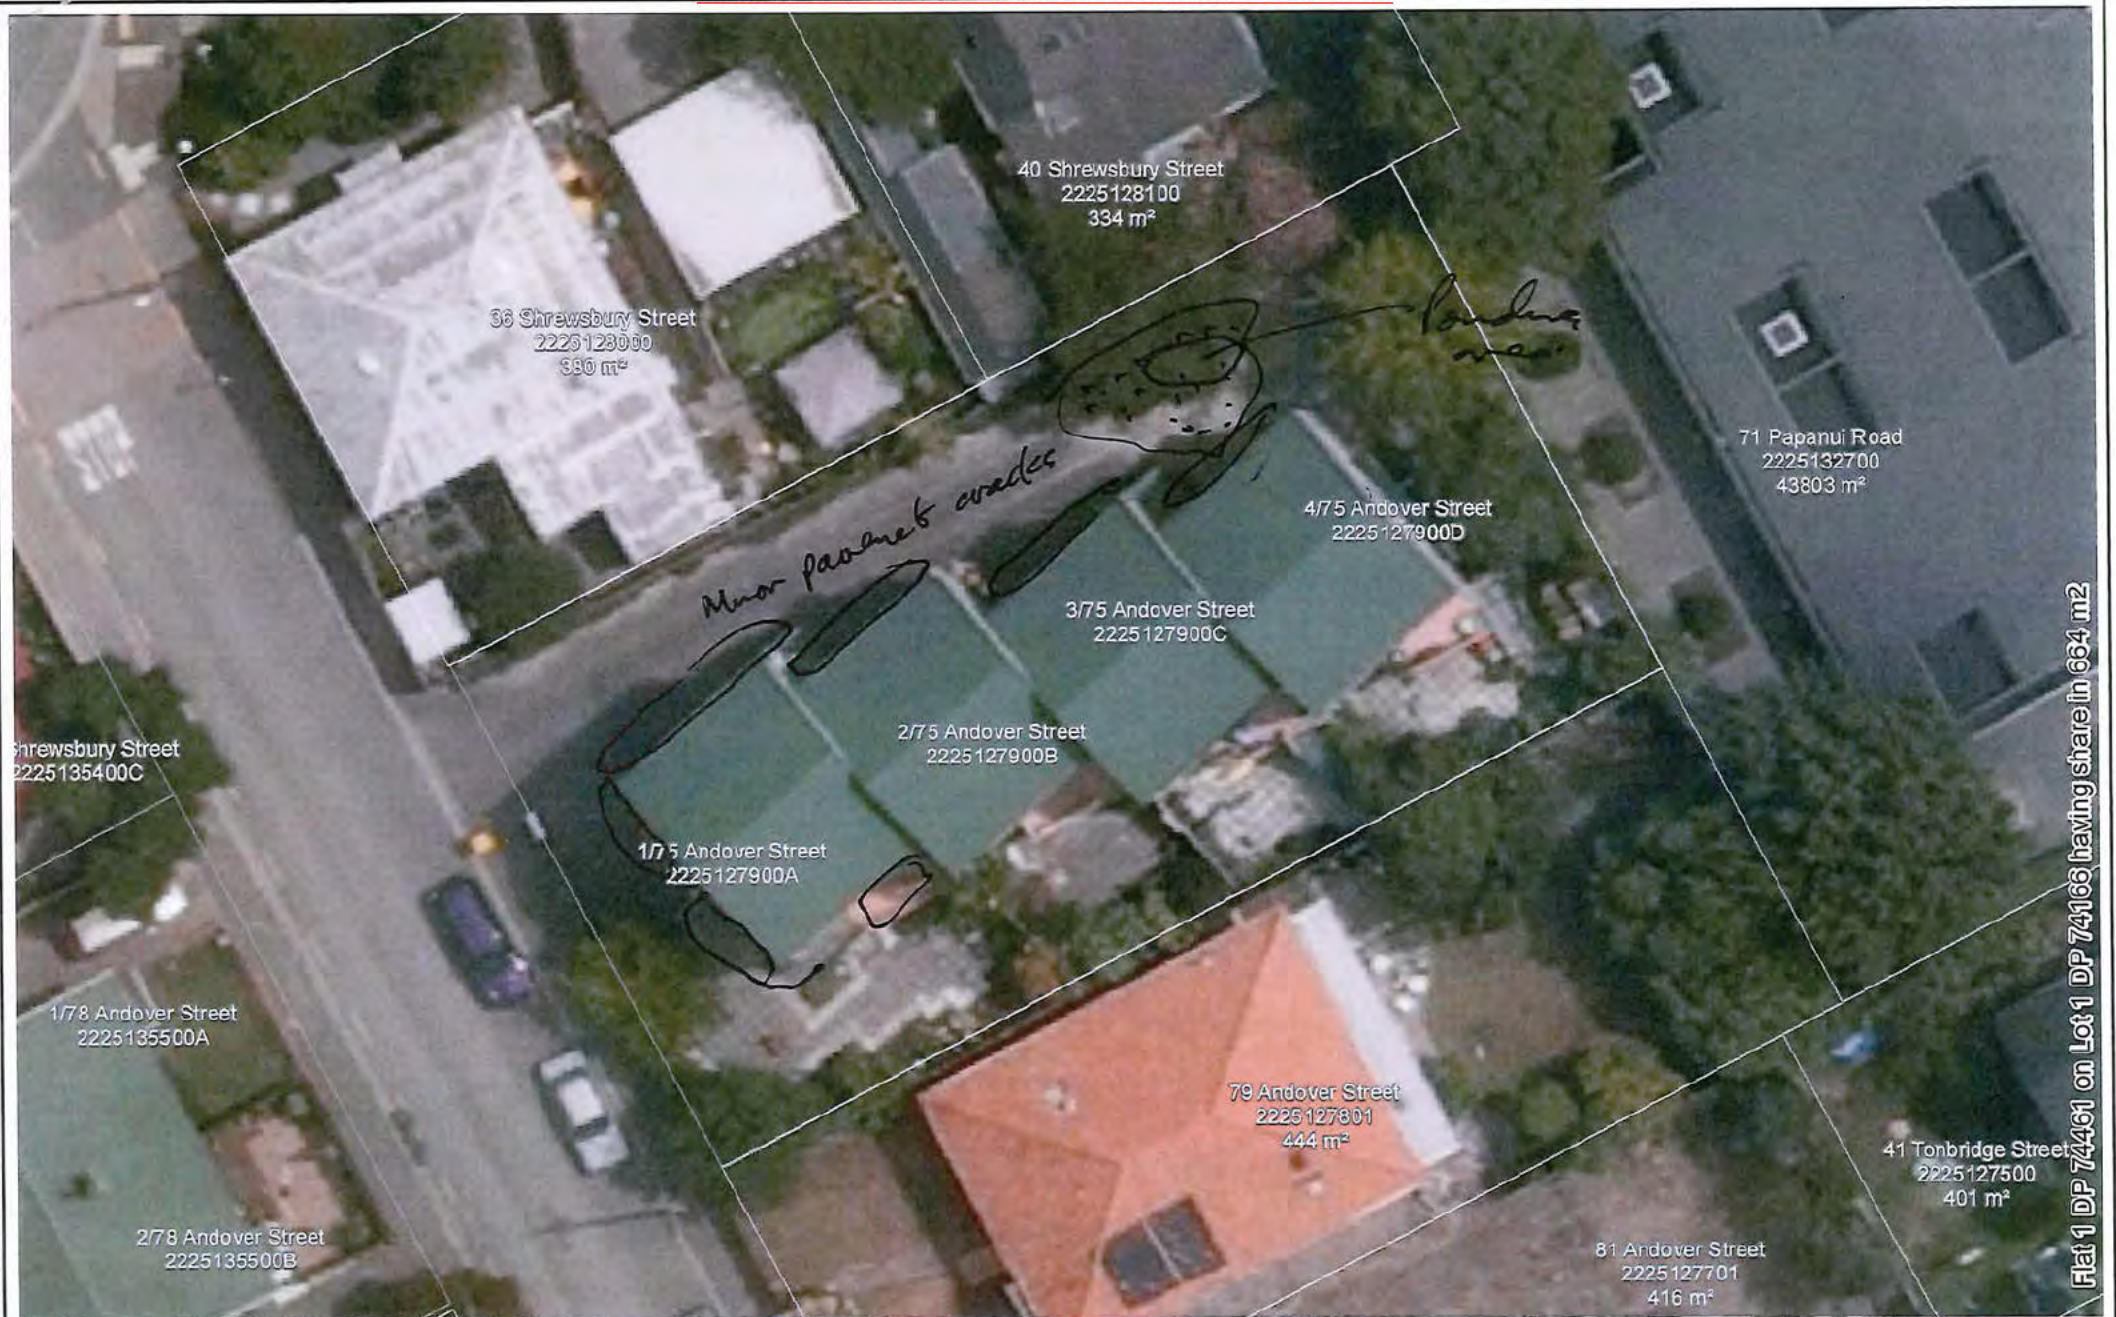
○ Ponding areas. caused by global settlement
