EARTHQUAKE RECOVERY (EQR) DOCUMENTATION

Released under the Official Information Act 1982 EQR Property Overview Report

Company	Fletcher EQ	R (division of I	FCC) as agent for E	QC								Printed Da	te: 26-04-2018
EQC Property ID	Property Ac	idress			Vulne	erable?	Property F Stat	us	Property Finalisa	tion Indicator			
2010032990	4/75 ANDO	/ER STREET,	, MERIVALE				F3 - Complete &	k Finalised	Some Finalisatio	n has taken pla	ce		
Main Contractor:	CLOSED O	JT-National D	ecorators Limited **	***** (SB42	2)		Property F2'd By	:	EQR\AndrewAr		F2 Complete	ed Date:	25-03-2015
Cont Managing Hub	: <multiple< td=""><td>></td><td></td><td></td><td>VULN</td><td>IERABLE</td><td>Property F3'd By</td><td>':</td><td>System Generated</td><td>d Finalisation</td><td>F3 Complete</td><td>ed Date:</td><td>07-05-2015</td></multiple<>	>			VULN	IERABLE	Property F3'd By	':	System Generated	d Finalisation	F3 Complete	ed Date:	07-05-2015
Adjustments

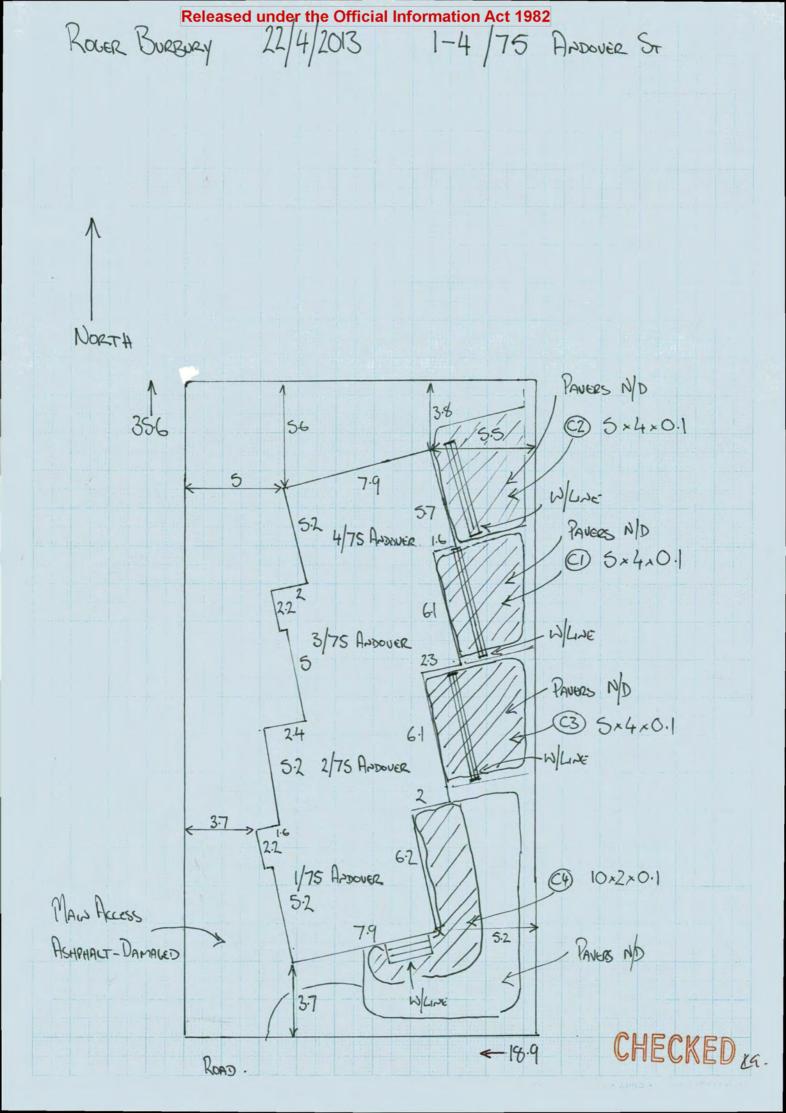
ituati	on c						Author:	K Buezi	sry	
Item N°	Description/Construction	Length	Height/ Width	Depth	Damage	Damaged Area	Evacuated m ²	Inundated m ²	Debris m³	Access E D
-1	LAND UNDER PAVERS 3/75 ANDONOR. ST.	5	4	0.1	UNDULATING LAND	20	20~2			ϵ
2	LAND UNDER PAVERS 4/75 AMDONER ST	5	4	0.1	CIAJ JAMAJUGAU	20	20 m2			ϵ
3	LAND UNDER PAVERS 2/75 ANDOVER ST	5	4	0.1	UNDUCATING LAND	20	20m²			E
-4	LAND UNDER PAVERS	10	2	0.1	GLAJ JULTAJUGGU	20	20 m²			ϵ

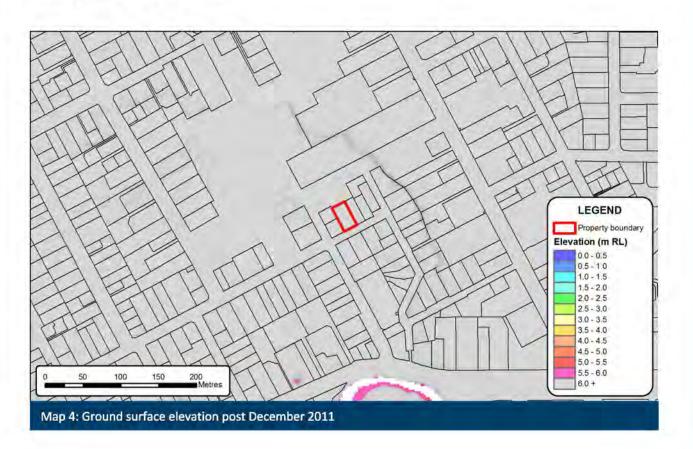
Map 4 shows the ground elevation (i.e. the height of the land) following the Canterbury earthquake sequence. The ground surface elevation was measured using an aerial LiDAR survey (which involved scanning the ground surface from an aircraft). This post-earthquake ground elevation survey is a key input into the modelling of the post-earthquake flood depth. Similar surveys were used as an input into the modelling of pre-earthquake flood depths.
