EQC CLAIM DOCUMENTATION

Released Under the Official Information Act 1982
EQR Property Overview Report

EQC Property ID	Property Address	Vulnerable?	Property F Status	Property Finalisation Indicator		
2010125315	10 SOPHORA PLACE, PARKLANDS		F3 - Complete & Finalised	Some Finalisation has taken place		
Main Contractor:	CLOSED OUT-Bruce Radovonich Builder ***** (S268)		Property F2'd By:	EQR\JamesL	F2 Completed Date:	17-10-2014
Cont Managing Hub:	Pages	Not Vulnerable	Property F3'd By:	Suzanne Loach	F3 Completed Date:	07-01-2015

Increased Liquefaction Vulnerability (ILV) Engineering Assessment

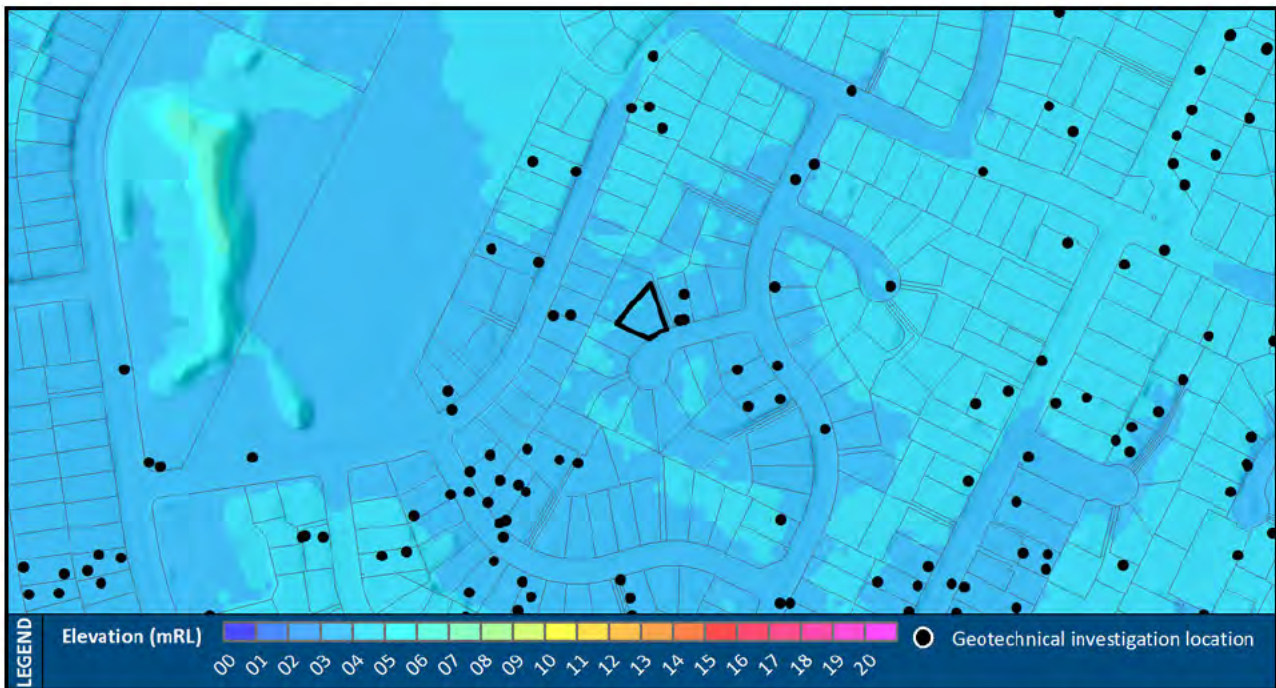
Map 1: Post Canterbury earthquake sequence ground surface elevation and geotechnical investigation locations

This map shows the ground surface elevation (i.e. the height of the land) following the Canterbury earthquake sequence. The elevation shown is the height above mean sea level.

The black dots show the locations of geotechnical investigations. These comprise a combination of Cone Penetration Tests (CPTs), boreholes and laboratory tests.

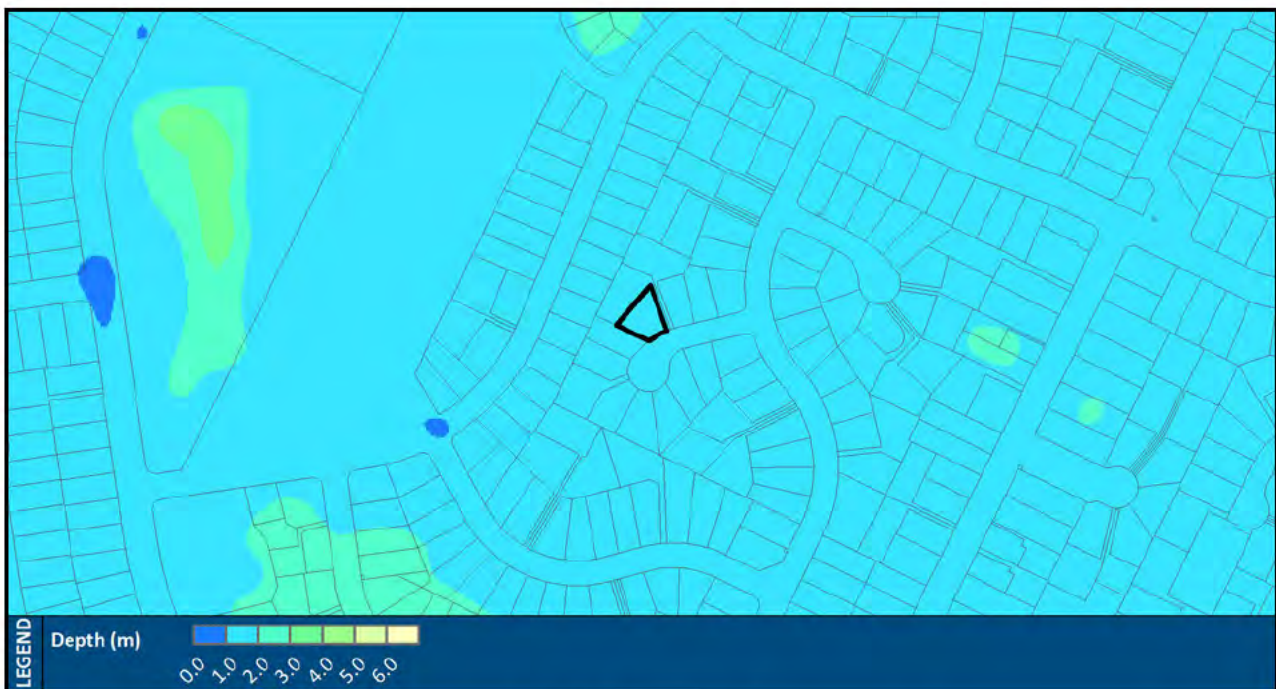
Map 2: Post Canterbury earthquake sequence depth to groundwater

This map shows the median depth to groundwater below the ground surface after the Canterbury earthquake sequence.

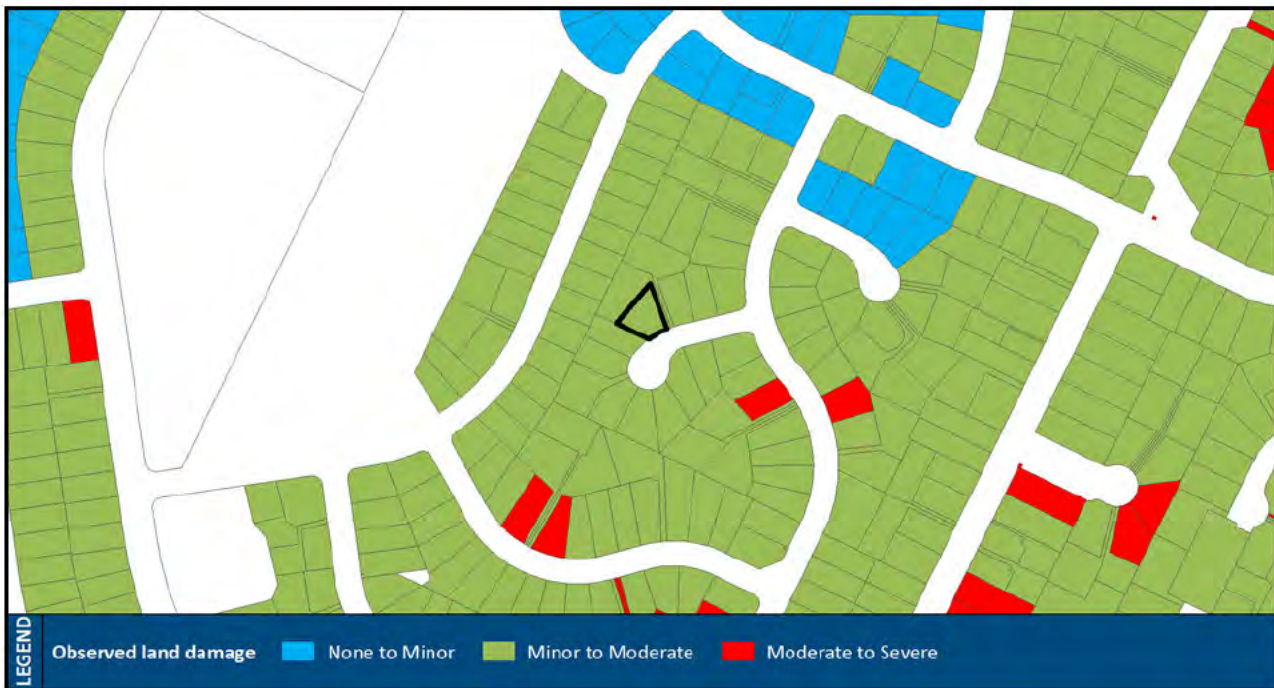
Map 3: Worst observed land damage due to the Canterbury earthquake sequence

This map shows the worst observed land damage recorded for the four main earthquakes during the Canterbury earthquake sequence. Descriptions of the observed land damage categories are: **None to Minor** – no observed liquefaction related land damage through to minor observed ground cracking but with no observed ejected liquefied material at the ground surface; **Minor to Moderate** – observed ground surface undulation and minor-to-moderate quantities of observed ejected liquefied material at the ground surface but with no observed lateral spreading; and **Moderate to Severe** – large quantities of observed ejected liquefied material at the ground surface and severe ground surface undulation and/or moderate-to-severe lateral spreading.

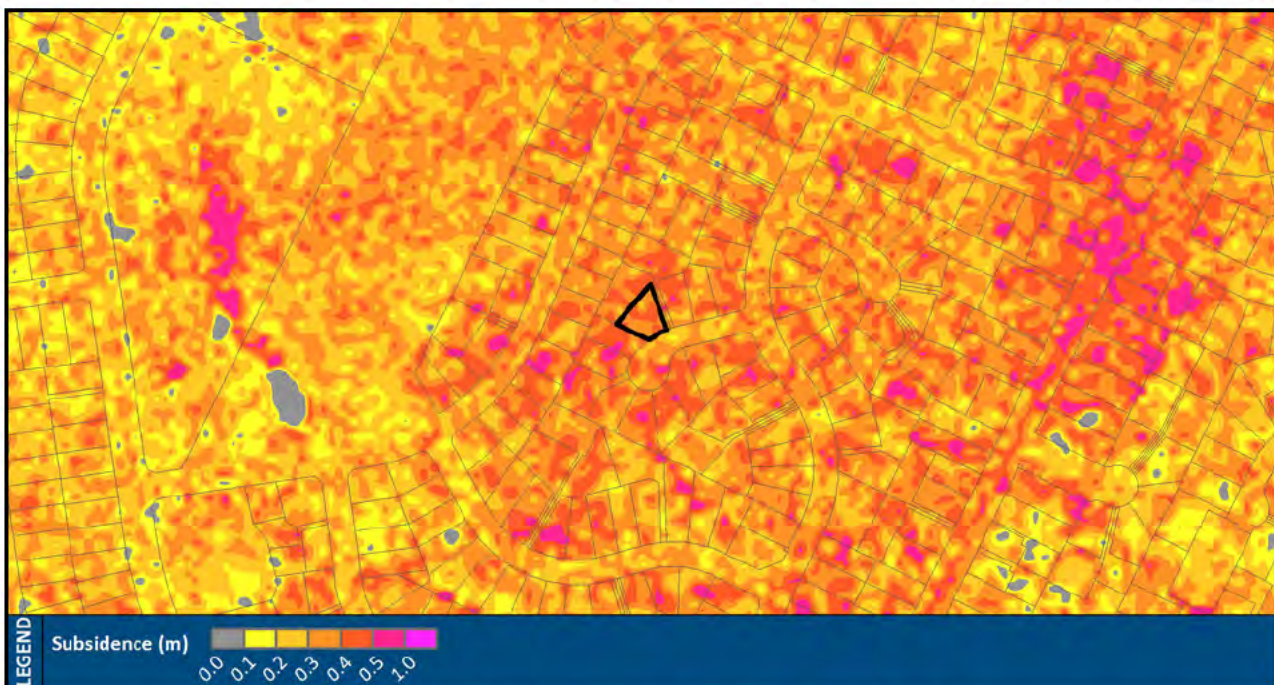
Map 4: Total ground surface subsidence due to the Canterbury earthquake sequence

This map shows the estimated total amount of ground subsidence as a result of the Canterbury earthquake sequence. Ground surface subsidence is estimated by comparing ground surface levels after each of the four main earthquakes. Adjustments have been made to the map to remove subsidence or uplift that is not as a result of the Canterbury earthquake sequence (e.g. man-made activities such as earthworks).
