STRUCTURAL ASSESSMENT  
49B INWOODS ROAD,  
PARKLANDS,  
CHRISTCHURCH  
PROJECT NO. 1371-2502

# STRUCTURAL ASSESSMENT REPORT

**49B Inwoods Road, Parklands, Christchurch**

**Date: 27/02/2025**

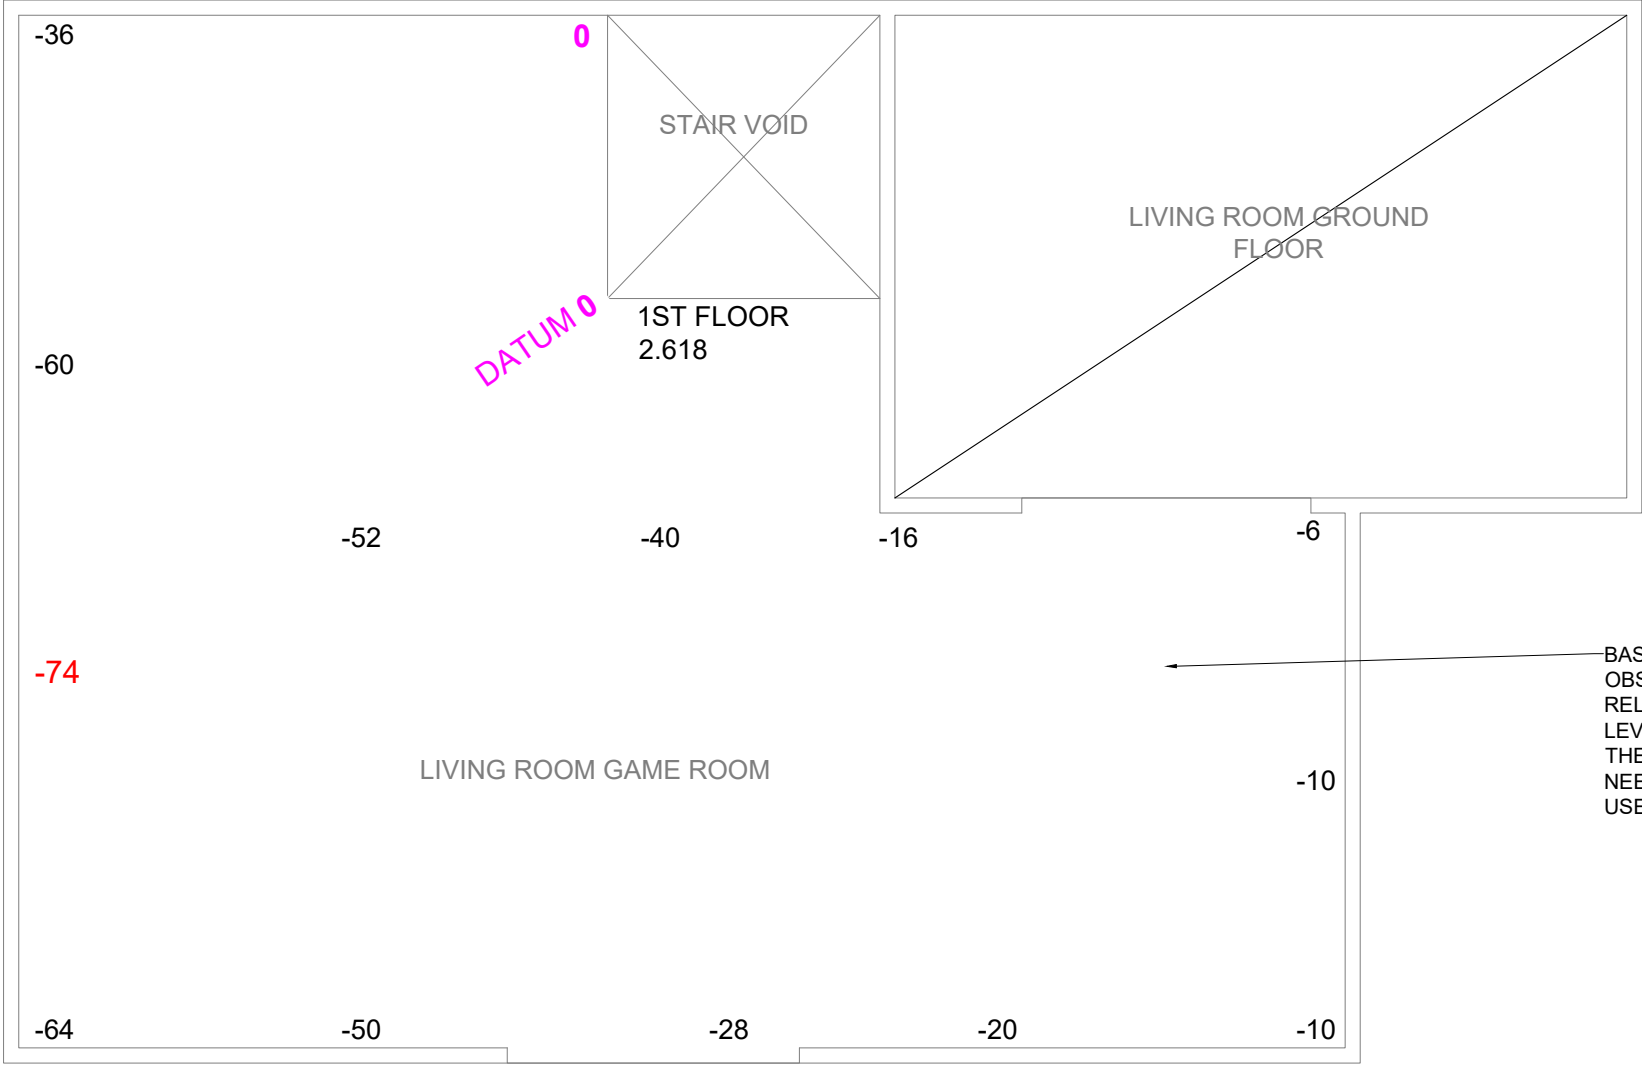
| Drawing Title: | ATTIC FLOOR RE-LEVELING PLAN |

1. MAXIMUM MEASURED FLOOR LEVEL DIFFERENCE POINT ARE AS FOLLOWS:  
- 74mm OVER THE DWELLING TIMBER FIRST FLOOR
2. TARGET LEVEL : RE-LEVEL TO WITHIN 25 - 30mm OVERALL, AND REMEDIATE ALL LOCAL SLOPES EXCEEDING 1:200
3. CONTRACTOR TO VERIFY THE LEVELS BEFORE RE-LEVELING
4. LOCATE & ENSURE SERVICES CAN ACCOMMODATE LIFT HEIGHTS, OR DETACH OR RELOCATE THESE BEFORE THE LIFT BEGINS.

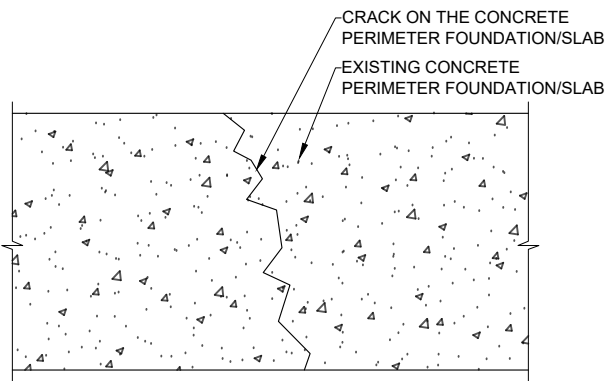
3  
S10

CRACK IN CONCRETE FOUNDATION (INDICATIVE)

| CRACK WIDTH | REPAIR METHOD | PRODUCT / MATERIAL |
| HAIRLINE TO 0.2mm | NO REPAIR IS REQUIRED | SPECIFICATION |
| 0.2mm - 5mm | LOW VISCOSITY EPOXY RESIN INJECTION | SIKADUR-52 NORMAL OR SIMILAR APPROVED |
| 5mm - 20mm | CEMENTITIOUS GROUT INJECTION | SIKADUR 31CF / SIKADUR-31+ OR SIMILAR APPROVED |
| >20mm OR WITH >2mm VERTICAL DISPLACEMENT OR OUT OF PLANE MOVEMENT | BREAKOUT AND REBUILD PERIMETER FOUNDATION / NEW SLAB | NOT APPLICABLE |

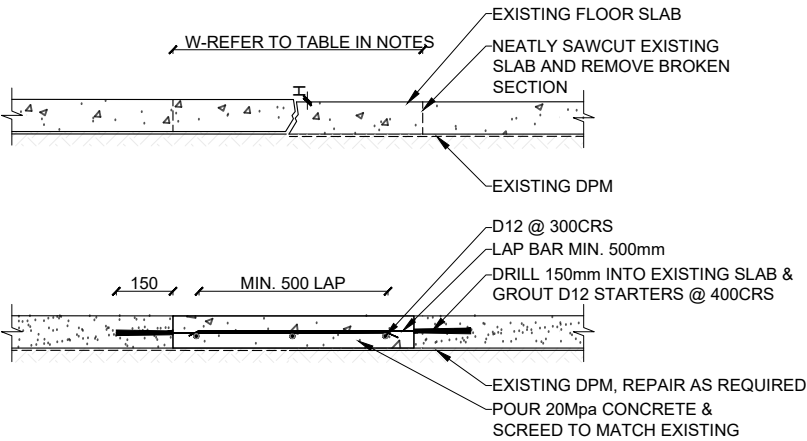
4  
S02

CONCRETE SLAB REPAIR

- NOTE:
1. TAKE CARE TO MINIMIZE DAMAGE TO POLYSTYRENE INSULATION OR DPM UNDER SLAB WHEN CUTTING & REMOVING SECTION TO BE REPLACED.
  2. H<2mm GRIND DOWN HIGH SECTION & REPAIR ACCORDING TO CRACK REPAIR SPECIFICATION.

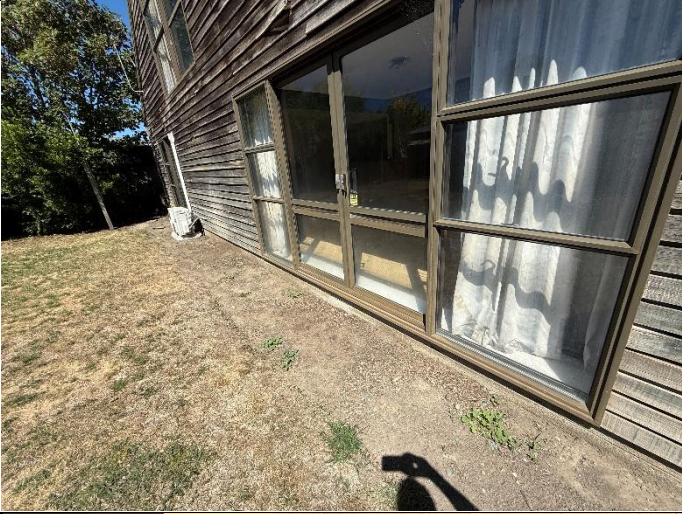
1. The foundation was observed to be reasonably in good condition.

However, it is advisable for the builders to undertake a survey once the floor relevelling is completed. If any cracks are found, it can be repaired as recommended in section 5.1

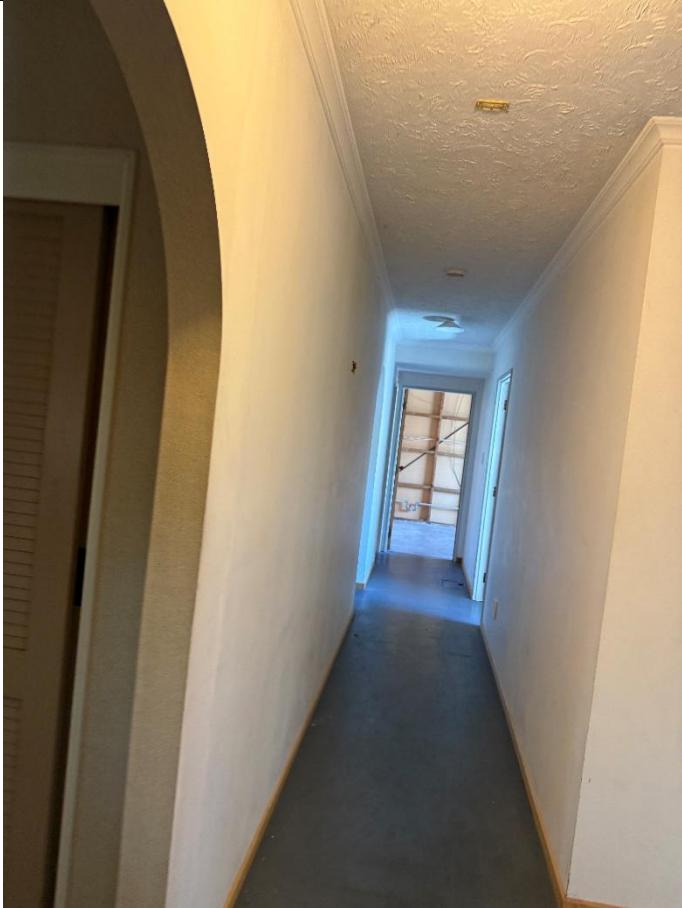
2. Internal wall lining has been removed at few rooms at the time of the inspection. No noticeable damages were observed in other locations.

However, it is advisable for the builders to undertake a survey once the floor relevelling is completed. If any cracks are found, it can be repaired as recommended in section 5.2.

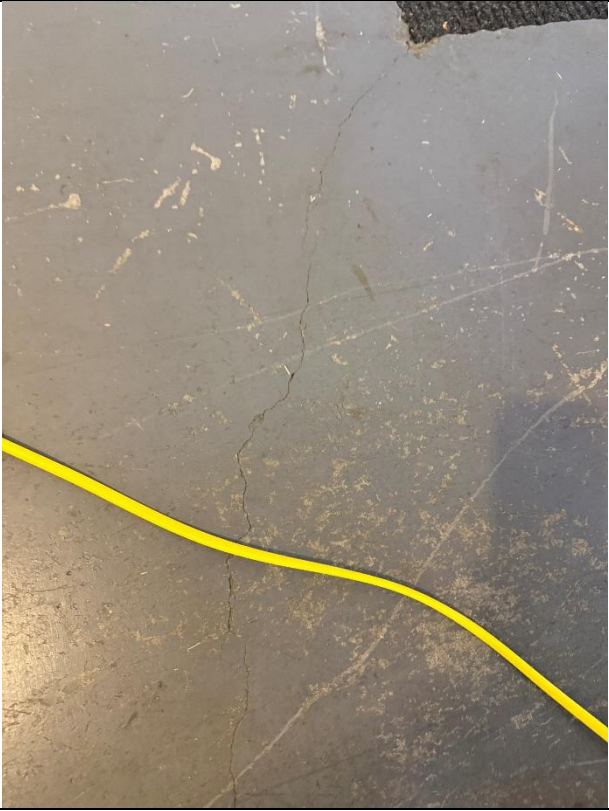
| <p>3. Cracking on the garage floor</p> <p>To be repaired following the foundation relevening.</p> | |
