RISKNET LIMITED
Postquake property
Due Diligence

Floor Levels Survey

**Address: 147 King Street,
Sydenham, Christchurch**

Assessments undertaken by Risknet Limited
Stuart Fletcher, Director
Site: 21.10.2025
Report: 26.10.2025

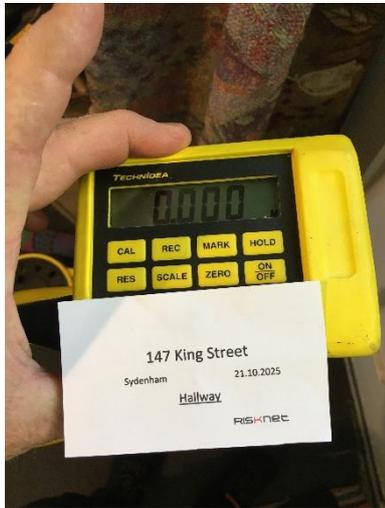
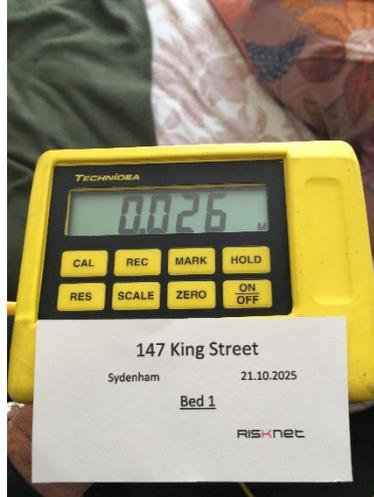
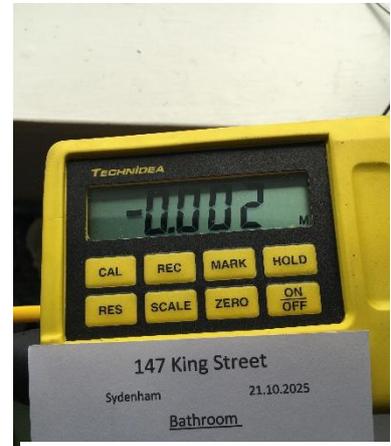
*NOTE LOW -2mm, once adjusted becomes -8mm

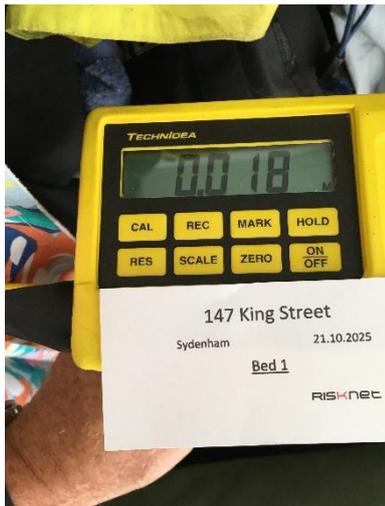
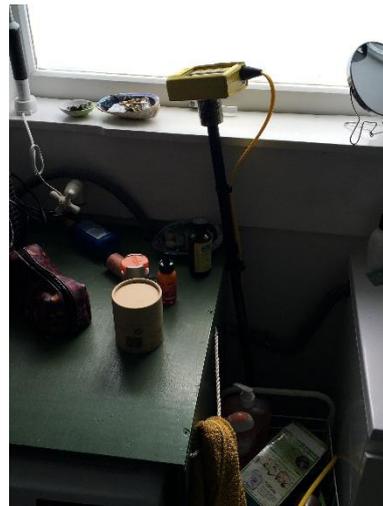
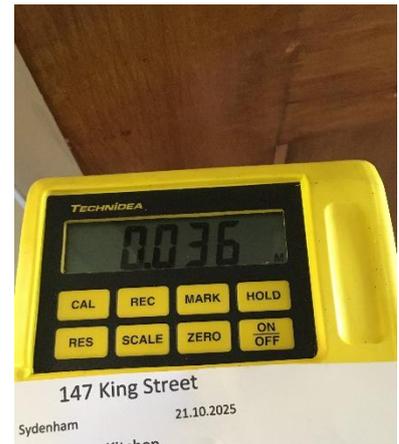
-2mm, once adjusted becomes -8mm

(Floor covering est. (6mm))

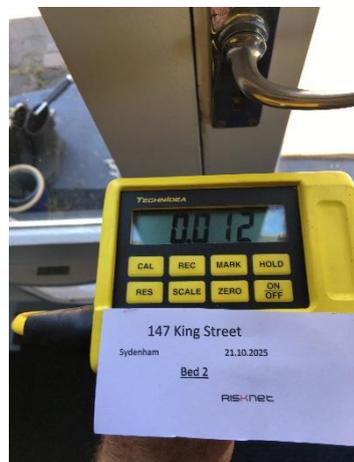
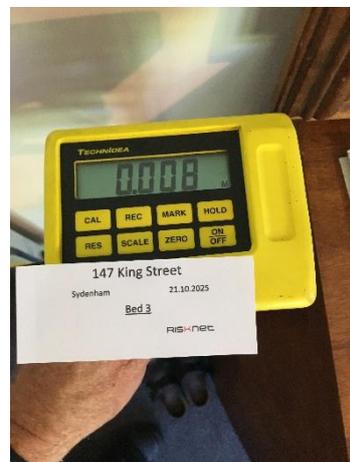
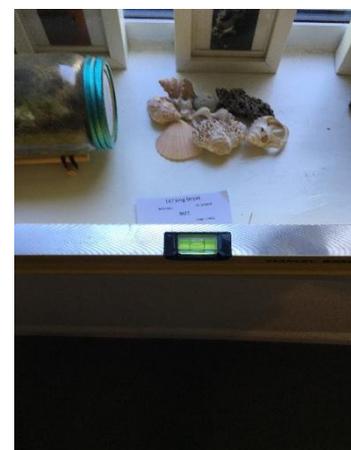
Once adjusted becomes 16mm
(flooring 20mm)
