## BUILDING INSPECTION REPORT

## NZ Residential Property Inspection Report

Inspection Date: Thu, 13 Nov 2025

Property Address: 43 Tovey Street, New Brighton,  
Christchurch 8061, New Zealand

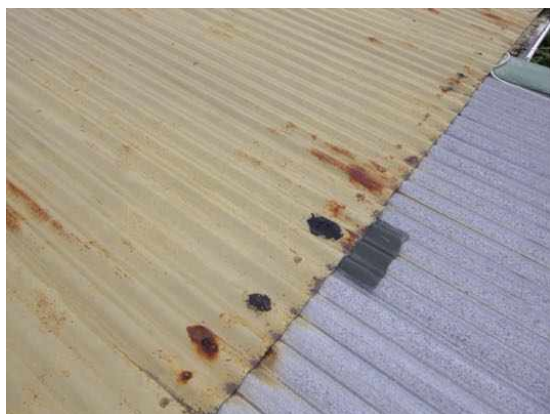
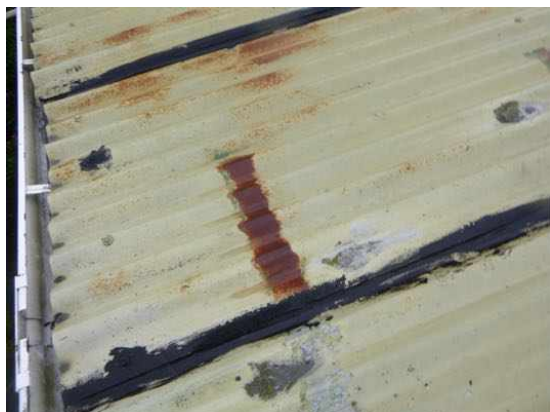
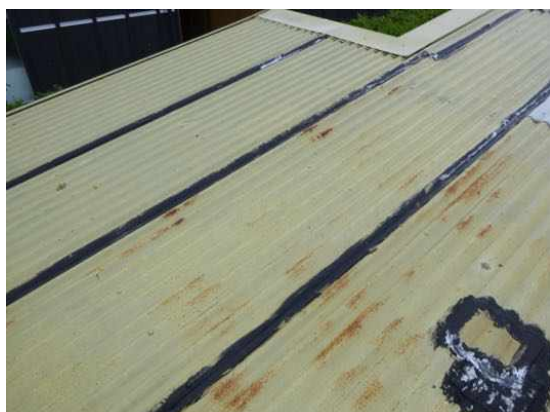
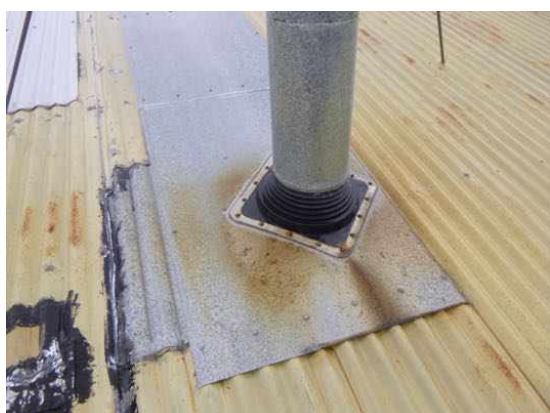
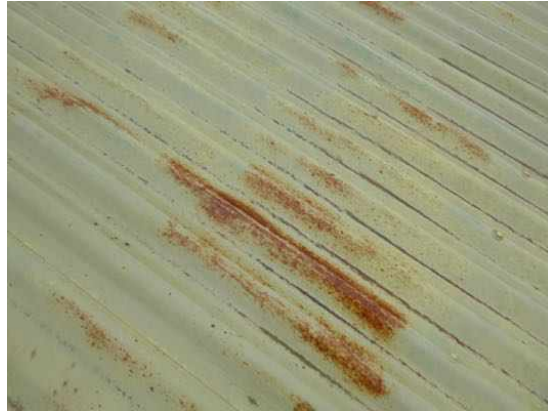
#### Defects 3.01

Building: Main Building  
Location: Roof Exterior  
Finding: Roofing - Condition  
Information: The visible corrugated roofing and flashings appeared in fair to poor condition for its age. All penetrations and flashings were installed and sealed adequately.

Evidence of surface rust to some sections was identified. Some patching and re-coating was evident. If left unmanaged, this could allow water ingress to the internal roofing structures, potentially leading to secondary damage of building elements. Accelerated deterioration of the roofing sheets and any associated building elements is also likely to occur. Replacement of the roofing should be considered. Failing this is advised that a professional painter be consulted to carry out works such as the application of rust-retardant surface protectors and roof paint, in the near future.

The roof is fastened down with roofing nails which can be prone to popping overtime. As general house maintenance, periodically check nails and replace any that may have popped with suitable roofing screws.

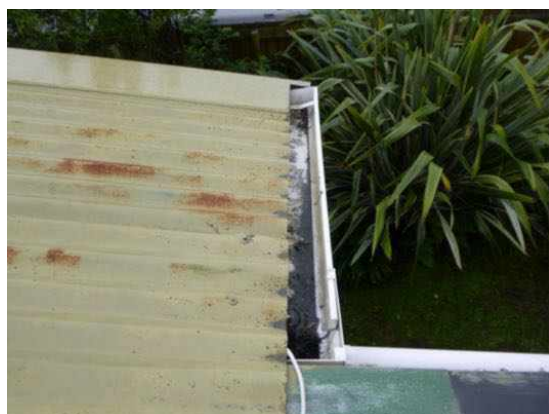
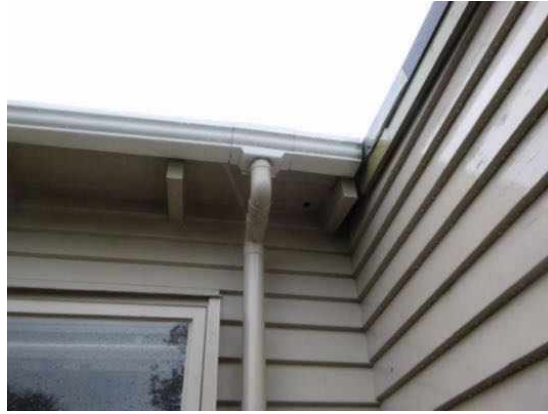
Defects 3.02

Information: The PVC gutters and downpipes around the property appeared to be in good condition, allowing good drainage to the downpipes. There does not appear to be any stormwater risers or connection the stormwater system.

Roof plumbing structures, such as guttering and downpipes should be free of all debris to prevent blockages. It is advised that gutters are checked by the homeowner or a general handy person as part of regular maintenance.

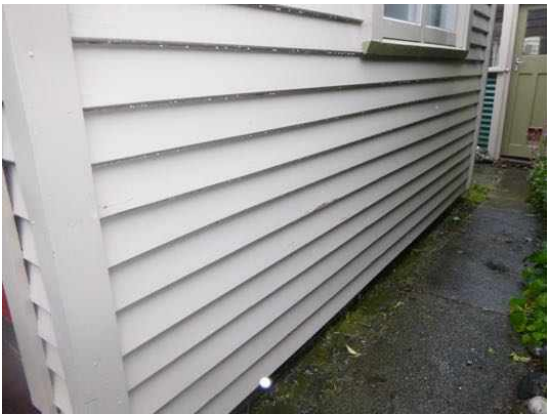
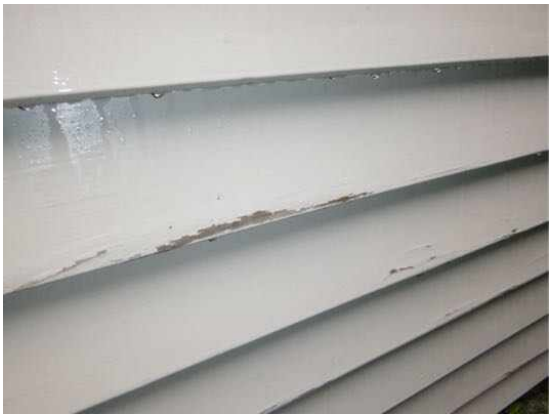
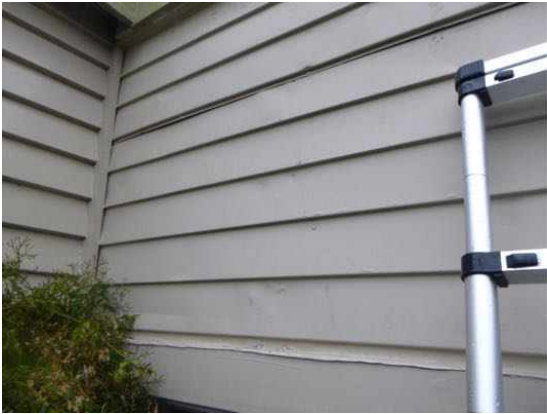
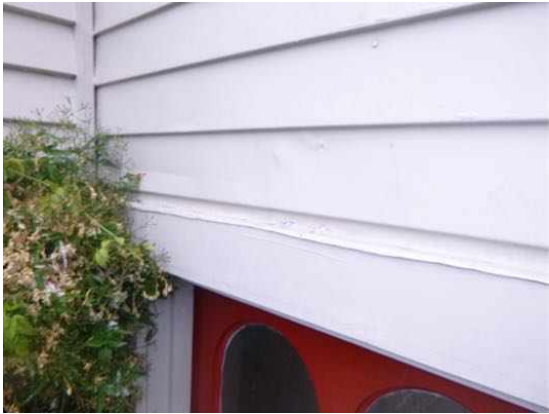
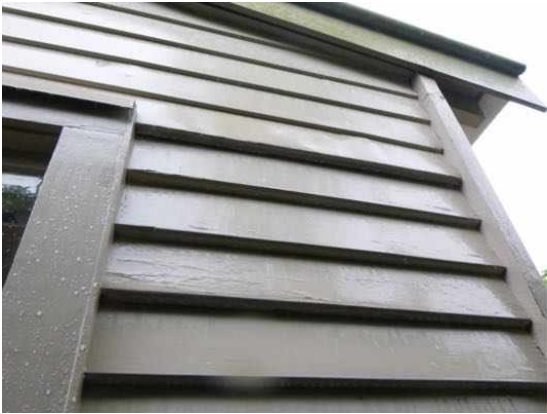
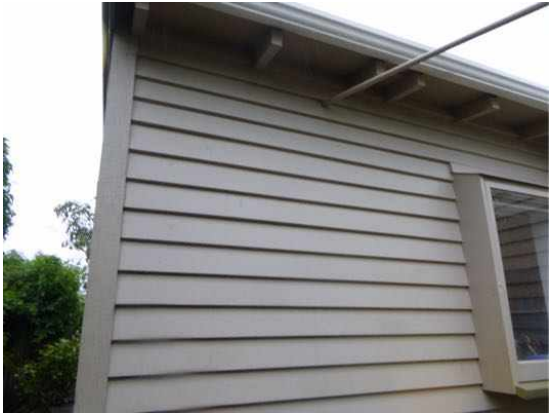
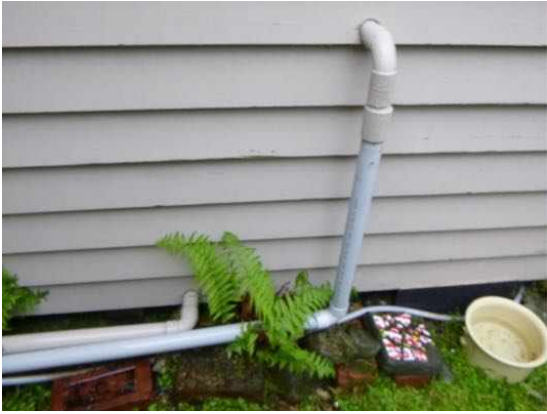
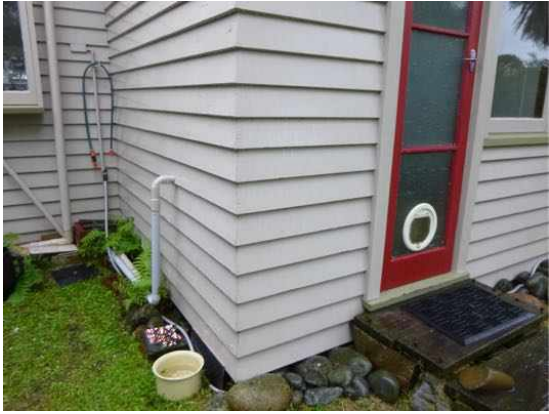
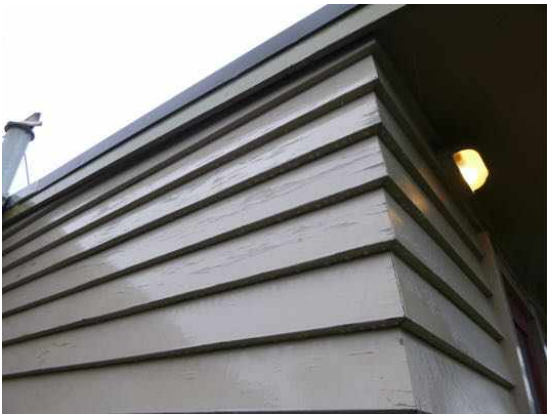
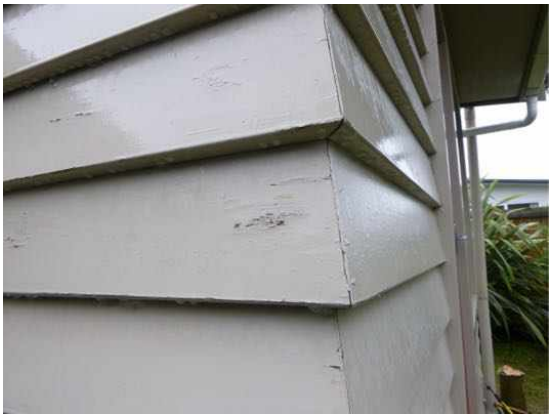
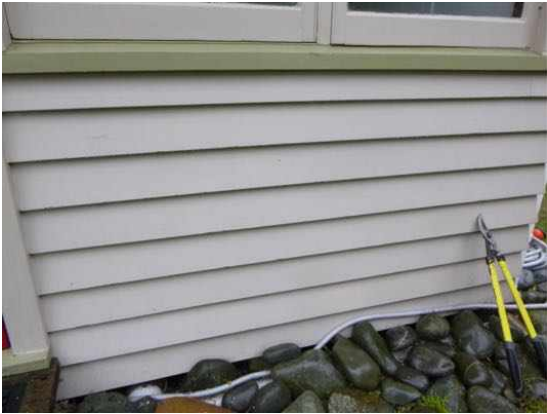
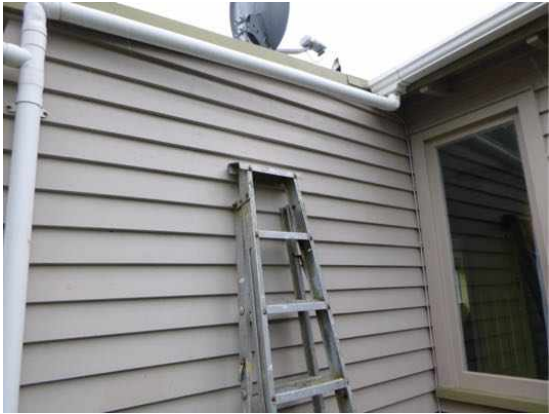
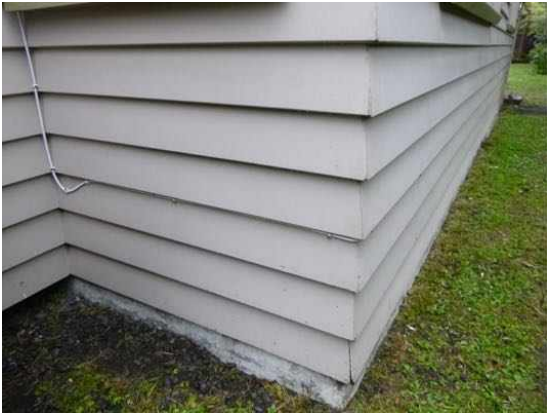
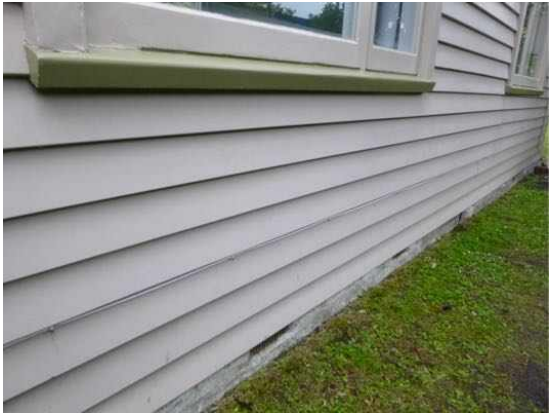
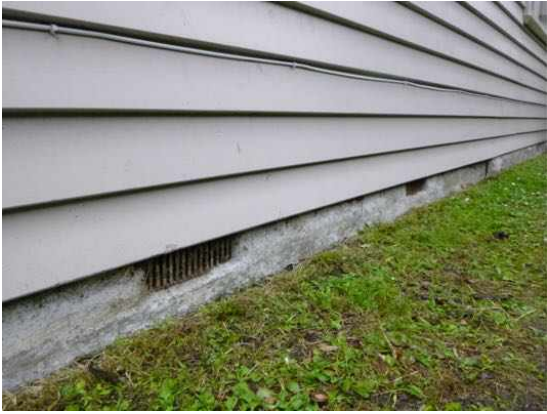
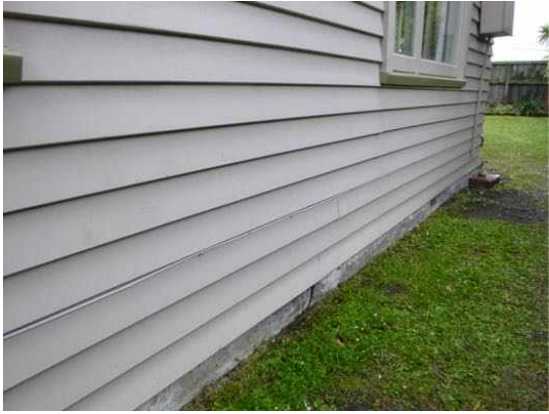
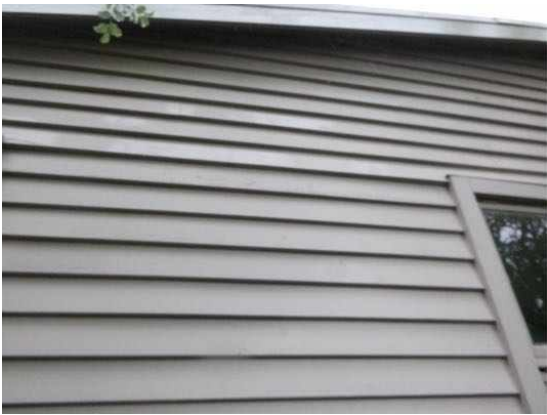
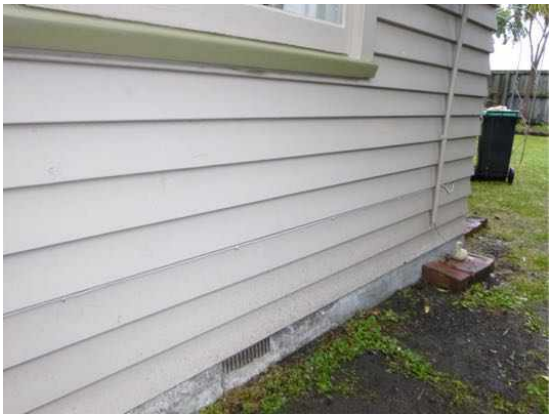
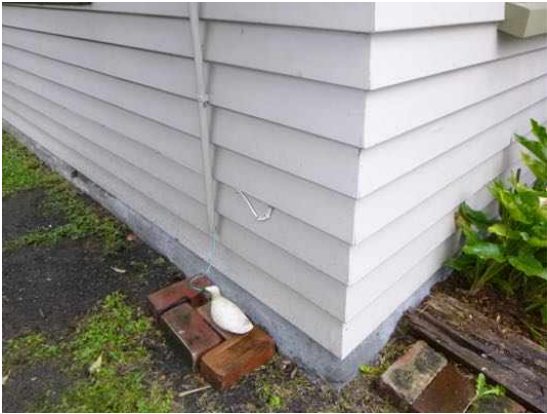
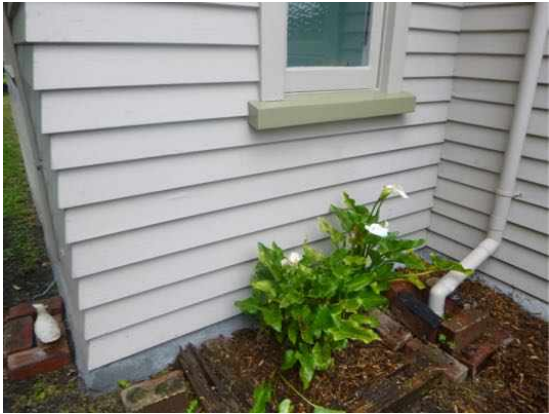
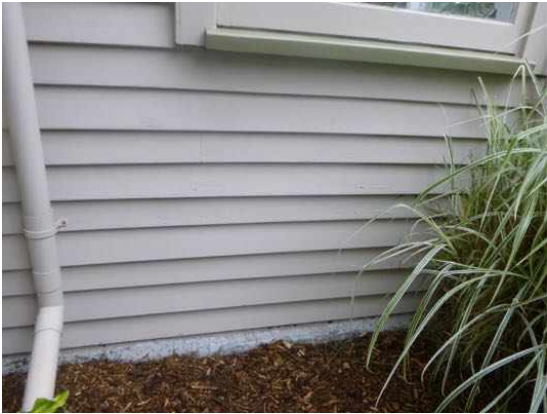
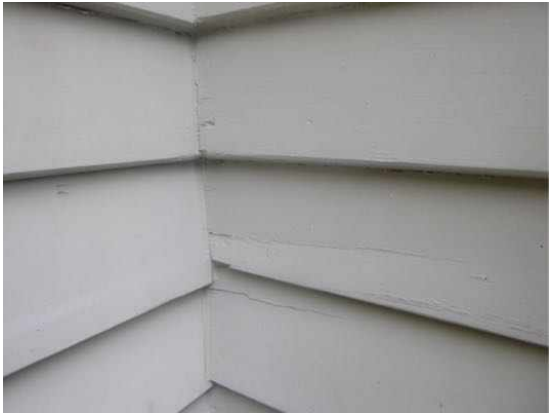
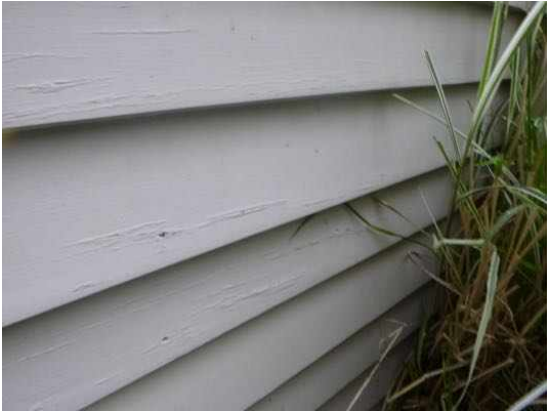
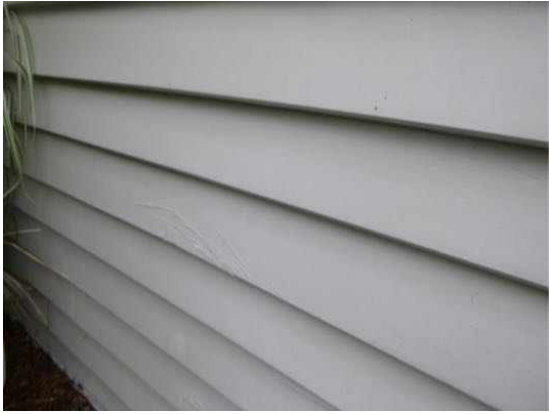
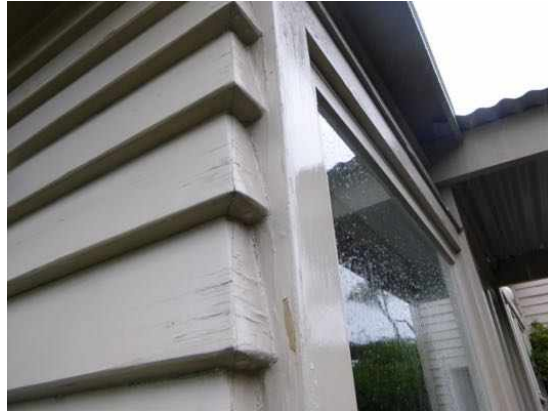
### Defects 3.04

| Information: | The exterior painted timber weatherboards were in fair condition overall. All windows and doors were flashed and sealed adequately. |

The paint finish was found to be deteriorating in some areas. Paint deterioration is generally classified as an appearance defect. However, the substandard appearance may also be indicative of poor surface preparation and substandard workmanship. A painting contractor should be appointed to perform necessary works to aid the appearance of the affected area and to ensure that the area is protected against further deterioration. Alternatively, the homeowner following manufacturer instructions may be able to provide this service.

I would recommend monitoring the weatherboard joints and junctions as this is where moisture issues are most likely to occur.

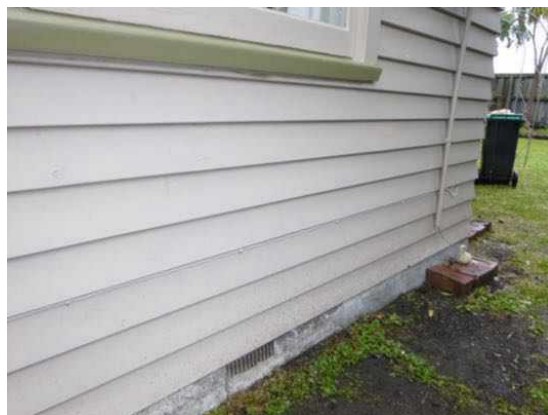
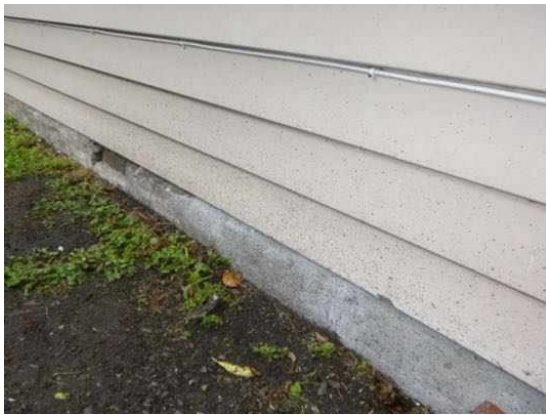
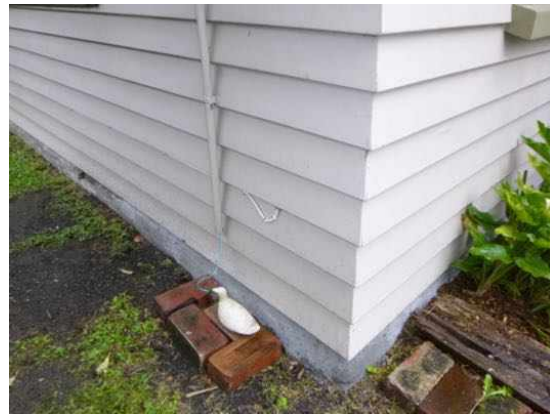
### Defects 3.05

Building: Main Building  
Location: All External Areas  
Finding: Foundation - Condition  
Information: There is no access to the subfloor due to the proximity of the framing to the ground. This is typical for the era of build. Good ventilation is maintained.

The concrete ring foundation visible showed no noticeable cracking.

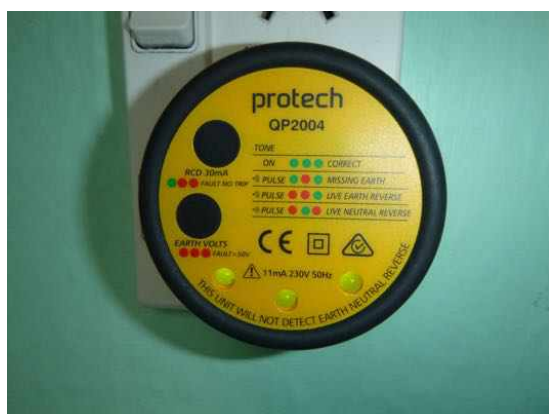
## Defects 3.07

One issue was found during the inspection. Polarity faults were found to a plug in the laundry and two plug in the sleepout. This may mean that the neutral wire is connected to where the hot wire should be, or it is missing the earth wire. This could result in a shock if the appliance is mishandled

A qualified electrician should be appointed to further investigate the fault

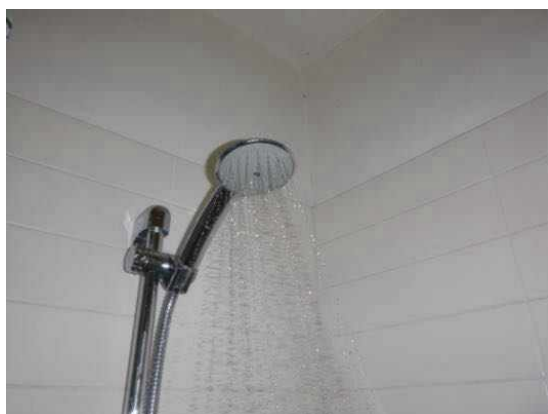
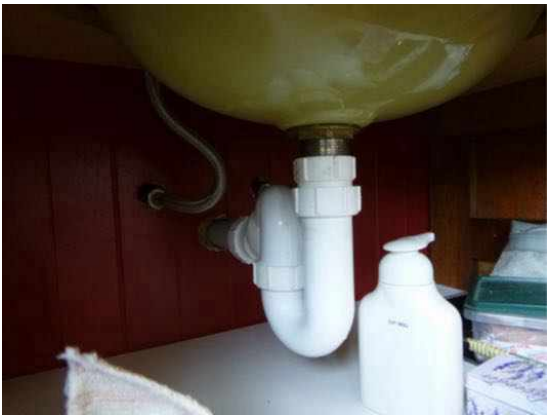
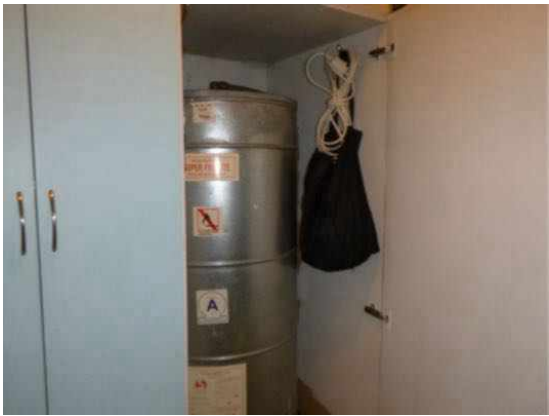
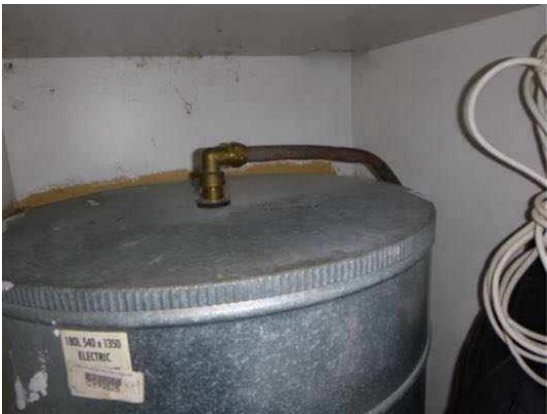
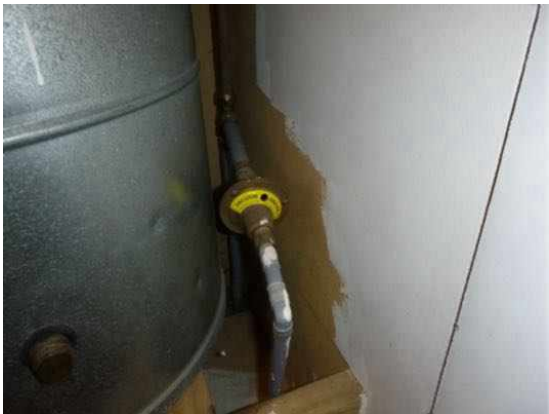
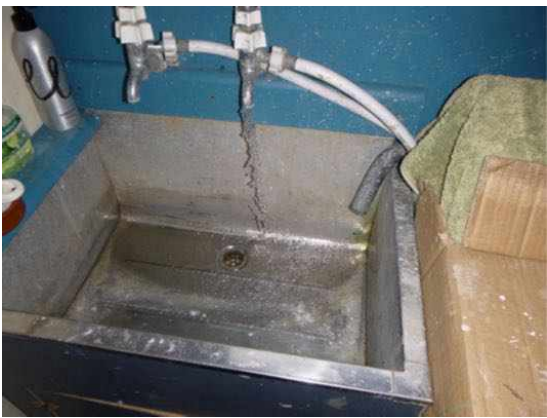
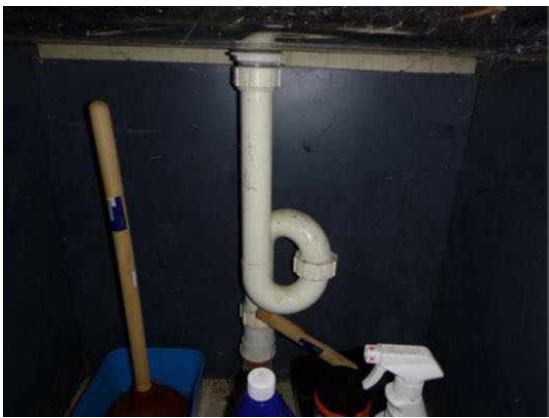
Noted Item

Building: Main Building  
Location: All Areas  
Finding: Plumbing items - Condition  
Information: All taps and the shower were run for a period of time and toilet flushed, it appears the water is running freely. The water pressure was good. The plumbing items appear to be in good condition where visible and tested.

The gully traps were checked and were clear, and are sufficient height off finished ground level. Covers are installed on traps to prevent debris getting into the grey water system

The water is heated via an electric hot water cylinder.

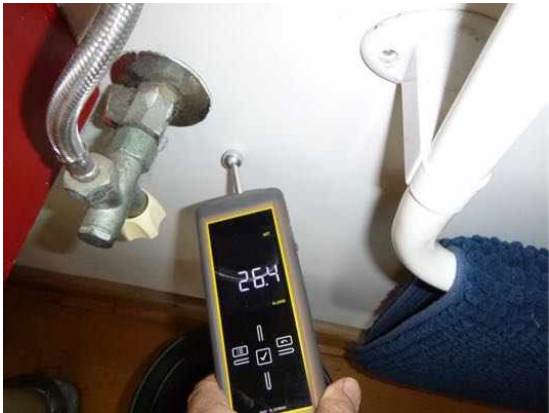
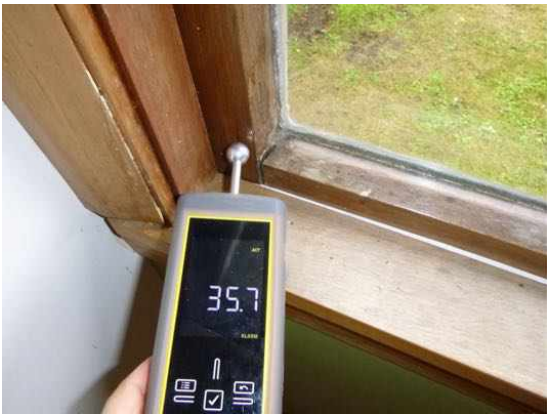
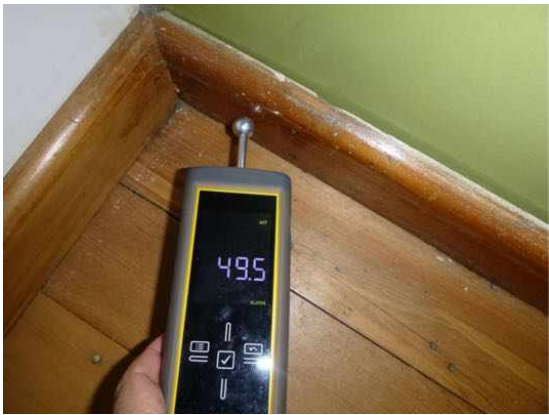
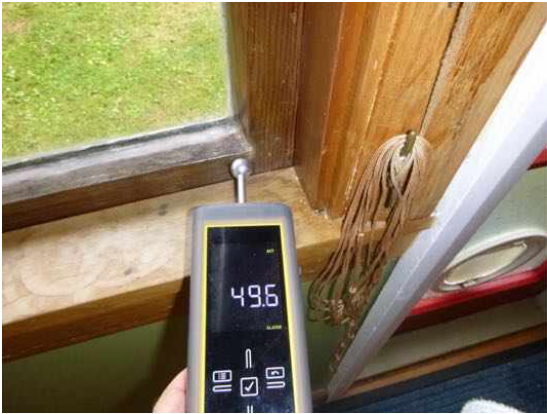
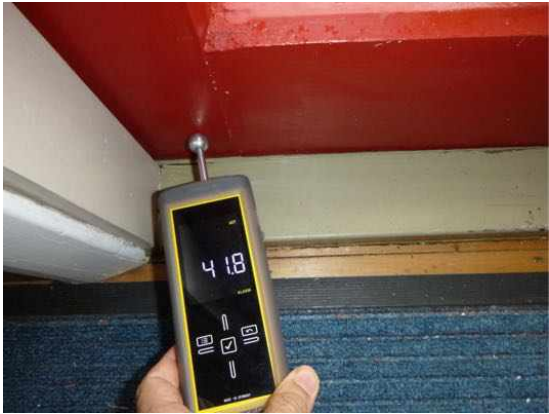
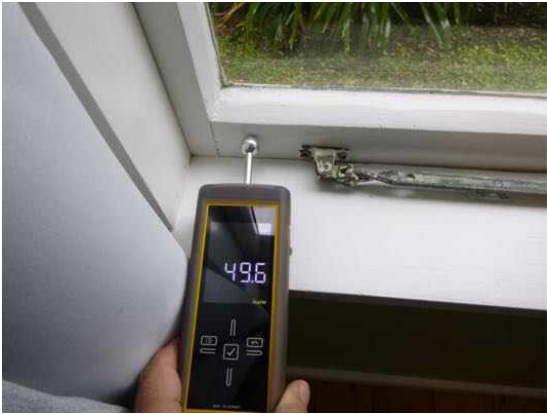
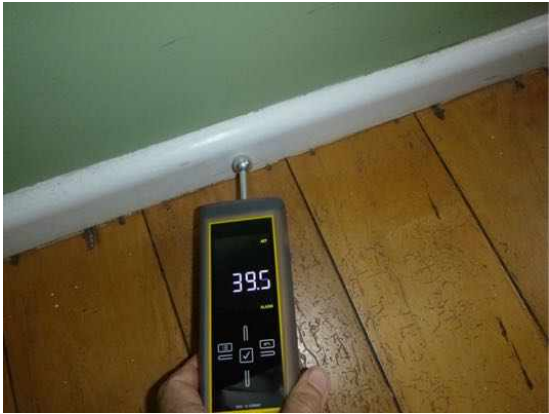
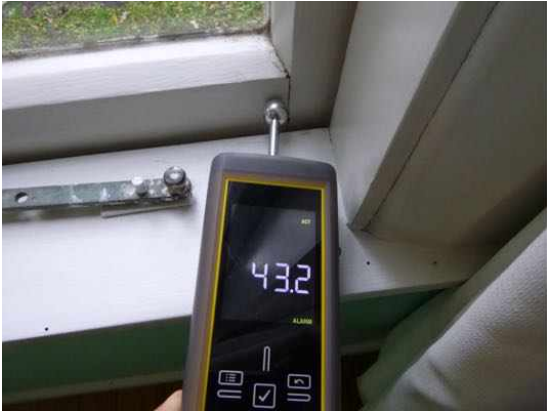
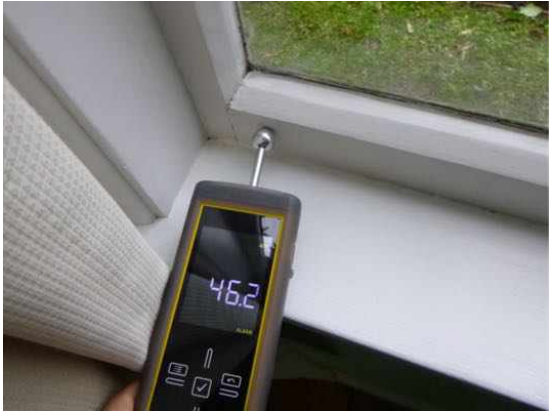
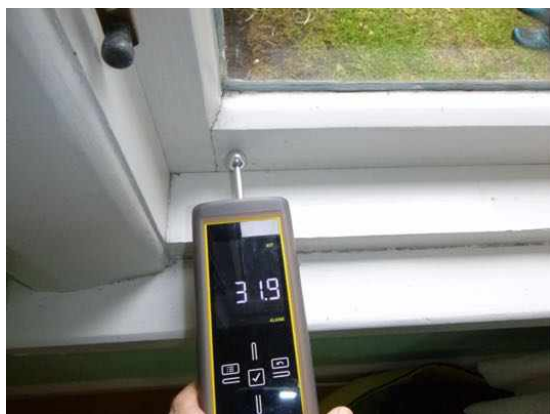
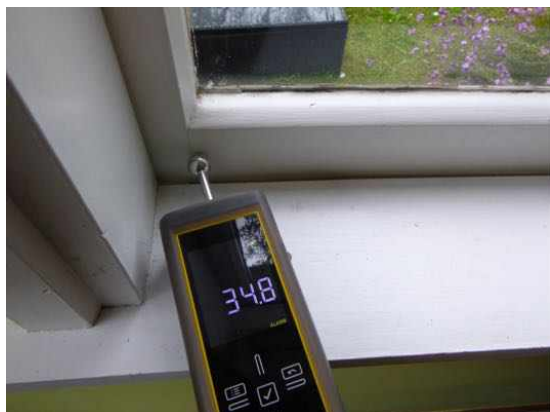
### Noted Item

Building: Main Building  
 Location: All Areas  
 Finding: Moisture Readings  
 Information: Moisture readings were taken using a Trotec T660 capacitive non-invasive moisture meter. No indications of any elevated moisture levels were detected.

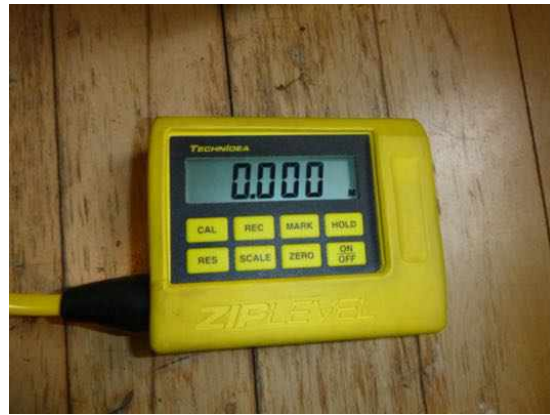
### Noted Item

Building: Main Building  
 Location: All Areas  
 Finding: Floor - Levels  
 Information: Spot floor level readings were taken throughout the main floor areas of the dwelling where accessible. (JBI take into account floor covering thicknesses as needed throughout the dwelling)

This falls within the MBIE guidelines of 50mm over 10 metres.

All levels are within the MBIE guidelines over a short distance, being less than 0.5% or 10mm over 2 meters.

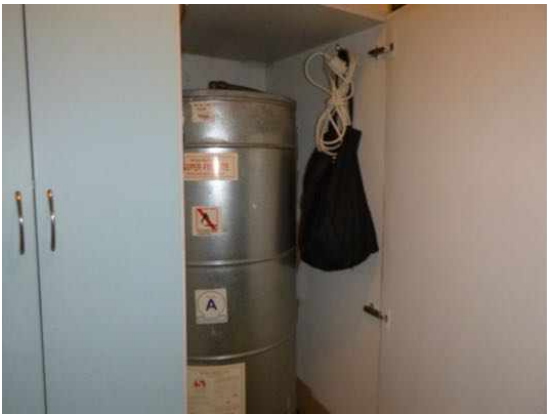
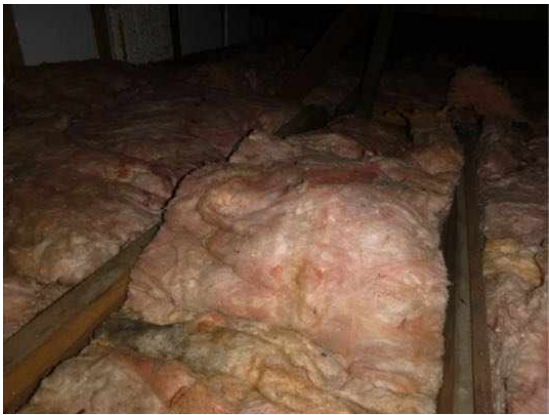
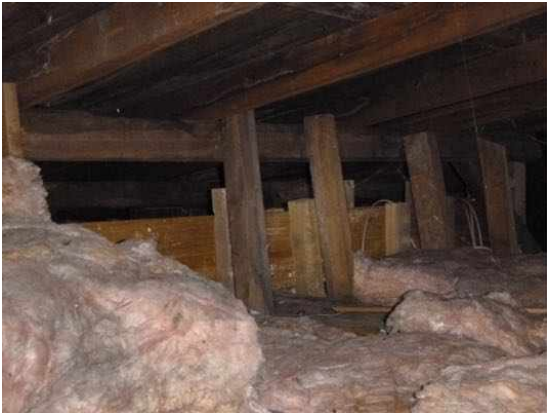
## Noted Item

Building: Main Building  
 Location: All Areas  
 Finding: Additional Photos - Obstructions and Limitations  
 Information: These photographs are an indication of the obstructions and limitations which can impede a full inspection of the property at the time of inspection. These obstructions can hide an array of defects.
