EARTHQUAKE RECOVERY (EQR) DOCUMENTATION

Released under the Official Information Act 1982
EQR Property Overview Report

EQC Property ID	Property Address	Vulnerable?	Property F Status	Property Finalisation Indicator		
2010089178	15 WYCHWOOD CRESCENT, BISHOPDALE		F3 - Complete & Finalised	Some Finalisation has taken place		
Main Contractor:	CLOSED OUT-Hollyford Limited t/a Renovation Specialists ***** (S745)		Property F2'd By:	System Generated Finalisation	F2 Completed Date:	10-04-2015
Cont Managing Hub:	<UNALLOCATED>	Not Vulnerable	Property F3'd By:	System Generated Finalisation	F3 Completed Date:	10-04-2015

Address	15 WYCHWOOD CRESCENT, BISHOPDALE, CHRISTCHURCH, 8051	EQC Claim Number	CLM/2011/138670
Hazards	Nil	EQC Assessor (L,F)	Shanahan, Foss
Inspection Date	04-Nov-2011	Placard	No Sticker
Status	Current	EQC Estimator (L,F)	Thomas, Charles

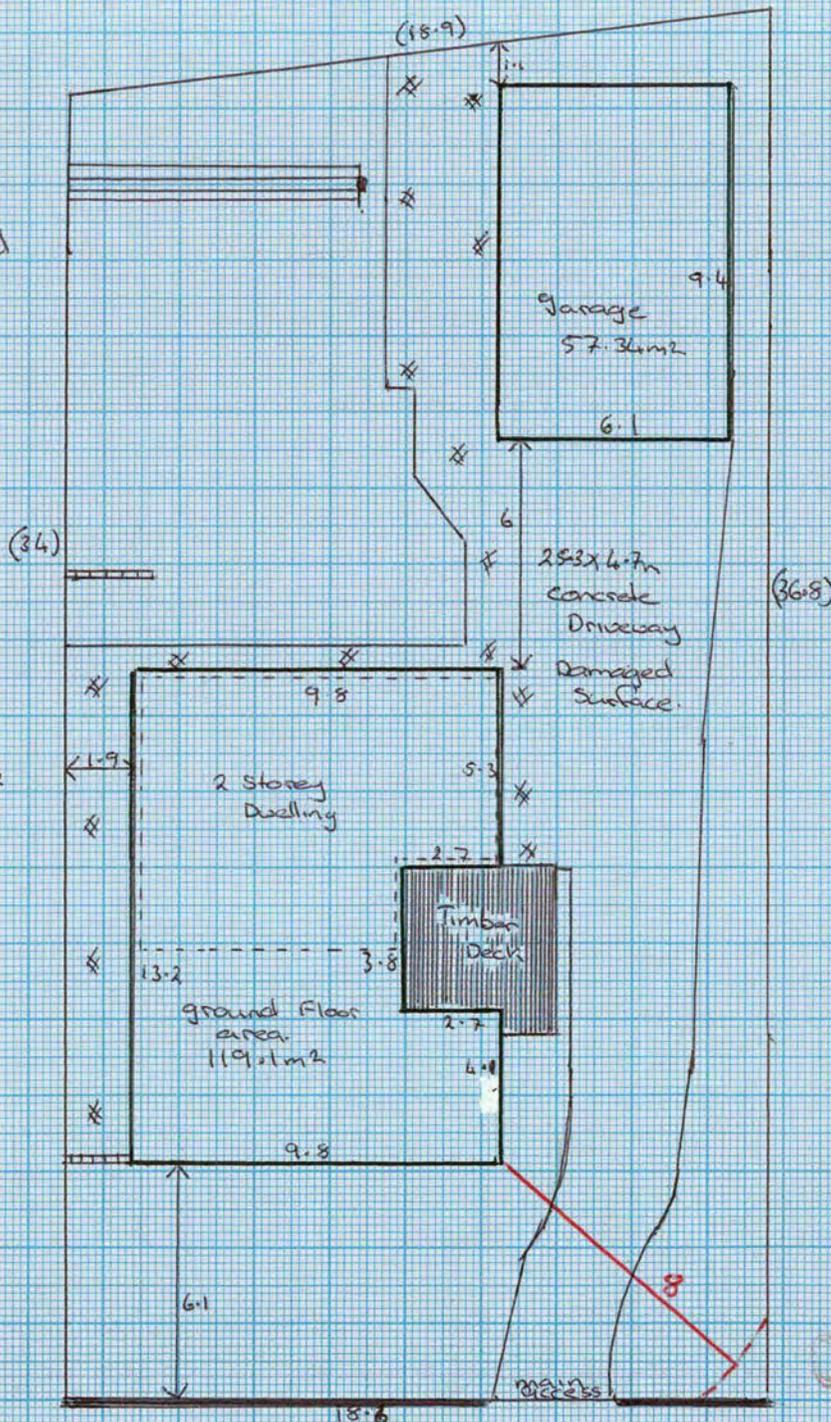
All Hard paved surfaces are damaged

Timber Deck 17.3m²
Hebal Fence 15.4
Timber Fence 4.3m

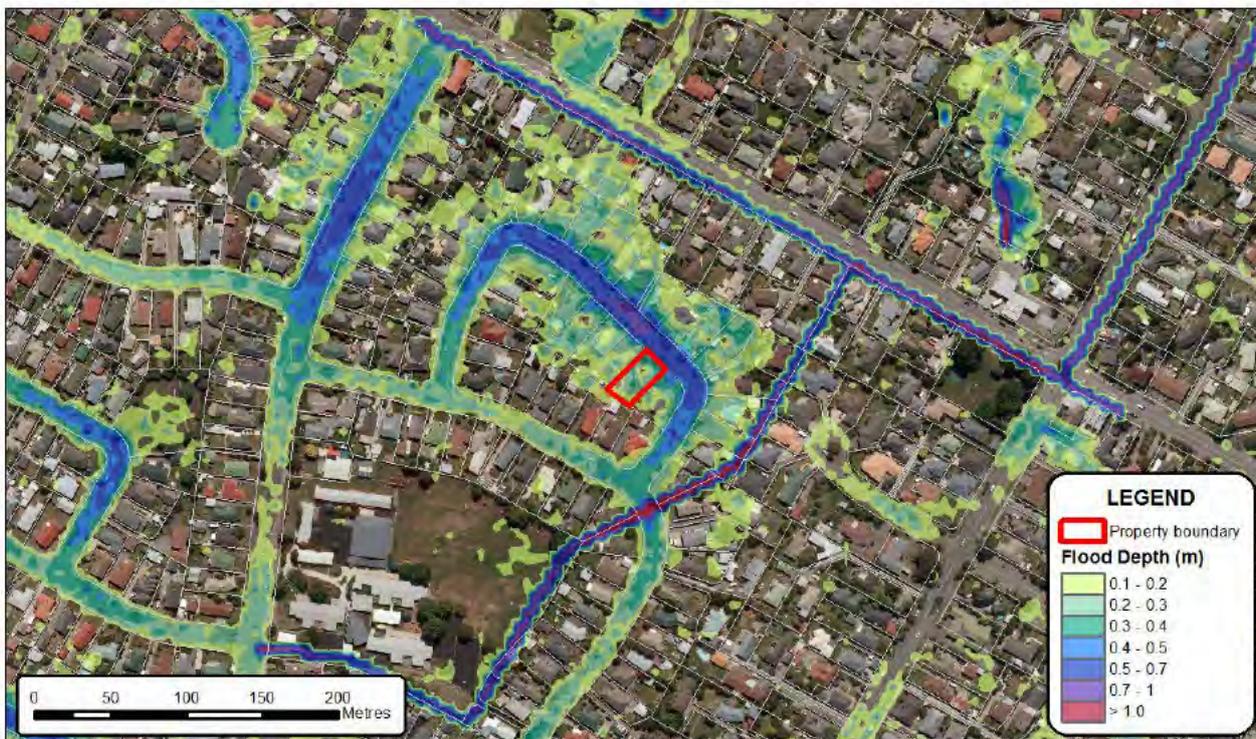
Map 2: Modelled flood depths for a 1 in 100 year flood event before Canterbury earthquake sequence

Map 2 shows flooding for the 1 in 100 year flood event before the Canterbury earthquake sequence.

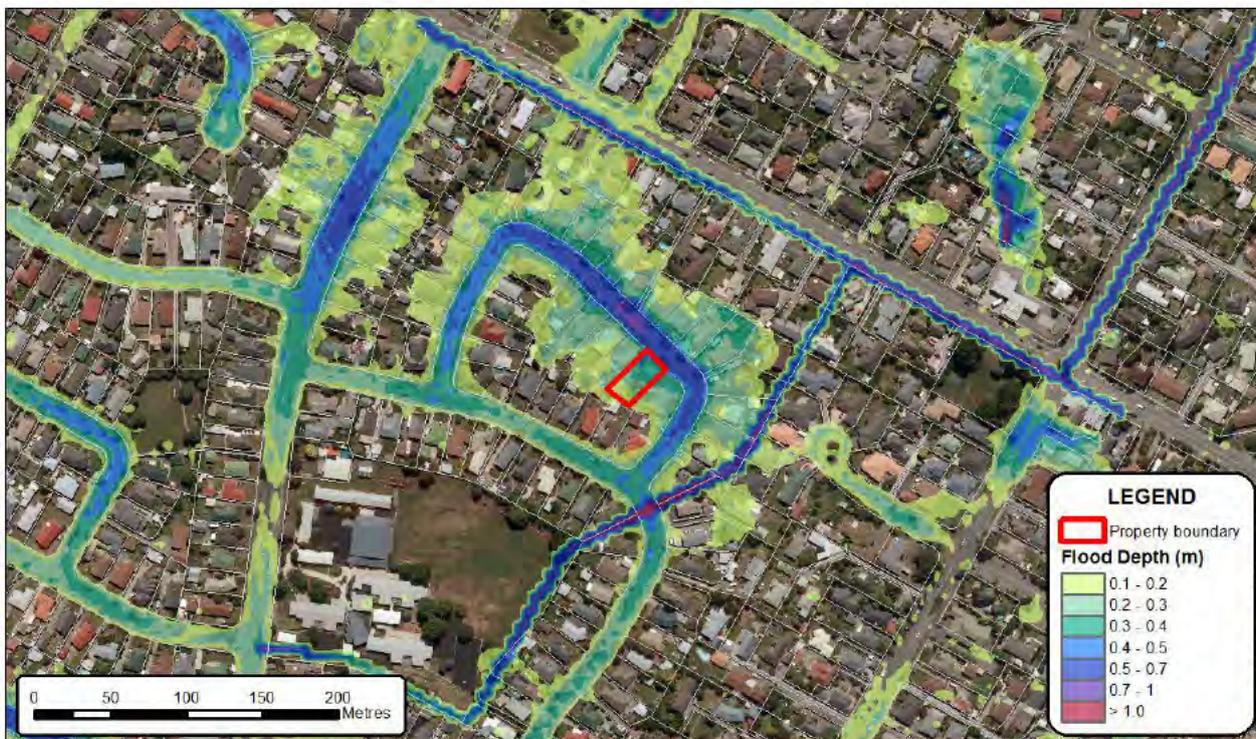
Map 3: Modelled flood depths for a 1 in 100 year flood event after the Canterbury earthquake sequence

Map 3 shows flooding for the 1 in 100 year flood event after the Canterbury earthquake sequence. EQC's flood model maps are available to technical professionals on the Canterbury Geotechnical Database.

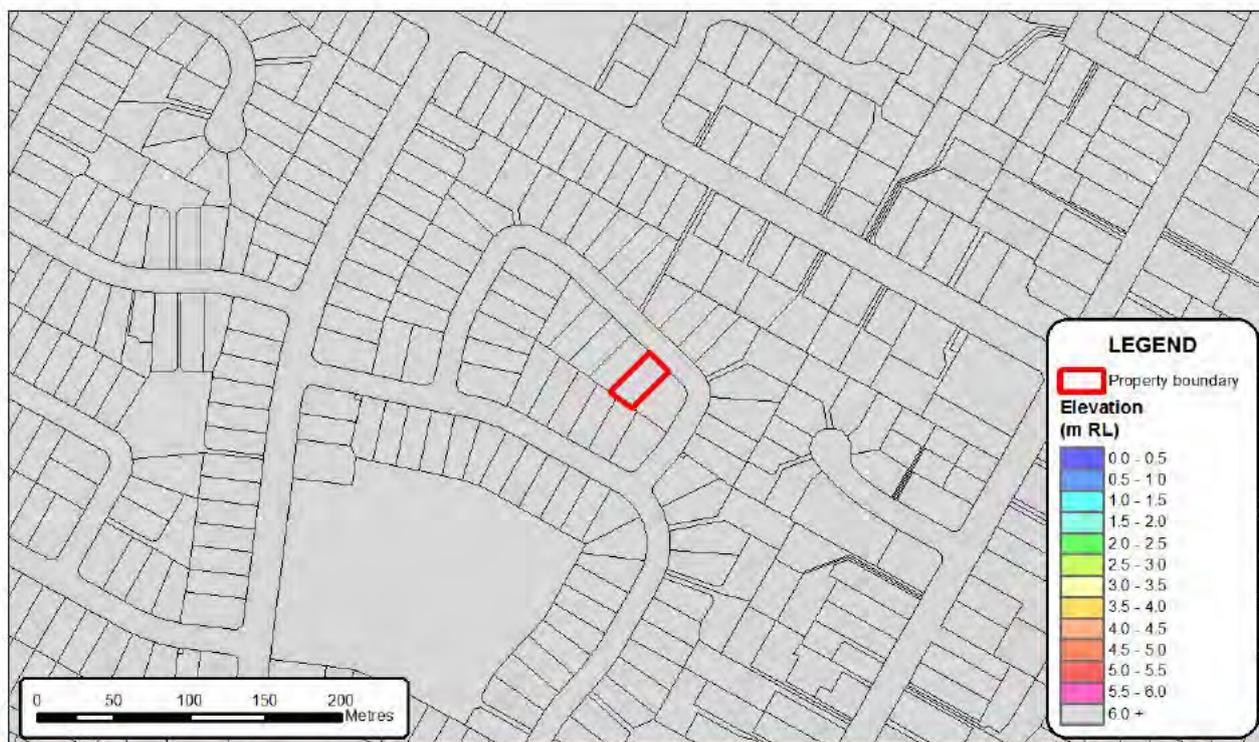
Map 4: Ground surface elevation post December 2011

Map 4 shows the ground elevation (i.e. the height of the land) following the Canterbury earthquake sequence. The ground surface elevation was measured using an aerial LiDAR survey (which involved scanning the ground surface

from an aircraft). This post-earthquake ground elevation survey is a key input into the modelling of the post-earthquake flood depth. Similar surveys were used as an input into the modelling of pre-earthquake flood depths.

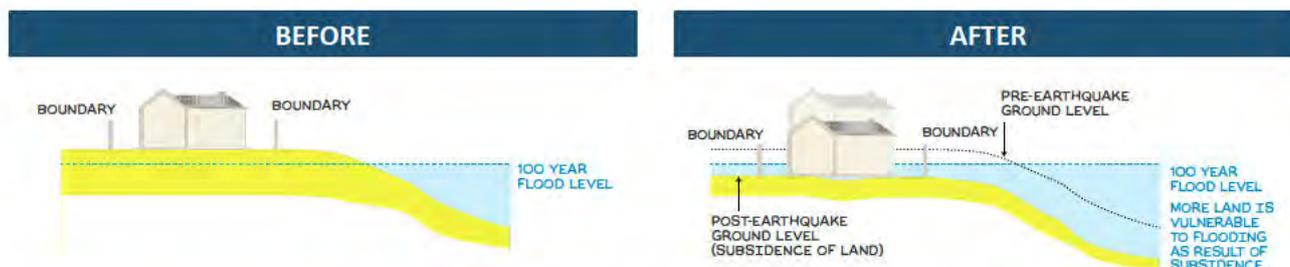
The above diagram shows how ground subsidence from the Canterbury earthquakes has made some properties more vulnerable to flooding.
