BUILDING INSPECTION REPORT

RED LBP PRE-PURCHASE REPORT

PRE-PURCHASE BUILDING REPORT

Property Address	49B Inwoods Road, Parklands, Christchurch 8083
Client	Tanglewood Developments Ltd
Date of Inspection	24th November 2025
Time	9:00 am
Inspector	Jamie Chapman National Certificate in Carpentry
LBP Number	BP137228
People Present	Inspector
House Occupied	Staged

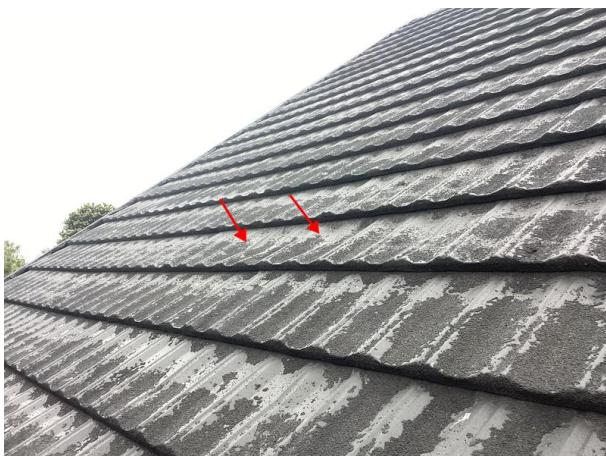
Photo 5

There were also a few other areas of dented metal tiles noticed in random locations around the roof system. It is recommended to have these repaired or replaced in the near future.

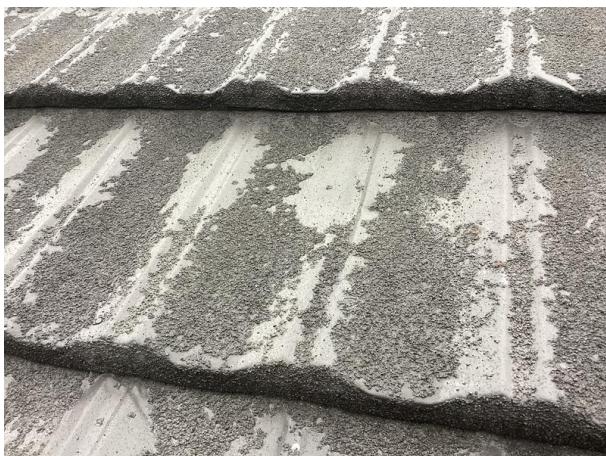
Photo 6

The original decramastic coating appears to have deteriorated and has since been painted.

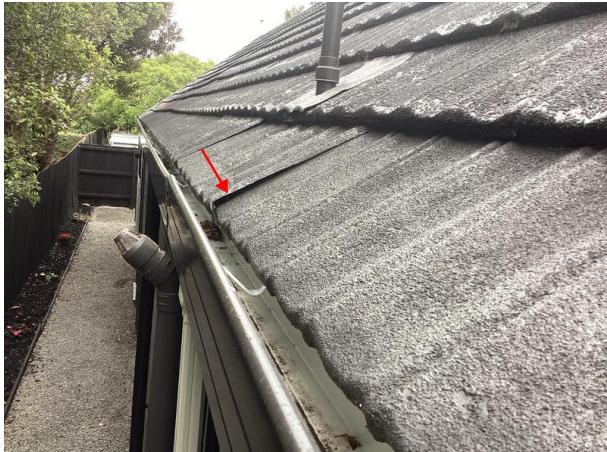
Photo 7

Lifting lap join on the East side of the roof system requires resealing down.

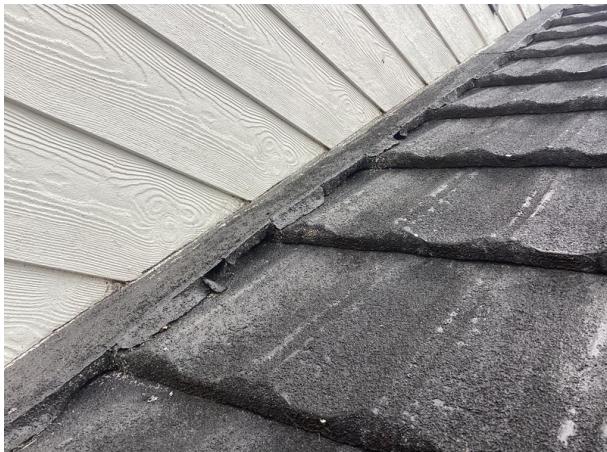
Photo 9

Metal apron flashing located at the roof to wall junction. Areas of the missing lead flashing folding onto the metal tiles were noticed exposing some gaps.

It is recommended to have a licensed roofer to advise further on repairs and maintenance needed to the gaps visible at the barge and apron flashings located around the dwelling as driven rain may get through these gaps from time to time and birds were visible entering these junctions during the inspection.

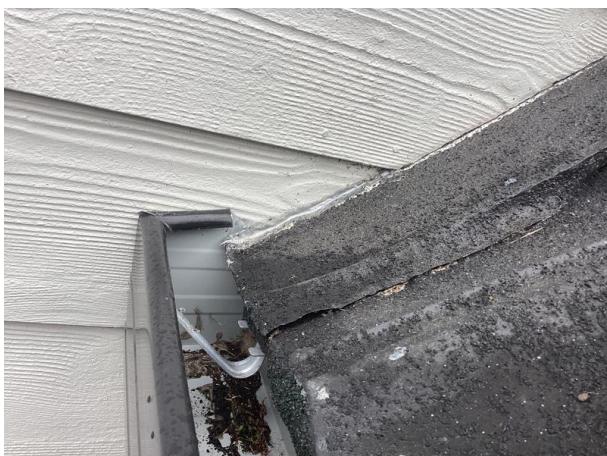
Photo 10

The metal apron flashing has been sealed against the cladding. No kick out flashing was visible. Installing a kick out flashing will help divert the water away from the building and into the gutter.

It is recommended to install kick-out flashings to any apron flashing that flows into a gutter, these are a critical flashing in protecting the roof/wall/fascia/gutter junction, that when correctly installed diverts water away from a high weathertight area of risk.

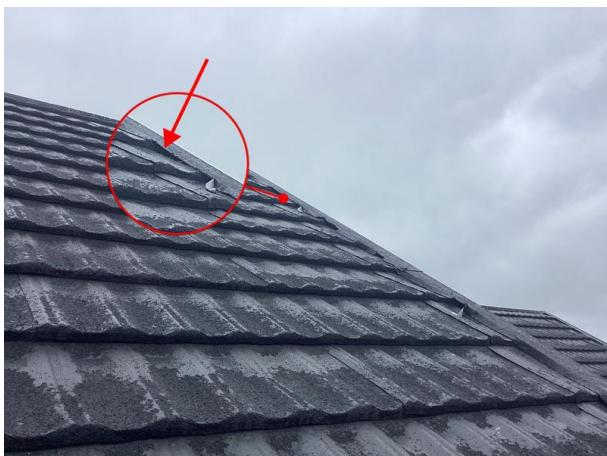
Photo 11

Example of the visible gaps between the metal tiles and barge flashing due to the lead parts of the flashing being torn or missing. A couple birds were noticed entering through these junctions.

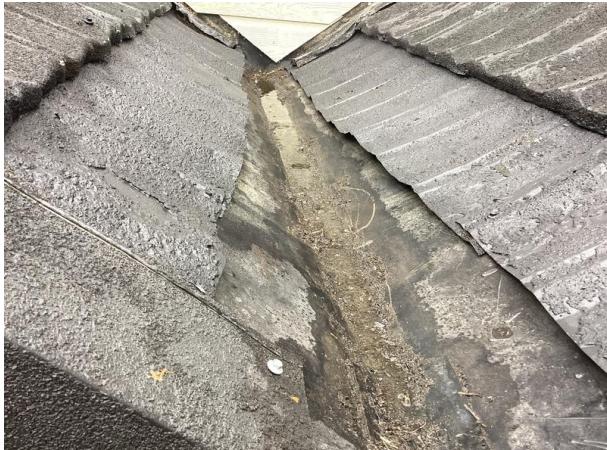
Photo 12

Minor water ponding and debris was visible above the entrance on the membrane valley. Ensure this is clean and clear for sufficient water flow.

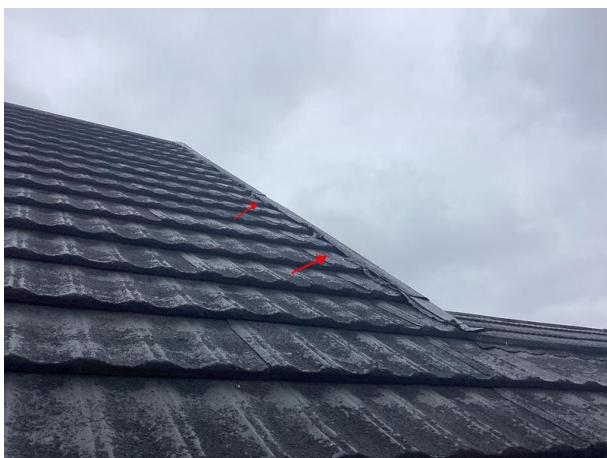
Photo 13

Example of the gaps visible between the barge flashings and metal tiles. It is recommended to have a licensed roofer to advise further on repairs needed to these flashings.

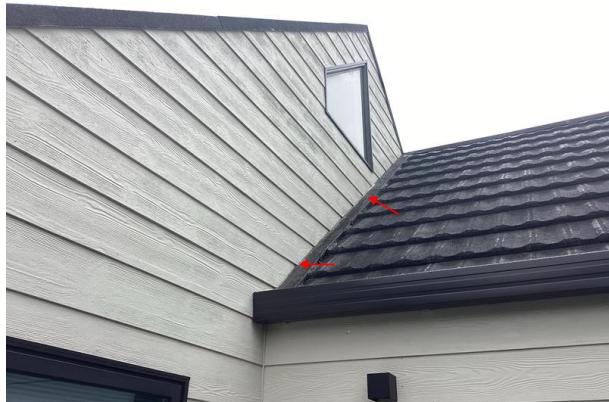
Photo 18

No clearance was visible between the cladding and roof flashing. However no significant deterioration was observed to the cladding. Modern building methods require a gap between these junctions.

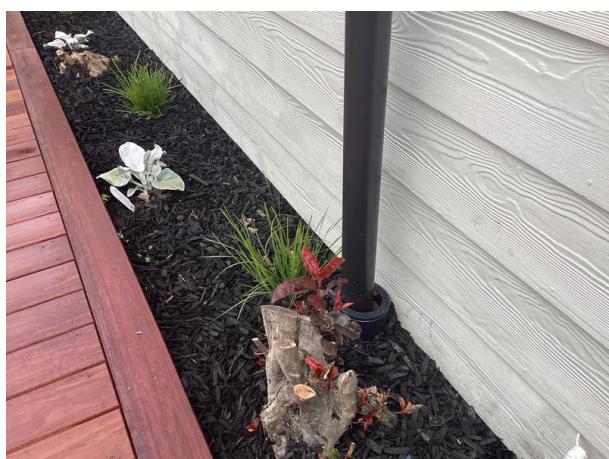
Photo 19

A couple areas of garden beds are within close proximity to the bottom of the weatherboard cladding. It is recommended to lower these garden beds.

It is recommended garden beds and any other ground coverings are kept below and away from the exterior cladding. This clearance is essential for the proper functioning of the cladding system and helps prevent moisture intrusion into the home via capillary action.

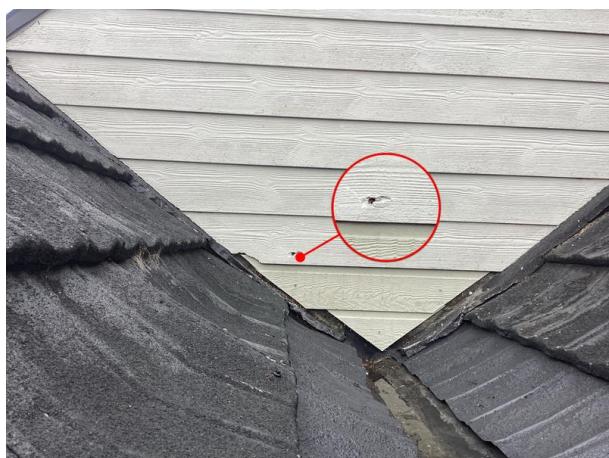
Photo 20

Above the entrance was a visible hole in the fibre cement board. Repairing or replacing this board is recommended.

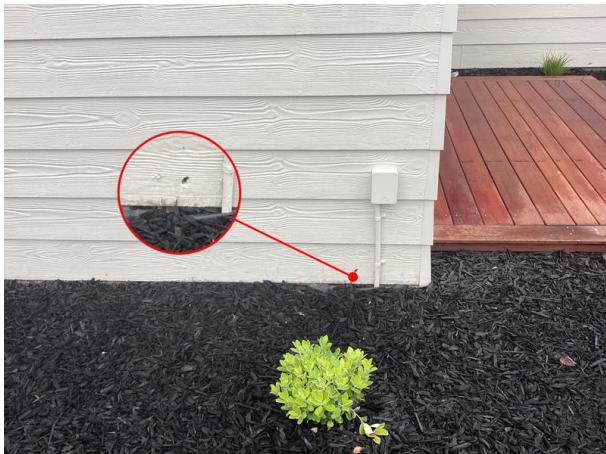
Photo 21

Near the entrance was a visible hole. Ensure this is sufficiently sealed or repaired.

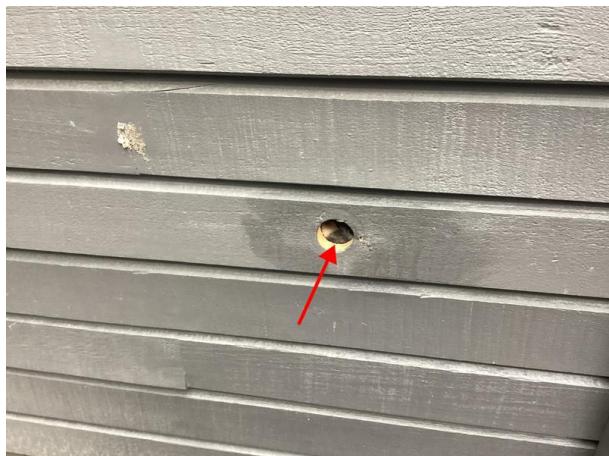
Photo 24

An unused penetration hole was visible near the gas bottle station. Recommend appropriately sealing.

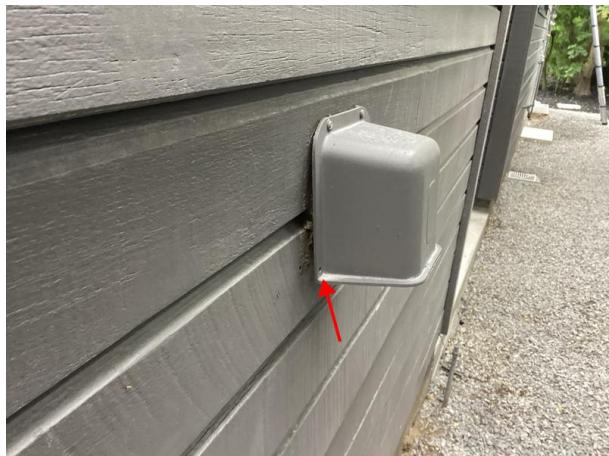
Photo 25

Recommend re-attaching and sealing this PVC capping on the east side of the dwelling.

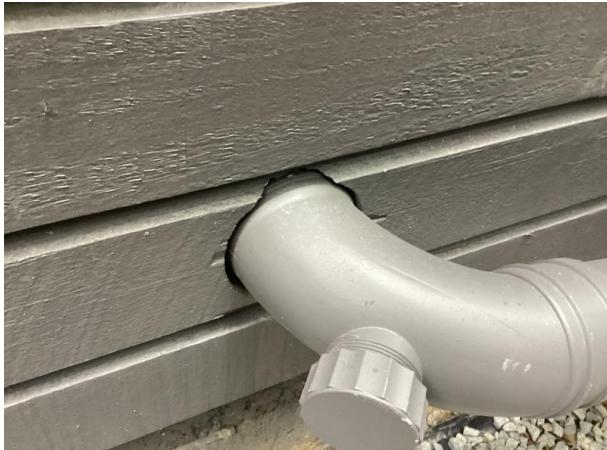
Photo 26

Ensure the cladding penetration holes are well sealed. Some appear to have no silicone installed.

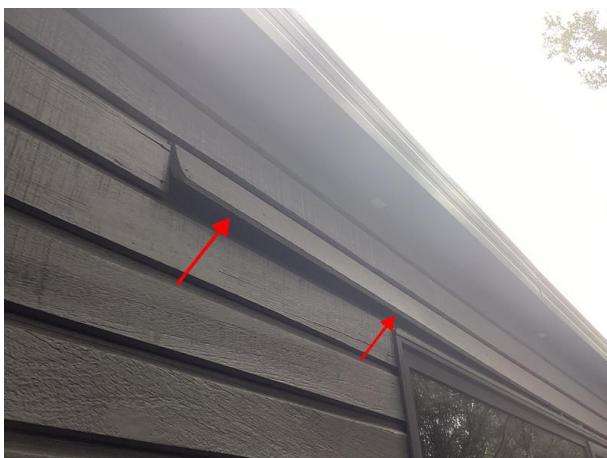
Photo 27

A weatherboard on the east side of the dwelling has detached away and requires resecuring into place.

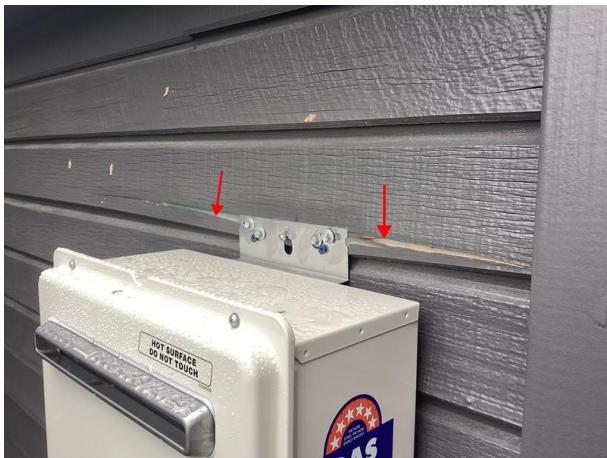
Photo 28

A split timber weatherboard located above the gas hot water Califont was noticed and has been filled with silicone.

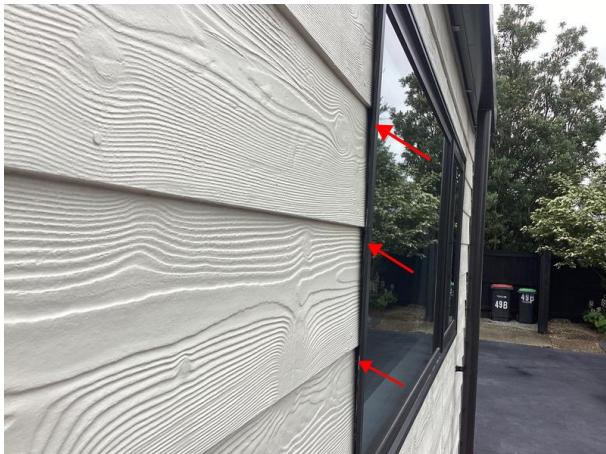
Photo 30

Future maintenance could include sealing these junctions between the cladding and aluminium windows as some visible gaps were observed.

It is recommended to install rustic plugs/scribers or seal in key areas around exterior joinery. These plugs act as a barrier, sealing any gaps or openings to prevent water from seeping in, thereby reducing the risk of moisture.

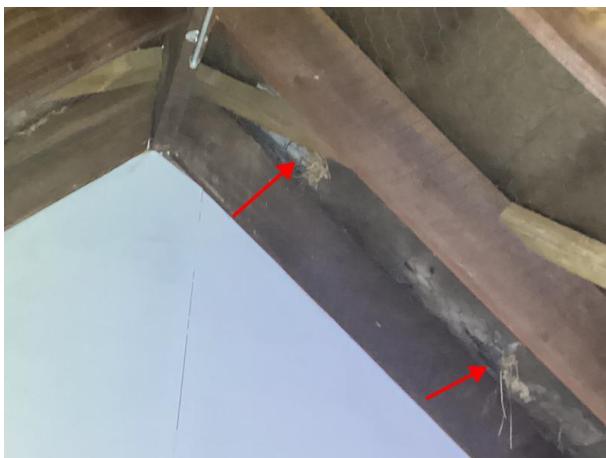
Photo 37

Defects - Areas of torn and ageing roofing underlay was noticed around the roof space.

A few areas of torn underlayment and signs of birds entering these areas were noticed in the garage.

Damaged or torn roofing underlay should be repaired in accordance with the manufacturer's specifications to ensure it performs as intended and meets the requirements outlined under Clause B2 Durability of the New Zealand Building Code. Proper repairs are essential to maintain the underlay's role in providing secondary protection against moisture ingress, enhancing the roof system's overall weathertightness.

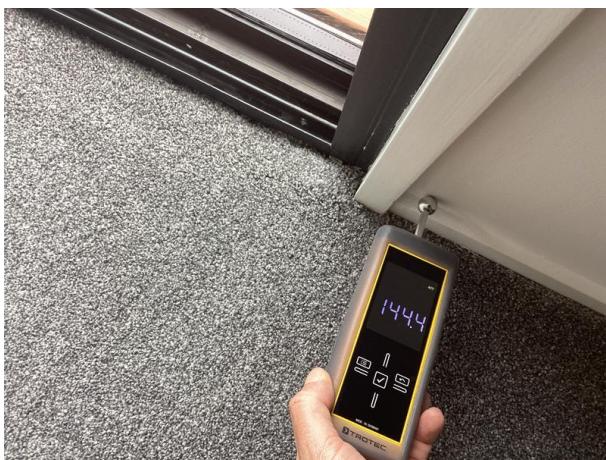
Photo 45

Indications of elevated moisture were detected in the dining room. This is detailed further in the living and dining room section of this report.

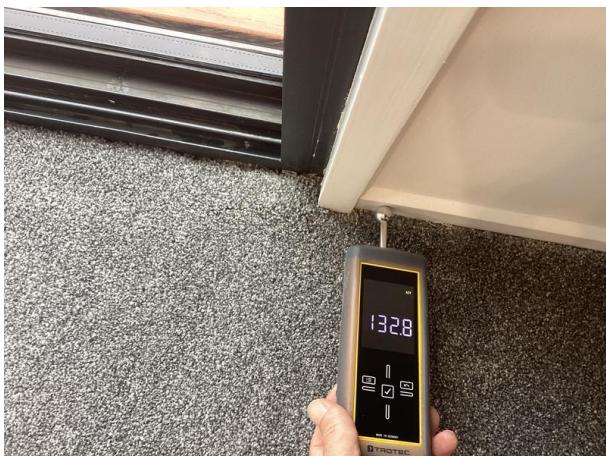
Indications of elevated moisture were detected on the north side of the dining room beside the external sliding door. The FLIR thermal imaging camera was then used with no significant thermal abnormalities discovered during the inspection. When viewing the other side, the timber weatherboards appear to have recently been replaced. It is unknown if the moisture readings detected are historic or a current issue. Further information or investigation is recommended into this area.

Photo 49
Indications of elevated moisture were detected on the right hand side of north side external sliding door.

As detailed in the photos below, indications of elevated moisture were detected on the north side of the dining room beside the external sliding door. The FLIR thermal imaging camera was then used, with no significant thermal abnormalities discovered during the inspection. When viewing the other side the timber weatherboards appear to have recently been replaced. However, there were gaps noticed between the timber weatherboards and window joinery. It is unknown if the moisture readings detected are historic or a current issue. Further information or investigation is recommended into this area.

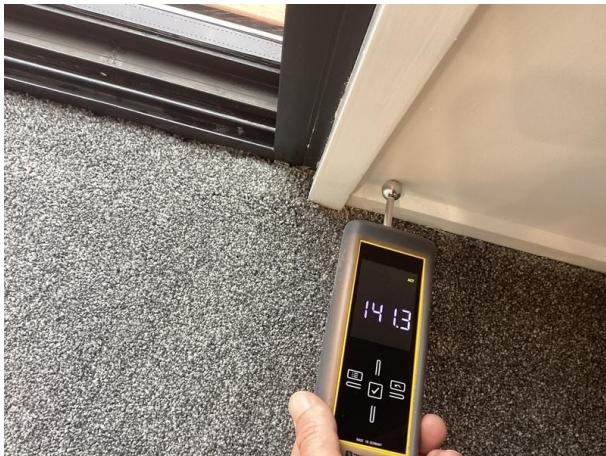
Photo 50

Indications of elevated moisture were also detected on the plasterboard wall lining.

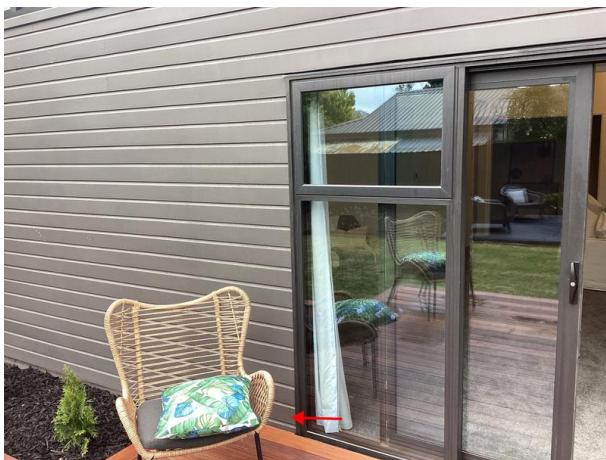
Photo 52

The red arrow is pointing to where the indications of elevated moisture were detected on the other side of the wall.

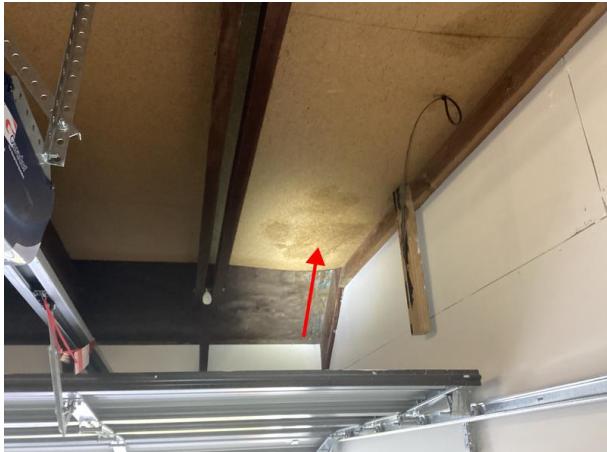
Photo 66

Staining and sagging was visible on the storage attic area. However, no indications of elevated moisture readings were detected around this area during the inspection.

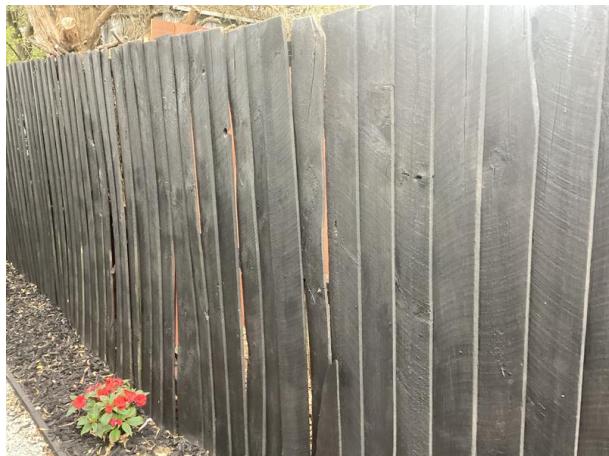
Photo 69

A few broken and loose timber palings were noticed.
