CASH SETTLED CLAIM(S)

Statement of Claim Checklist / Repair Strategy

Claim No: 2010 / 072092

## Assessment of Property at 1430 LEESTON ROAD, DOYLESTON 7682 on 22/09/2011

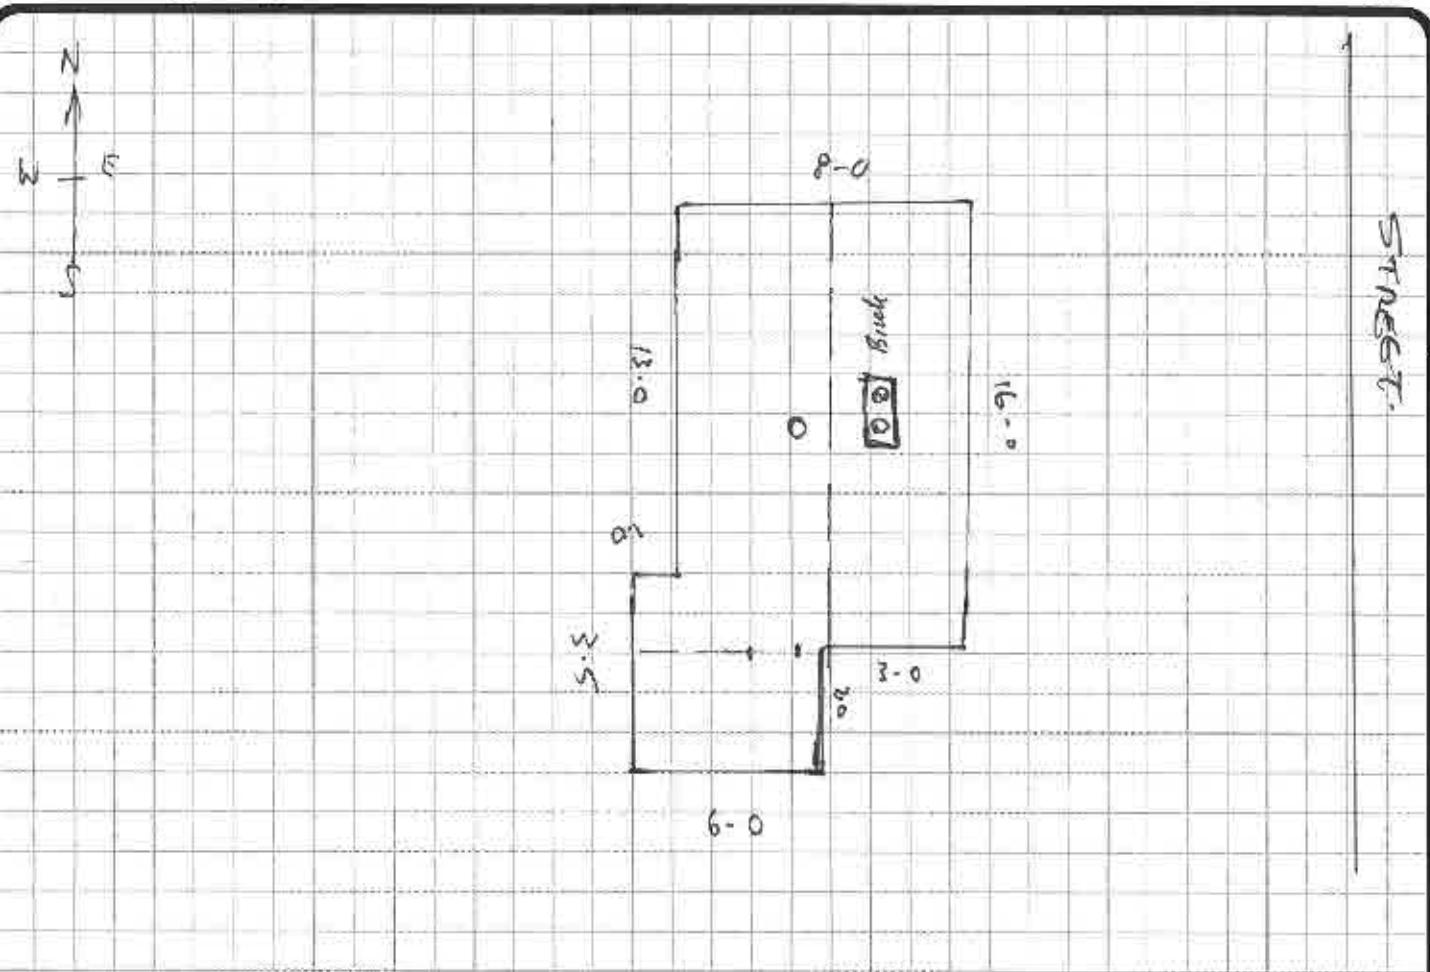
## Dwelling Inspection Checklist: Show measurements indicate damage

Area m ² :	146 m ²		
Stud Heights:	2.4		
Wall Finish:	Wallpaper	Plastered	<input checked="" type="radio"/> Paint Finish
Other:	N/A		
Services:	Specify Damage: NO DAMAGE		
Chimneys:	Construction Type: BRICK x1 : Metal Flue x1 Height		
NO DAMAGE	Damage Description: Above Roof      Below Roof      Total Repair		
Foundations Damage:	<input checked="" type="radio"/> Timber	Concrete Ring	Concrete Slab
NO DAMAGE	Minor	Moderate	Severe
	House Moved off Foundations? NO		
	Concrete Slab Cracked? Crack Width: ..... Crack Length: .....		
Roof:	Framed	Trussed	
NO DAMAGE	Type: Clay Tiles	Concrete Tiles	<input checked="" type="radio"/> Rolled Metal
	Damage:		
Cladding Type:	<input checked="" type="radio"/> Weatherboard	Brick Veneer	Hardi Plank
	Other:
