## BUILDING INSPECTION REPORT

## **NZ Residential Property Inspection Report**

Inspection Date: Thu, 13 Nov 2025

Property Address: 43 Tovey Street, New Brighton,  
Christchurch 8061, New Zealand

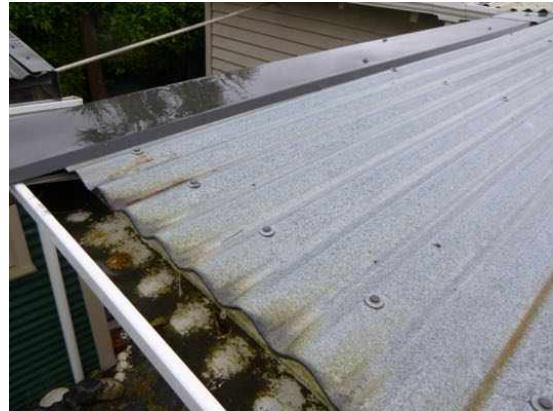
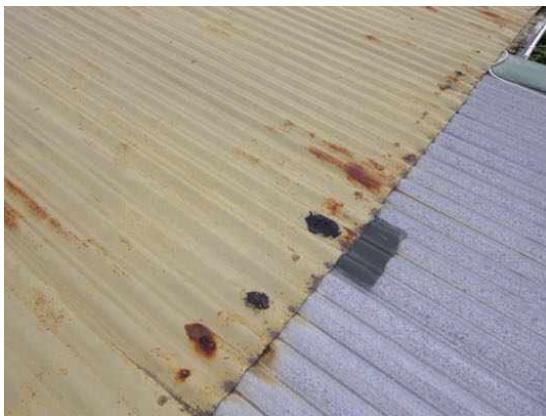
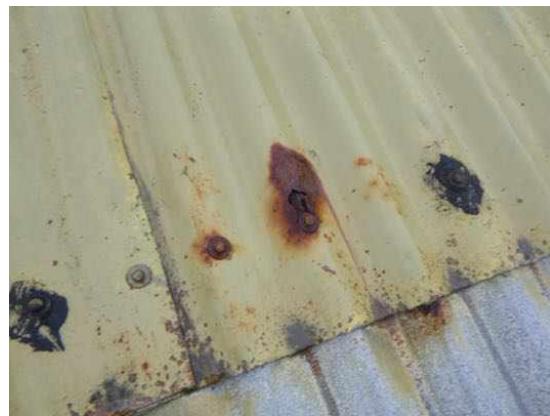
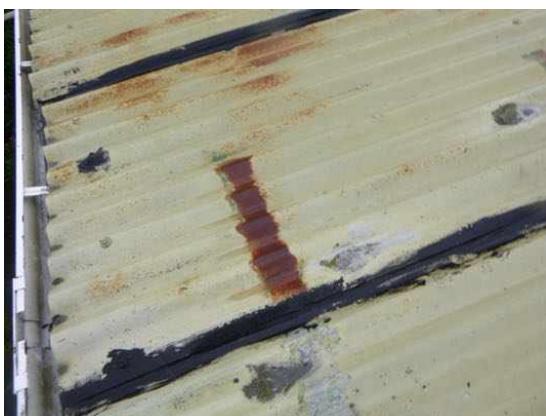
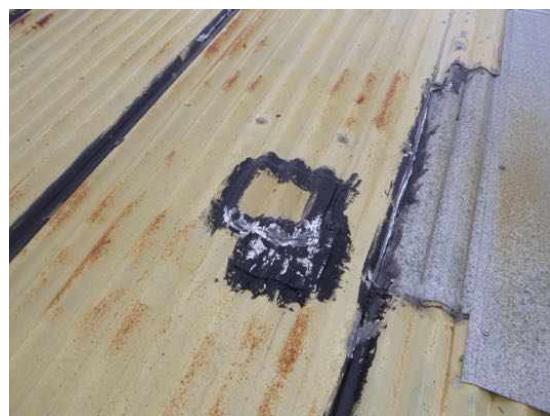
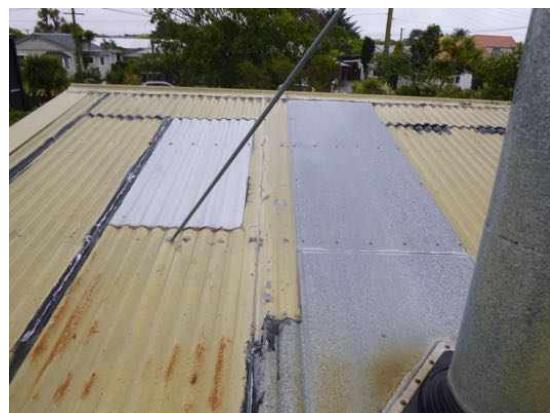
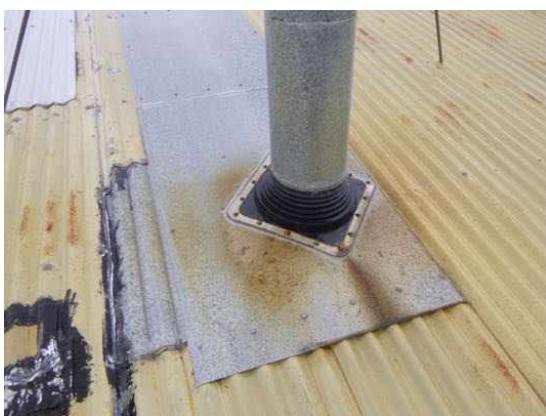
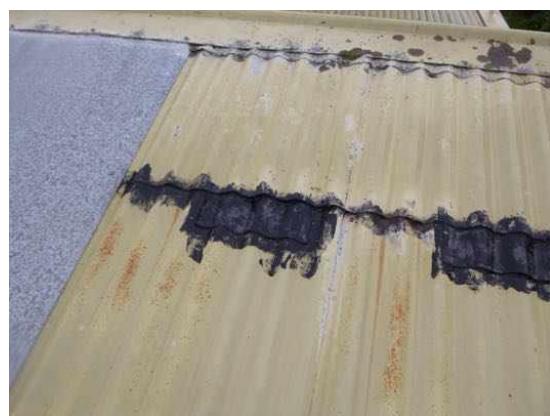
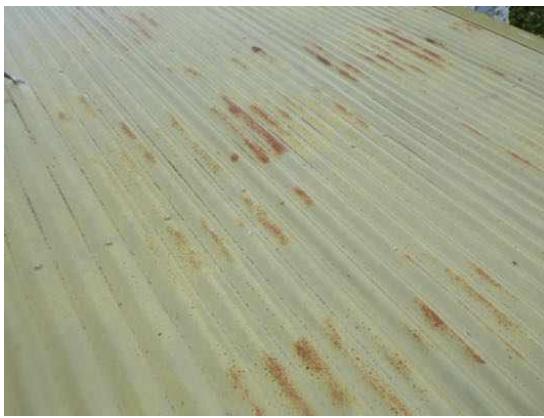
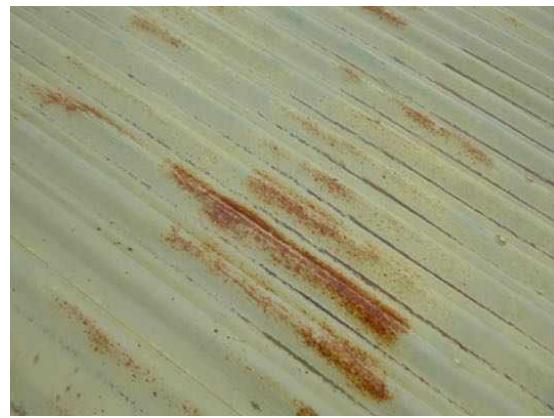
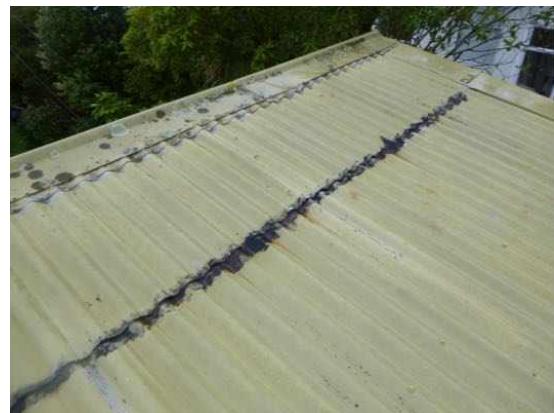
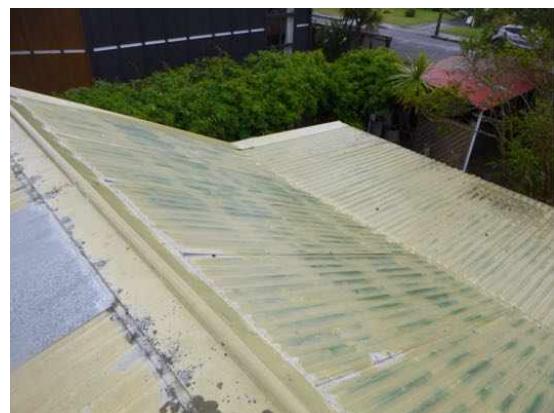
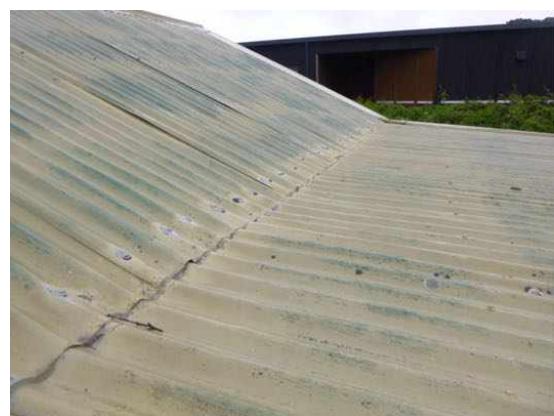
#### Defects 3.01

Finding: Roofing - Condition

Information: The visible corrugated roofing and flashings appeared in fair to poor condition for its age. All penetrations and flashings were installed and sealed adequately.

Evidence of surface rust to some sections was identified. Some patching and re-coating was evident. If left unmanaged, this could allow water ingress to the internal roofing structures, potentially leading to secondary damage of building elements.

The roof is fastened down with roofing nails which can be prone to popping overtime. As general house maintenance, periodically check nails and replace any that may have popped with suitable roofing screws.

Accelerated deterioration of the roofing sheets and any associated building elements is also likely to occur. Replacement or the roofing should be considered. Failing this is advised that a professional painter be consulted to carry out works such as the application of rust-retardant surface protectors and roof paint, in the near future.

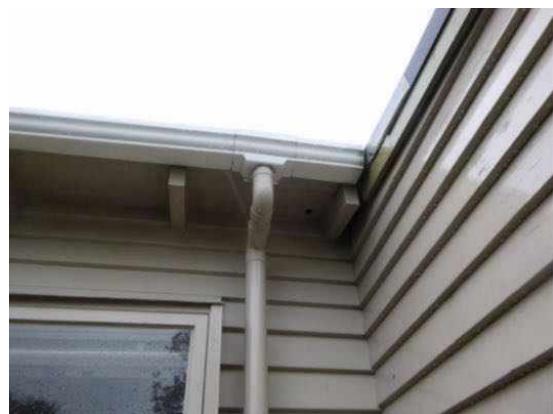
### Defects 3.02

Building: Main Building  
Location: Roof Exterior  
Finding: Gutters and downpipes - Condition  
Information: The PVC gutters and downpipes around the property appeared to be in good condition, allowing good drainage to the downpipes. There does not appear to be any stormwater risers or connection the stormwater system.

Roof plumbing structures, such as guttering and downpipes should be free of all debris to prevent blockages. It is advised that gutters are checked by the homeowner or a general handy person as part of regular maintenance.

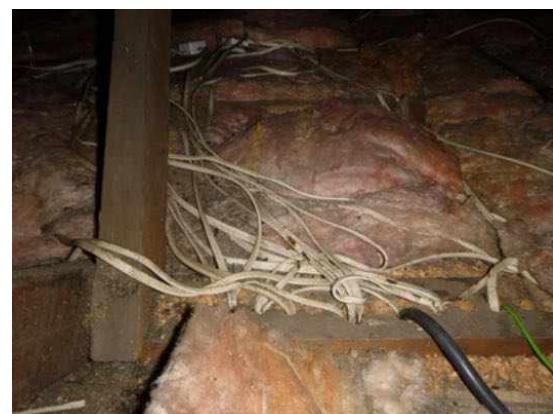
### Defects 3.03

Building: Main Building  
Location: Roof Void  
Finding: Roof space - Condition  
Information:

The roof space was in good order. This consists of pitched timber rafters and ridge boards with timber purlins and sarking underlay. No evidence of active or historic leaks was detected.

One timber purlin was found to be broken. This does not pose any structural issues.

The fibreglass Insulation has been installed to a good standard, with full coverage achieved. Not slumped or compressed. No obvious water damage observed.

Structural modifications have been noted within the roof spaces, it is recommended that council records are checked to ensure compliance has been obtained.

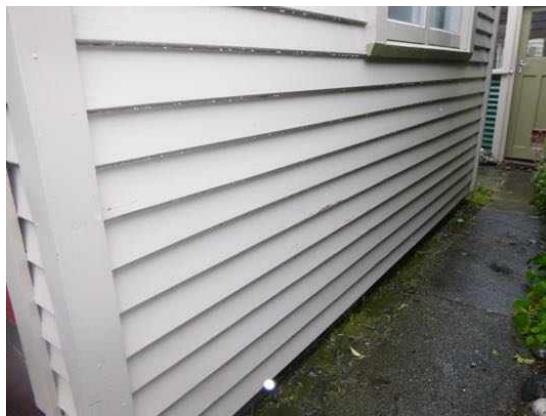
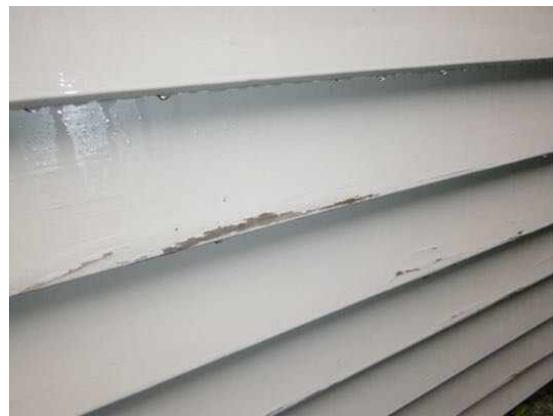
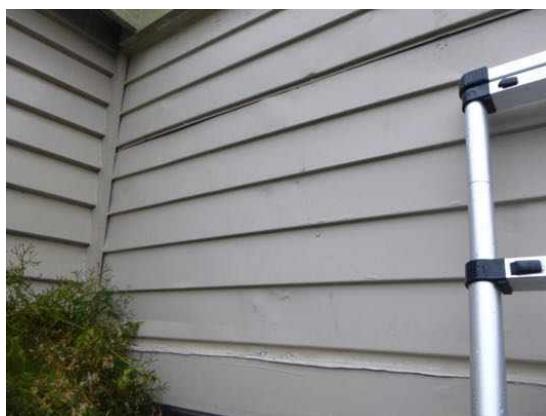
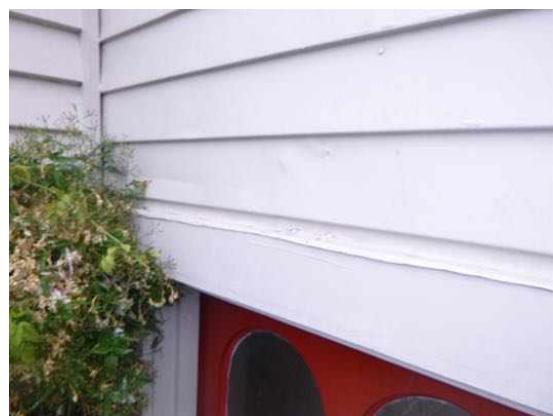
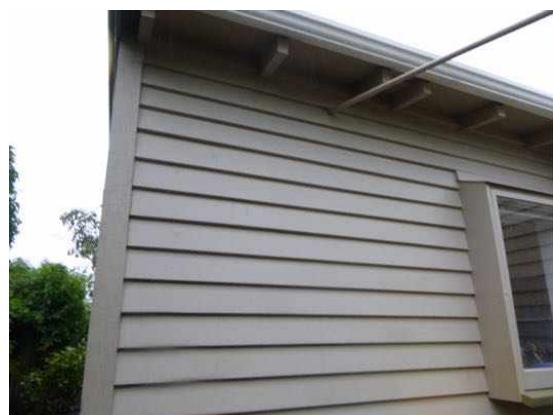
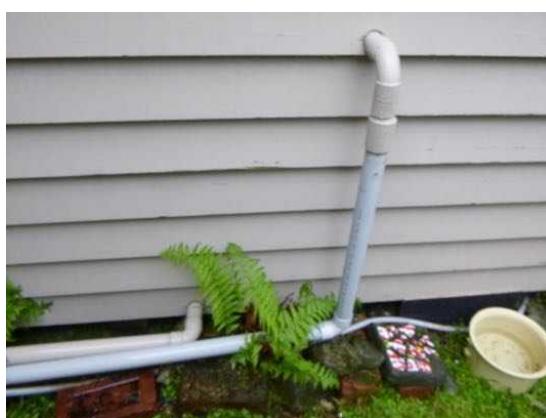
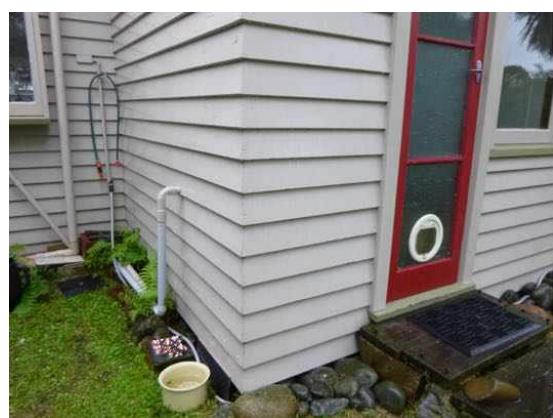
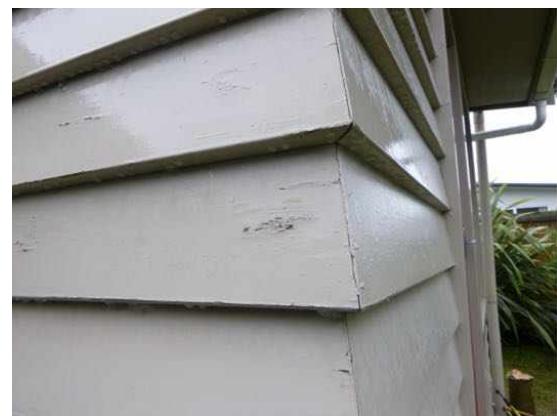
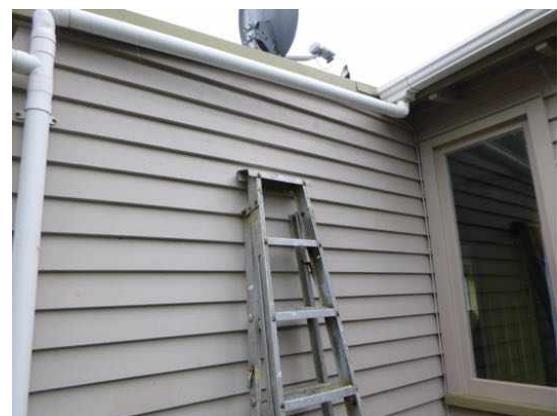
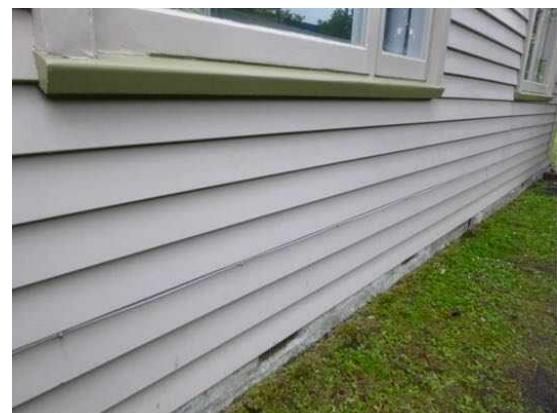
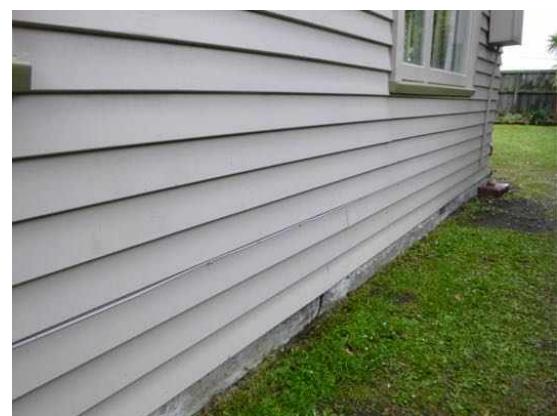
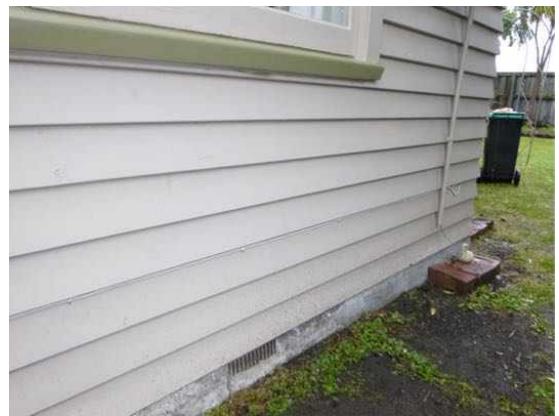
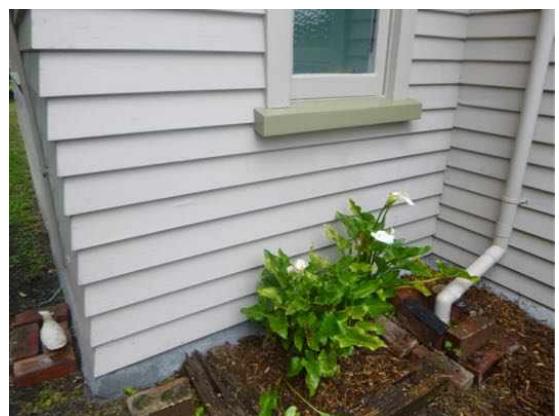
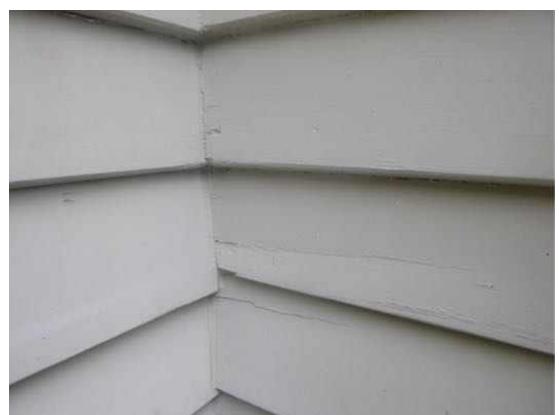
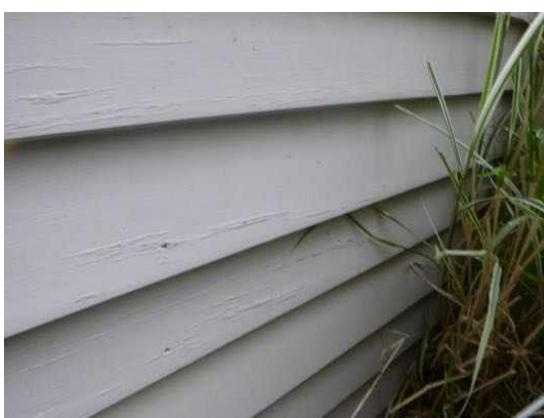
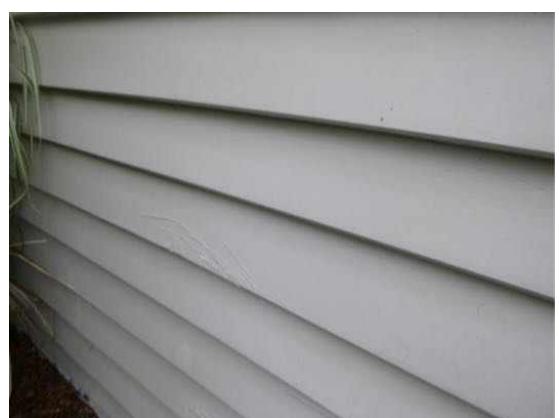
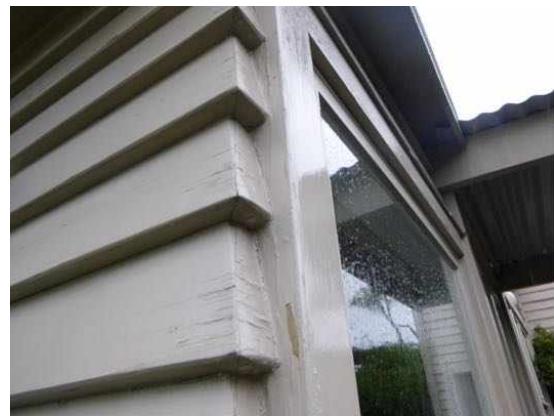
### Defects 3.04

Building:	Main Building
Location:	All External Areas
Finding:	Cladding - Condition
Information:	The exterior painted timber weatherboards were in fair condition overall. All windows and doors were flashed and sealed adequately.

The paint finish was found to be deteriorating in some areas. Paint deterioration is generally classified as an appearance defect. However, the substandard appearance may also be indicative of poor surface preparation and substandard workmanship. A painting contractor should be appointed to perform necessary works to aid the appearance of the affected area and to ensure that the area is protected against further deterioration. Alternatively, the homeowner following manufacturer instructions may be able to provide this service.

I would recommend monitoring the weatherboard joints and junctions as this is where moisture issues are most likely to occur.

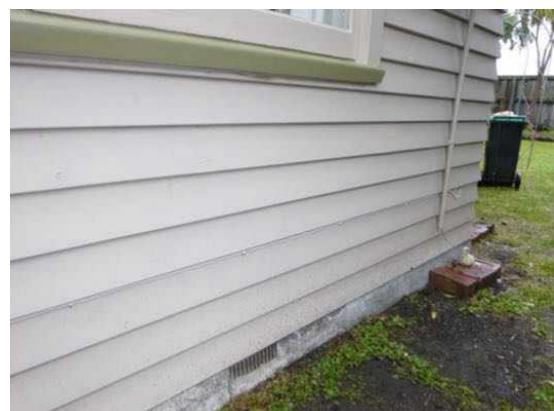
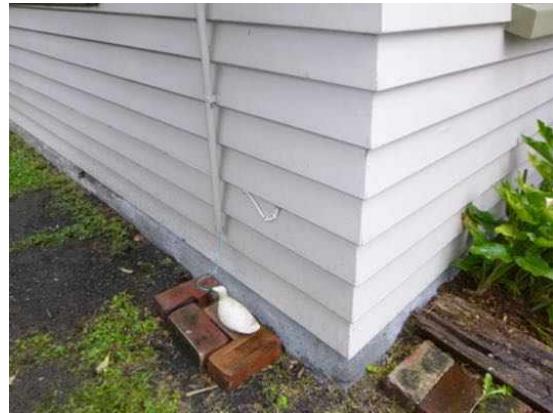
### Defects 3.05

Building: Main Building  
Location: All External Areas  
Finding: Foundation - Condition  
Information: There is no access to the subfloor due to the proximity of the framing to the ground. This is typical for the era of build. Good ventilation is maintained.

The concrete ring foundation visible showed no noticeable cracking.

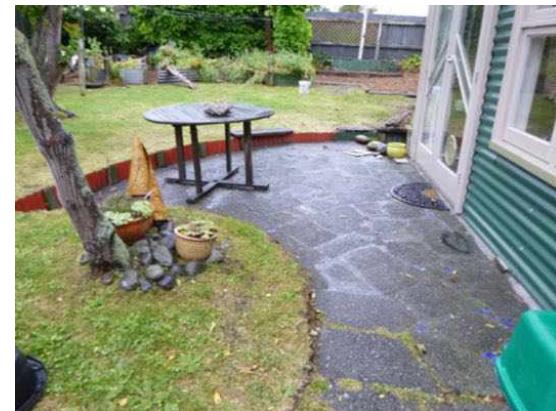
### Defects 3.06

Building: Yard  
Location: All Areas  
Finding: Yard - Landscaping  
Information: The timber fences/gates, sheds, clothesline and concrete/paved areas appeared to be in good condition for their age. The landscaping and lawn areas also appeared in good overall condition.

Typical age related deterioration to the timber fencing and cracking to the concrete areas was identified.

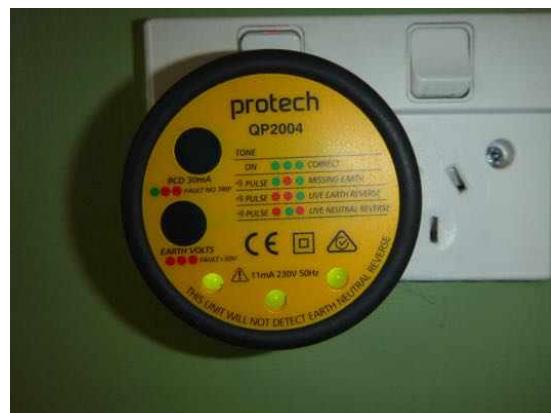
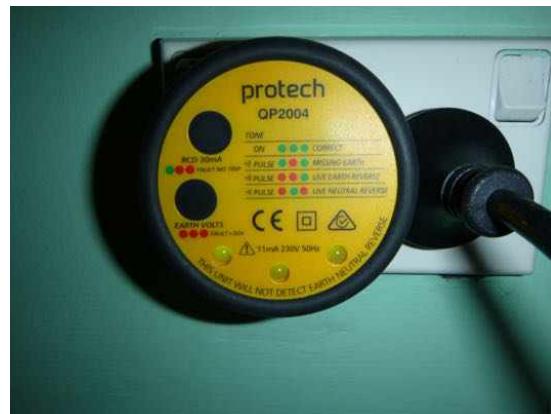
### Defects 3.07

Building: Main Building  
 Location: All Areas  
 Finding: Electrical - Potential Safety Risk  
 Information:

One issue was found during the inspection. Polarity faults were found to a plug in the laundry and two plug in the sleepout. This may mean that the neutral wire is connected to where the hot wire should be, or it is missing the earth wire. This could result in a shock if the appliance is mishandled

**Note: A qualified electrician has investigated and rectified this fault. Please see supporting "Electrical Works" documentation provided.**

A qualified electrician should be appointed to further investigate the fault

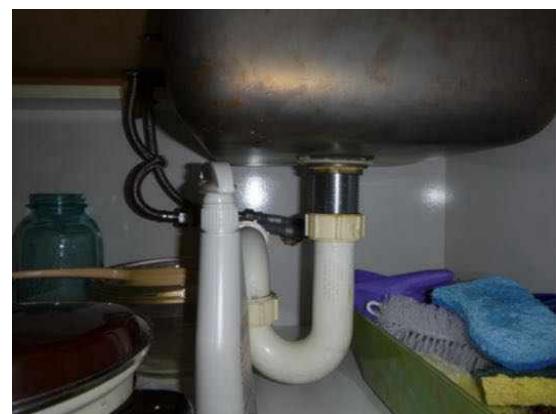
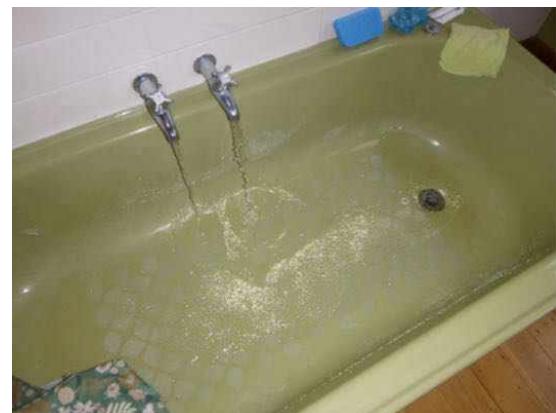
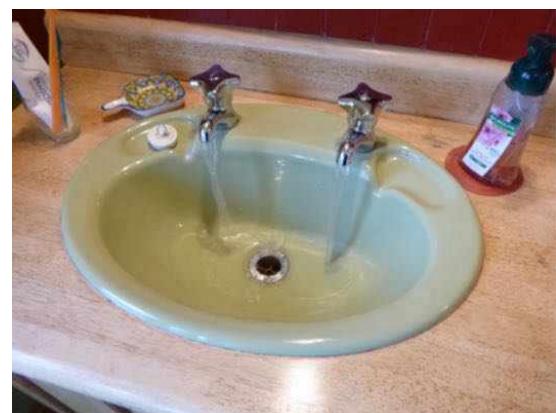
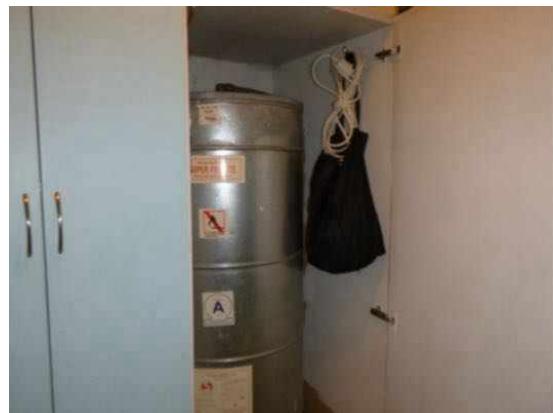
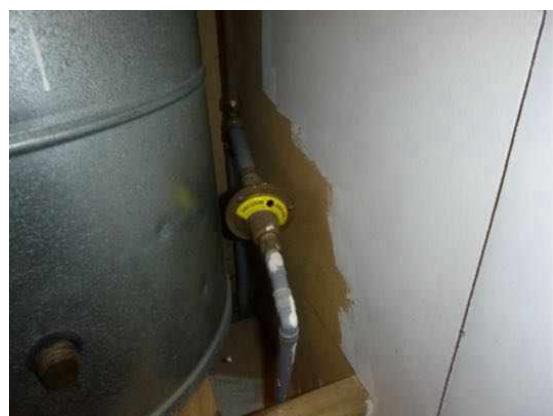
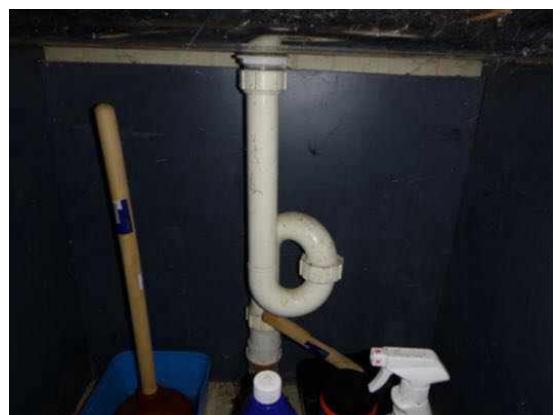
**Noted Item**

Building: Main Building  
Location: All Areas  
Finding: Plumbing items - Condition  
Information: All taps and the shower were run for a period of time and toilet flushed, it appears the water is running freely. The water pressure was good. The plumbing items appear to be in good condition where visible and tested.

The gully traps were checked and were clear, and are sufficient height off finished ground level. Covers are installed on traps to prevent debris getting into the grey water system

The water is heated via an electric hot water cylinder.

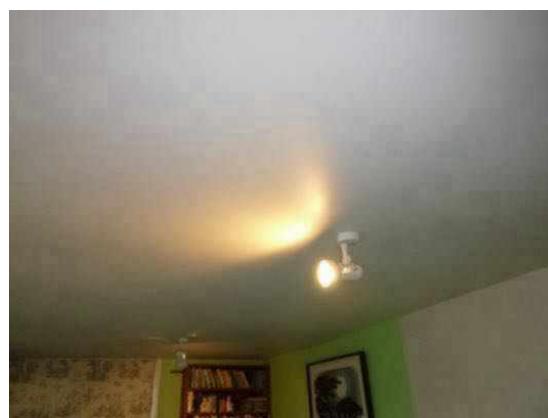
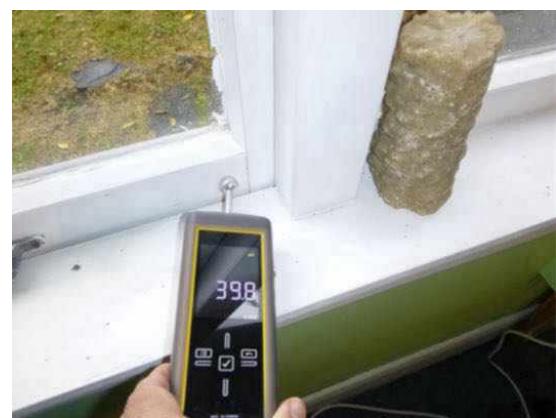
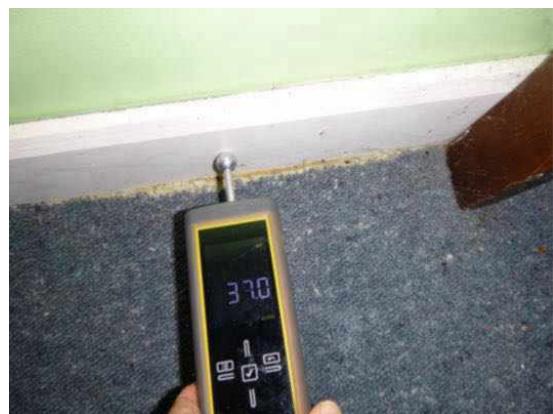
**Noted Item**

Building: Studio  
Location: All Areas  
Finding: Laundry/Studio - Condition  
Information: The detached building is timber framed construction with coated corrugated metal roofing. This sits on a concrete slab. The exterior cladding is horizontal corrugated iron.

This appeared in good overall condition and structurally sound.

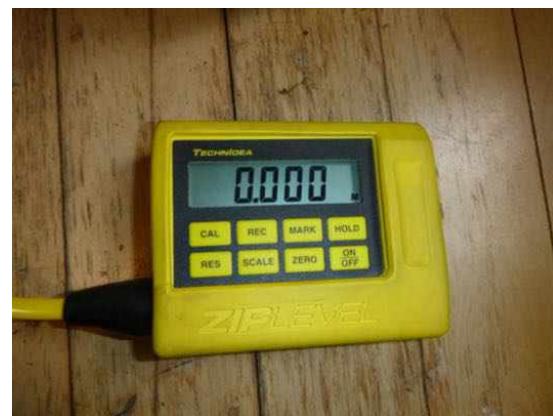
## Noted Item

Building: Main Building  
 Location: All Areas  
 Finding: Floor - Levels  
 Information: Spot floor level readings were taken throughout the main floor areas of the dwelling where accessible. (JBI take into account floor covering thicknesses as needed throughout the dwelling)

This falls within the MBIE guidelines of 50mm over 10 metres.

All levels are within the MBIE guidelines over a short distance, being less than 0.5% or 10mm over 2 meters.
