PROJECT SUMMARY

Site Address 19 Belfield Street, Dallington, Christchurch 8061

Project No. 25288

REPAIR DESIGN FOR EXISTING RESIDENTIAL DWELLING

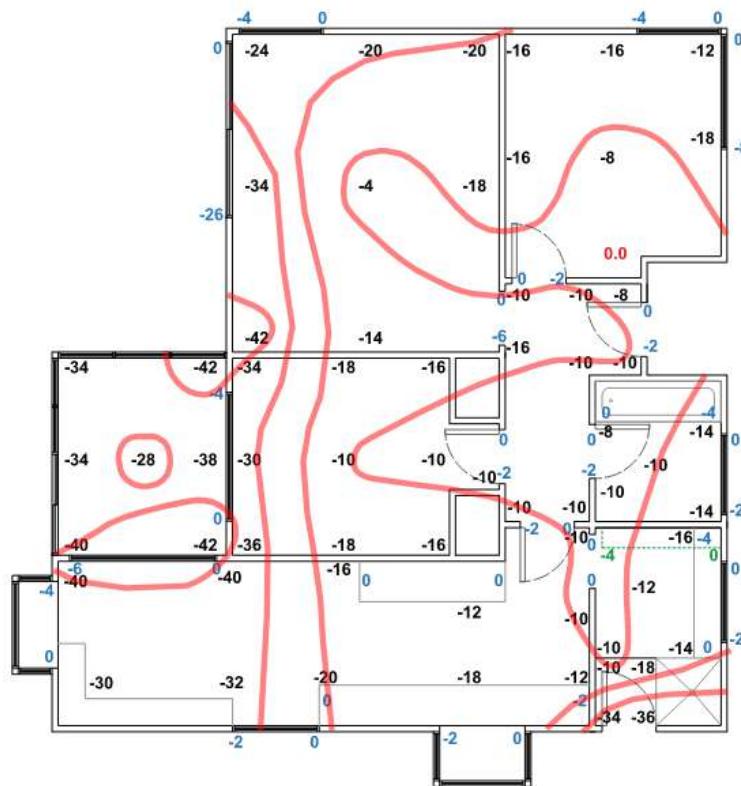
LEVEL SURVEY - MAIN DWELLING
scale 1:100

A level survey was carried out with a Zip® Level altimeter. An overall floor level variation of 42mm was recorded over the floor of the dwelling. The floor slopes from high points in the north-eastern corner, in bedroom 1, towards a low point on the west elevation, particularly around the lounge and sunroom area.

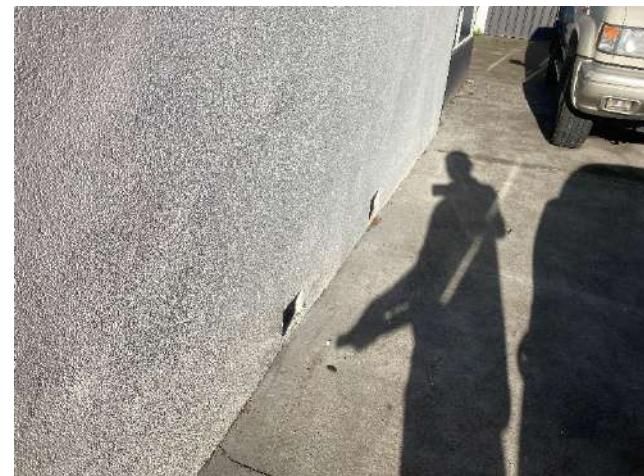
- Cracking to the plaster was noted at the interface with the concrete patio. A timber board was also showing signs of rot.
- No damage to the concrete patio was noted on this elevation.

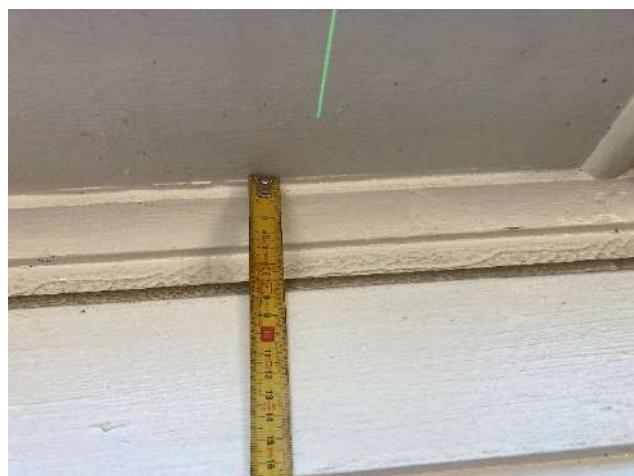
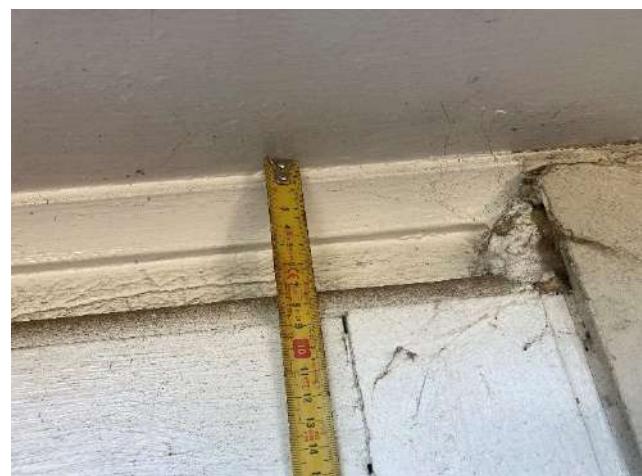
- The frame outside of the lounge was measured to be plumb. However, the top of the frame showed some adjustment, being smaller at the centre of the span. There was no sign of damage to the frame or surroundings.

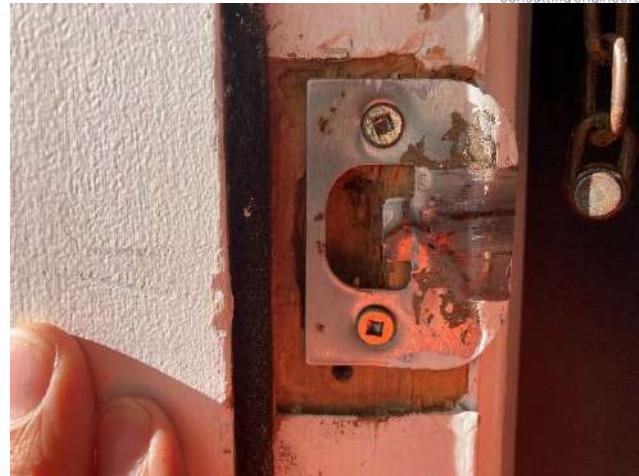
- There were reasonably consistent gaps around the entry door. However, it appeared that the striker plate had been adjusted or replaced.

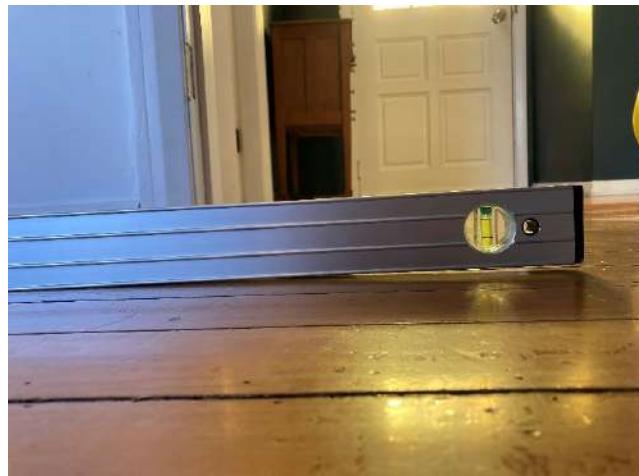
- The door has been removed, and the adjacent floor has a noticeable hump.

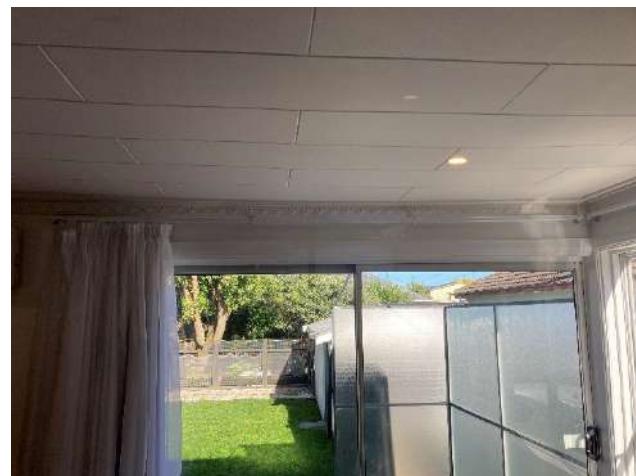
- There was an uneven finish on top of the sliding door. No damage was noted in the surroundings. It appears that the ceiling in this location has been adjusted to suit.

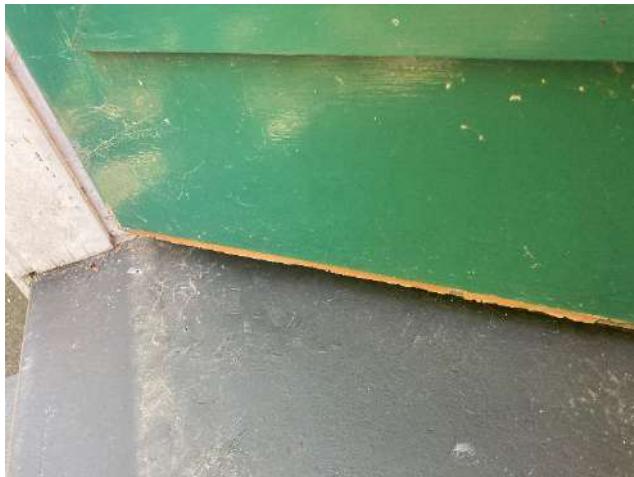
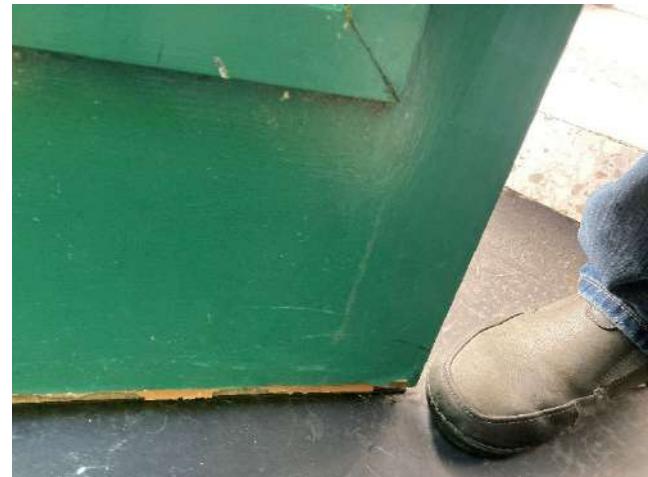
- The bench and tiles were installed after the earthquakes.
- The external door appeared to have been modified on the bottom. There was also a new cover installed on the inside face.

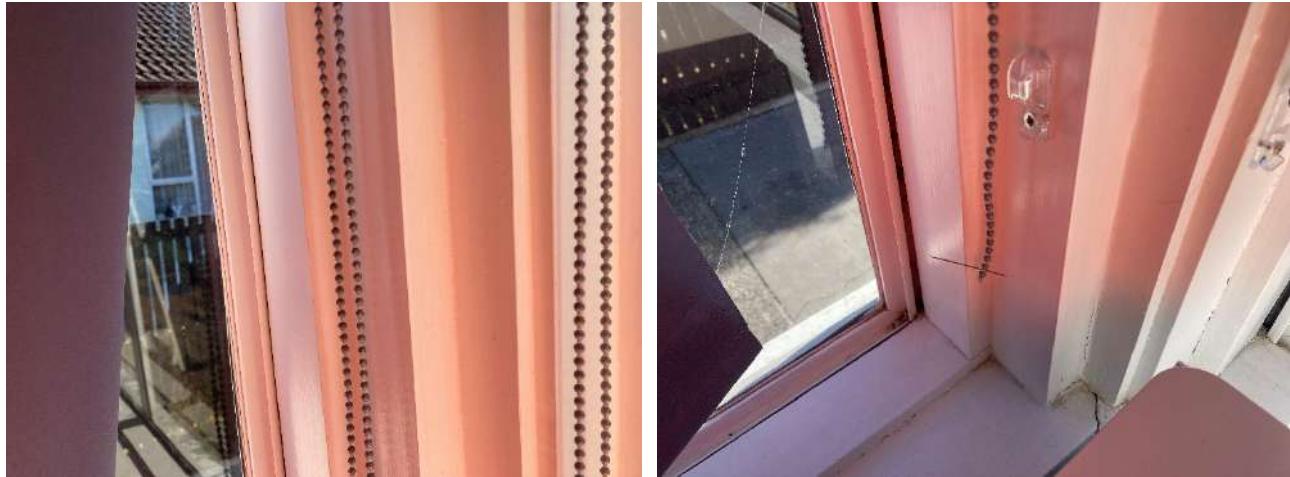
- The windows were operational. However, there was a tapered gap on one side between the window frame and the timber.

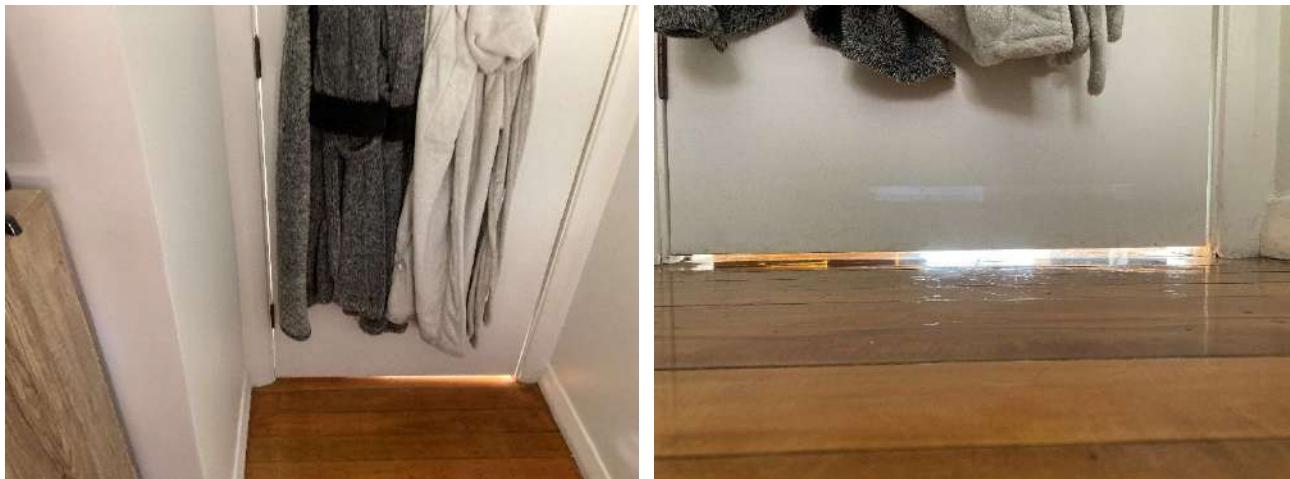
- The windows operated freely, with no issues noted.
- There was a noticeable tapered gap at the bottom of the door.

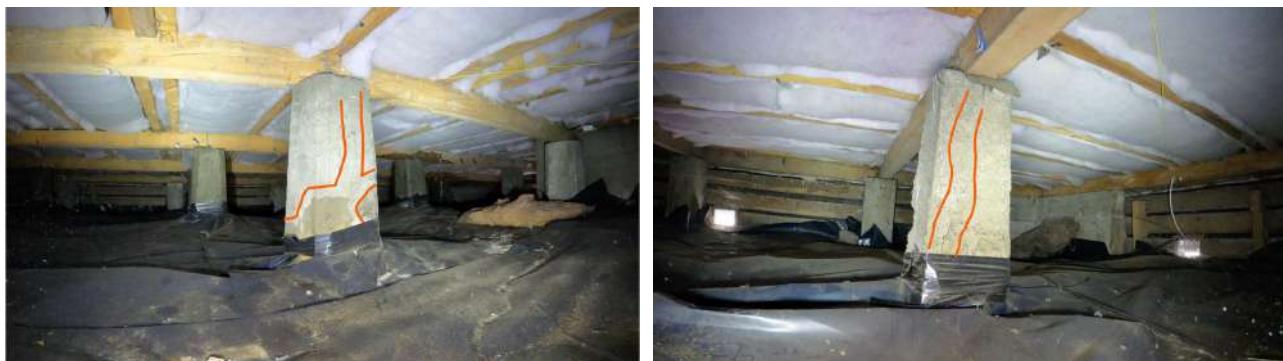
- There were two piles cracked in the middle.

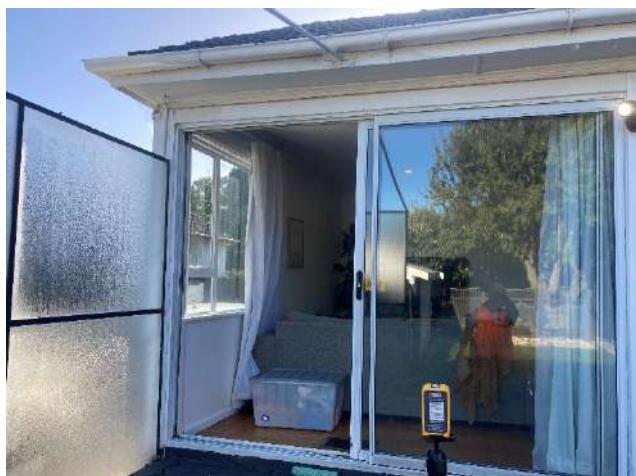
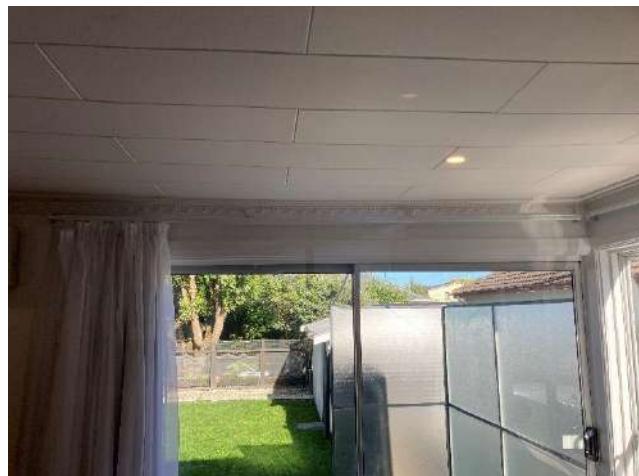
There were some inbuilt inconsistencies recorded between the floor levels and adjacent elements. The top of the lounge sliding door was sloping 26mm down towards the south, while the floor was only sloping 10mm. There were elements on the outside and inside of the frame that showed that some adjustment was made at the time of construction. In the lounge slider, the separation between the frame and the soffit was 10mm less in the middle to allow for the difference with the soffit. A similar situation was observed inside with the cornice, moulding, and the top of the sliding door.

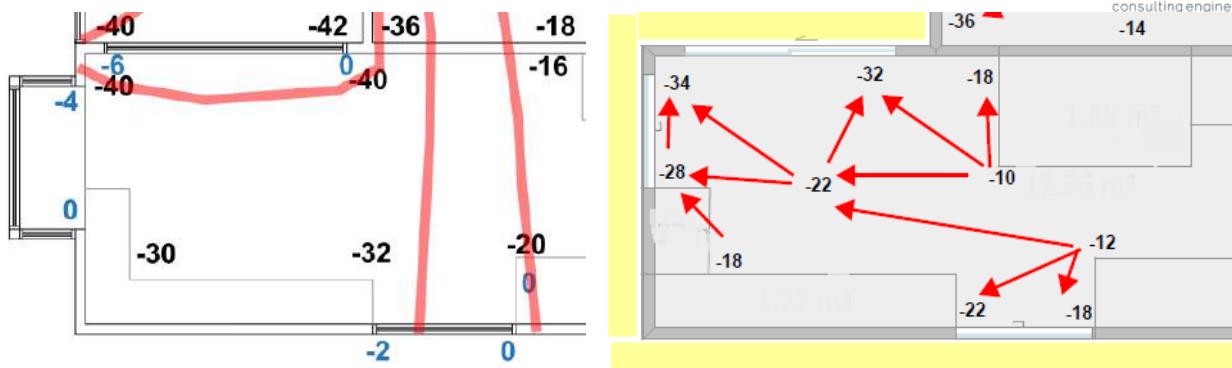
The window on the southern elevation, between the kitchen and the dining area, was generally level, while the adjacent floor was 12mm sloping down towards the west. However, the floor levels were recorded around the furniture and not directly under the windowsill. When this area is compared to the Wrightway floor level survey, the levels recorded directly under the windowsill were sloping 4mm down towards the west, in line with the windowsill sloping 2mm in the same direction. See localised floor surveys below:

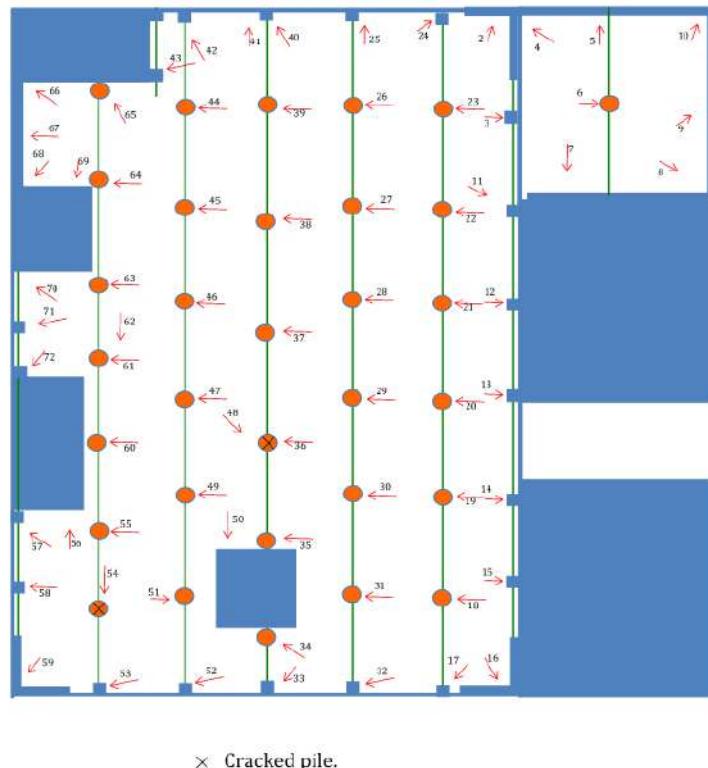
packing piles, replacing them or underpinning of the perimeter foundation elements. Due to the make up of the foundation and the combination of footings, piles and foundation beams, a combination of strategies will be required. See the foundation plan below and the levelling strategy appended to this document.

If levelling is confirmed, it should target a 'when new' condition and be performance-based. The target levels provided are an indicator. However, the final levels will need to be determined during levelling and based on the acceptable level of consequential damage. See A03 for the proposed extent of the levelling.

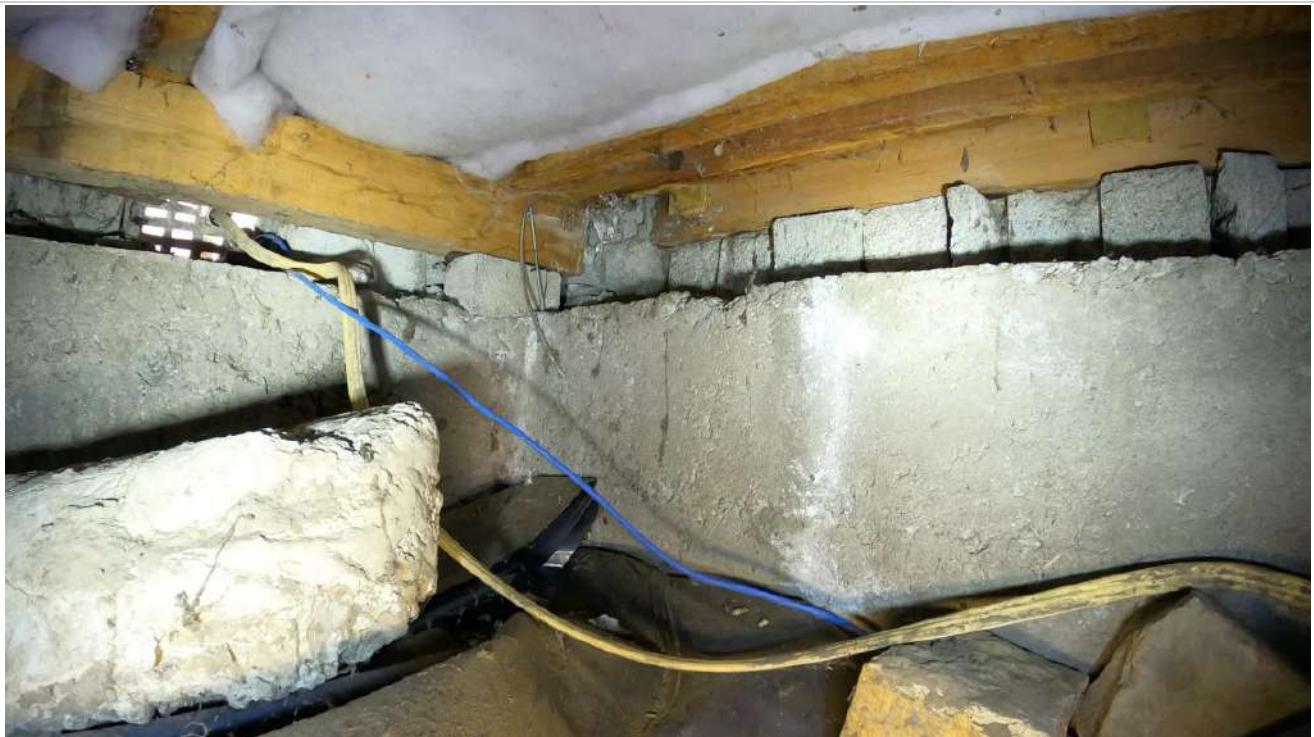
8: View of ring foundation. There are some non-compliant issues with the wiring seen in this home. They could also be a significant hazard to anybody operating under the floor. This relates specifically to unclipped wires. An electrical inspector could be consulted regarding this. The communication cable has also not been laid in a compliant manner and would easily be damaged by people accessing the subfloor.

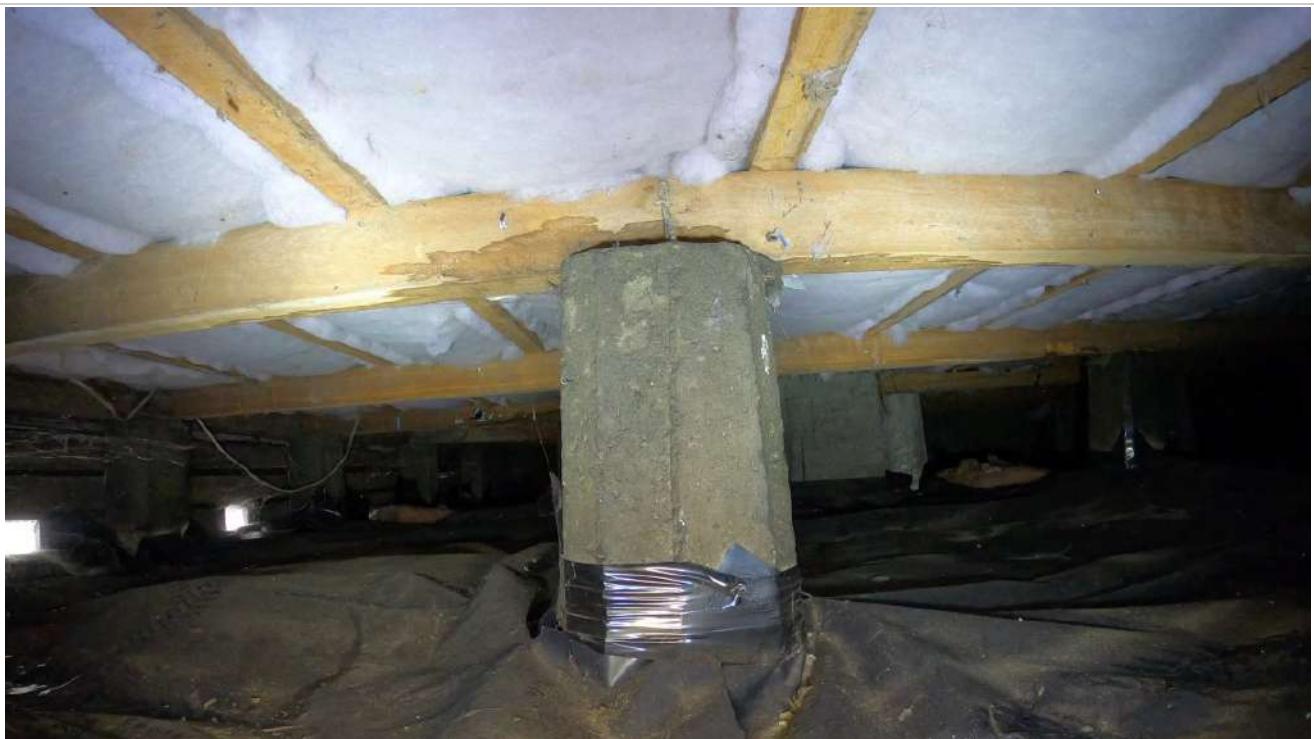
18: The home has precast concrete piles. These maybe concreted into the ground but the polythene obscures this. They are connected to the bearers with stapled off wire ties. We do see a couple of broken ones.

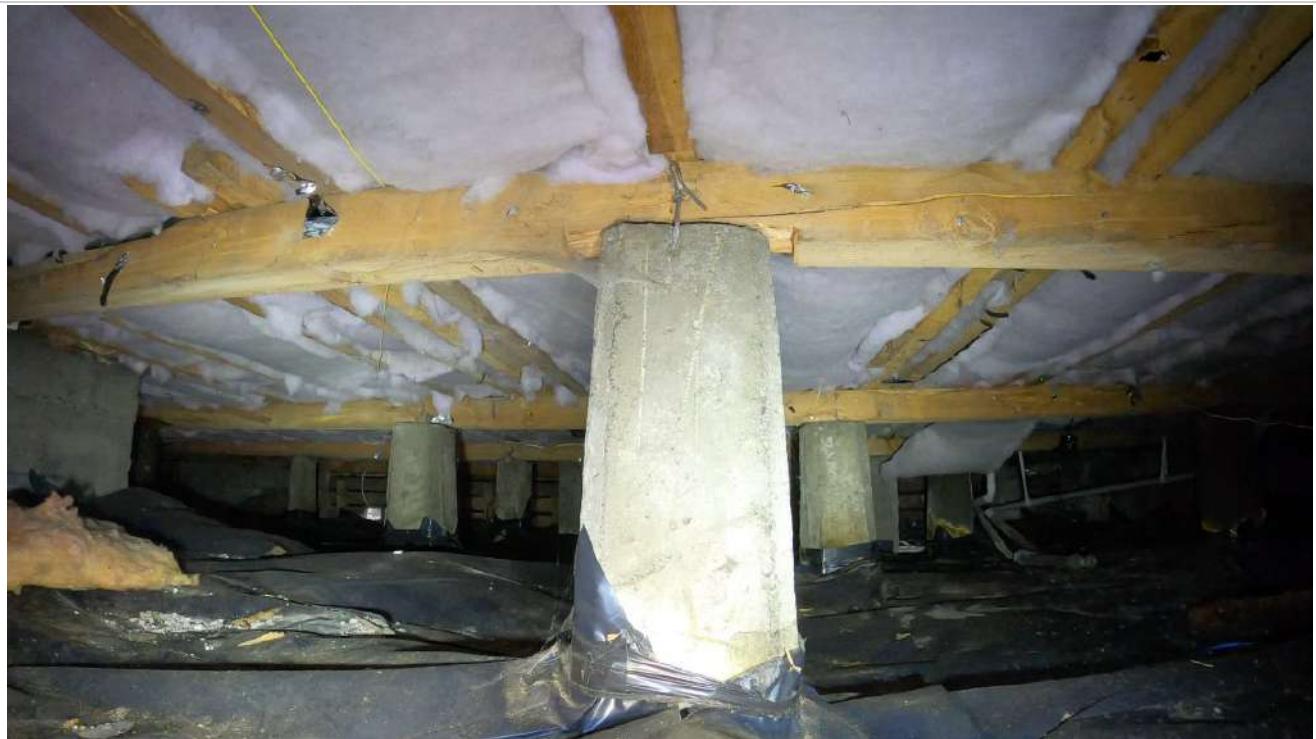
36: Here we see that the bearer has been notched and not reinforced. The bearer has also cracked. We can't see it here but in shot 48 of the other side of this pile we see that it is cracked.

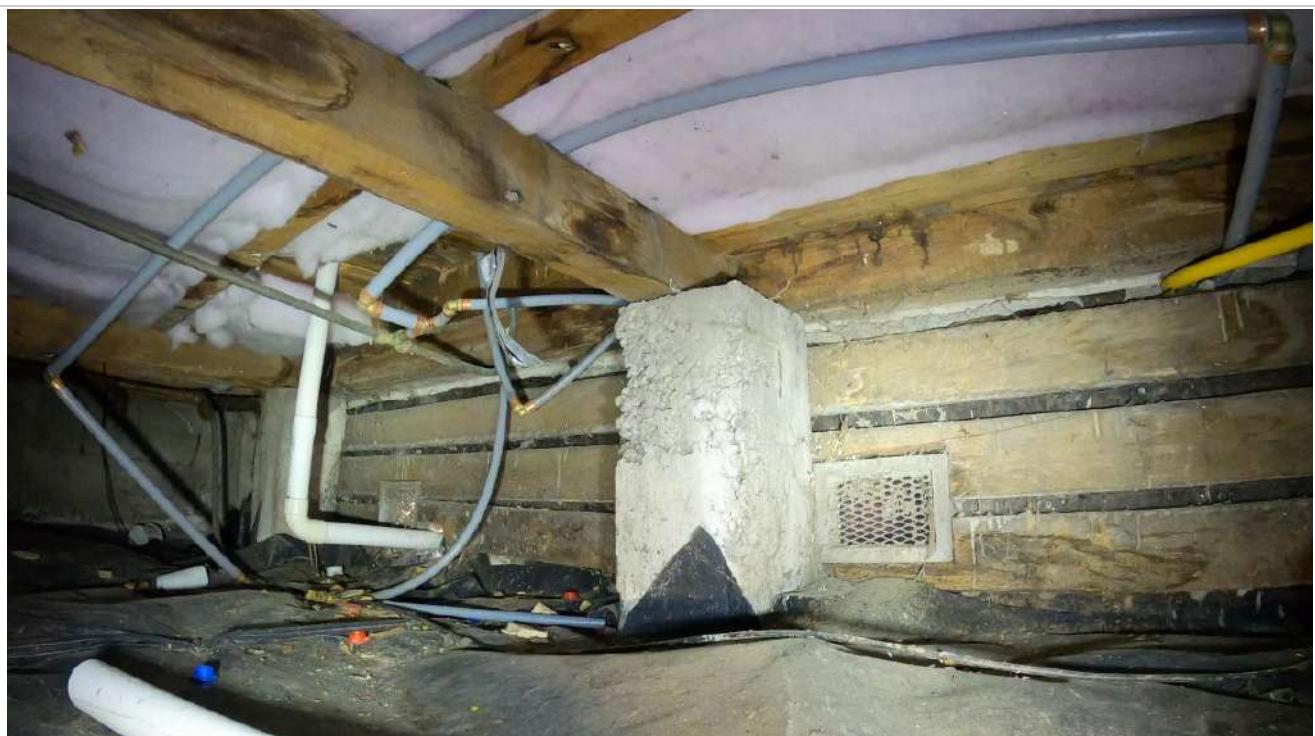
40: Cast in place concrete pile. There has been a water leak in this area which may have been fixed but the timber has been damaged.

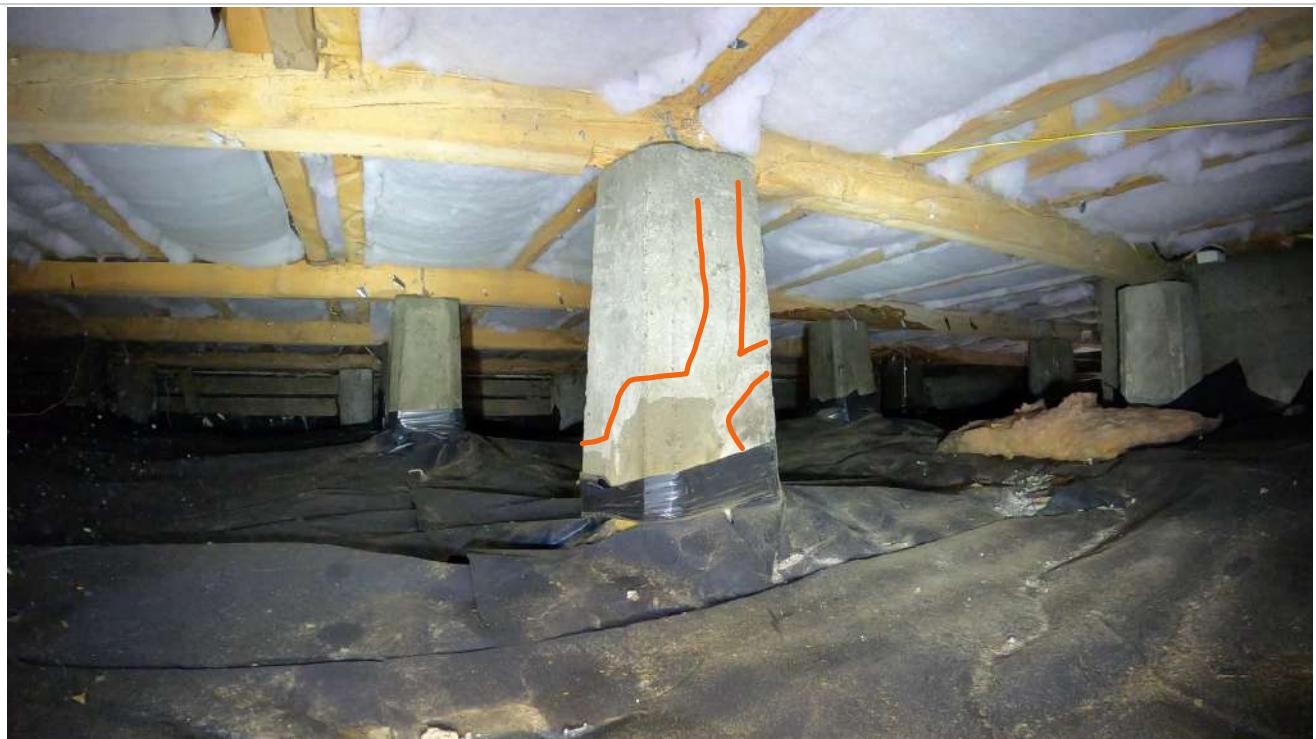
48: This pile is cracked.

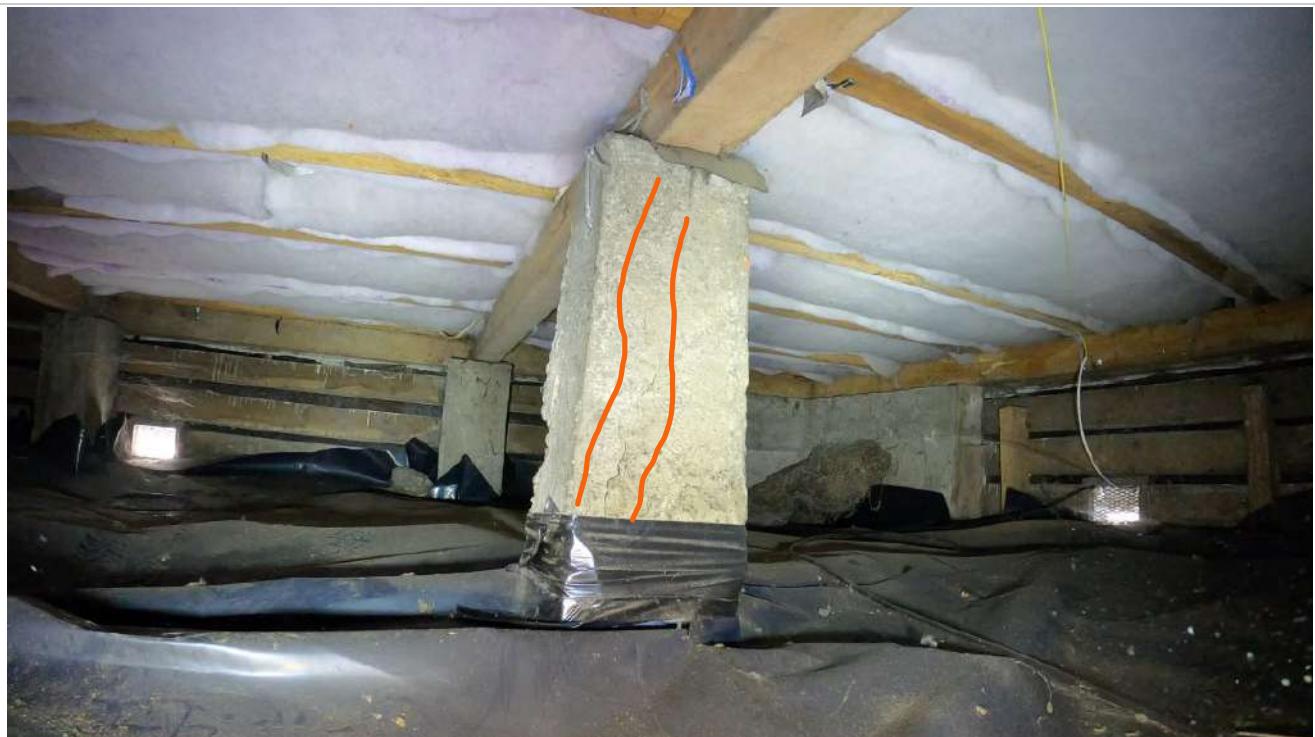
54: This pile is cracked. It is possible that there are other cracked piles we can't see due to the polythene.

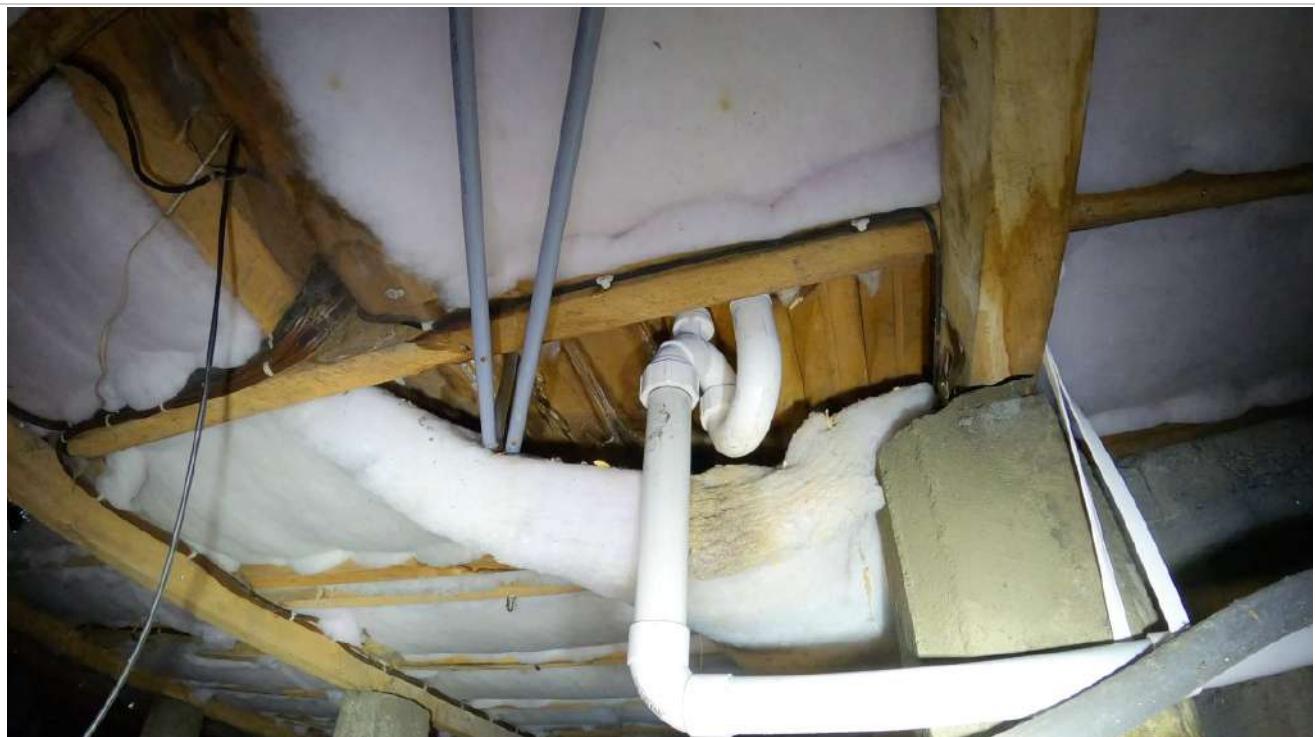
62: There has been a water leak in this area which may have been fixed but the timber has been damaged.

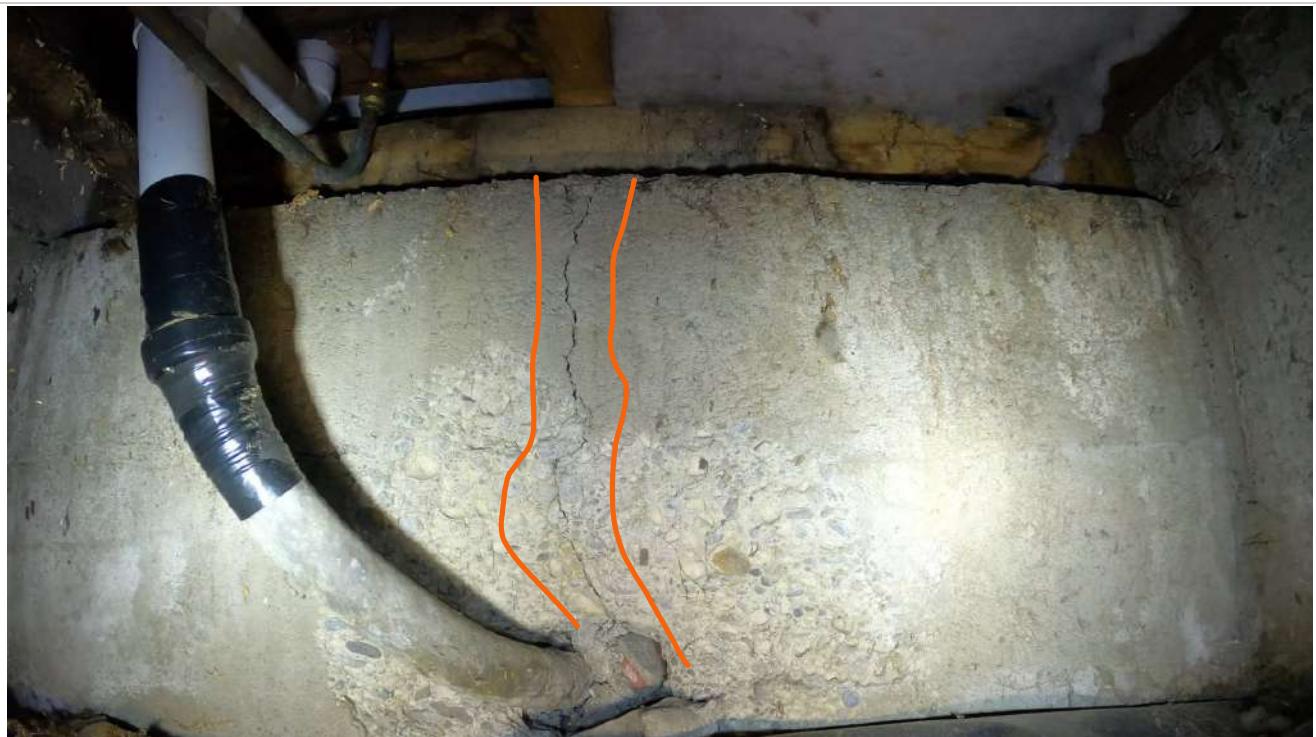
67: View of foundation with cracking. Note that the taped waste.
