**SUBJECT: STRUCTURAL INSPECTIONS AND SIGN-OFF FOR REPAIR / RE-LEVEL TO EXISTING  
RESIDENTIAL BUILDING AT 19 BELFIELD STREET, DALLINGTON, CHRISTCHURCH 8061.**

## STRUCTURAL REPAIR ASSESSMENT

**Project Number** 25288 **Issue Date** 05 December 2025

19 Belfield Street, Dallington, Christchurch 8061

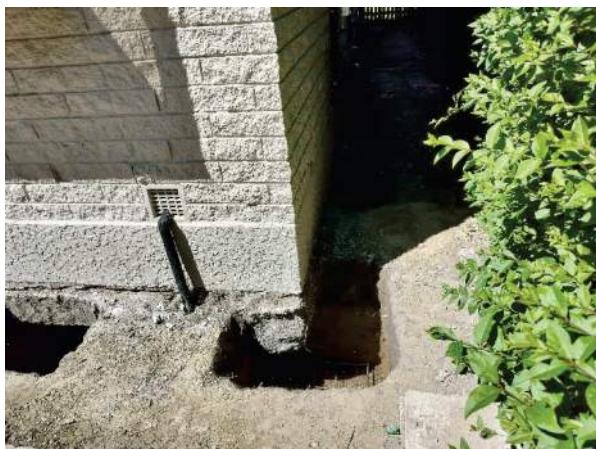
Photo 1. View of excavated pits for underpinning pads.

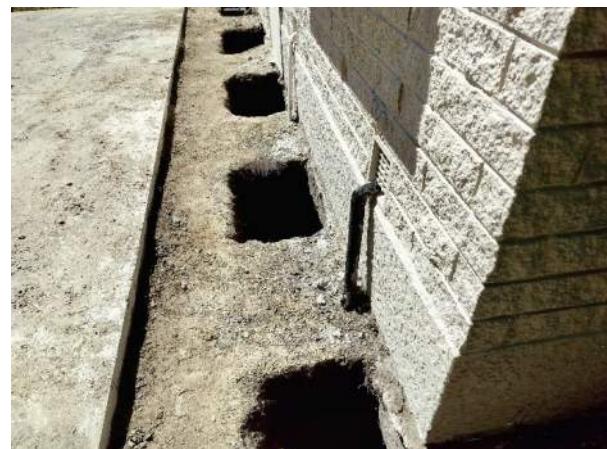
Photo 2. View of excavated pits for underpinning pads (1).

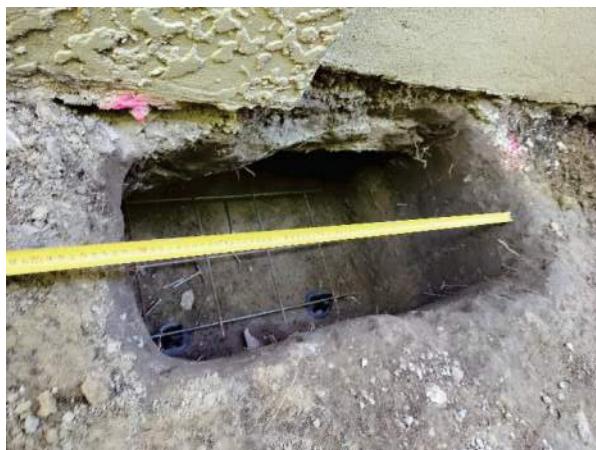
Photo 3. View of excavated pits for underpinning pads (2).

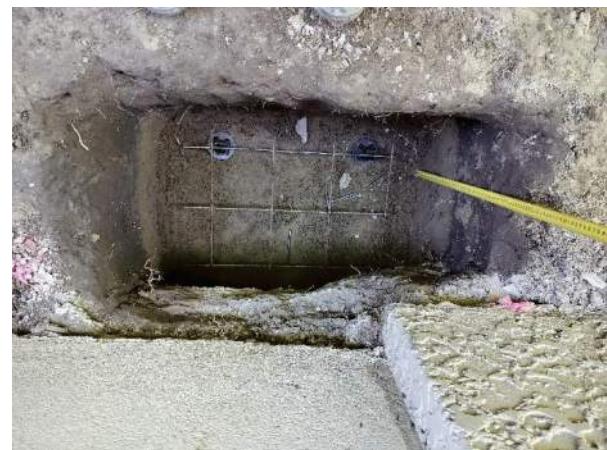
Photo 4. View of excavated pits for underpinning pads (3).

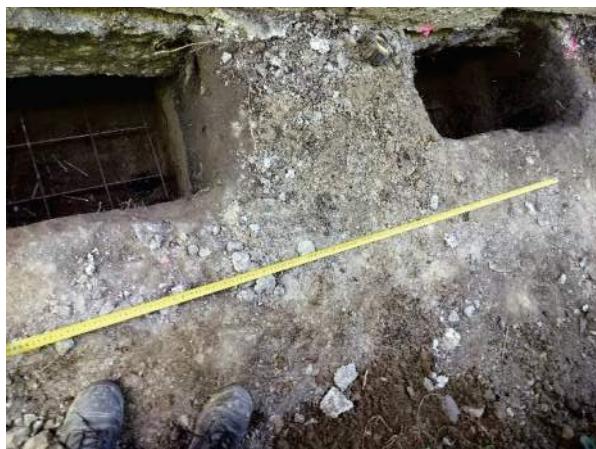
Photo 5. View of excavated pit for underpinning pads (4).

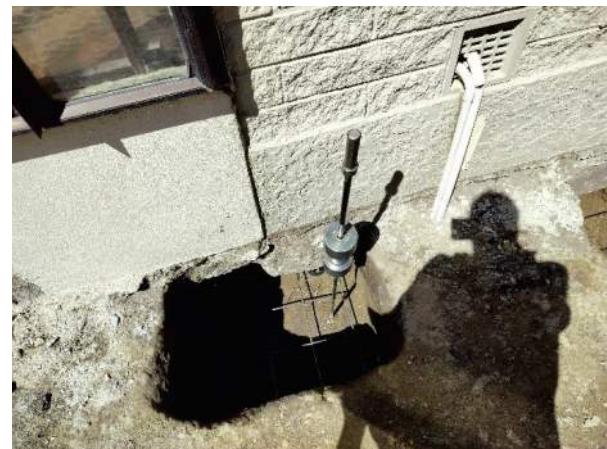
Photo 6. View of excavated pit for underpinning pads (5).

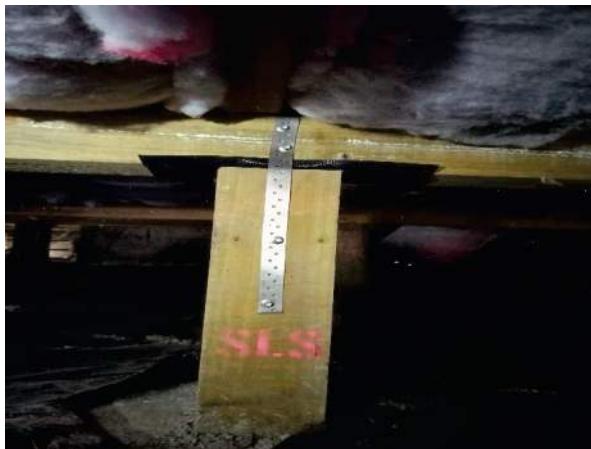
Photo 7. View of subfloor connections.

- g) Sub-floor connections carried out as per our specification. OK.
- h) Cracking damages to the perimeter foundation repaired as per details. - OK

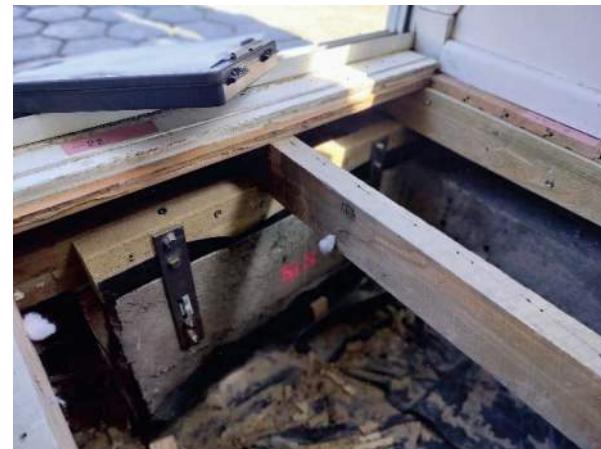
Photo 8. View of subfloor connections (1).

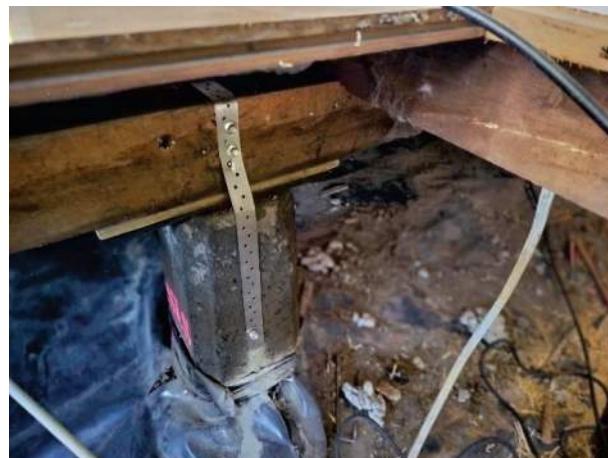
Photo 9. View of subfloor connections (2).

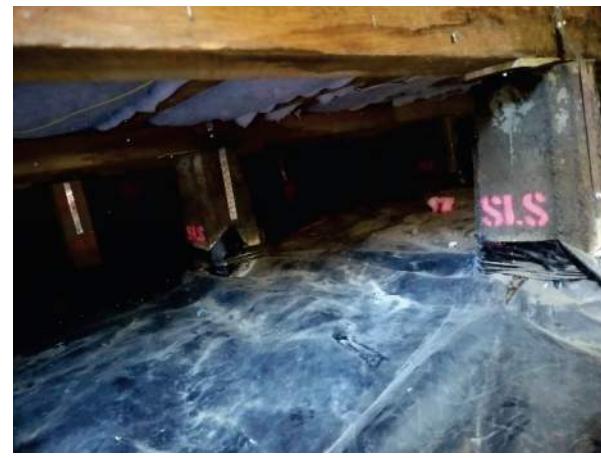
Photo 10. View of subfloor connections (3).

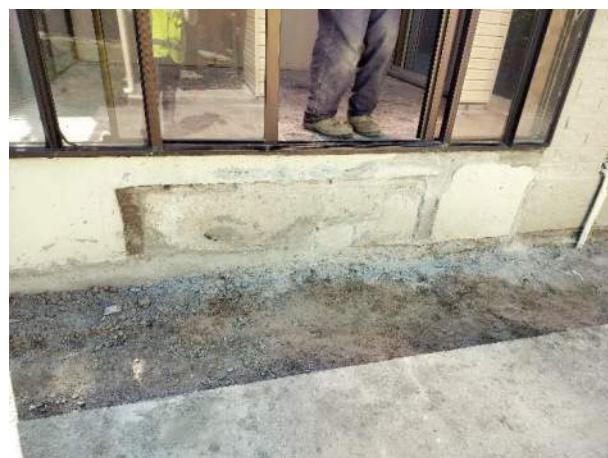
No further cracking damage to the perimeter foundation was observed during our final inspection. Therefore, Peridot considers that the crack repairs to type B foundation have been completed and there is no further cracking damage to the foundation of the dwelling.

Photo 11. View of crack repaired to the perimeter foundation.

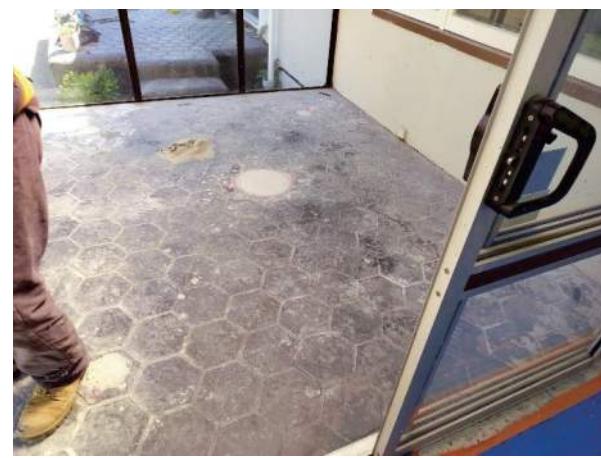
Photo 12. View of internal slab floor in Sunroom post re-levelling .

- f) Minor localised floor slope exceeding the limit of 0.5% was identified at the centre of the sunroom. Re-levelling has been completed to the maximum practicable extent, and any further re-levelling is likely to result in adverse impacts on surrounding levels. Therefore, the localised slope at the centre of the Sunroom is considered to be associated with as built condition. - OK.

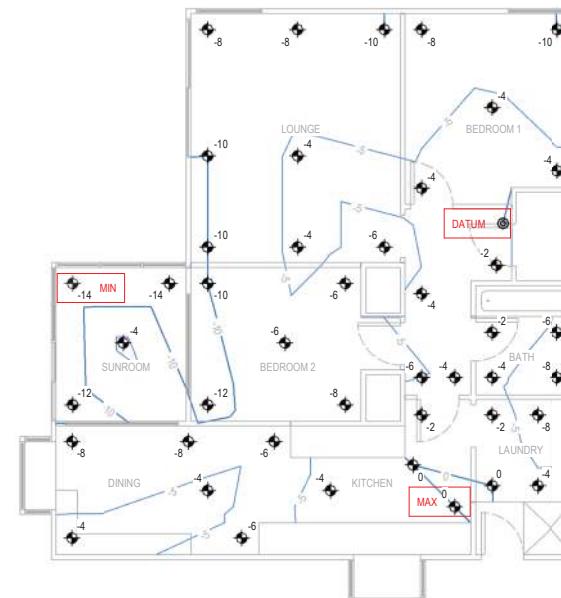
FLOOR LEVEL SURVEY - FINAL

The floor levels post remediation measured showed a maximum floor level variation of 14mm (0, -14) across the main dwelling footprint, within the 50mm suggested threshold of "no foundation re-level considered necessary" set out in Table 2.3 of the MBIE Guidance. Minor localised floor slope exceeding the limit of 0.5% was identified at the centre of sunroom. Re-leveelling has been completed to the maximum possible extent, and any further re-leveelling is likely to result in adverse impact on surrounding levels. Therefore, the localised slope at the centre of the Sunroom is considered to be associated with as built condition. All the earthquake related floor slopes have been remediated. Any identified localised slopes were a subject of as-built / historical.
