Independent Builders Report

Total Home Inspection Services Porirua City Ltd

Wed 17 Dec 2025

**12 Charlotte Way, Raumati South, Paraparaumu, 5032,
New Zealand**

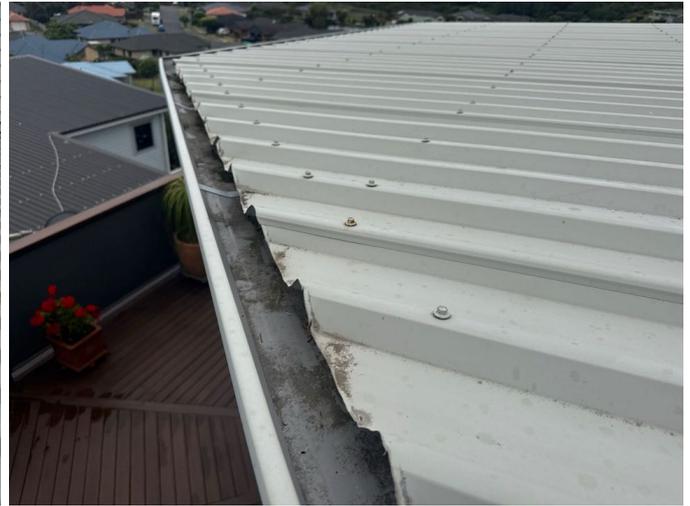
The spouting is in an average condition and was clear at the time of the inspection. The effectiveness of the spouting will need to be checked during rainy periods. Due to the dry conditions that were evident on the day of our inspection we cannot comment on any leaks that maybe evident to the spouting or down pipes.

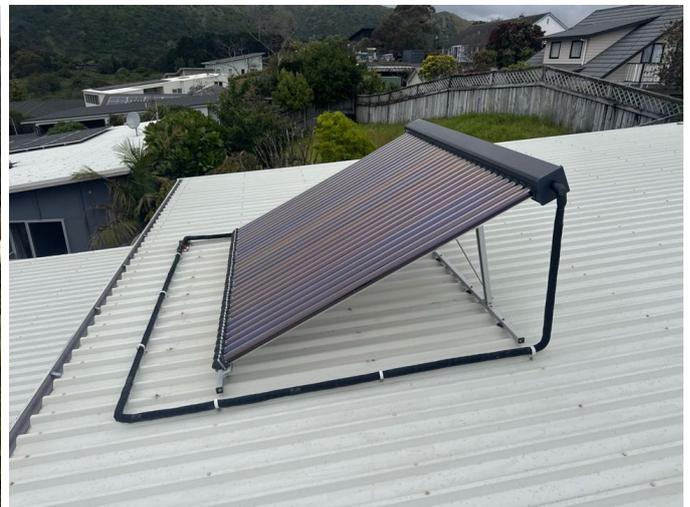
Solar water heating pipes to the roof. Outside the scope of this inspection.

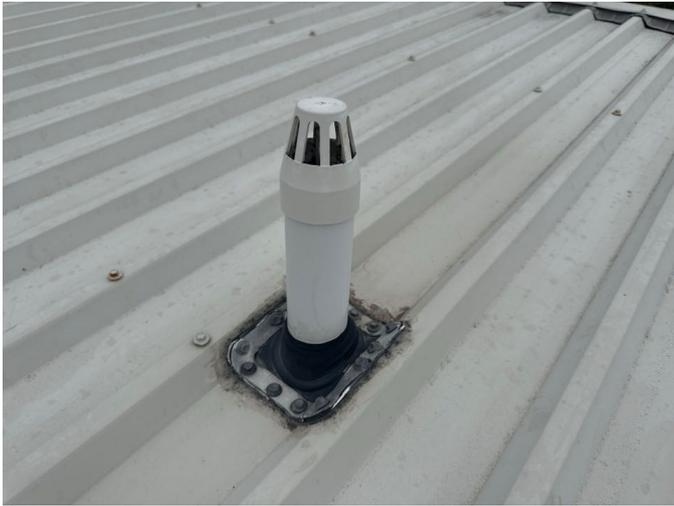
The roof penetrations are effectively sealed. The perimeter of the boot flashing at the base is finished with silicone which has a limited lifespan. The condition of the silicone seals should ideally be checked periodically and some replacement should be expected over time.

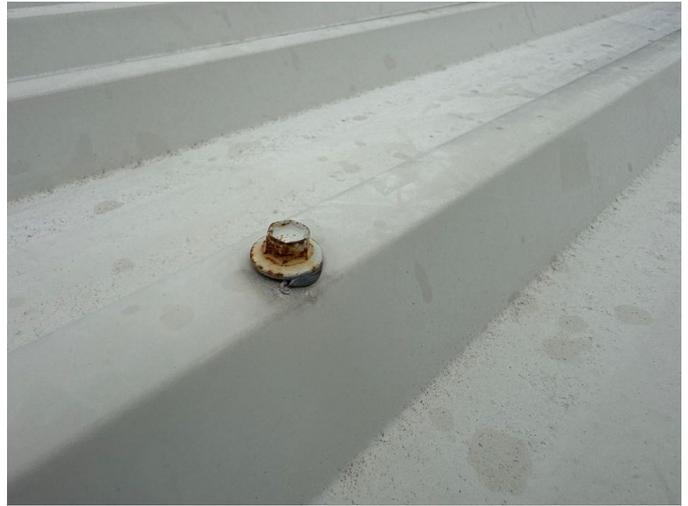
Early stage rust to the screws will need to be monitored. Rust treatment may help slow the deterioration.

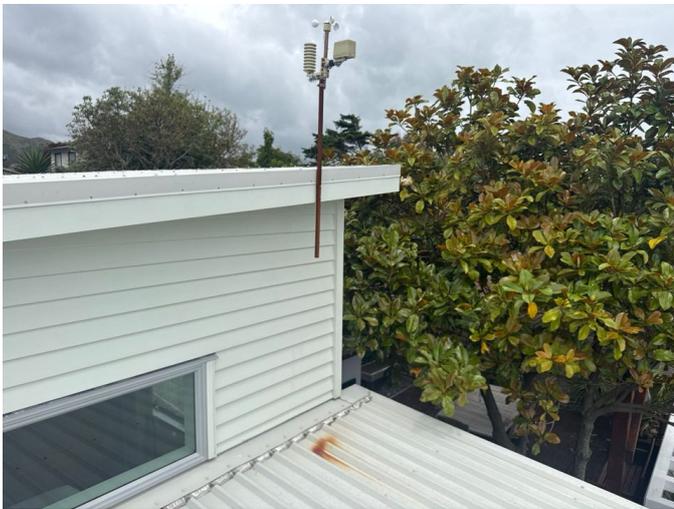
The weather station is causing rust staining to the roof surface beneath. Rust treatment and a plant upgrade may help prevent further staining.

Roofing - The rust affected weather station requires remediation to prevent further rust staining. The rust should be treated with rust converter and painted.

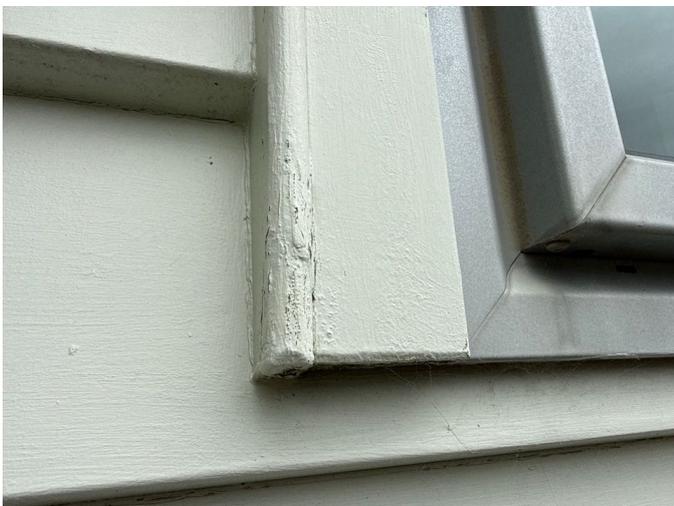
Paint deterioration to the timber scribes in some areas

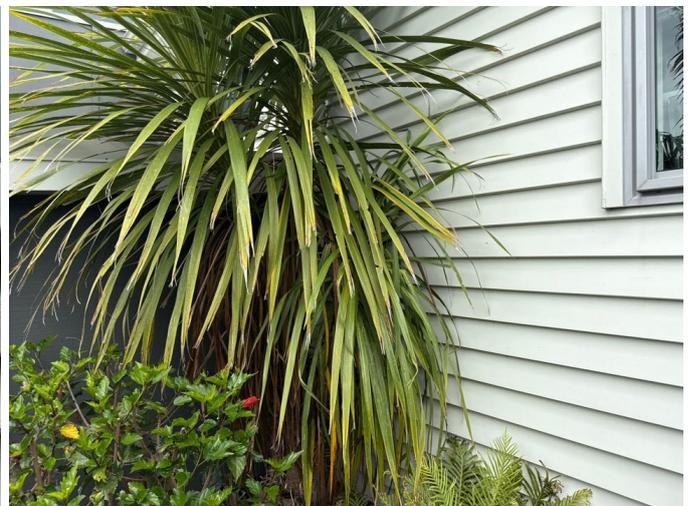
Plants in close contact with the cladding should be trimmed back to prevent the risk of premature deterioration

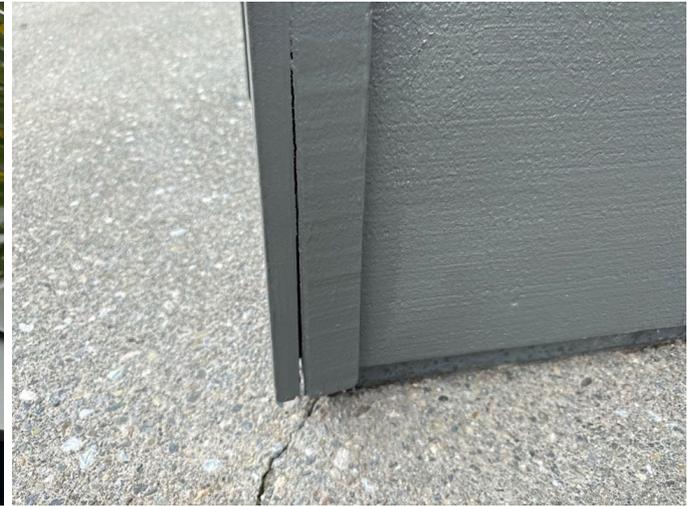
The base of the timber barge boards is often the first area to deteriorate and must be kept well sealed with paint. A paint upgrade will be required within the next 1-2 years.

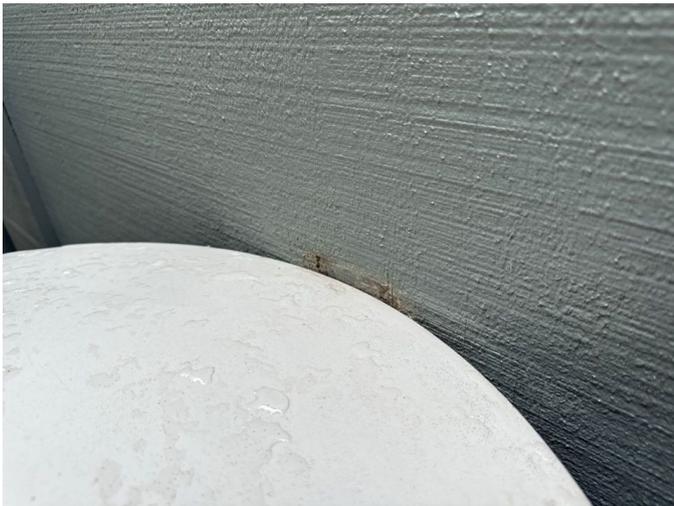
Movement from the water storage tank has worn the surface of the plywood and there is a risk of deterioration to the timber if left. T.H.I.S recommends the tank be moved and the plywood painted.

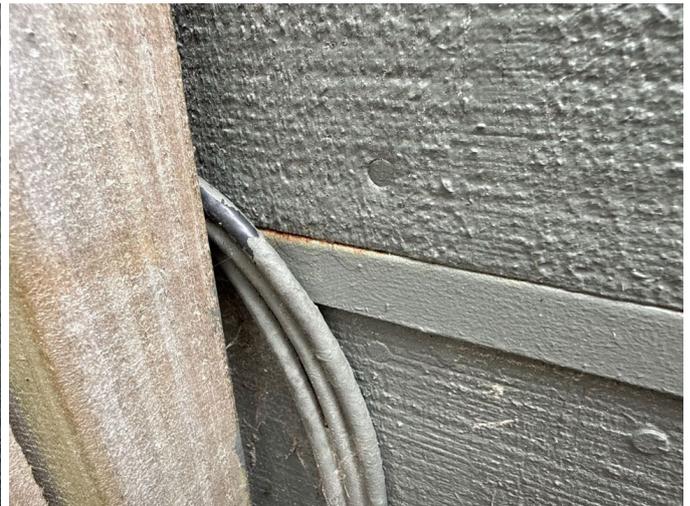
Surface rust to the junction flashings requires rust treatment and paint touch ups to prevent further deterioration.

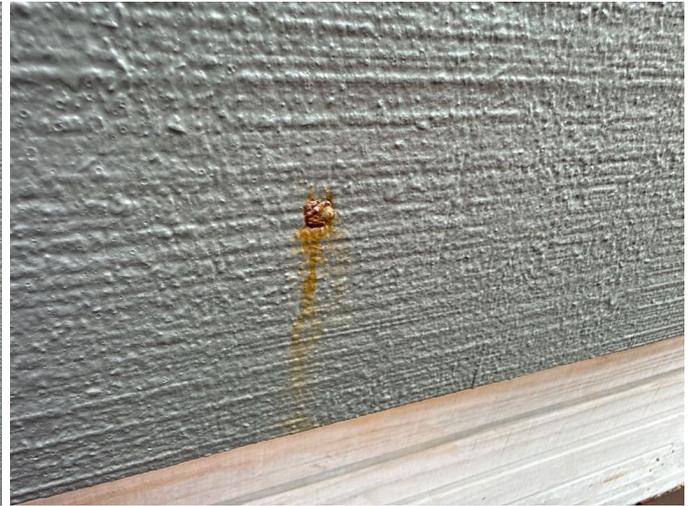
Rust affected nails need to be treated with rust converter and painted

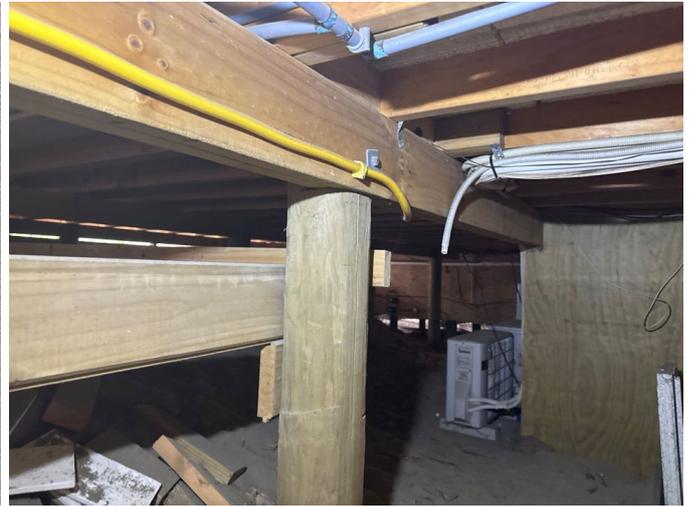
The timber piles are solid at the time of inspection. Galvanised bolts and Z nails connect the bearers to the piles and anchors the structure to the ground.

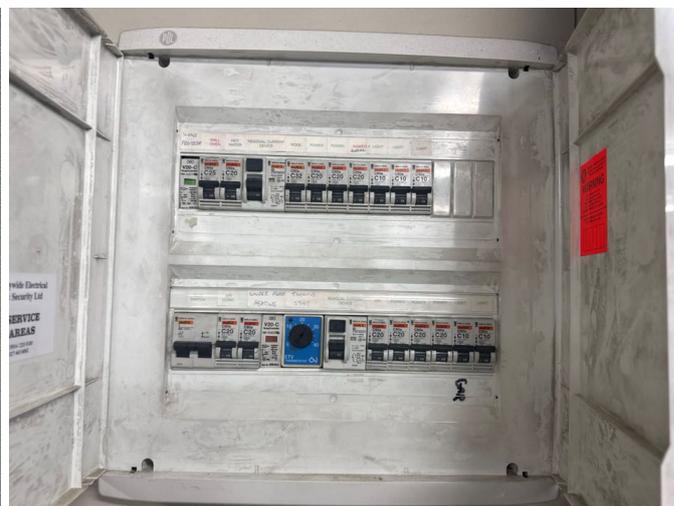
The meter board is effectively sealed at the time of inspection. The outer box should have a head flashing installed to move water away from the top. Elevated risk of moisture ingress here, ideally a head flashing should be installed. Smart meter installed, no obvious concerns sighted.

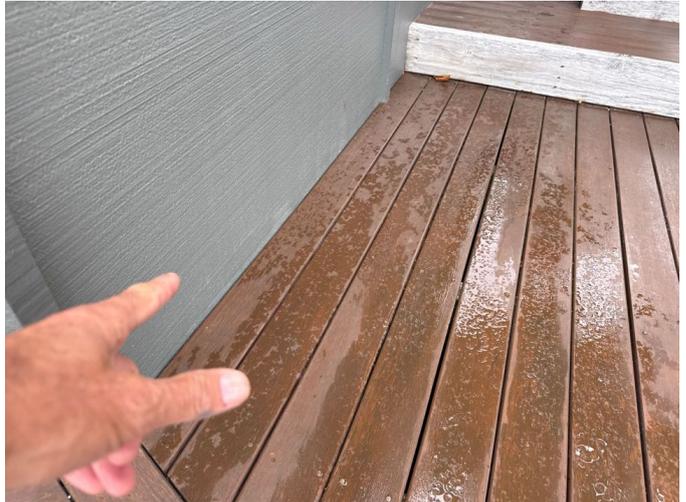
There is a risk of premature deterioration at the deck/cladding junction where the gap is less than the recommended. The gaps should be regularly cleared of debris to prevent the risk of damage. No current damage sighted.

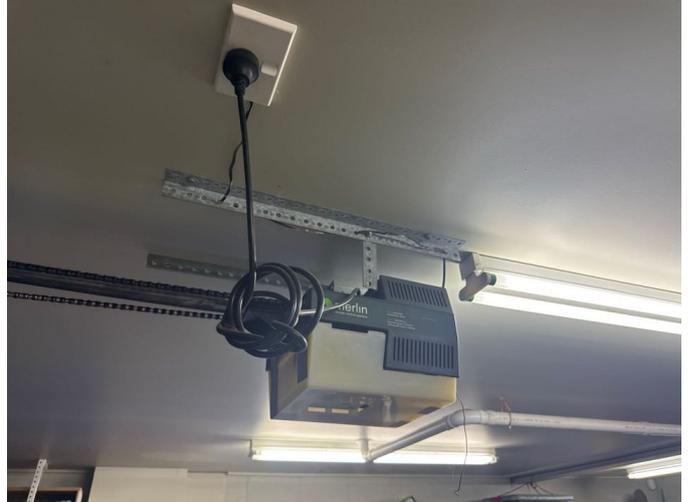
Not all areas of the garage could be fully inspected due to the presence of stored items. A full inspection is recommended once cleared. This applies to all concealed locations throughout the house.
