EARTHQUAKE RECOVERY (EQR) DOCUMENTATION

Released Under the Official Information Act 1982
EQR Property Overview Report

EQC Full Assessment Report

Claim Number: CLM/2011/054939 **Assessment Date:** 06/09/2011 10:26
Claimant: Ke Zhang **Assessor:** Burgess, Kelvin
Property Address: 16A DUNSFORD CLOSE **Estimator:** Barber, Jeff
 HALSWELL
 CHRISTCHURCH 8025 **Property Occupied By:** Owner Occupied

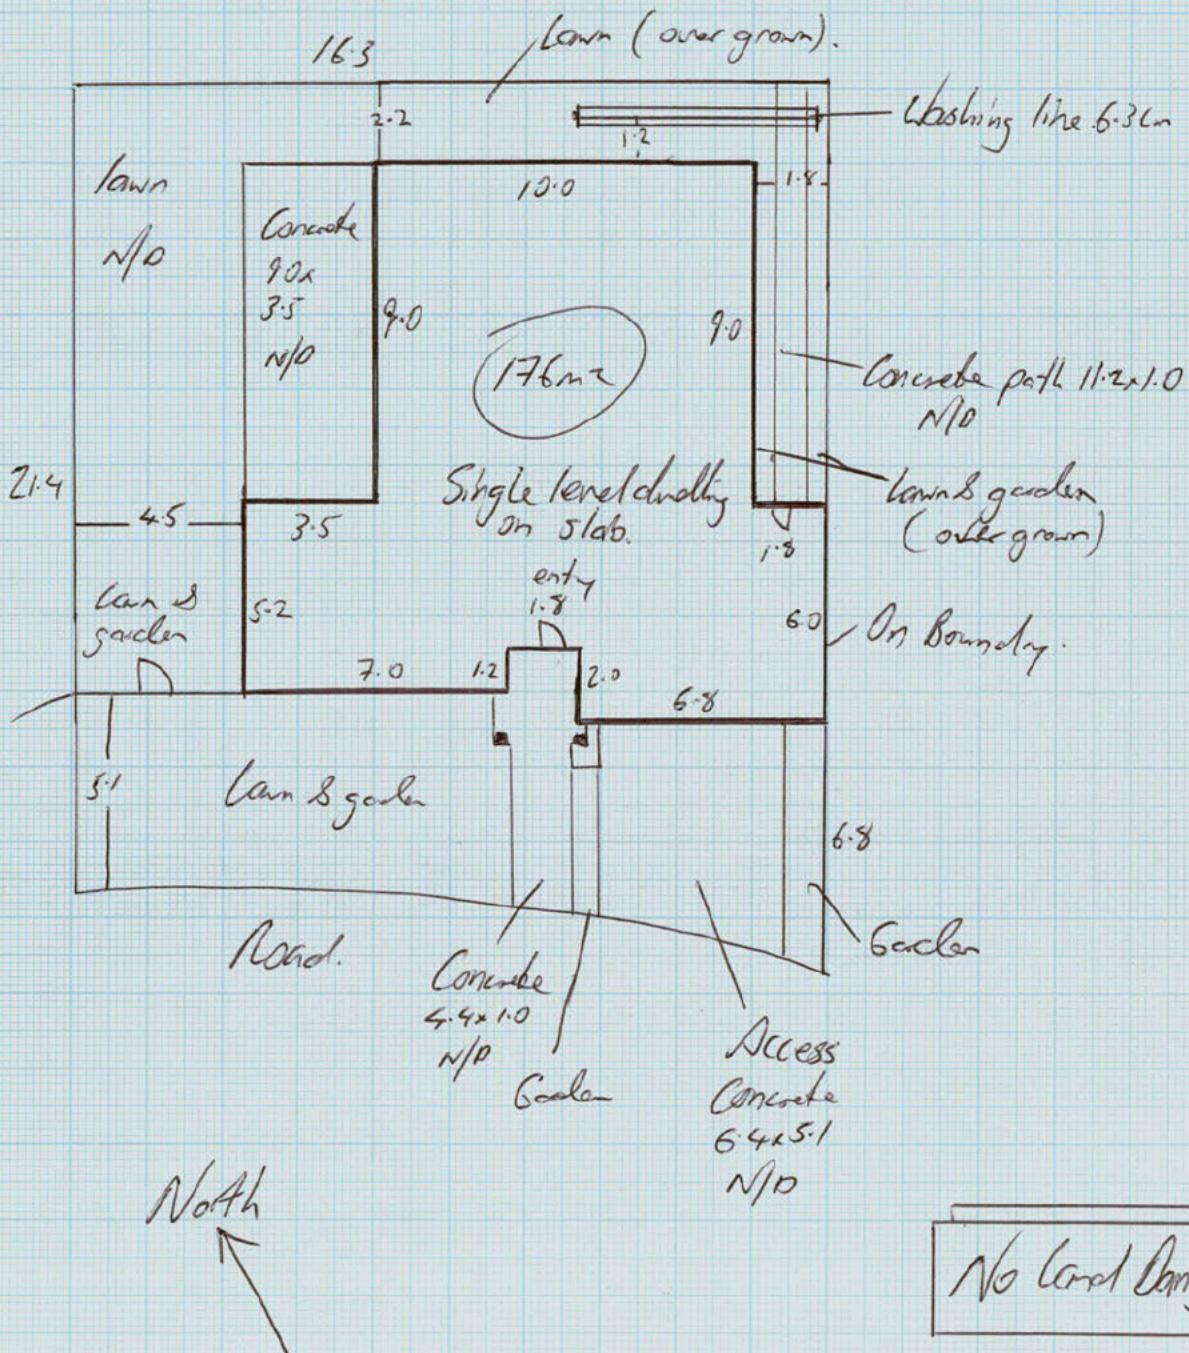
CLM / 2011 / 054939

No land damage

Total Area 433m²
entire section
within land
