EARTHQUAKE RECOVERY (EQR) DOCUMENTATION

EQR Property Overview Report

Address	33 NANCY AVENUE, MAIREHAU, CHRISTCHURCH, 8052	EQC Claim Number	CLM/2011/246150
Hazards	No hazards identified	EQC Assessor (L,F)	Batty, Alan
Inspection Date	08-Dec-2011	Placard	No Sticker
		EQC Estimator (L,F)	Atkinson, John

BULK SAMPLING INSPECTION & REPORT (Asbestos Sampling Report)

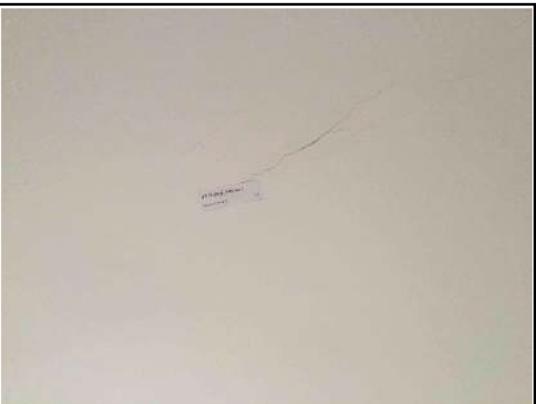
Sample Number	1
Location Description	Hallway
Location of Sample	Ceiling.
Material Description	Jointing Compound
Level of Identification	Bulk Sampled and Identified
Laboratory Sample ID	E05991.1
Asbestos Type	NAD
Notes / comments:

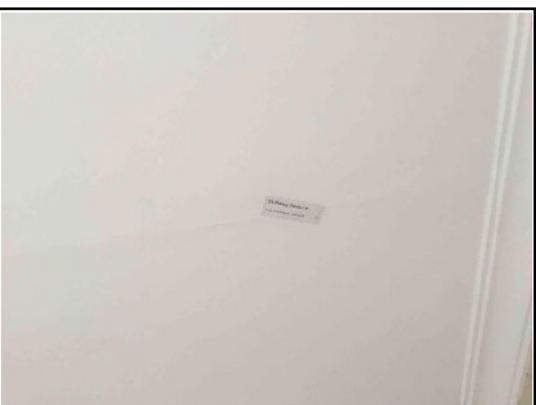
Sample Number	2
Location Description	South East Bedroom
Location of Sample	Ceiling.
Material Description	Jointing Compound
Level of Identification	Bulk Sampled and Identified
Laboratory Sample ID	E05991.2
Asbestos Type	NAD
Notes / comments:

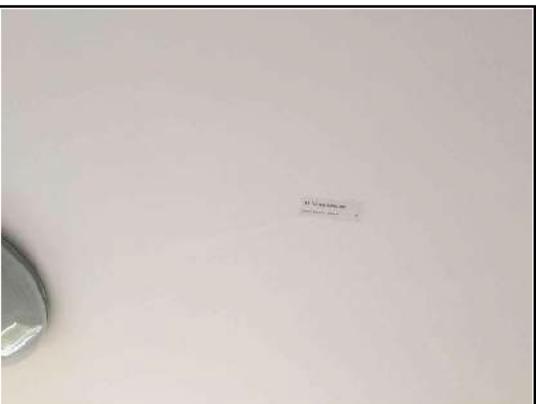
Sample Number	3
Location Description	Master Bedroom
Location of Sample	Ceiling.
Material Description	Jointing Compound
Level of Identification	Bulk Sampled and Identified
Laboratory Sample ID	E05991.3
Asbestos Type	NAD
Notes / comments:

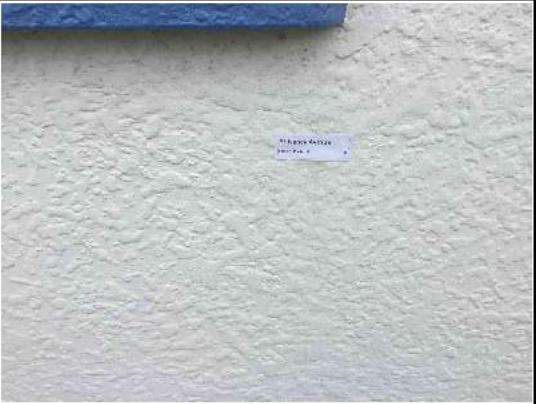
Sample Number	4
Location Description	Exterior North
Location of Sample	Cladding
Material Description	Solid Plaster
Level of Identification	Bulk Sampled and Identified
Laboratory Sample ID	E05991.4
Asbestos Type	NAD

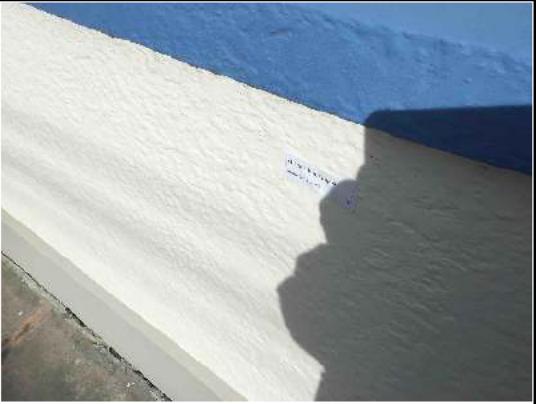
Sample Number	5
Location Description	Exterior East
Location of Sample	Cladding
Material Description	Solid Plaster
Level of Identification	Bulk Sampled and Identified
Laboratory Sample ID	E05991.5
Asbestos Type	NAD

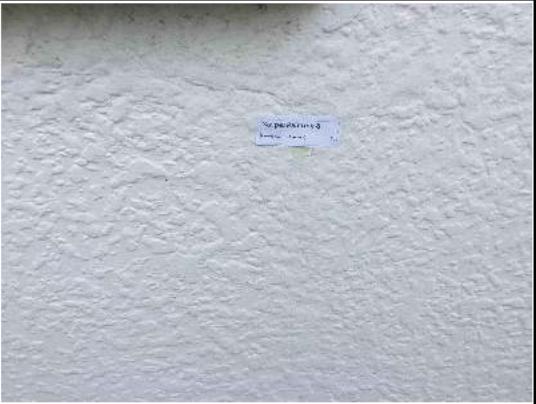
Sample Number	6
Location Description	Exterior South
Location of Sample	Cladding
Material Description	Solid Plaster
Level of Identification	Bulk Sampled and Identified
Laboratory Sample ID	E05991.6
Asbestos Type	NAD

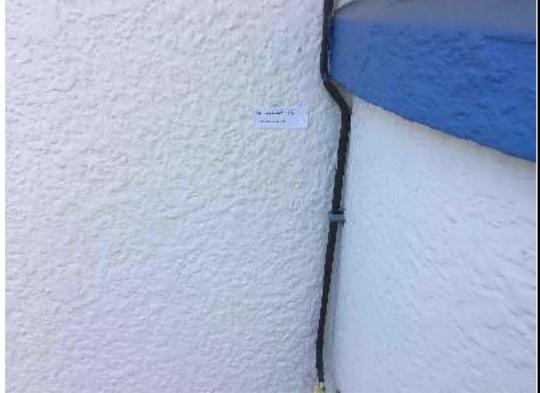
Sample Number 7
Location Description	Exterior West
Location of Sample	Cladding
Material Description	Solid Plaster
Level of Identification	Bulk Sampled and Identified
Laboratory Sample ID	E05991.7
Asbestos Type	NAD
Notes / comments:
