CASH SETTLED CLAIM(S)

Claim Number: 2010/058596

## EQC Full Assessment Report

### Assessment of Property at 25 WESTFIELD AVENUE, TEMPLETON, CHRISTCHURCH 8042 on 7/12/2011

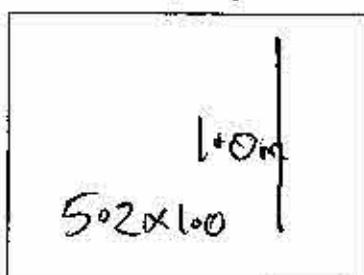
Stairwell

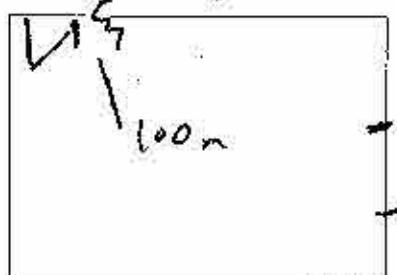
Laundry
